BELDEN COTTAGE
Owners
Anne B. Belden and John R. Belden
Trustees of the Anne B. Belden Living Trust

13 OAK AVENUE
PEAKS ISLAND, MAINE 04108

SCALE: 1/4" = 1'-0"
second floor plan and roof plan with Demo

A .3

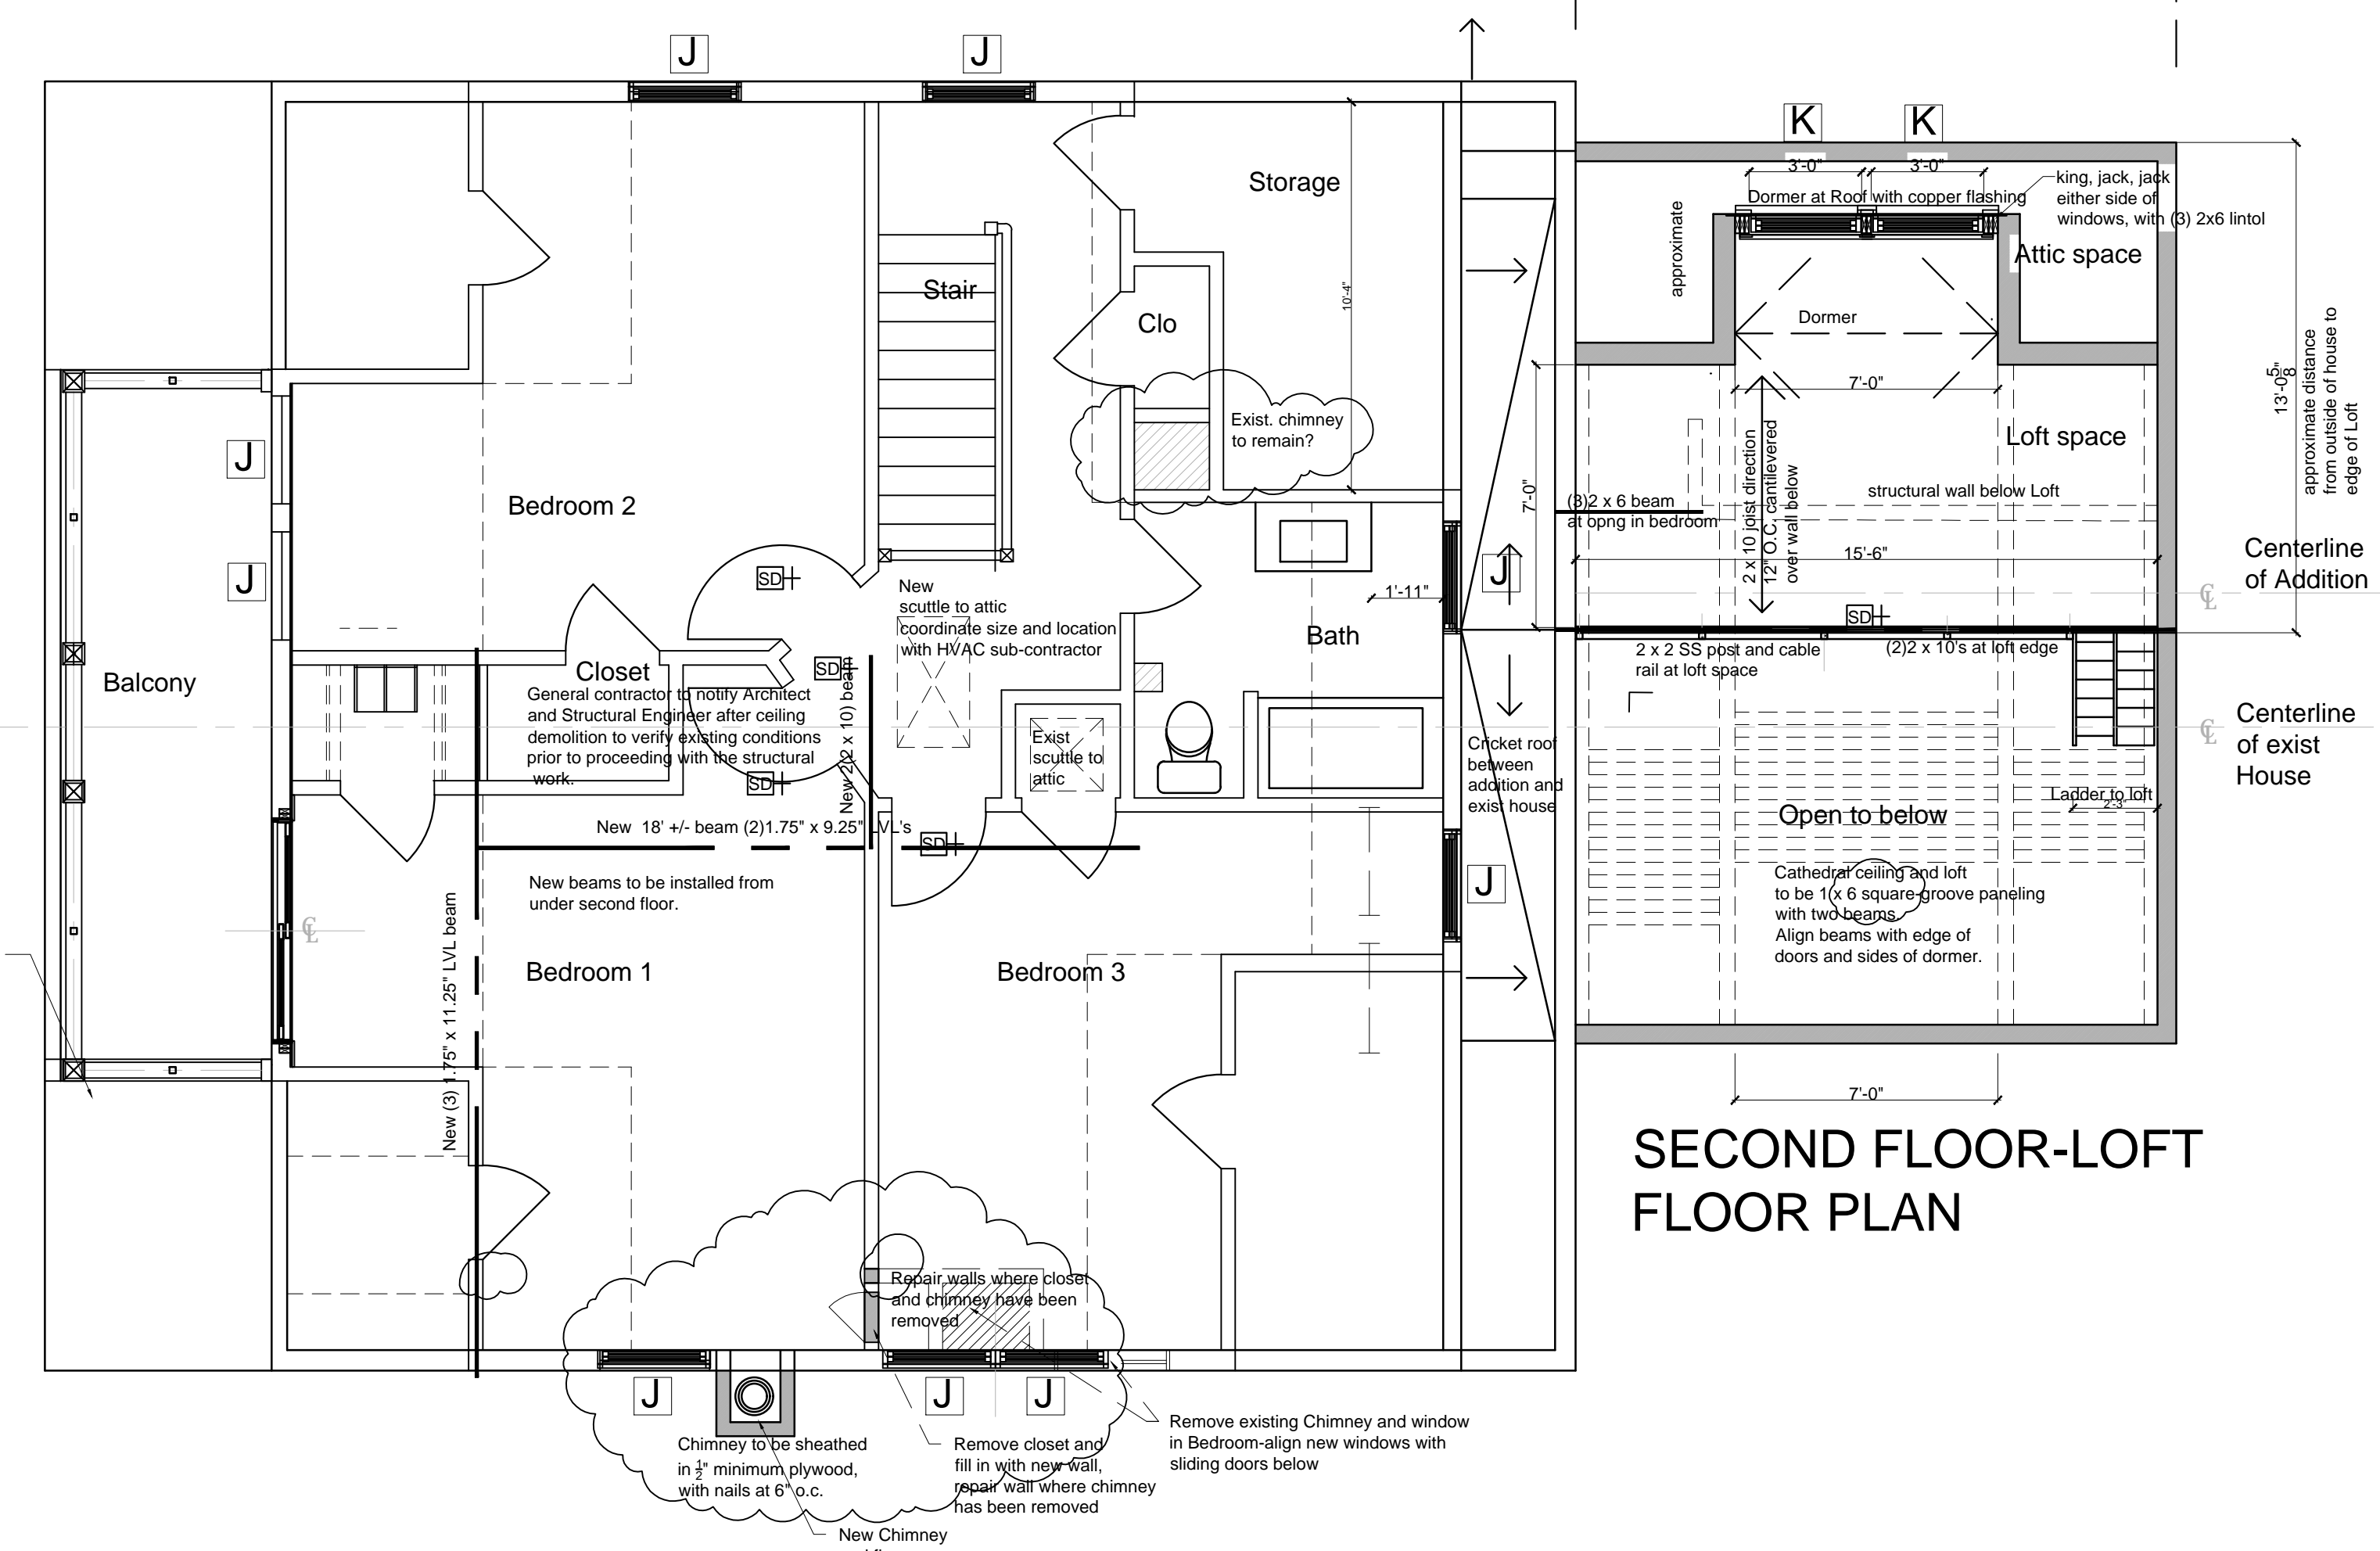
SECOND FLOOR-LOFT FLOOR PLAN

Work on Second Floor consist of Loft Area above New Bedroom Addition, heating system, scuttle to attic, smoke detectors, new windows and trim, new chimney, new wall at old chimney, millwork in closets, new vanity in exist. bath, painting of trim,walls and ceilings where needed and removal of existing chimney.

scale : 1/4" = 1'-0"
