STRUCTURAL NOTES:

SECTION C-C

SECTION A-A

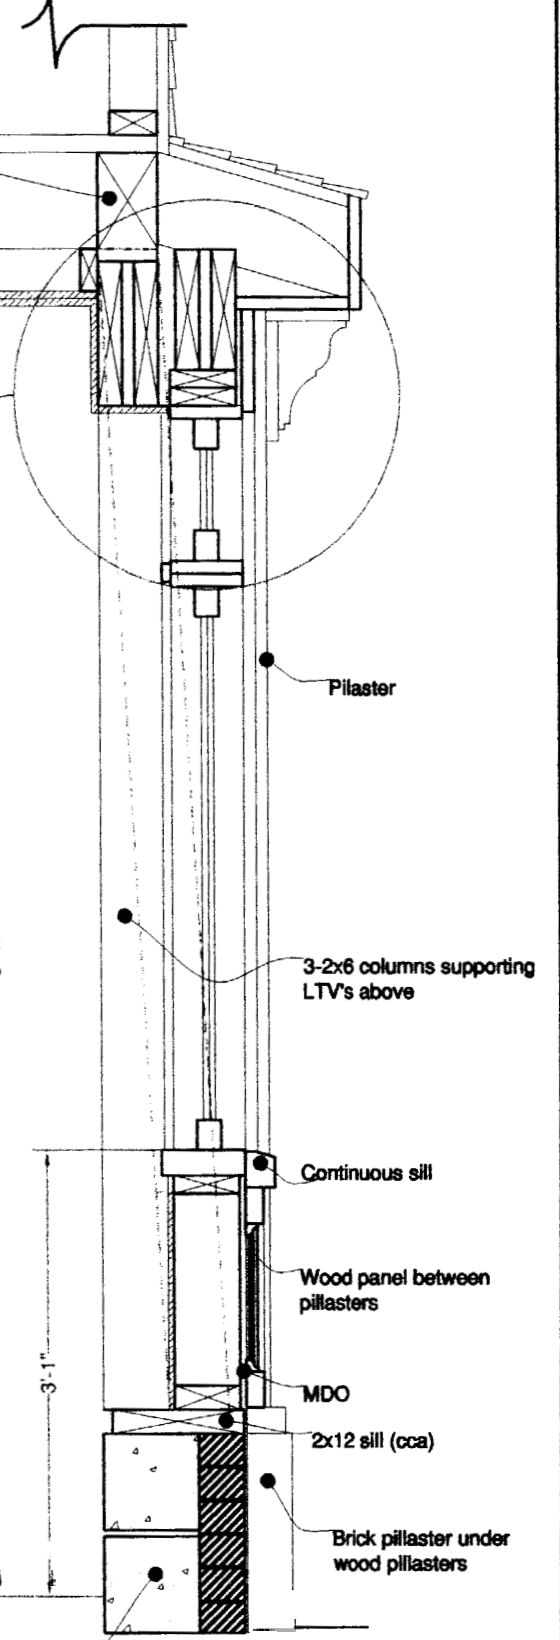
New 8" CMU wall

CMU filled

NOTE:
 Section B-B is the same as Section A-A except window openings are replaced with 2x6 wall & casement & transom windows are replaced with wood flat panels with OG billection mouldings.
