UNIVERSITY OF NEW ENGLAND

ALUMNI HALL RENOVATION

RESTORATION ELEVATION

RE1.2

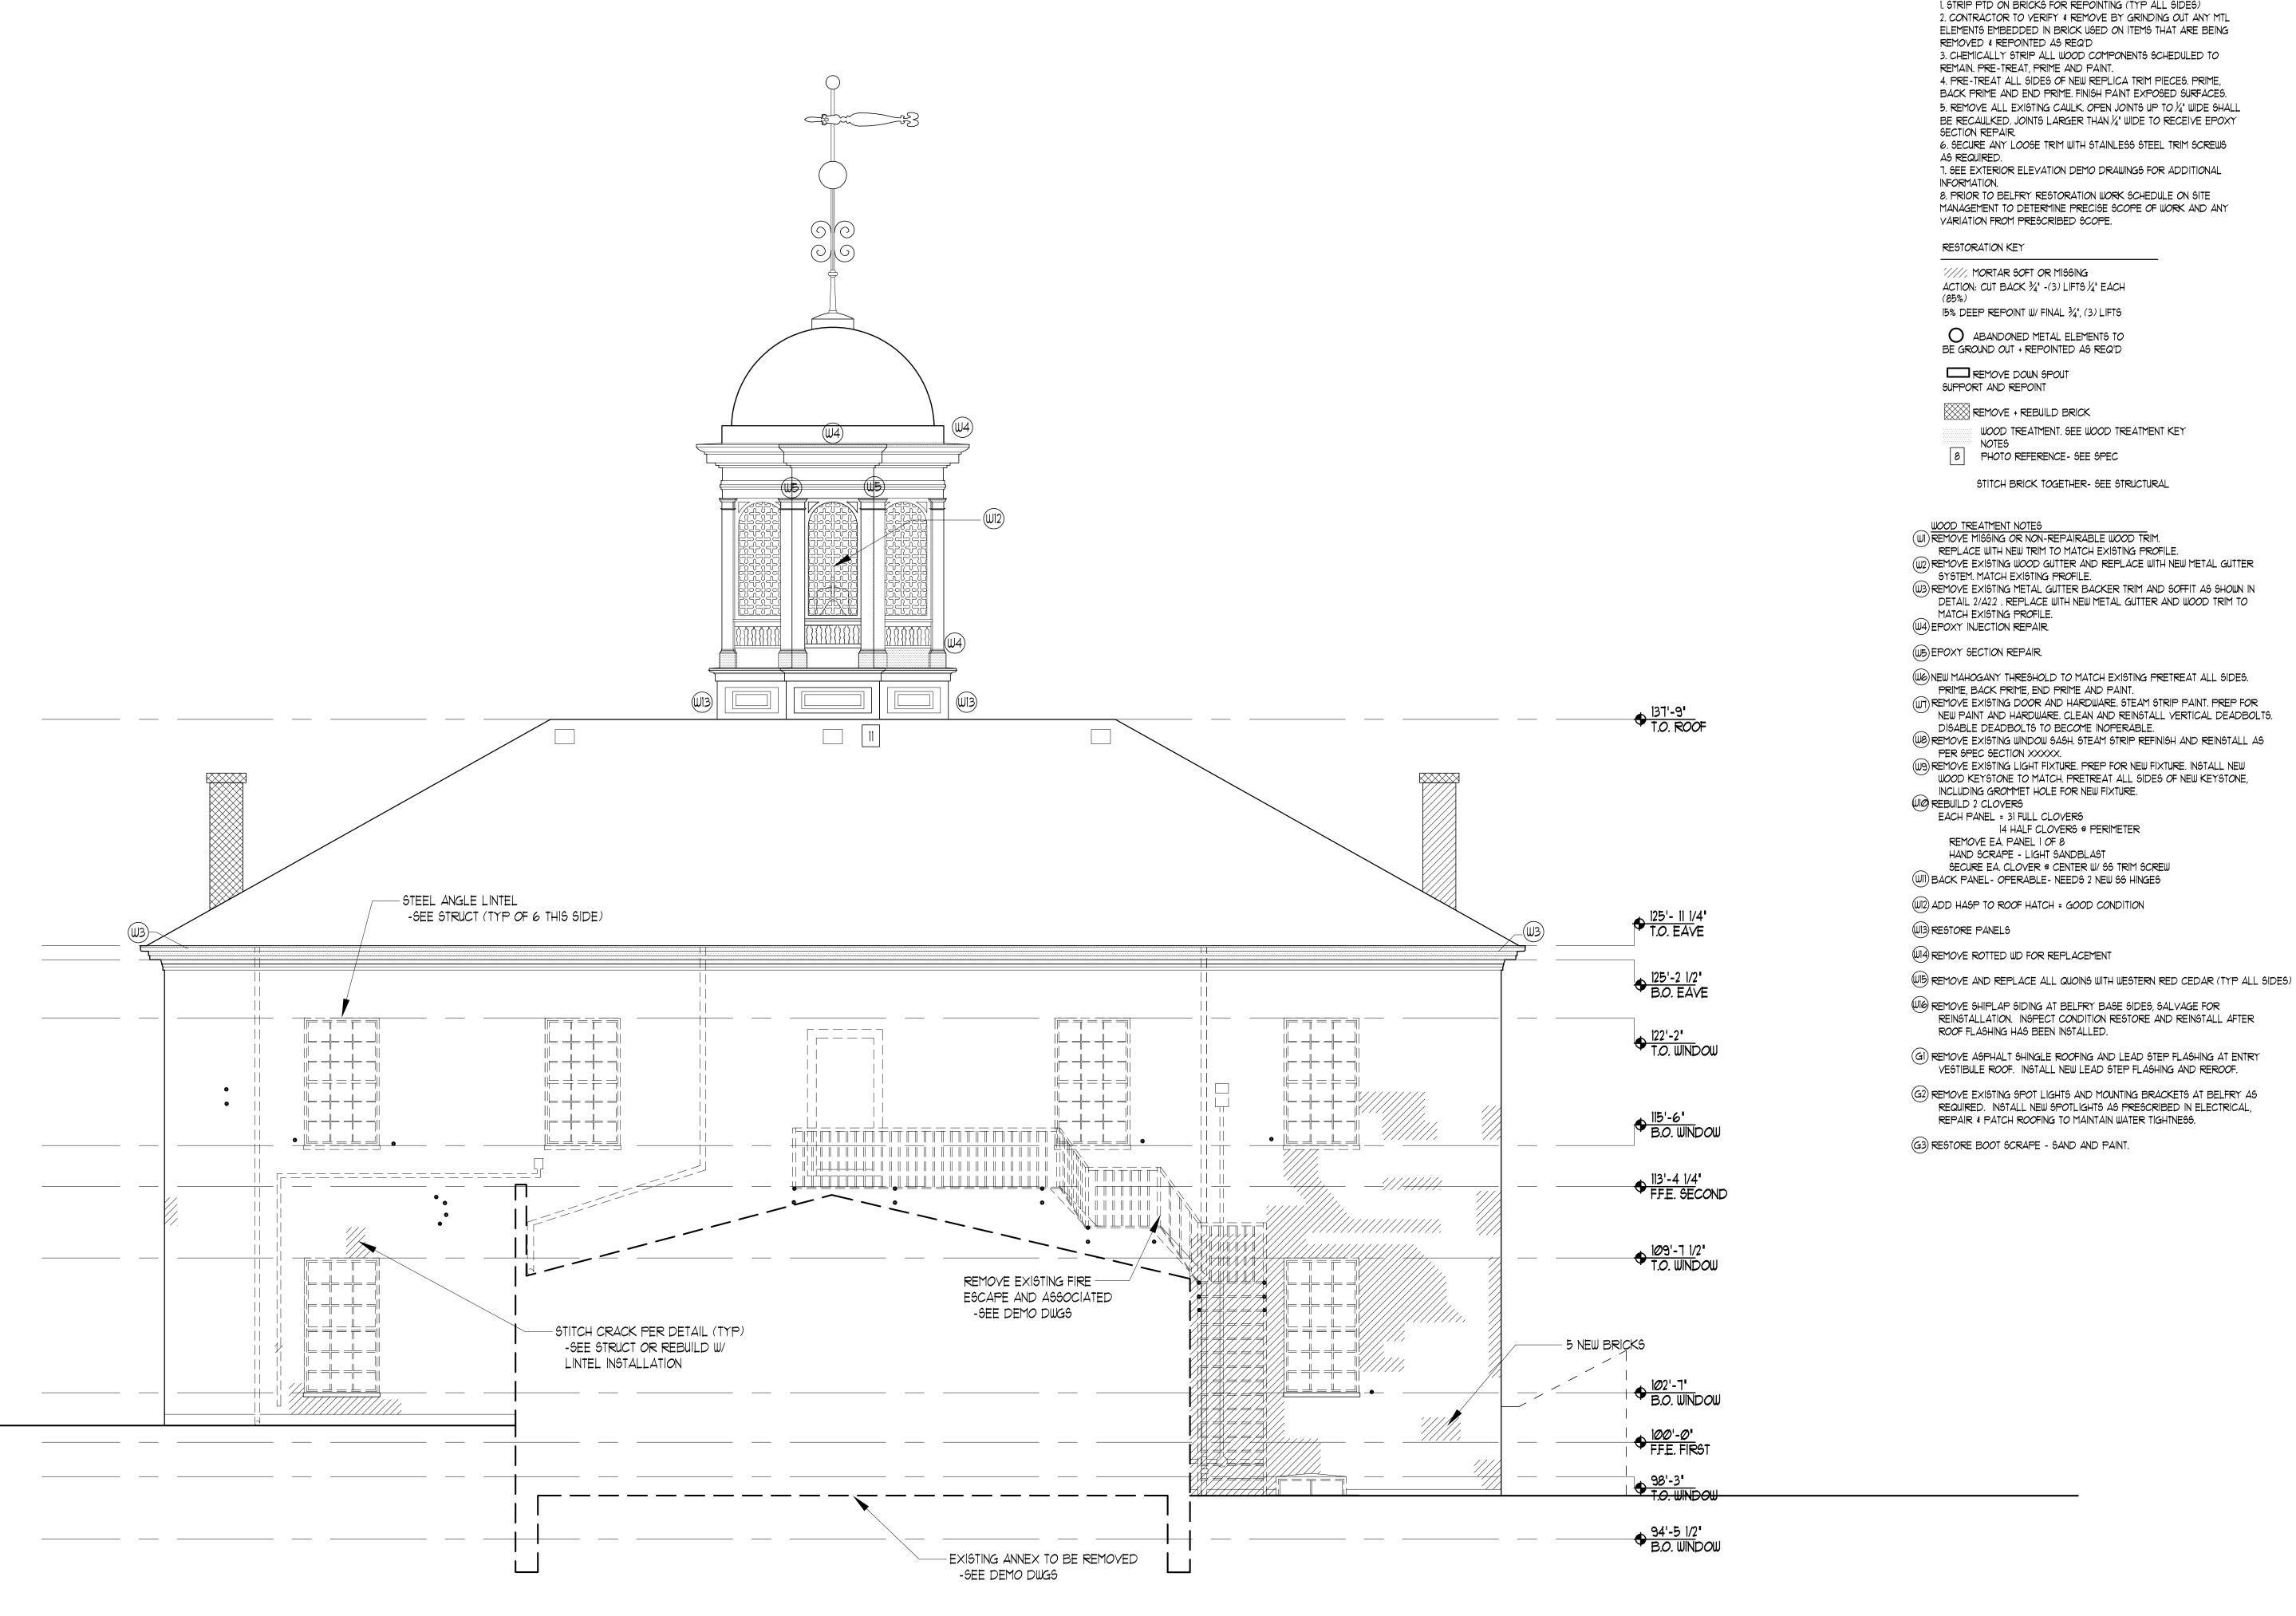
EXISTING CONDITION - WEST ELEVATION

GENERAL CONDITION RESTORATION NOTES: 1. STRIP PTD ON BRICKS FOR REPOINTING (TYP ALL SIDES)

(W2) REMOVE EXISTING WOOD GUTTER AND REPLACE WITH NEW METAL GUTTER

DETAIL 2/A22 . REPLACE WITH NEW METAL GUTTER AND WOOD TRIM TO

(W6) NEW MAHOGANY THRESHOLD TO MATCH EXISTING PRETREAT ALL SIDES.

NEW PAINT AND HARDWARE. CLEAN AND REINSTALL VERTICAL DEADBOLTS.

REINSTALLATION. INSPECT CONDITION RESTORE AND REINSTALL AFTER ROOF FLASHING: HAS BEEN INSTALLED.

(GI) REMOVE ASPHALT SHINGLE ROOFING AND LEAD STEP FLASHING AT ENTRY

(G2) REMOVE EXISTING SPOT LIGHTS AND MOUNTING BRACKETS AT BELFRY AS REQUIRED. INSTALL NEW SPOTLIGHTS AS PRESCRIBED IN ELECTRICAL,
