<p><b>SD-100</b></p> <p>ROOF/FRAMING DEMOLITION PLAN</p> <p>REPLACE BAY #8 ROOF SYSTEM F.M.S. #1 PORTLAND, MAINE</p>	<p>Date: 03/10/2006</p> <p>Drawn By: PED</p> <p>Checked By: WPF</p> <p>Project Mgr: WPF</p> <p>Project No: 06009</p> <p>Cad File: 06009SD.DWG</p> <p>Graphic Scale: 0 1"</p>	<p>REVISIONS</p> <table border="1"> <thead> <tr> <th>NUMBER</th> <th>DATE</th> <th>BY</th> <th>DESCRIPTION</th> </tr> </thead> <tbody> <tr> <td> </td> <td> </td> <td> </td> <td> </td> </tr> </tbody> </table>	NUMBER	DATE	BY	DESCRIPTION					<p> </p> <p> </p> <p> <b>Allied Engineering</b>          Structural Mechanical Electrical Commissioning       </p> <p>         160 Veranda Street          Portland, Maine 04103          T: 207.221.2260          F: 207.221.2266          Web: www.allied-eng.com       </p>
	NUMBER	DATE	BY	DESCRIPTION							
<p>© COPYRIGHT 2006 ALLIED ENGINEERING, INC.</p>	<p> </p>	<p> </p>	<p> </p>

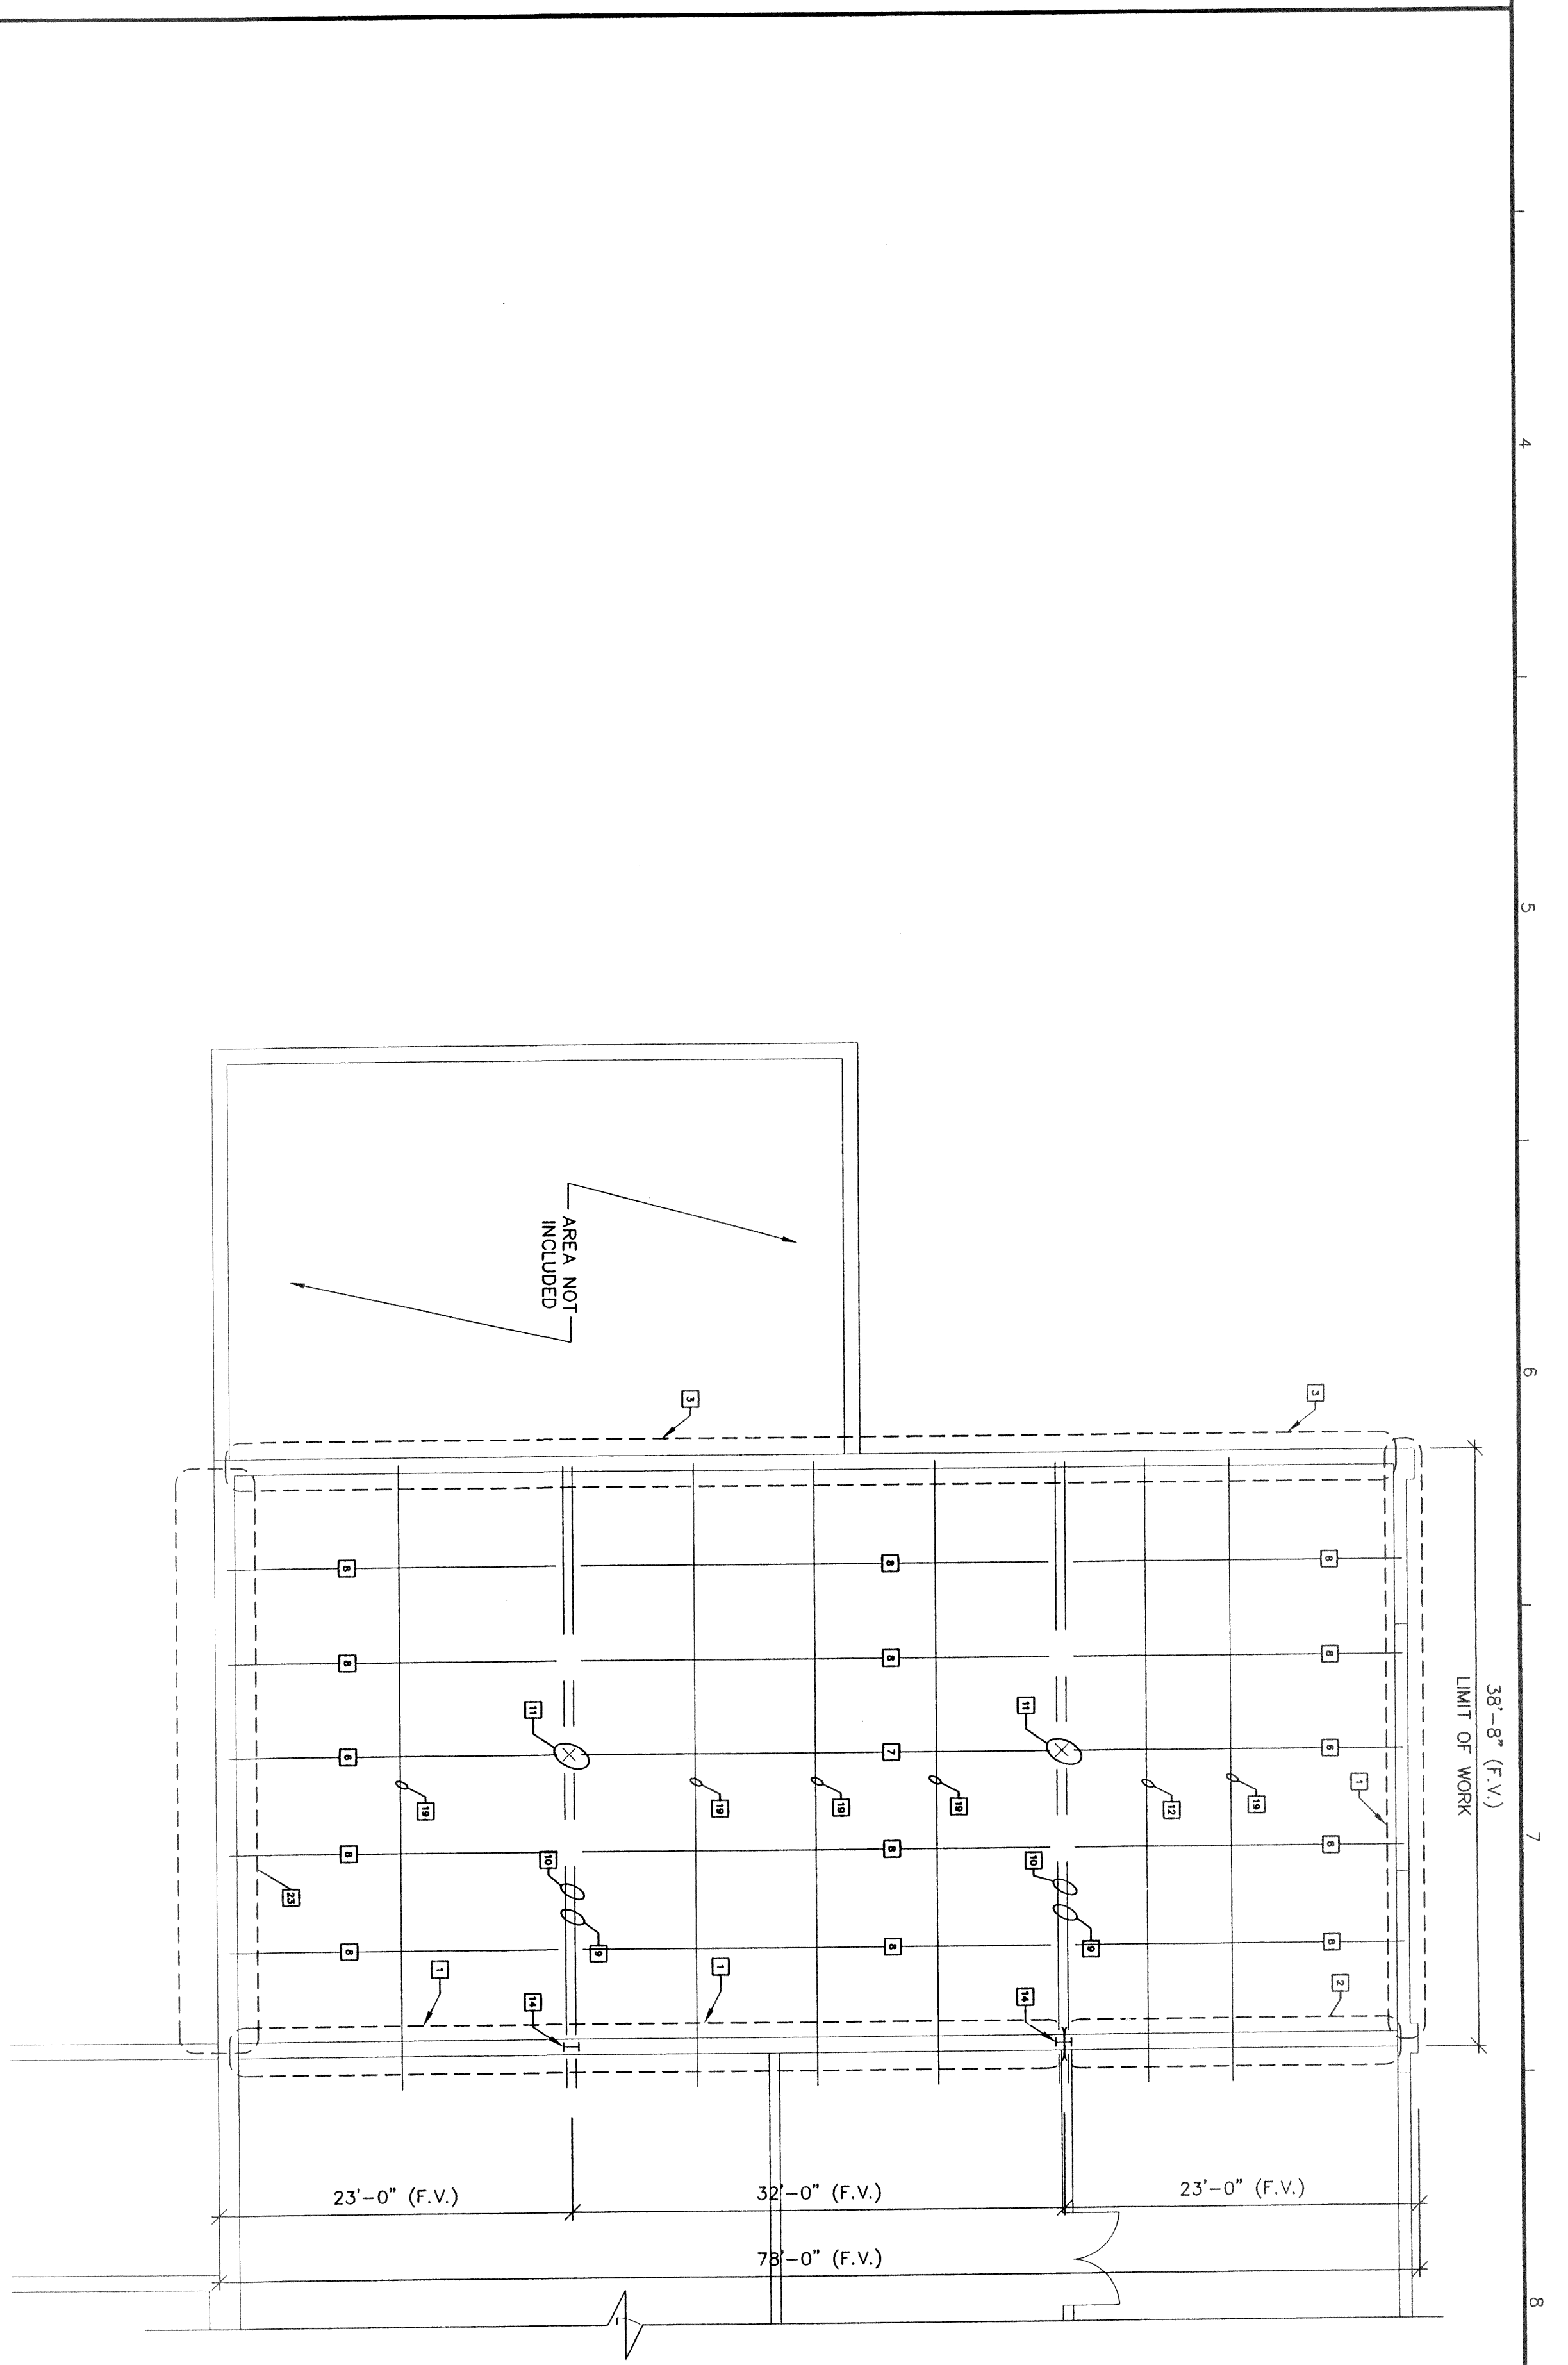
E4 FRAMING DEMOLITION PLAN  
1/8" = 1'-0"

- FRAMING DEMOLITION KEY NOTES**
- 1 DEMO EXISTING MASONRY WALL DOWN TO 21'-0"± ABOVE FINISH FLOOR AND REMOVE (E) CHANNEL. SEE E5/SF-100.
  - 2 DEMO EXISTING MASONRY WALL DOWN TO 21'-0"± ABOVE FINISH FLOOR. SEE 08/SF-100.

- 3 DEMO EXISTING MASONRY WALL DOWN TO 19'-3"± ABOVE FINISH FLOOR. SEE DETAIL E3/SF-100 AND C3/SF-100 FOR INSTALLATION.
  - 4 NOT USED
  - 5 NOT USED
  - 6 REMOVE EXISTING LOW BAY TRUSSES COMPLETE. PROVIDE BRICK INFILL AT EXISTING MASONRY WALL.

- 7 REMOVE EXISTING HIGH BAY TRUSSES COMPLETE.
  - 8 EXISTING INTERMEDIATE WOOD MEMBERS TO BE REMOVED COMPLETELY.
  - 9 EXISTING (2) 18W50 TO REMAIN (LOW)

- 10 EXISTING CHANNEL TO BE REMOVED (HIGH)
  - 11 EXISTING COLUMN (HIGH) TO BE REMOVED. CUT FLUSH w/TOP OF EXISTING STEEL MEMBER TO REMAIN.
  - 12 EXISTING ANGLE TO REMAIN. PROVIDE L 2x2x1/4 SUPPORTS TO NEW ROOF JOISTS. PROVIDE TEMPORARY SUPPORT UNTIL NEW STRUCTURE/SUPPORTS ARE INSTALLED. NOT USED

- 13 REMOVE EXISTING COLUMN DOWN TO ELEVATION 2'-0"± ABOVE FINISH FLOOR.
  - 14 REMOVE EXISTING COLUMN DOWN TO ELEVATION 2'-0"± ABOVE FINISH FLOOR.
  - 15 NOT USED

- 16 NOT USED
  - 17 NOT USED
  - 18 NOT USED
  - 19 EXISTING TIE-BEAMS TO BE REMOVED. TYP.
  - 20 NOT USED
  - 21 NOT USED
  - 22 NOT USED
  - 23 DEMO EXISTING MASONRY WALL DOWN TO 21'-0"± ABOVE FINISH FLOOR AND REMOVE (E) CHANNEL. SEE 08/SF-100.
