165 WOODLAWN AVENUE  
RENOVATIONS  
PORTLAND, MAINE

SHEET TITLE:  
ELEVATIONS

A2-0

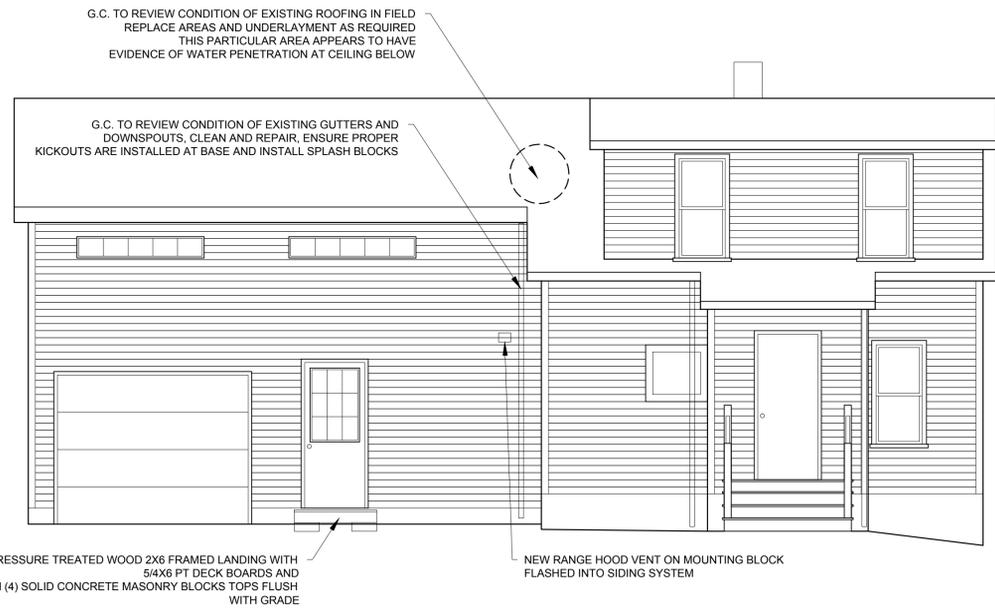
4 NORTH ELEVATION  
1/4" = 1'-0"

- G.C. TO REVIEW CONDITION OF EXISTING FLASHING MASONRY JOINTS AND CAP AT CHIMNEY REPAIR AS REQUIRED FOR WEATHER TIGHT CONDITION
- G.C. TO REVIEW CONDITION OF EXISTING ROOFING IN FIELD REPLACE AREAS AND UNDERLAYMENT AS REQUIRED
- EXTEND AND OR MODIFY DRIP EDGE AS REQUIRED FOR POSITIVE DRIP OVER NEW BREAK METAL FLASHING
- WRAP EXISTING TRIM WITH PREFINISHED BREAK METAL FLASHING SEAL ALL JOINTS
- APPLY SEALANT TO ALL GAPS AT EXISTING EAVE AND RAKE TRIM
- INSTALL NEW 1/2" PVC SOFFIT BOARD FASTEN TO SOLID FRAMING

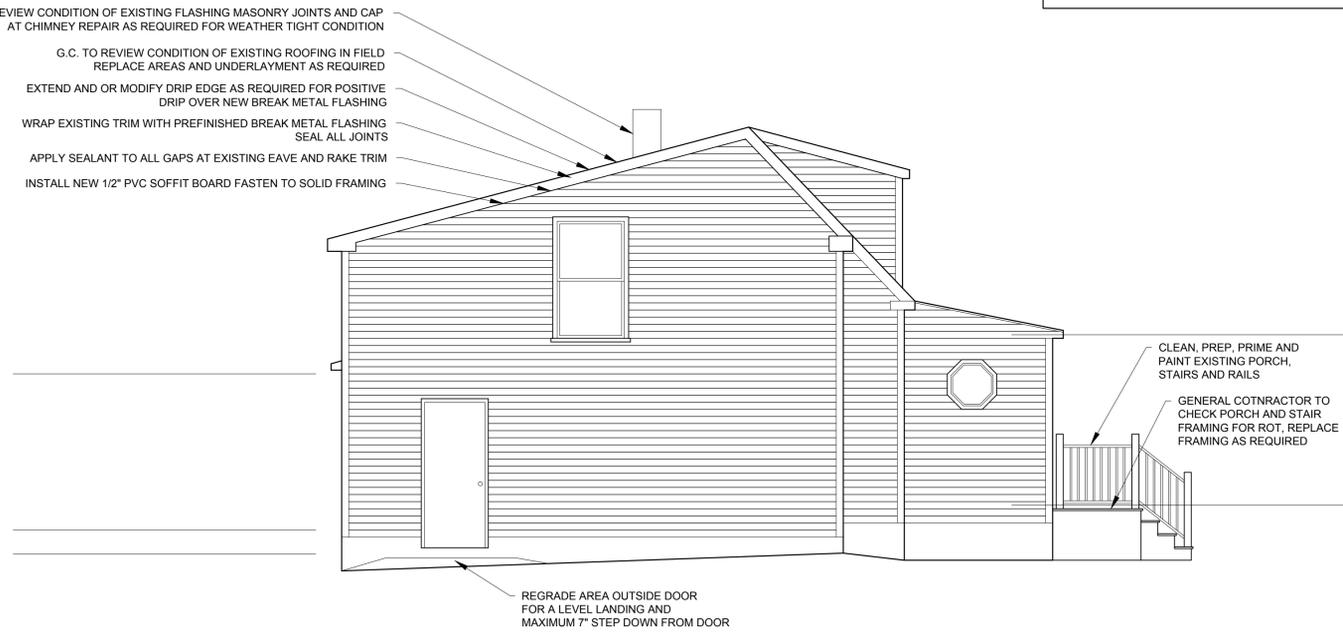
2 EAST ELEVATION  
1/4" = 1'-0"

- WRAP EXISTING TRIM WITH PREFINISHED BREAK METAL FLASHING SEAL ALL JOINTS
- APPLY SEALANT TO ALL GAPS AT EXISTING EAVE AND RAKE TRIM
- INSTALL NEW 1/2" PVC SOFFIT BOARD FASTEN TO SOLID FRAMING
