NRPA Individual Permit Application - Embankment Repairs and Trail Improvements on Back Cove Trail. Portland, Maine - NRPA Permit No. L-24096-4E-A-N

Alternatives Analysis and Avoidance/Minimization Statement

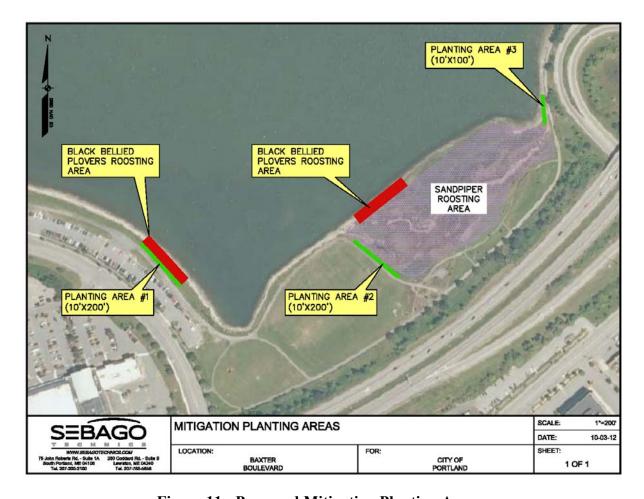
Figure 11: Proposed Mitigation Planting Areas

As part of the prior NRPA permit for retaining wall repairs, the City of Portland agreed to a mitigation plan that included plantings for upland stabilization and screening of waterfowl roosting areas along two sections of the Back Cove recreational trail. The original mitigation plan was revised to include a third section of plantings north of the sandpiper roosting area and along the trail in accordance with IF&W and MDEP. Figure 11 shows the three proposed planting areas and their proximity to the trail, parking lot and field areas.

The three proposed planting areas shall be planted with 24"-36" Rosa Rugusa plants. New plantings shall be planted 3-feet on center in a loosely offset pattern within upland areas close to the trail and outside the coastal wetland. The City arborist will maintain mitigation plantings as part of the maintenance plan for adjacent Yardscaping Gardens at Back Cove.

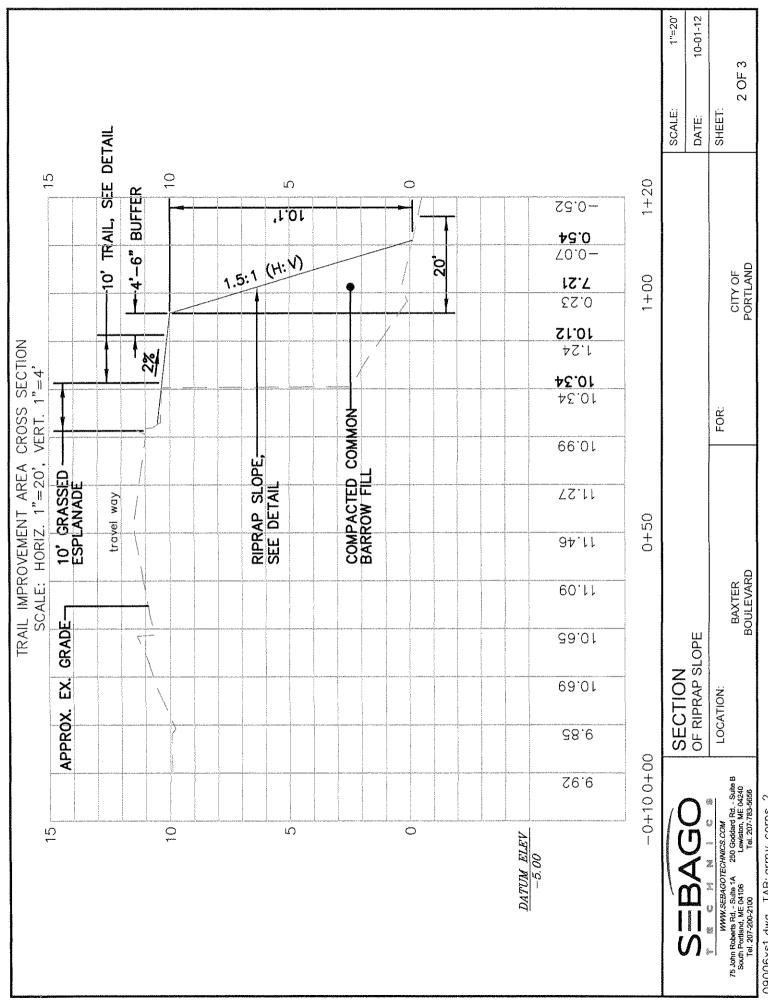
09006xs1.dwg, TAB:army corps 2

NOTES: 1. UNLESS NOTED OTHERWISE, RIPRAP SLOPE SHALL MATCH EXISTING GRADE, UNLESS SLOPE IS STEEPER THAN 1.5:1 (H:V).

2. INSTALL GEOTEXTILE FABRIC PER MANUFACTURER'S RECOMMENDATIONS.

TYPICAL RIPRAP SLOPE NOT TO SCALE

- 1. As discussed during an onsite meeting, the embankment slope that will replace the failing retaining wall was steepened from 2:1 (H: V) to 1.5:1 (H: V) so that impacts to the coastal wetland are minimized. Revised drawings showing the steepened slope are enclosed.
- 2. Language was added to the Alternatives Analysis and Avoidance/Minimization Statement (Attachment 2) to show that the proposed 10-feet wide esplanade complies with the minimum standards of <u>Chapter 5-3.1</u>, <u>AASHTO Guide for the Planning</u>, <u>Design and Operation of Bicycle Facilities</u>.
- 3. The Mitigation Plan (Attachment D) of the original application was revised to show Planting Area #3 adjacent to the trail and north of the sandpipers roosting area.

The proposed alternative to stabilize the area includes installation of a riprap embankment in place of the concrete retaining wall. The existing deteriorated wall will be demolished, and fill material will be installed to create the embankment to match the existing slope on either side of the wall. The slope at the toe of the embankment will be 2:1. A vegetated buffer will be planted at the top of the slope adjacent to the stone dust trail and riprap will be placed on the slope, again to match the adjacent embankments.
