Monte's Fine Foods Stormwater Narrative

Date: June 12, 2018
To: City of Portland
From: John Mahoney, P.E.
Peer Review: Stephen J. Bradstreet, P.E.
Location: 788 Washington Avenue, Portland, Maine

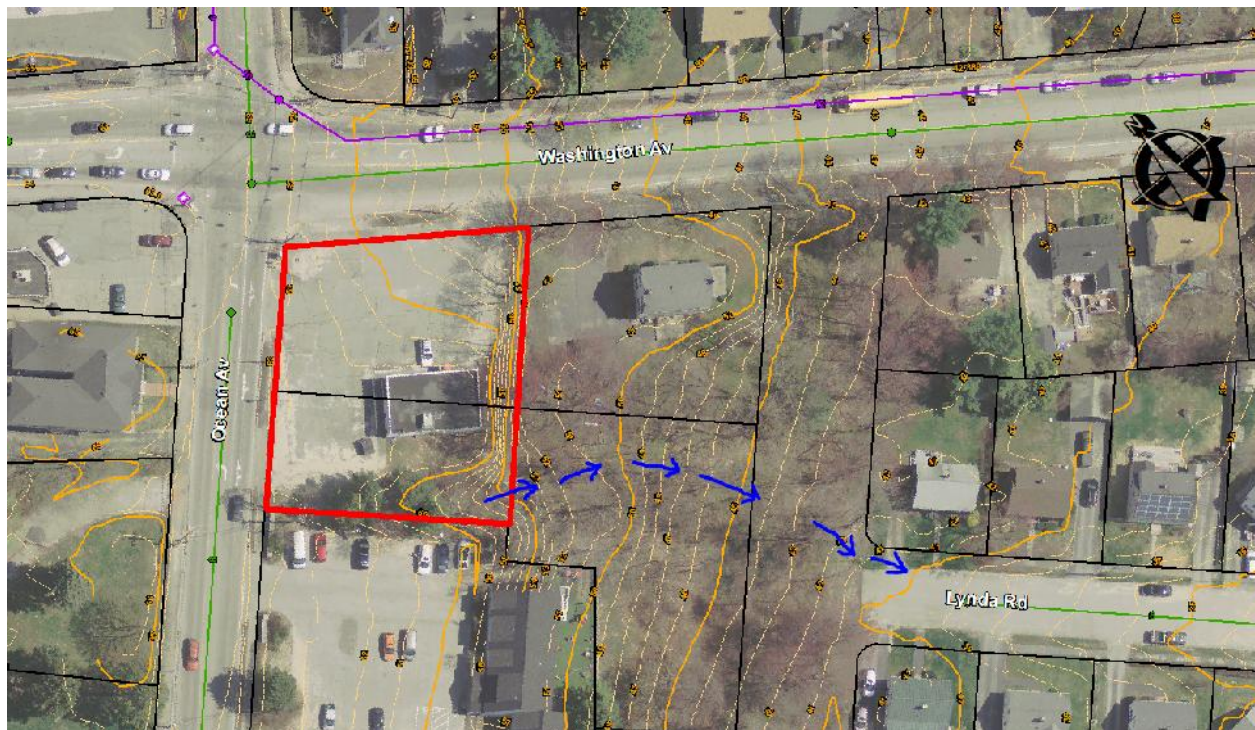
Stormwater discharged from western portion of site

The site drains from north to south, away from Ocean Avenue. The eastern portion of the site, including the majority of the parking area, drains to the Washington Avenue gutter via an existing curb cut in the south east corner of the site. The western portion of the site, including the existing building and a smaller paved area drains to a drainage swale that runs along the western property line. Stormwater discharge from this channel flows through an undeveloped wooded area and eventually onto Lynda road (see image based on GIS data below). Based on GIS contours and site reconnaissance, stormwater appears to flow through the wooded area in a dispersed manner, maximizing filtration/infiltration, increasing time of concentration, and minimizing thermal impacts.
