Final Report of Special Inspections

Project: *Addition and Renovation*

Location: *503 Woodfords Street, Portland, ME*

FIELD NOTES

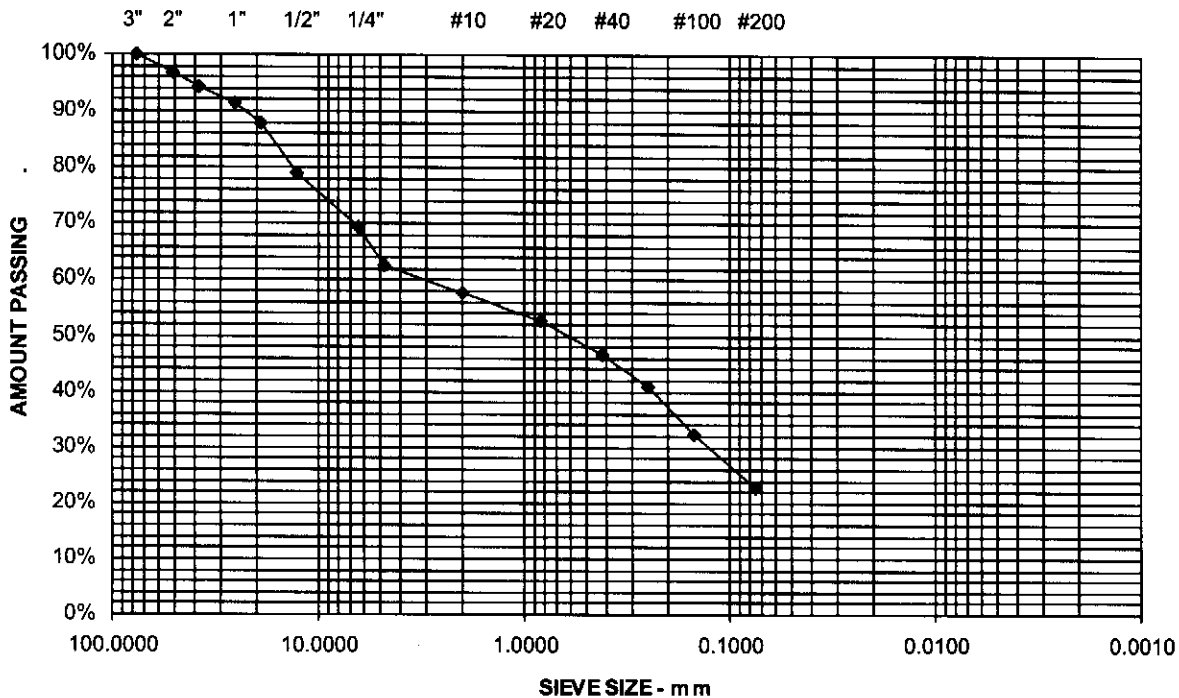
| <u>STANDARD</u> <u>DESIGNATION (mm/μm)</u> | <u>SIEVE SIZE</u> | <u>AMOUNT PASSING (%)</u> | <u>SPECIFICATIONS (%)</u> |
|---|---|---|---|
| 150 μm | No. 100 | 32 | |
| 75 μm | No. 200 | 22.7 | |

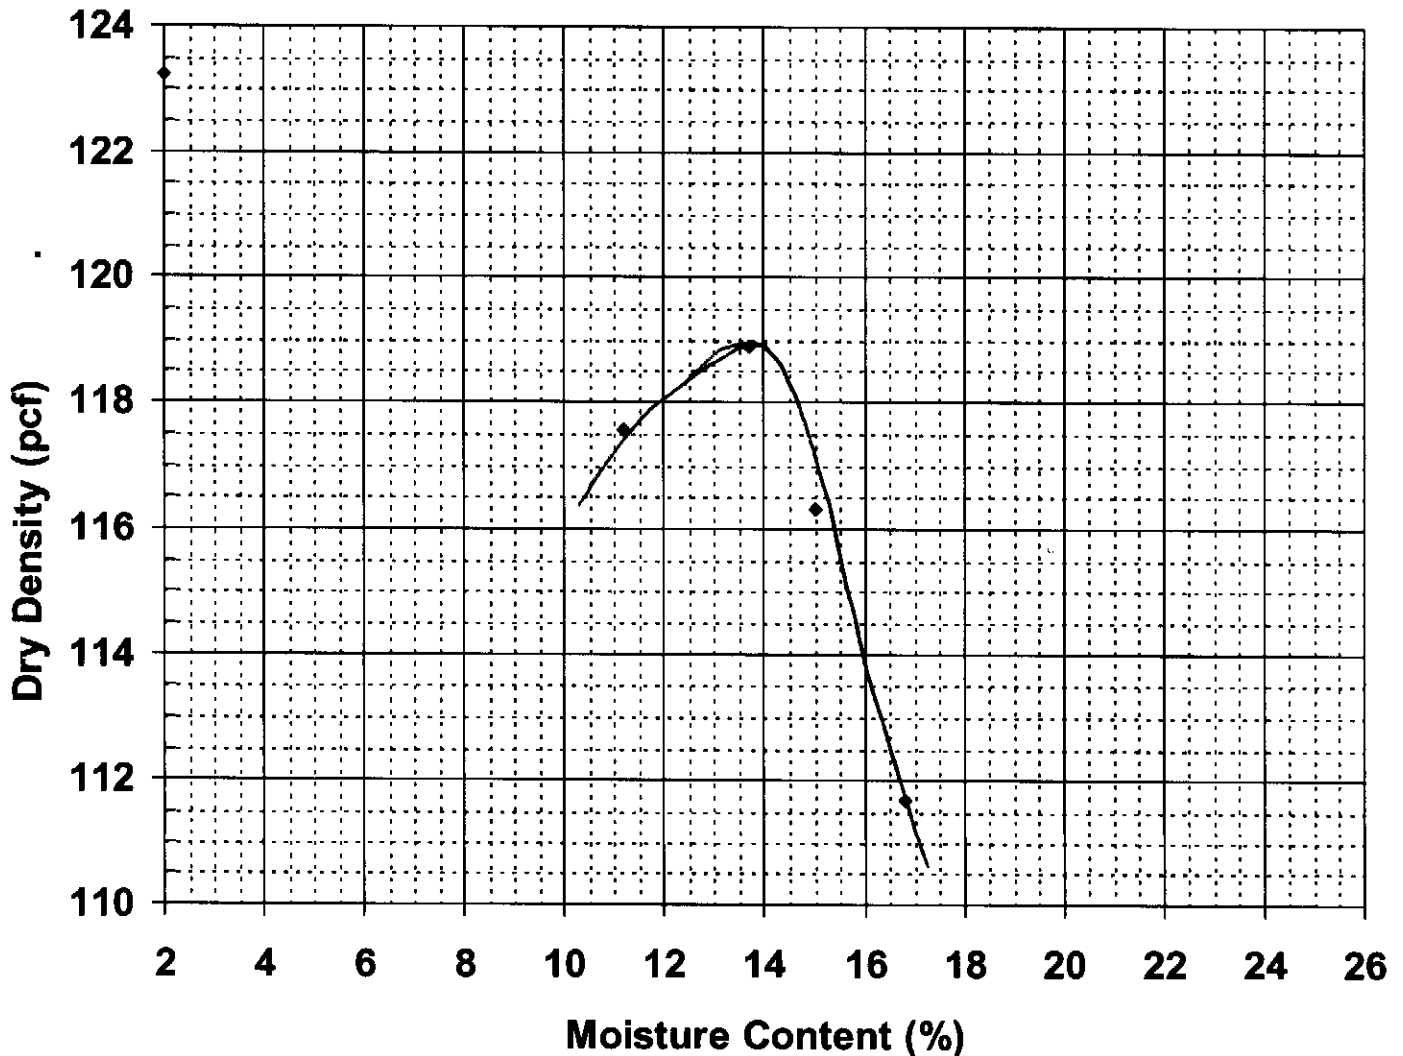
Moisture-Density Relationship Curve

Maximum Dry Density (pcf) **119**

Optimum Moisture Content (%) **14**

Corrected Moisture Content (%) **12.6**
