## CONSTRUCTION OBSERVATION REPORT

**Project:** TD Bank Building Portland, Maine  
**Client:** Pizzagalli Construction Company  
**Client's Rep.:** Ed Hume

**SWCE Project No.:** 08-0395.2  
**Date:** 10-19-10  
**Weather:** Mostly clear, 40s-50s

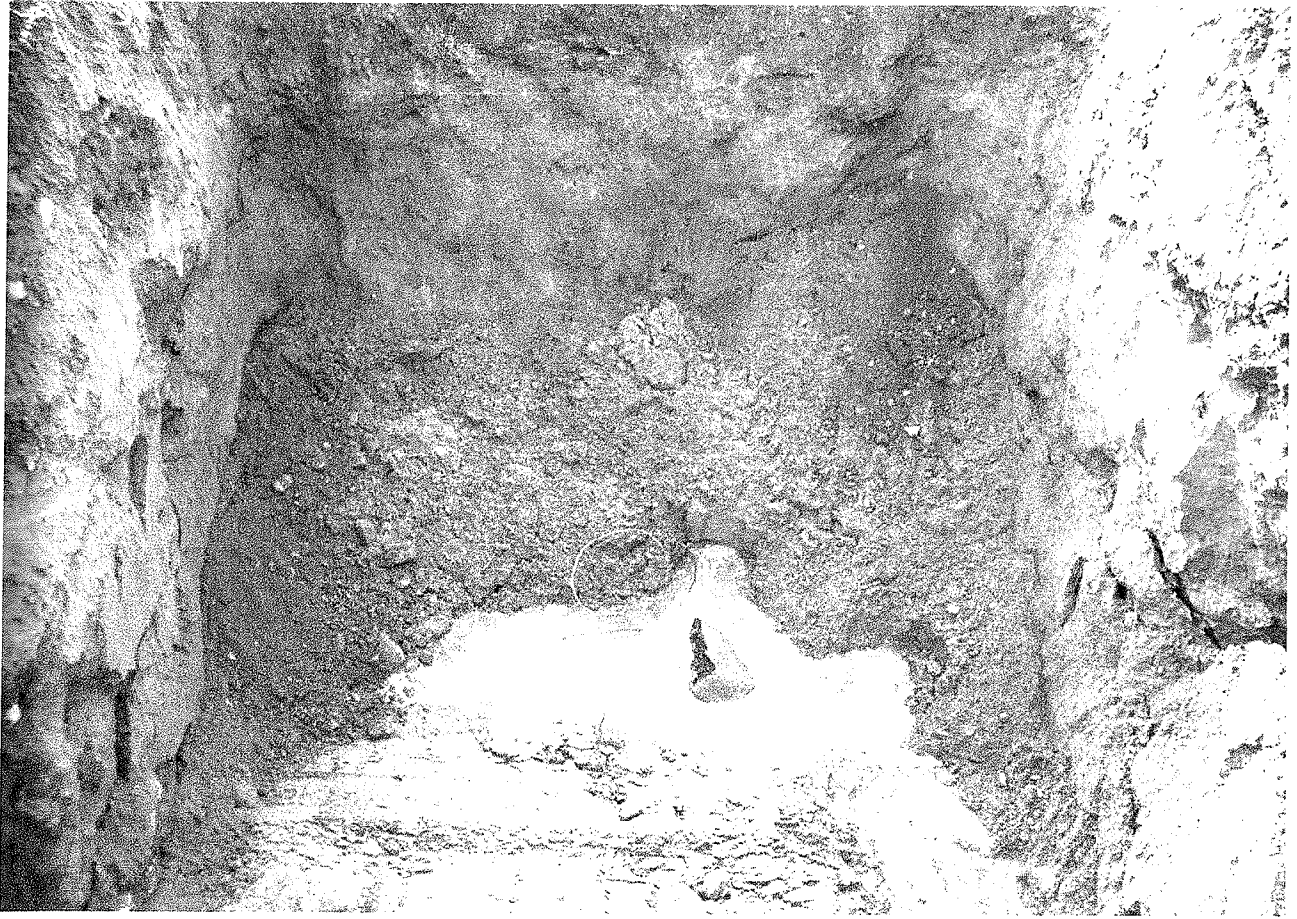
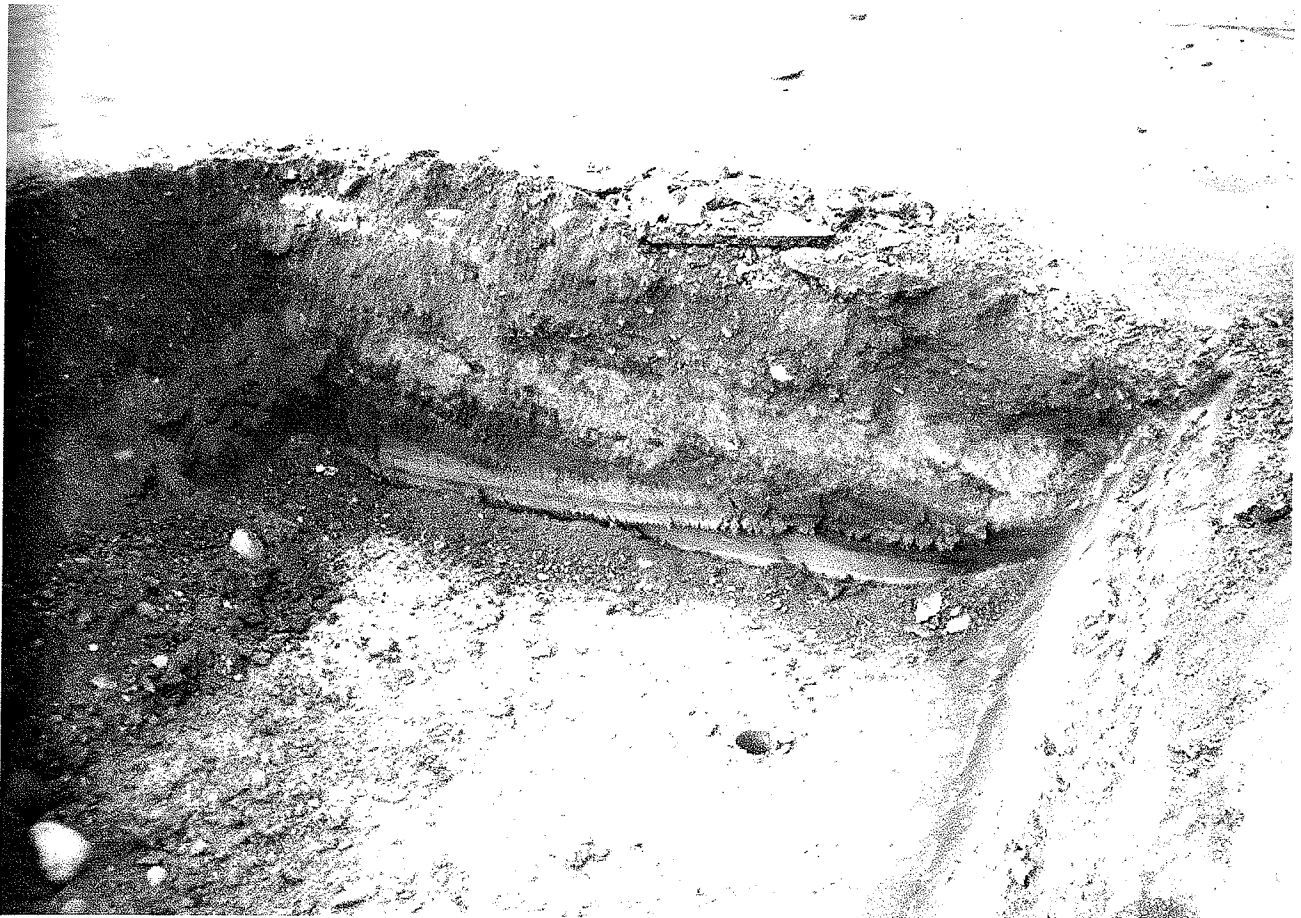
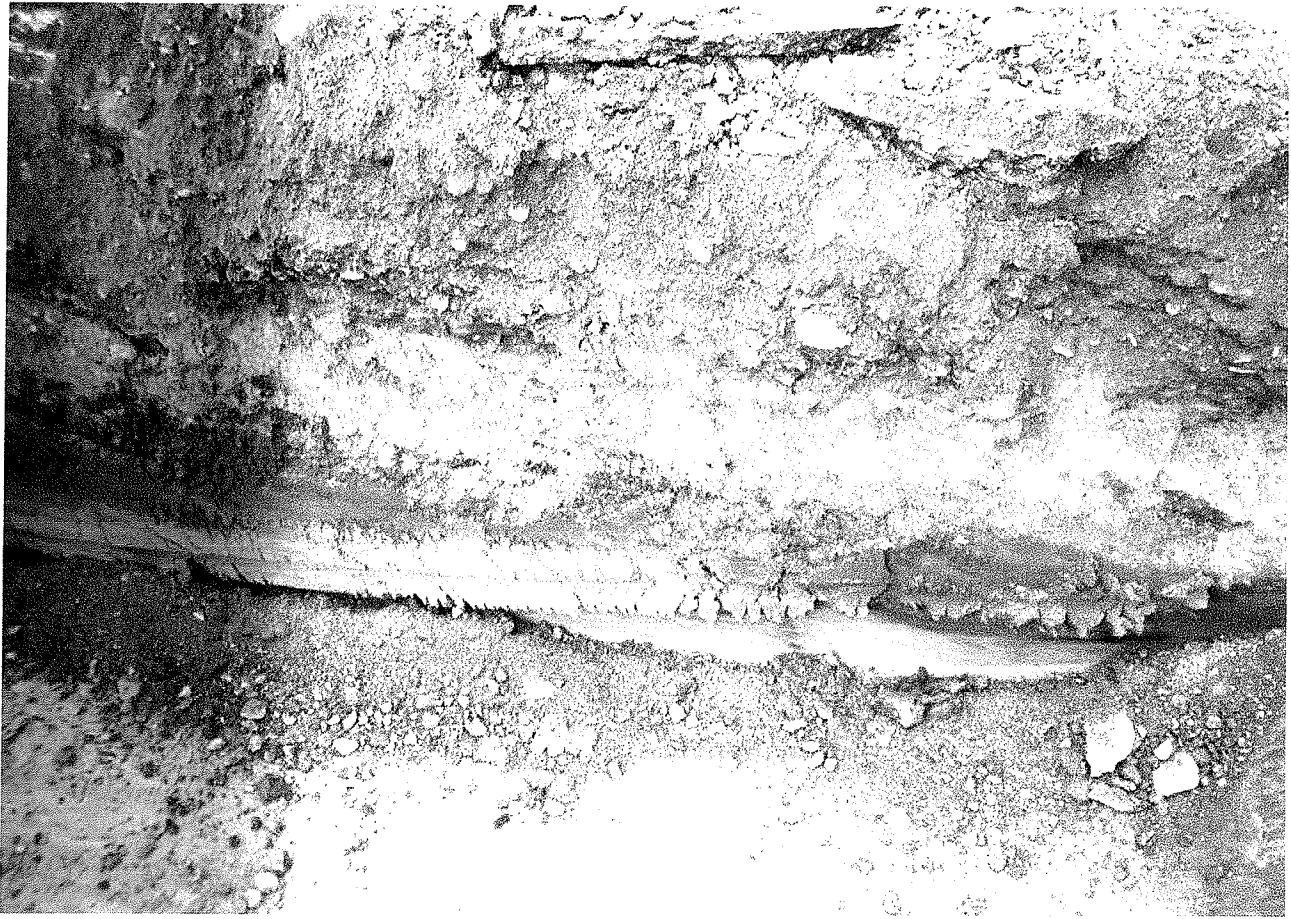
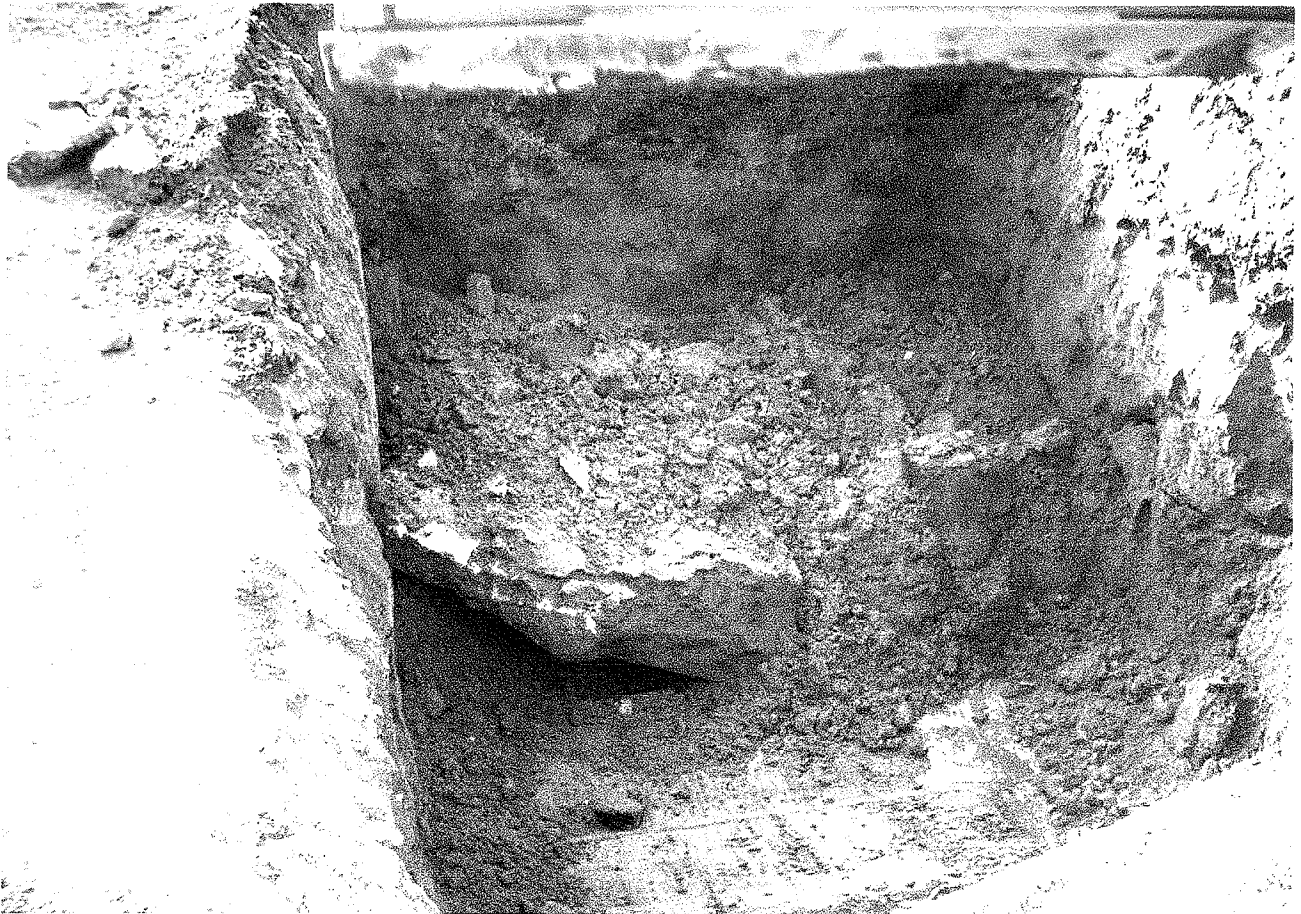
**General Observations, Discussions, Etc:** As discussed at the site meeting on 10-18-10, S. W. COLE ENGINEERING, INC. was on site to observe and log two test pits within the proposed bank building footprint. Upon arrival, GSG was stripping existing pavement from the site footprint. We observed GSG excavate two test pits (TP-1 and TP-2). TP-1 was located at approximately foundation line C-1 and TP-2 was located at approximately foundation line A.8-3.4. TP-1 encountered asphalt pavement overlying granular fill material with asphalt debris to a depth of about 1.8 feet, overlying dark brown clayey sandy silt to a depth of about 1.2 feet, overlying gray and olive clayey sandy silt transition to olive silty clay with depth. Pocket penetrometer readings taken on the clayey silt and silty clay ranged from about 4 to 5 KSF. The test pit was terminated at elevation 43.67 feet as measured by GSG. We advanced a hand auger into the olive silty clay to elevation 39.62 feet.

TP-2 encountered asphalt pavement overlying granular fill material containing asphalt debris, concrete, metal wire, metal pipe, and CMU blocks. Water was observed flowing in from a pipe within the fill material at about elevation 41.7 (about 5.3 feet deep) as measured by GSG. Because GSG was not setup to dewater excavations by pumping into an onsite frac tank at this time, the test pit was terminated within the fill material when water inflow was encountered.

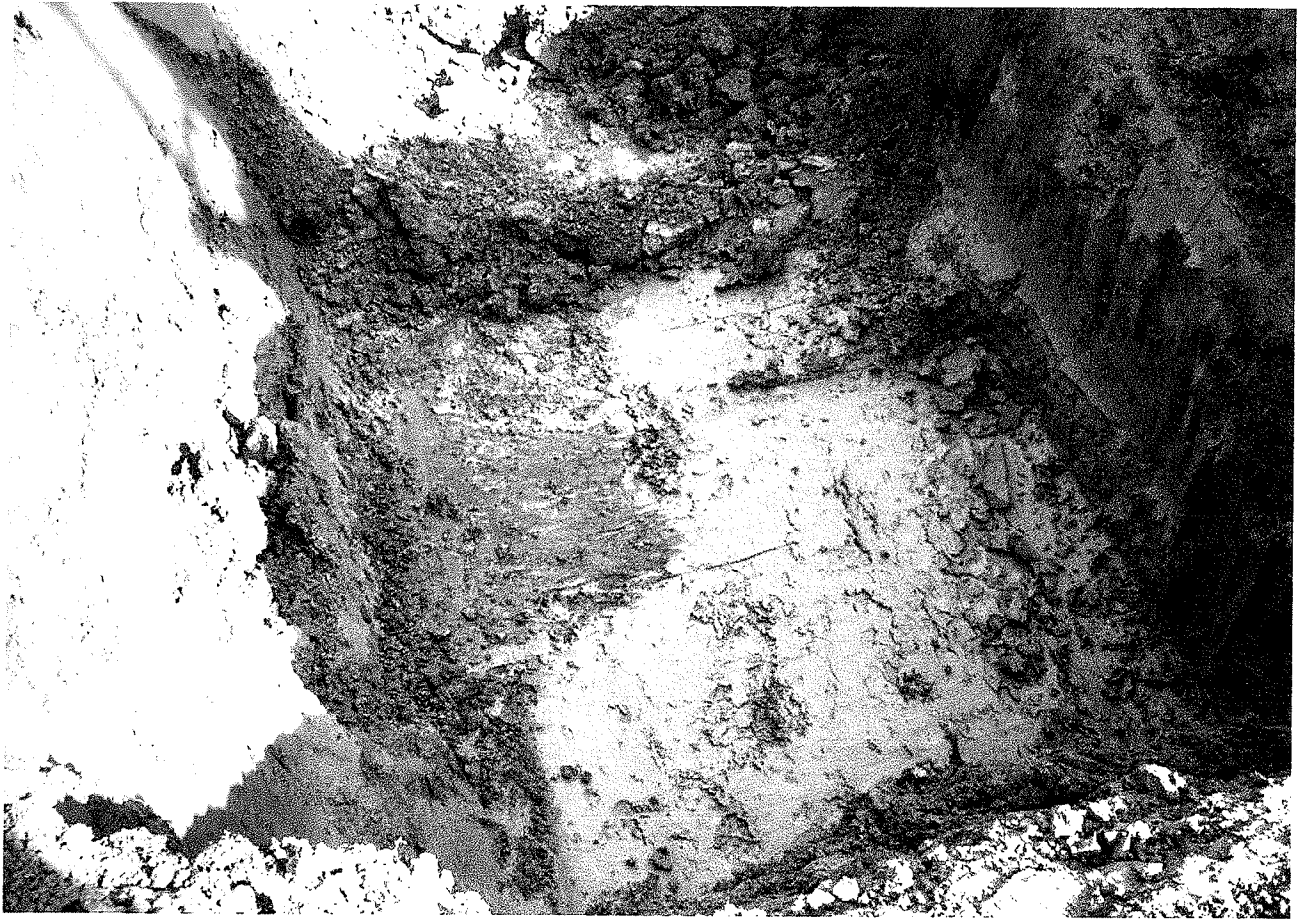
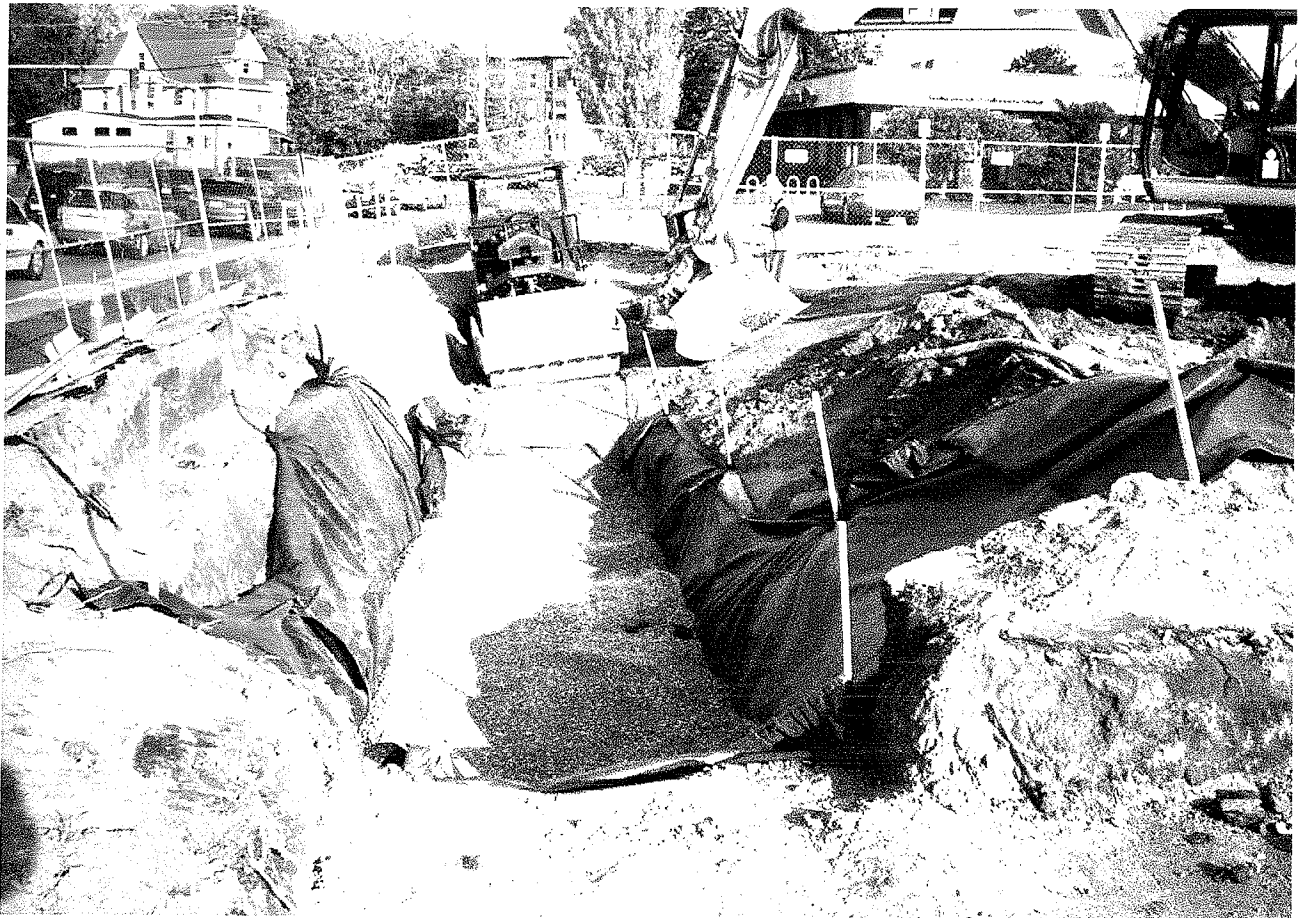
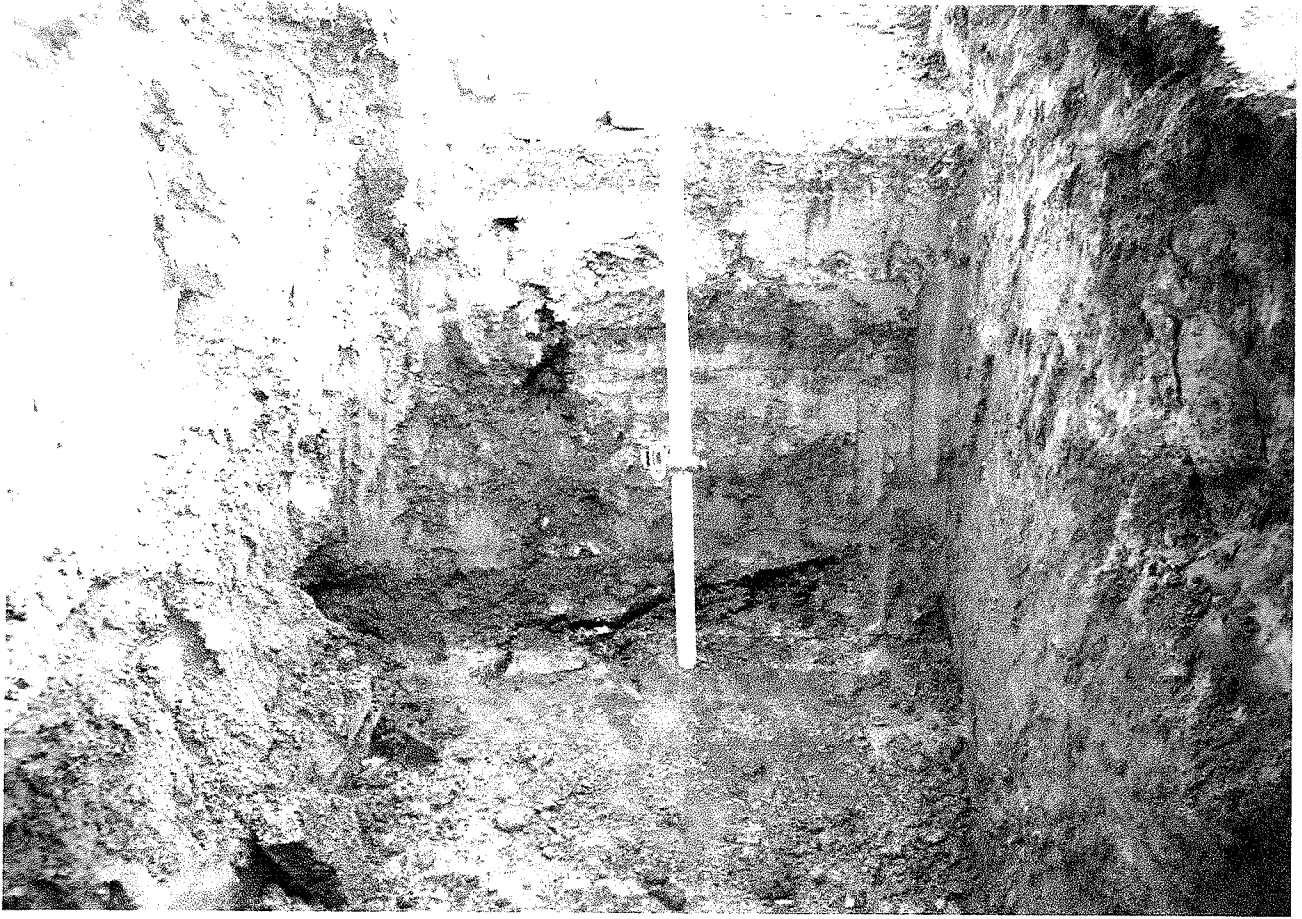
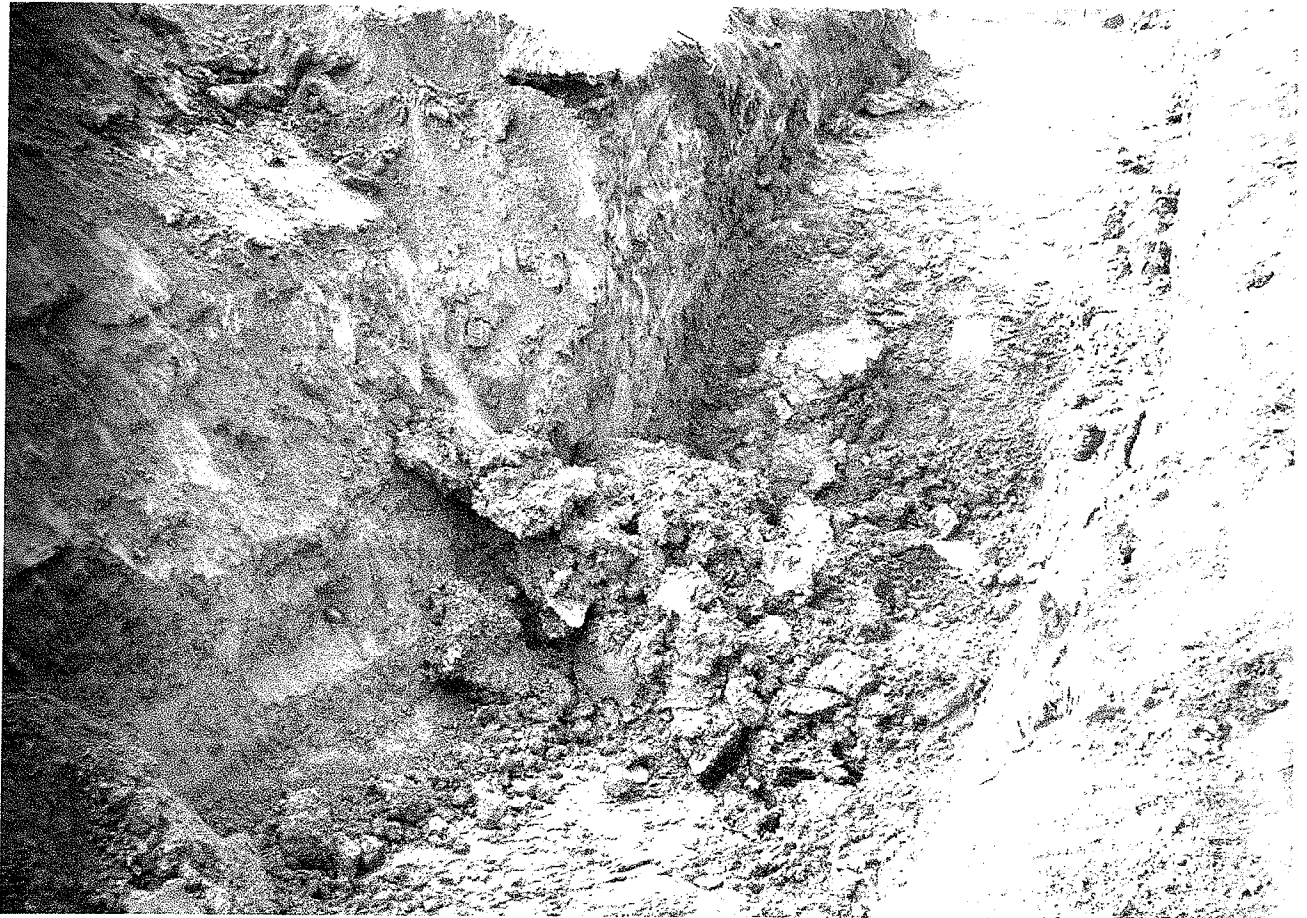
**General Observations, Discussions, Etc:** S. W. COLE ENGINEERING, INC. was onsite to observe GSG earthwork activities. Upon arrival, GSG was excavating to approximate bottom of footing grade along foundation line D. The length of subgrade exposed upon arrival was observed to consist of variable fill material. We recommended to Mark Johnson (GSG foreman) and Ed Hume (Pizzagalli Construction Superintendent) that the excavations continue in order to remove all fill material beneath the building footprint and extending 1H:1V from edge of proposed footings. GSG encountered a relatively deep zone of clayey fill material with asphalt debris along foundation line D extending approximately from line 2 to 3.4+5'. H.B. Fleming was on site to observe the excavation conditions in the event that excavation shoring may be needed to attain the 1H:1V over-excavation limits along Congress Street. However, as over-excavation continued, GSG determined that shoring would not be needed. The over-excavation of fill material in this zone extended until native gray silty clay was encountered at elevations varying from about 35.59 to 36.39 feet, as measured by GSG. The fill material was trucked off site. The native silty clay had pocket penetrometer readings on the order of 5 KSF where an undisturbed sample could be obtained. The sidewalls of the excavation appeared to consist of native olive to gray silty clay. A small amount of water was observed to flow into the over-excavation from a relic pipe or conduit within the fill materials.

Per our recommendation, GSG placed an initial approximate 2-foot thick layer of  $\frac{3}{4}$  inch crushed stone fully wrapped in Mirafi 160N geotextile in the base of the over-excavation. The crushed stone was compacted with 2 to 3 passes with an IR SB2 vibratory roller. GSG installed a sump for future pumping within the crushed stone layer. GSG will continue to backfill the excavation with Structural Fill at a later date. GSG will continue over-excavation moving southeast, into the building footprint on 10-21-10.

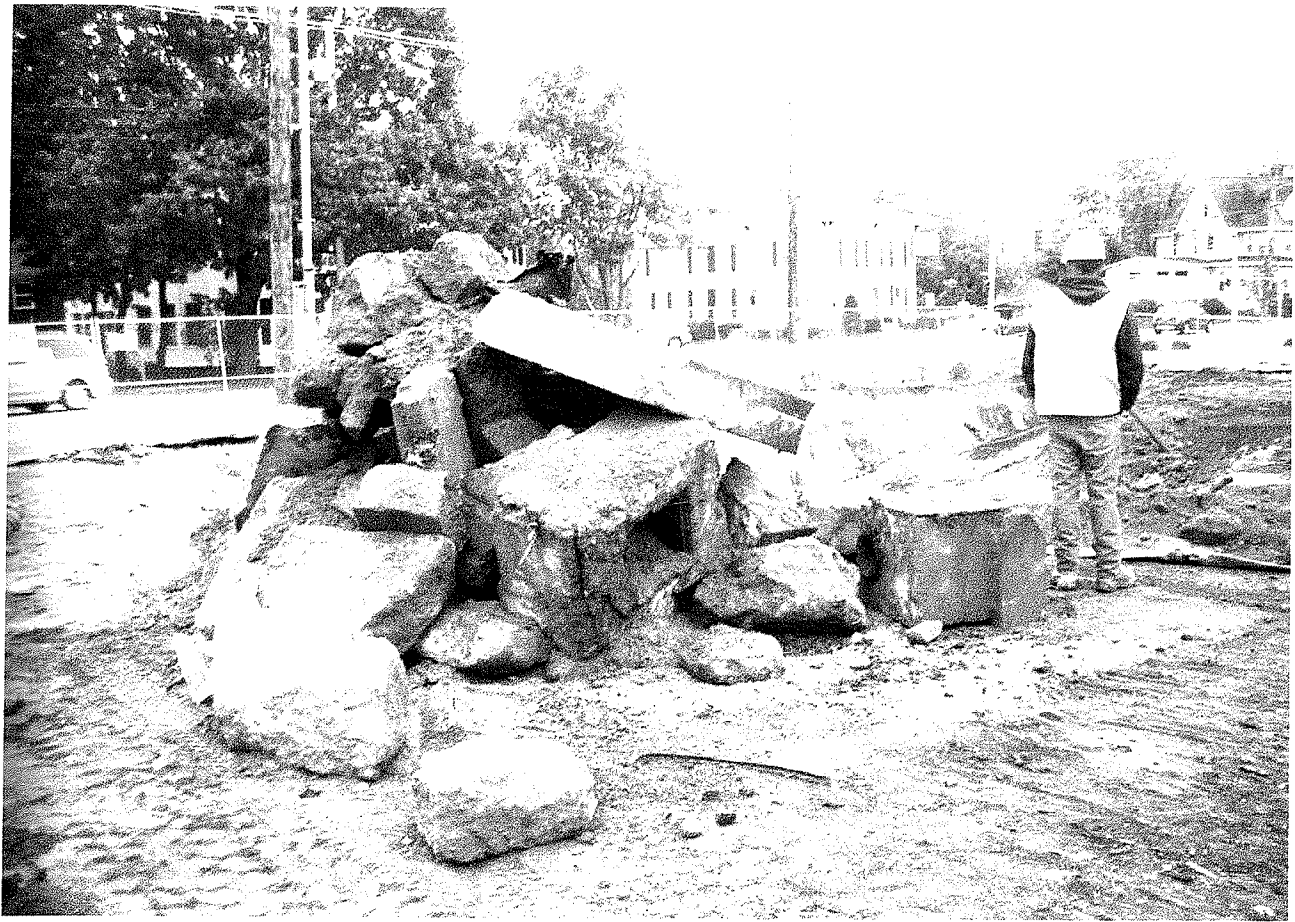
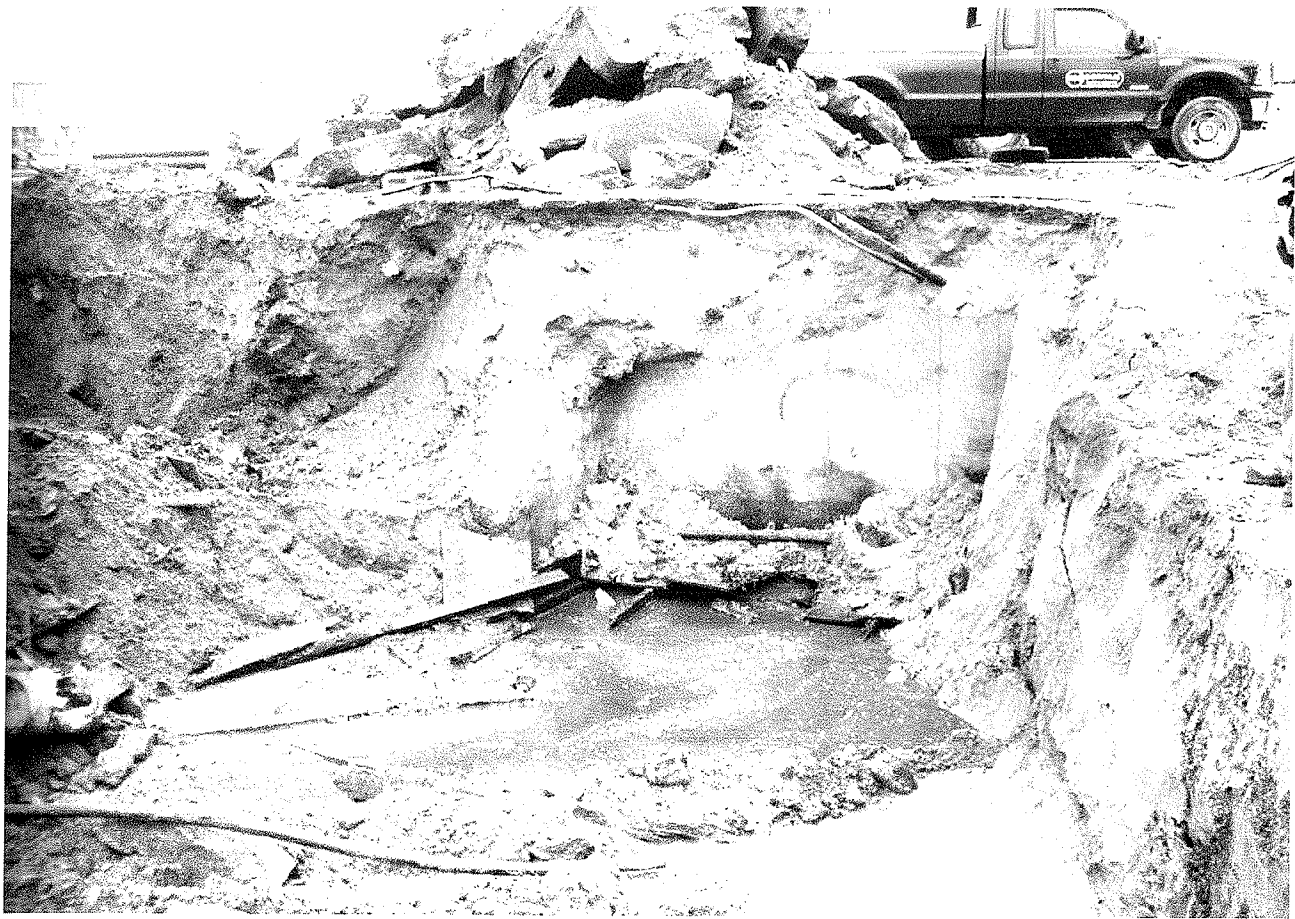
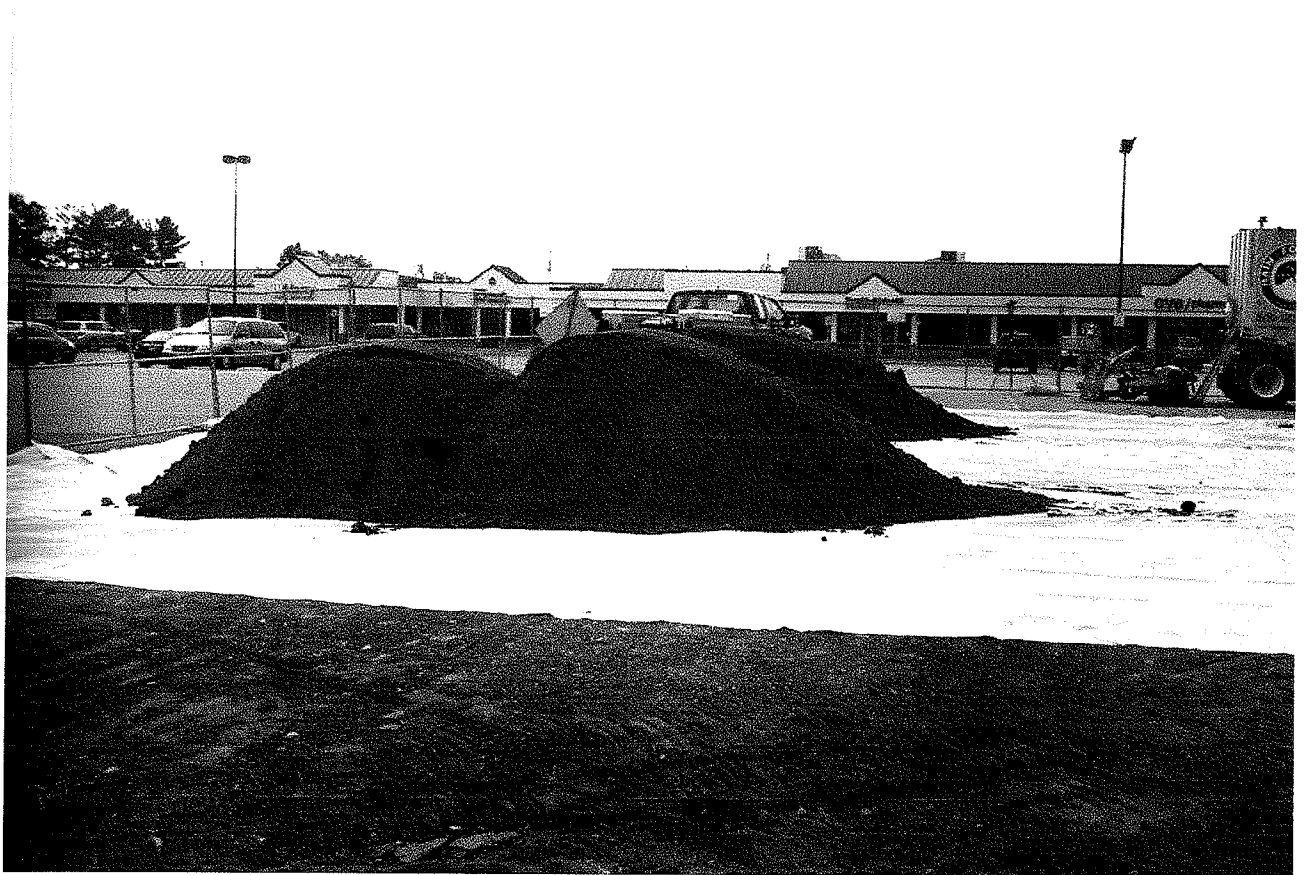
**General Observations, Discussions, Etc:** S. W. COLE ENGINEERING, INC. was onsite to observe GSG earthwork activities. Upon arrival, GSG was over-excavating existing fill material and debris along foundation line 4, working towards the southeast. The existing fill material consisted of highly variable sandy and silty/clayey material with very frequent debris including concrete foundation pieces, brick, metal wire and pipe, plastic signage and buckets, and wood. Petroleum odor was observed coming from the over-excavation. A partially demolished foundation wall and basement slab was encountered in foundation line 4 at approximately the intersection with line B+5'. Water was observed to flow into the over-excavation from relic pipes and conduits within the fill material. GSG excavated a trench to allow water to flow into the sump installed in the western corner of the building footprint on 10-20-10. GSG began to pump water from the sump into the on site frac tank. Karl Gimpel and Bob Chaput, P.E. (SWCE) made a site visit to observe over-excavation conditions and discuss work plans with Mark Johnson (GSG foreman). We discussed limits of over-excavation beneath sidewalks and foundations. We recommended that the fill material be removed at least to frost depth beneath sidewalk areas and replaced with compacted Structural Fill. We discussed potentially leaving deeper granular fill material free of debris in place provided GSG can pump water down and the material can be proof rolled. It was decided that further observation of the material will be needed once the loose debris and fill are cleaned off of the top and water is pumped down.

GSG was observed to separate granular fill material relatively free of debris and silty and clayey material into a plastic lined stockpile in the eastern portion of the site for potential reuse. Unsuitable fill material was placed in a separate plastic lined stockpile to be trucked off site once environmental testing by others is complete. Brian Bachmann of St. Germain Collins was onsite to observe environmental conditions of the fill material.

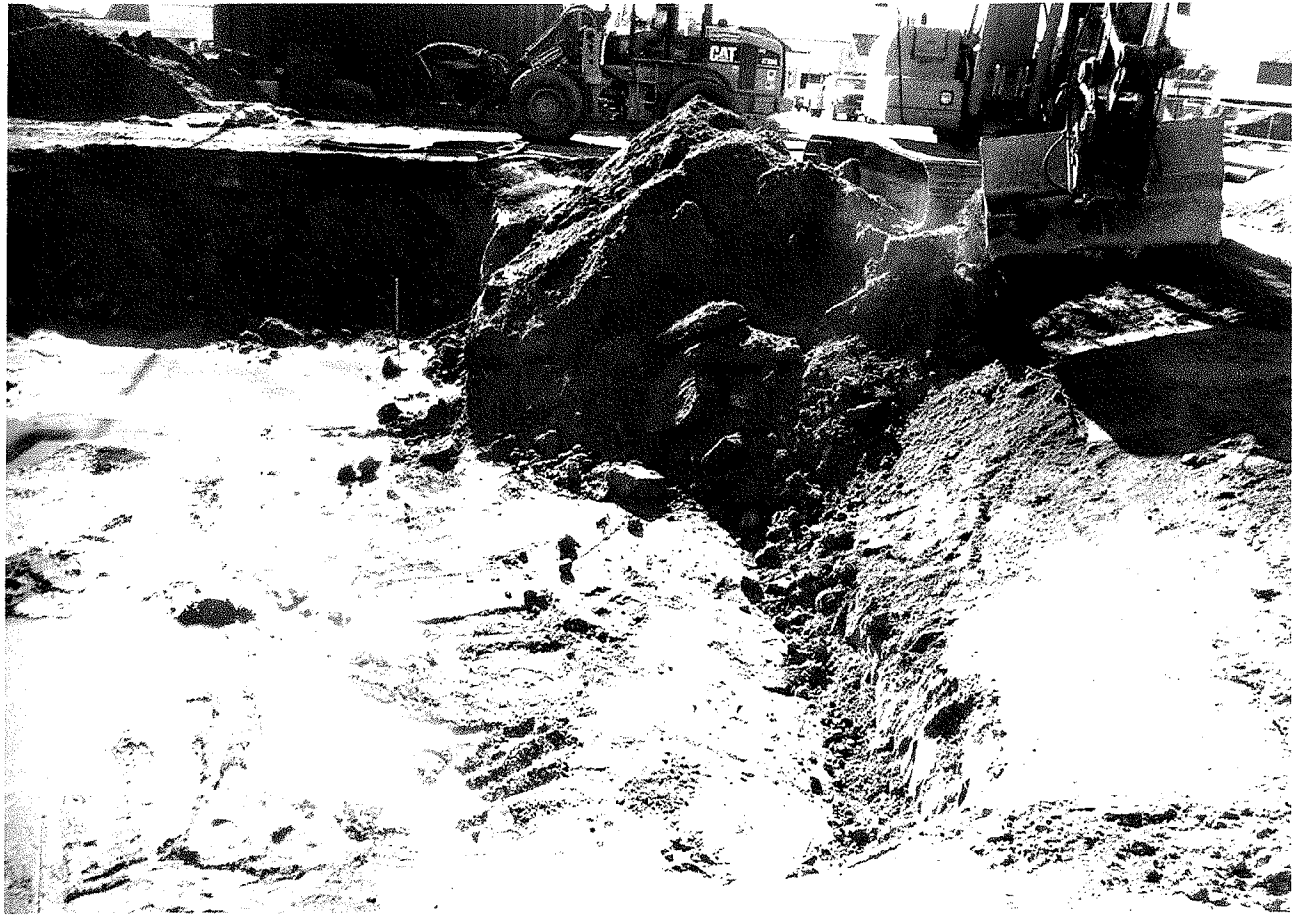
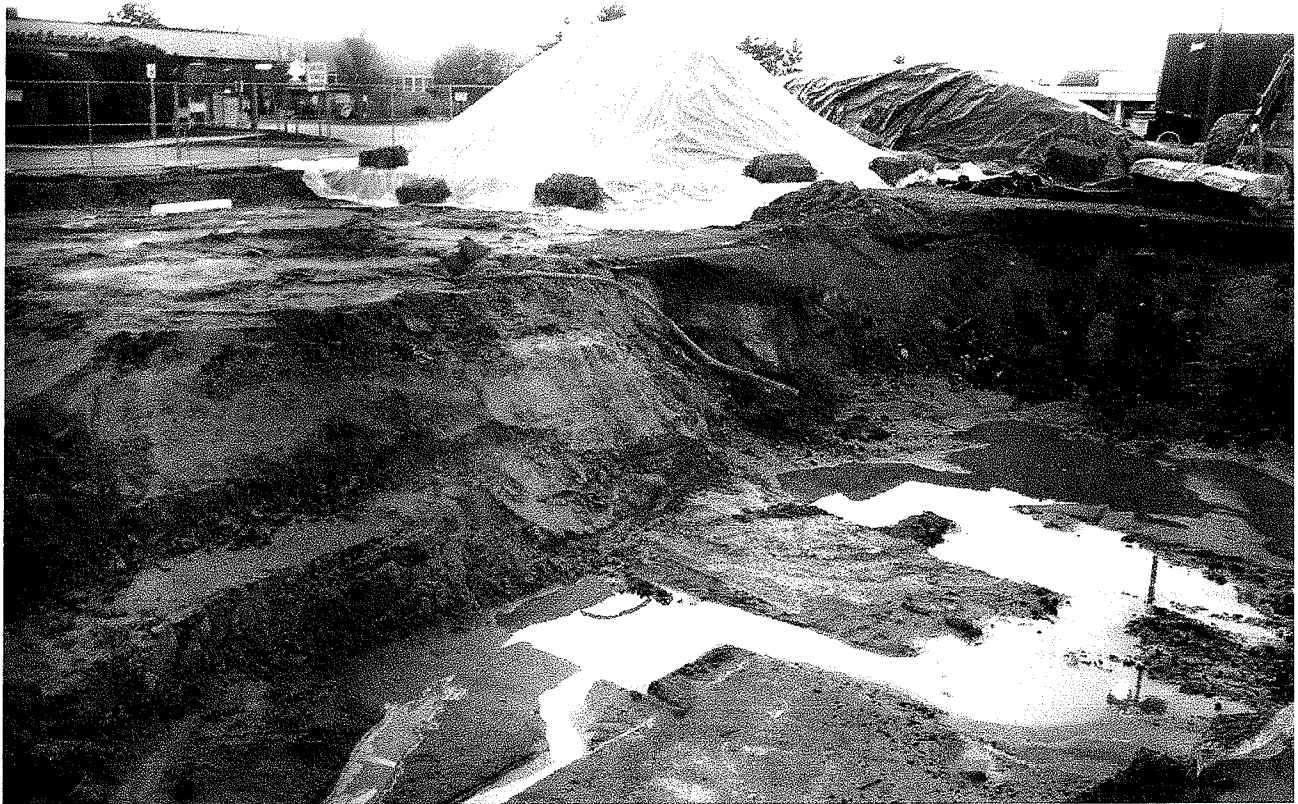
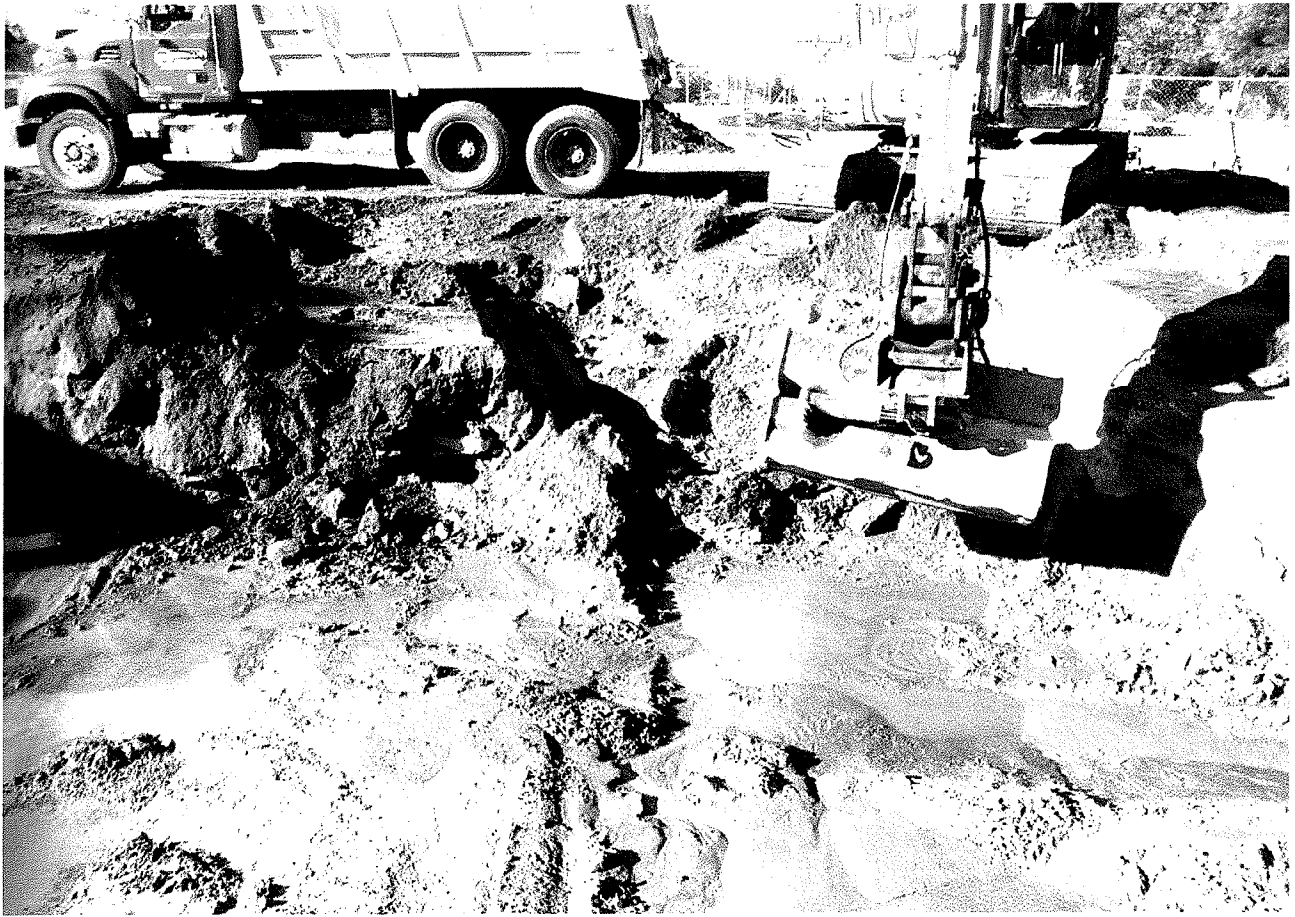
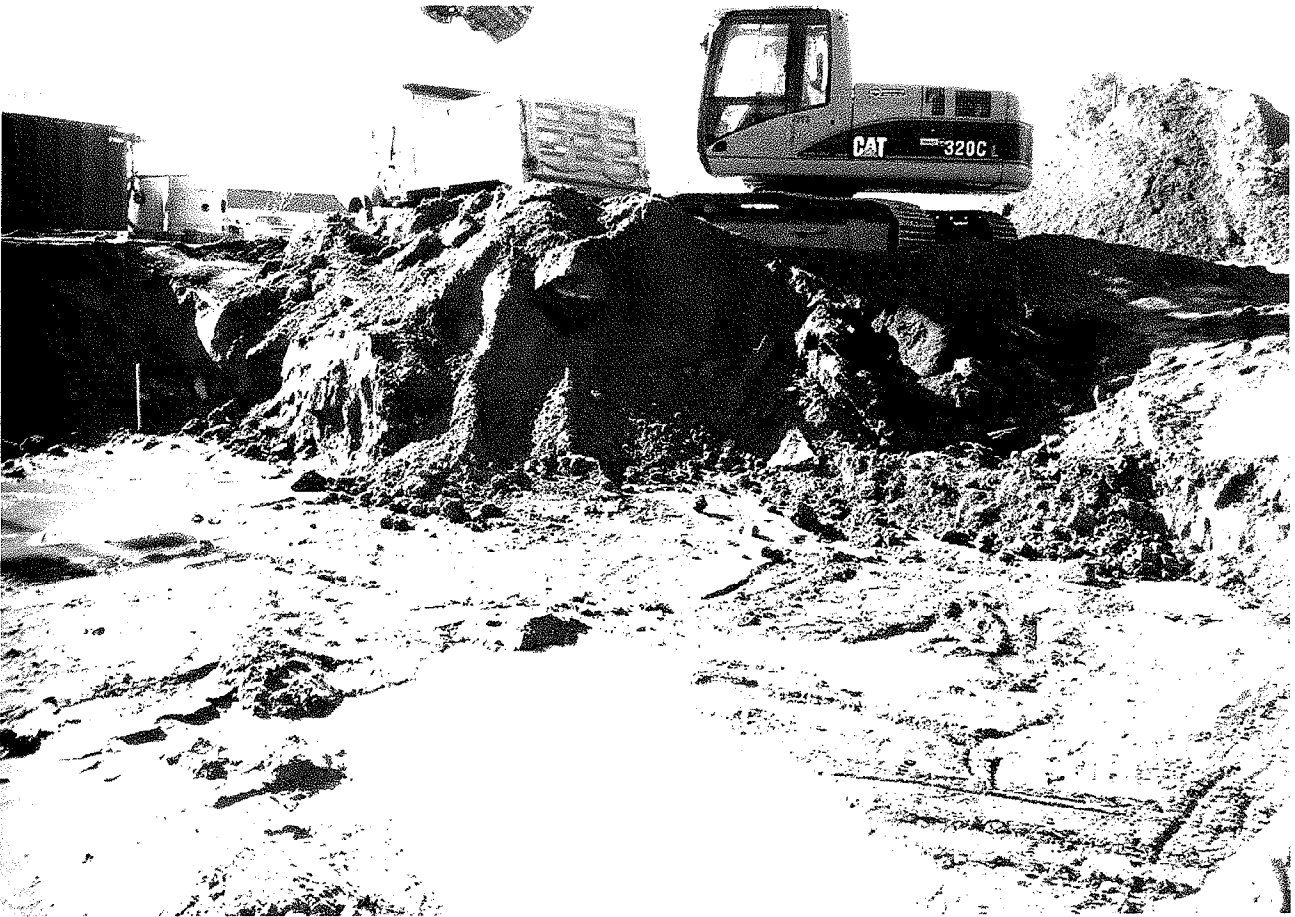
**General Observations, Discussions, Etc:** Gorham Sand & Gravel (GS&G) continued removing unsuitable fill under and adjacent to 4-line. A smooth edged bucket continues to be used for excavation and Gorham Sand is maintaining a sump/pump operation to help minimize subgrade soil disturbance. The excavation was laterally over-sized in accordance with our typical recommendations along 4-line at least at a 1:1 to account for the bearing splay below bottom of proposed footing. Based on layout provided by GS&G, the additional lateral excavation also appears to have removed the unsuitable fill soils from beneath the proposed sidewalk area adjacent to the building. Subgrade soils exposed in the sidewalk area consisted of mottled brown silty clay with pocket penetrometer strengths of between 5 and 7-ksf. The excavation southwest of 4-line was sloped back to meet the parking area pavement section at approximately a 3:1 also in accordance with our general recommendations. Some additional removal of fill soils and final subgrade preparation remains to be performed northwest of 4-line (directly underlying the proposed footing extending into the building interior), but GS&G opted to wait until Monday when trucks will be available to haul in crushed stone and structural fill as needed. Soils unsuitable for reuse on site are being hauled to Commercial Recycling and granular soils that appear to meet a granular fill specification are being blended and stockpiled on site. We discussed with Pizzagalli (Ed Hume) that where silty clay or saturated soils are encountered under building footings that our recommendation would be that a minimum of 12-inches of crushed stone enveloped in woven geotextile fabric be used (with subsequent lifts of compacted structural fill as needed) but that in other areas compacted granular fill can be used to replace any material removed below the recommended section. Work observed and conditions encountered thus far appears to be progressing in general accordance with recommendations and findings detailed in our June 10, 2008 geotechnical report.
