## CONSTRUCTION OBSERVATION REPORT

**Project:** TD Bank Building Portland, Maine  
**Client:** Pizzagalli Construction Company  
**Client's Rep.:** Ed Hume

**SWCE Project No.:** 08-0395.2  
**Date:** 10-19-10  
**Weather:** Mostly clear, 40s-50s

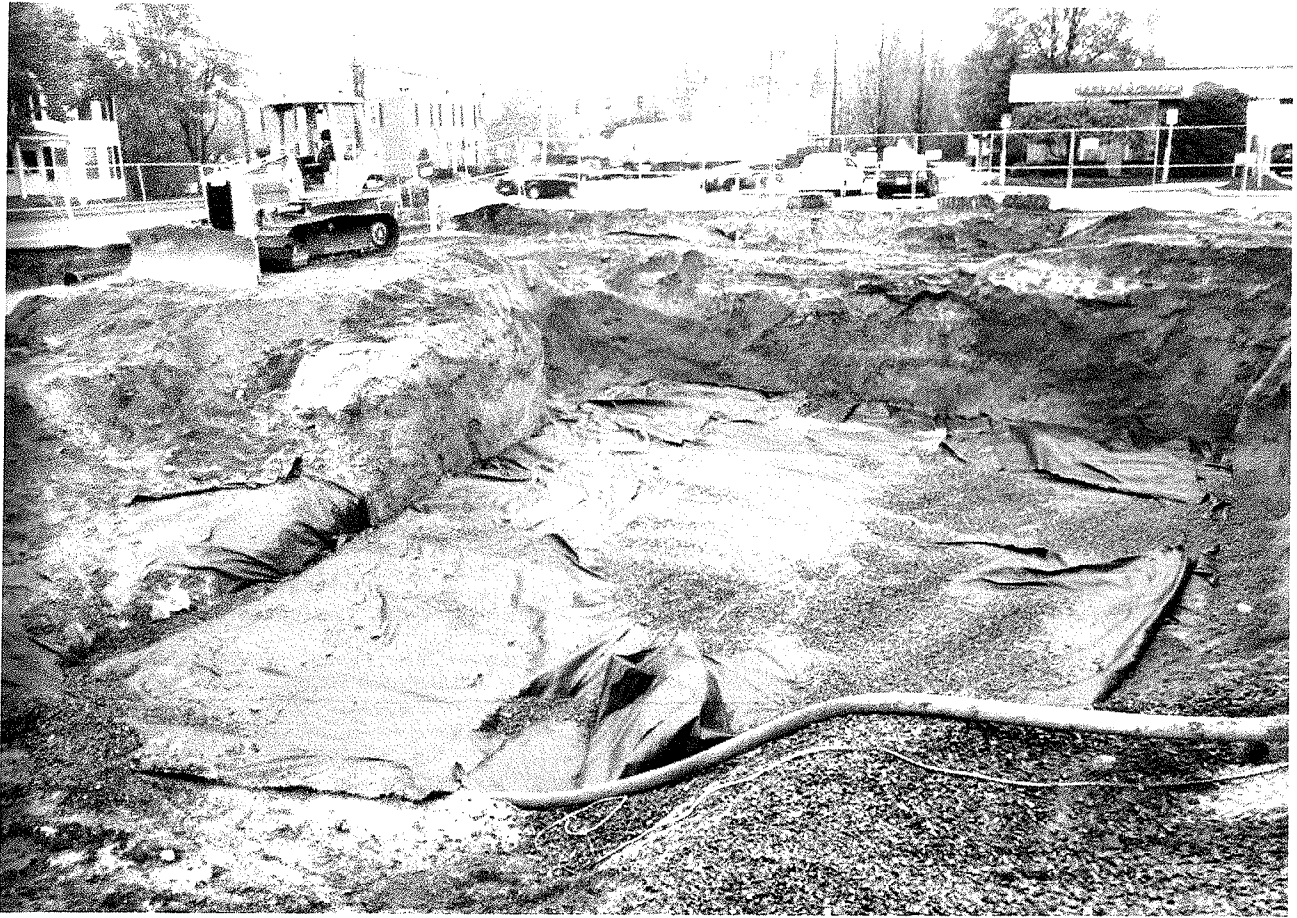
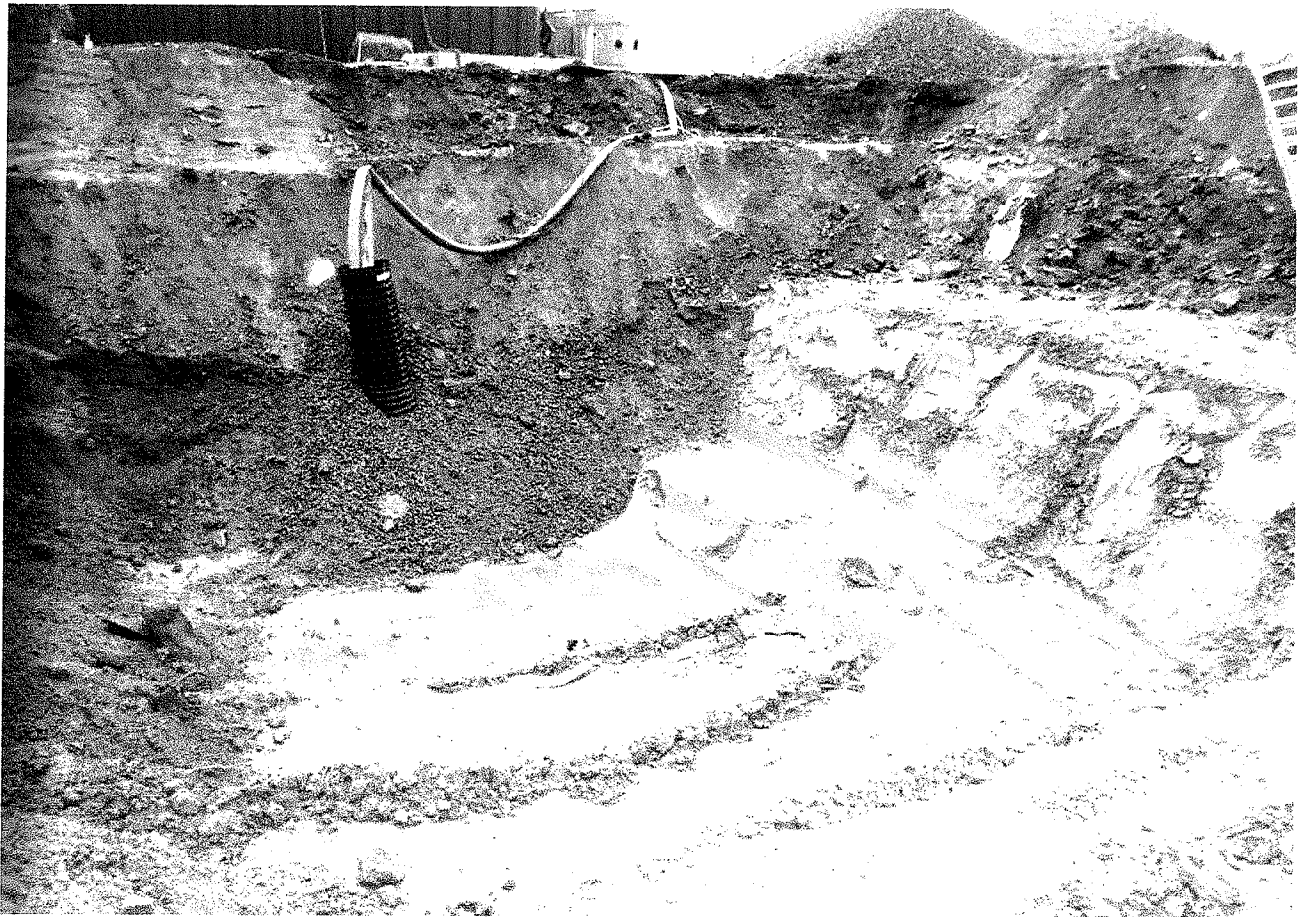
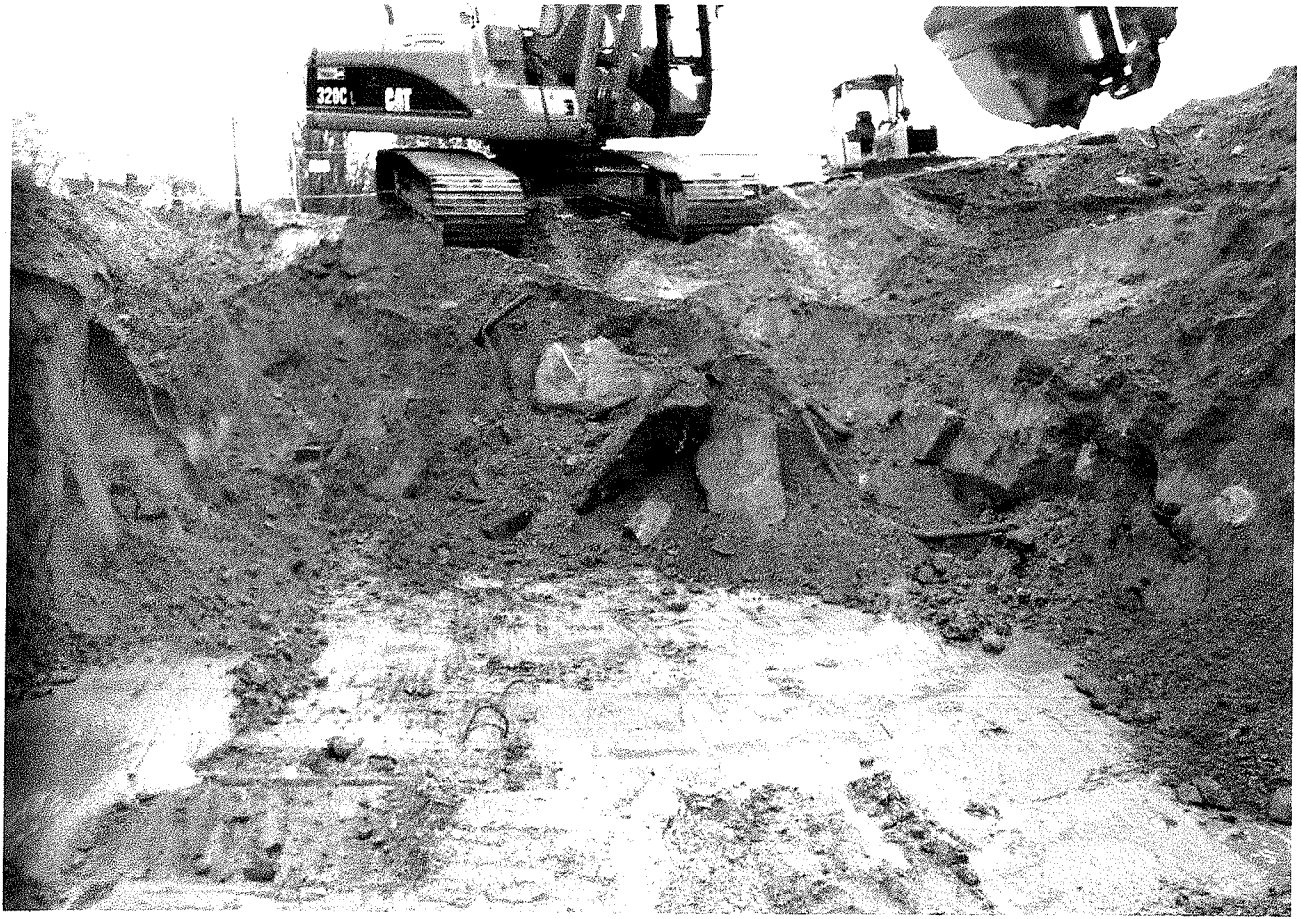
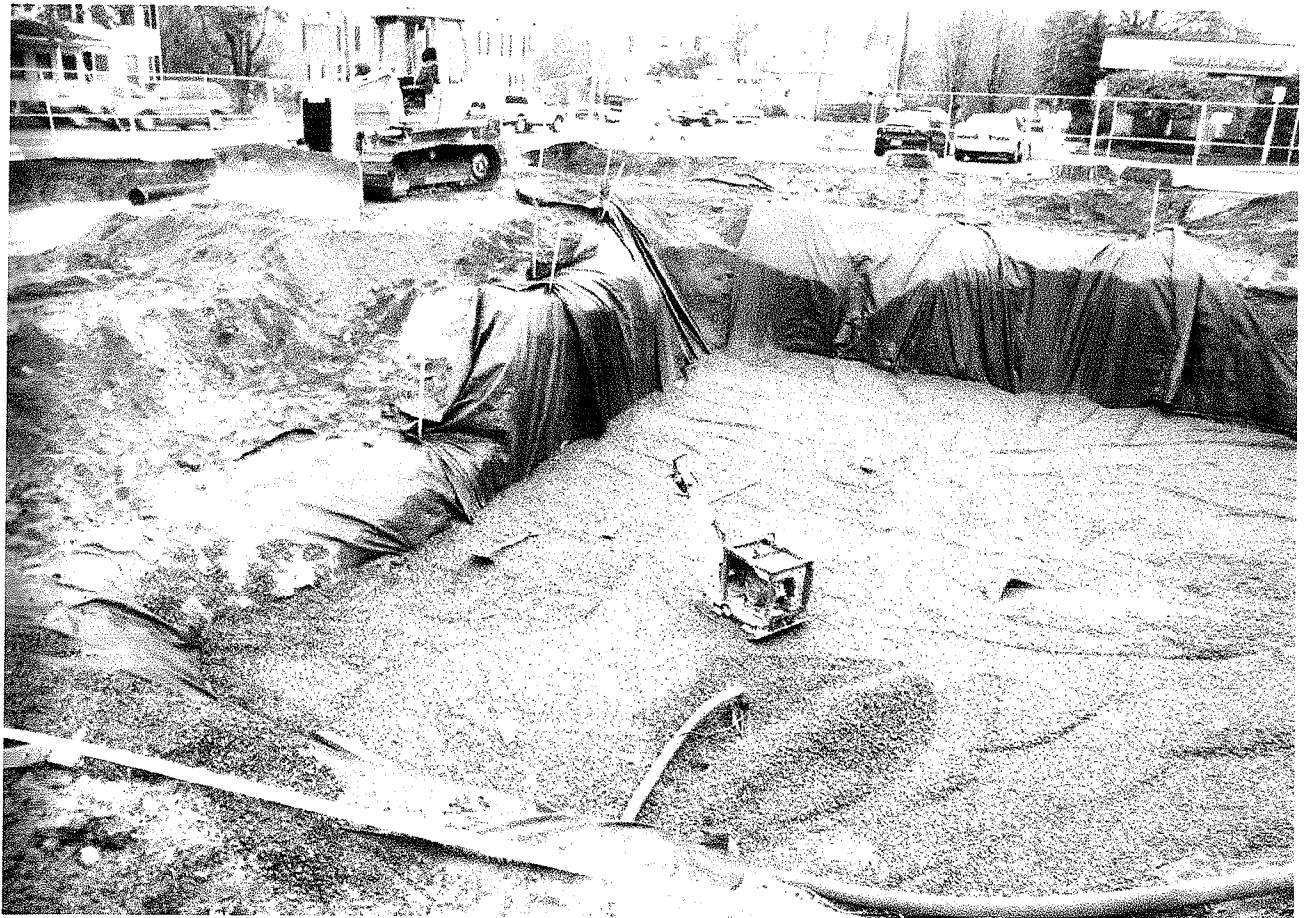
**General Observations, Discussions, Etc:** Gorham Sand and Gravel (GS&G) set back and resumed over-excavating unsuitable fill soils from the southern corner of the building where about 8-feet had been previously removed. The sump/pump operation lowered the water level enough to finish the recommended excavation and prepare subgrade for fill. In an area approximately located from column lines 2 (+4') to 4 (+3') and roughly falling between B and A (-6'), mixed loose fill was removed to an elevation of about 35.8-feet. Between A (-6') and A' (-4') fill was removed to an elevation of about 36.8-feet (canopy area). For the main building footings, the excavation was oversized laterally at about a 1:1 ratio below proposed bottom of footing except where native stiff undisturbed brown silty clay was encountered; in these areas the clay was exposed with a smooth edged bucket and left in place. Subgrade soils within today's work area consisted of saturated brown to gray fine sand with trace silt. This sandy material is still relic fill, but appeared to be free from unsuitable materials and acceptable to remain in place if properly densified. This residual granular fill is likely the old tank base material that based on a shallow test pit was found to be about 2-feet in depth. Underlying the sand fill was medium to soft gray silty clay consistent with our original geotechnical findings. After the unsuitable materials had been removed, GS&G installed a 12-inch compacted lift of ¾-inch crushed stone enveloped in woven geotextile fabric across the entire bottom of today's over-excavation. The crushed stone was compacted with the 800-pound +/- vibratory plate compactor and subsequent lifts of structural fill and granular borrow will be compacted with the 7-ton vibratory drum roller. Today's over-excavation largely completes anticipated removal of unsuitable fill and subgrade preparation for the main building and the canopy area. We did discuss with GS&G (Mark) that once the granular backfill has been graded and compacted to the top height of the confining stiff brown silty clay (where encountered) that we recommend that the overlying granular fill be removed laterally as needed to continue to provide the recommended 1:1 bearing splay support.

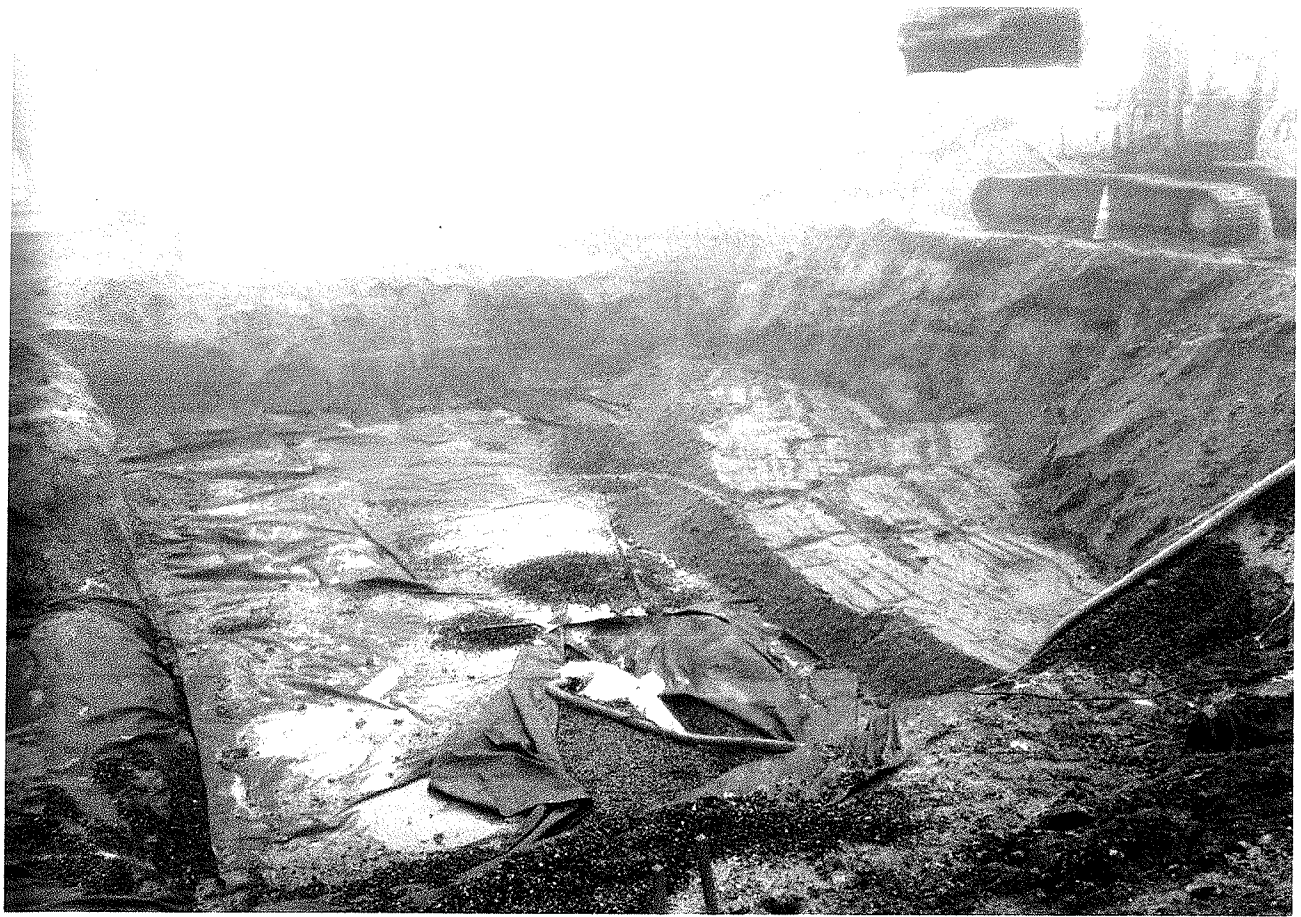
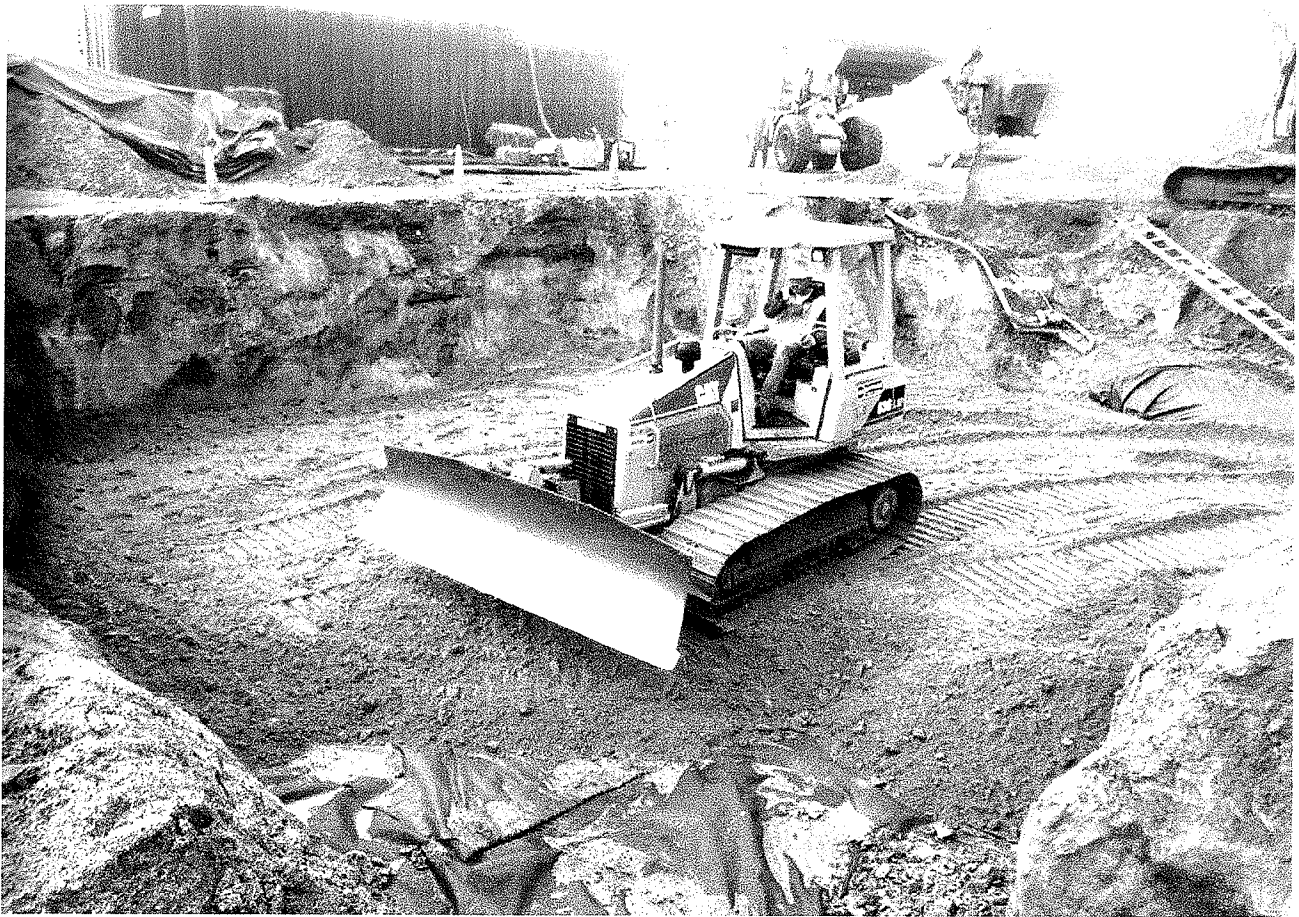
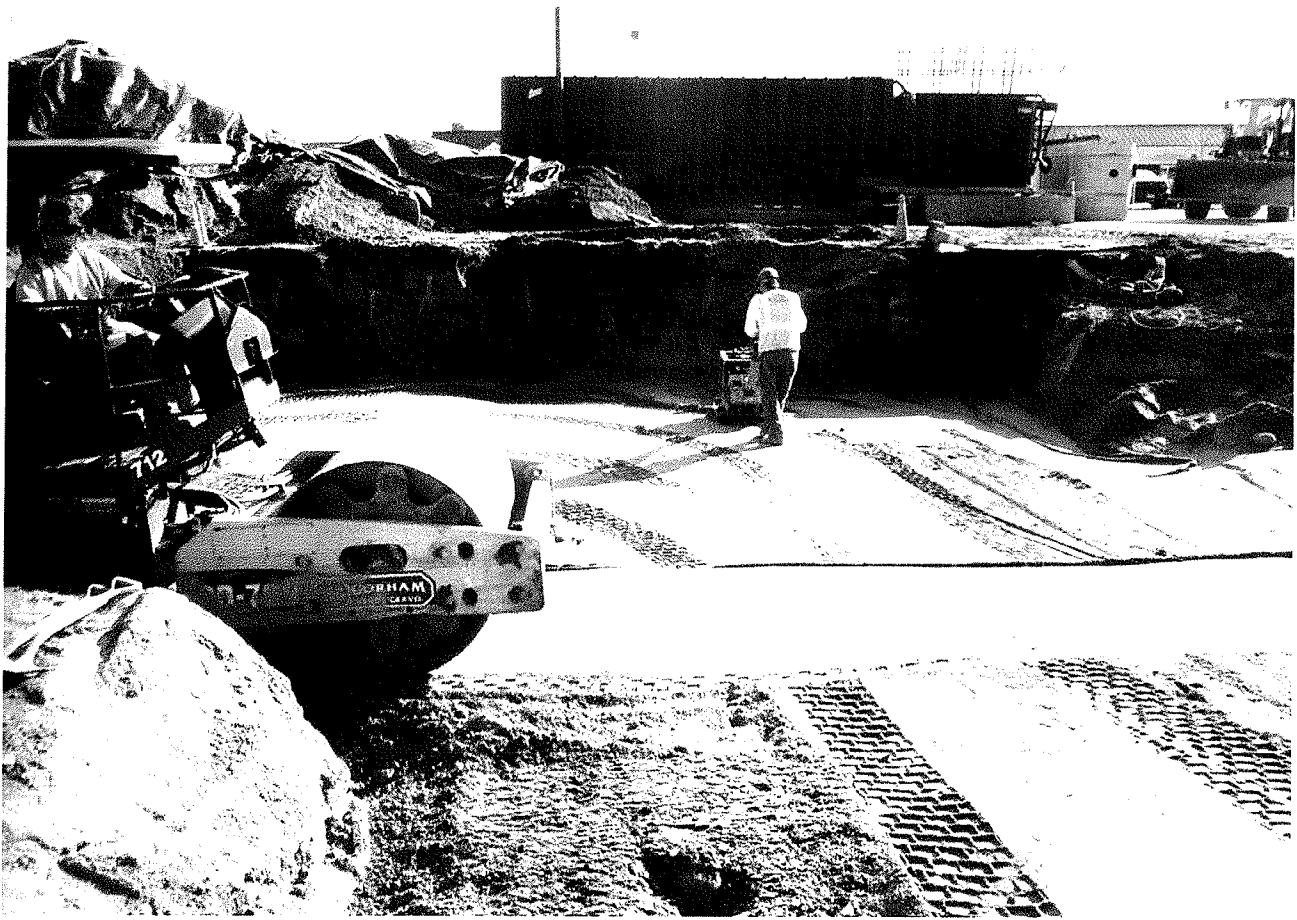
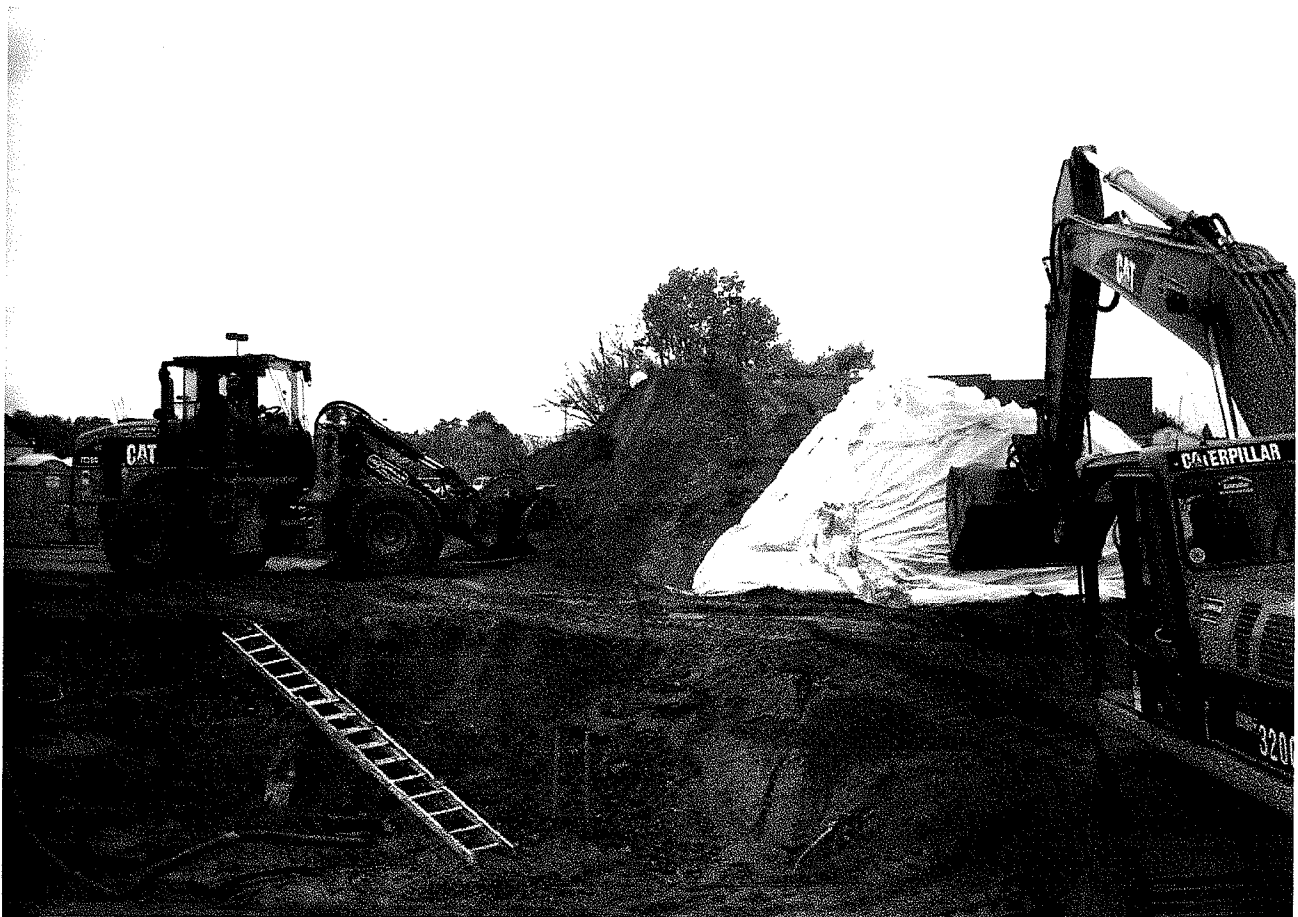
**General Observations, Discussions, Etc:** Upon arrival, the site was observed to generally be wet but in good condition after previous precipitation. Gorham Sand & Gravel (GS&G) began placing compacted lifts of both imported Structural Fill (Phinney pit crushed gravel) and reuse on site granular fill within the over-excavation performed previously on 10-27-10, approximately from column lines 2 (+4') to 4 (+3') and between B and A (-6'). As previously discussed with GS&G and Pizzagalli Construction, backfill material underlying building and canopy footings and within their zone of influence (1H:1V from bottom edge of footing) consisted of imported Structural Fill. In other areas, including beneath slab-on-grade areas, backfill consisted of reused on site granular fill material previously over-excavated. GS&G culled any large asphalt or concrete particles from the reuse material. All material was placed in approximate 12-inch lifts and compacted with several passes of an IR SD 70D vibratory roller. The first lift of material was placed directly over the 12-inch layer of crushed stone wrapped in Mirafi 600X geotextile, which was placed directly over subgrade on 10-27-10. The lifts of backfill were observed to be firm and unyielding in response to the compaction effort. Field densities were taken on the compacted lifts of material with results meeting or exceeding 95% of Modified Proctor values. Field density results will be provided under separate report. Brian Bachmann and Patrick Coughlin of St. Germain Collins were on site to make environmental observations. Backfilling of the area reached approximately elevation 41.5 feet on this date and will continue on 10-29-10.
