1. DEVELOPMENT DESCRIPTION

1.1 PROJECT OVERVIEW

The project consists of the development of Lot 7 of the previously approved Forefront at Thompson's Point Subdivision Plan at Thompsons' Point. The Lot 7 development fulfills the long-term goal of providing a location for a Cultural Center within a mixed-use development as shown on the Master Development Plan. In this case, the Children's Museum & Theatre of Maine is seeking to relocate from their existing location on Free Street, whereby they can address pressing needs for additional space and programming including exhibit and Theatrical performance space. As evidenced by the multiple past reviews and approvals granted by the Portland Planning Board for the Forefront site, we believe the current application will be welcomed and embraced by the community and continue the dynamic growth and excitement associated with the Thompson's Point redevelopment.

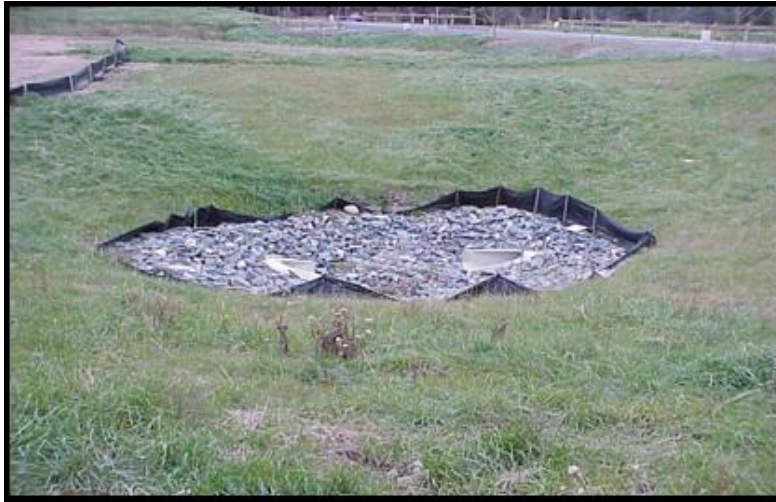
POORLY STABILIZED INLET ALLOWS ENTRANCE OF DEBRIS AND REDUCED CAPACITY

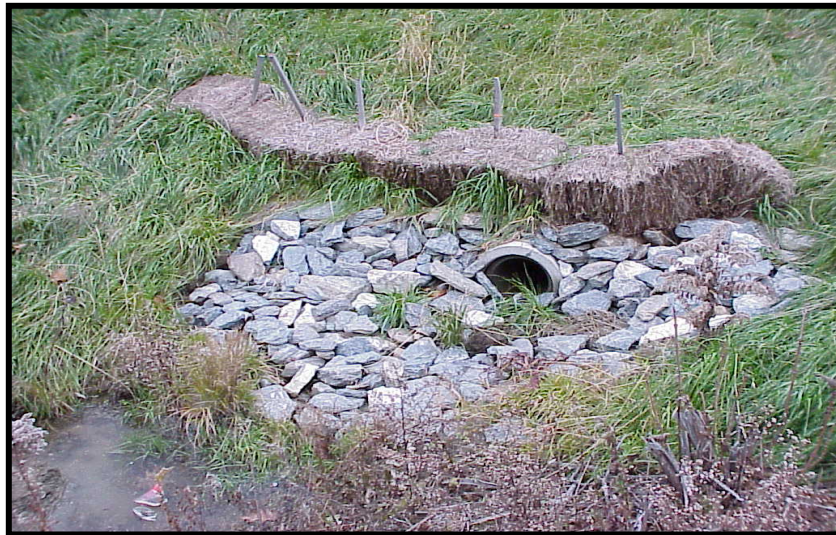
STABILIZED INLETS REDUCE DEBRIS ACCUMULATION AND MAINTAIN DESIGN CAPACITY

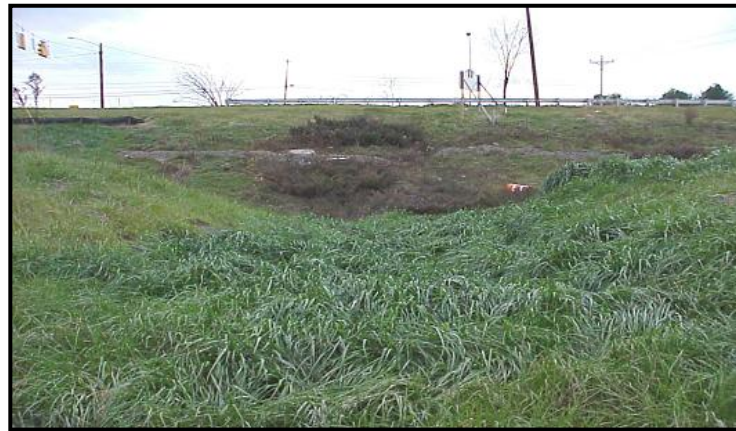
A WELL STABILIZED VEGETATED SWALE SHOWS LITTLE SIGNS OF EROSION VELOCITIES OR FLOWS. THIS SWALE ALSO FUNCTIONS AS A POND SPILLWAY

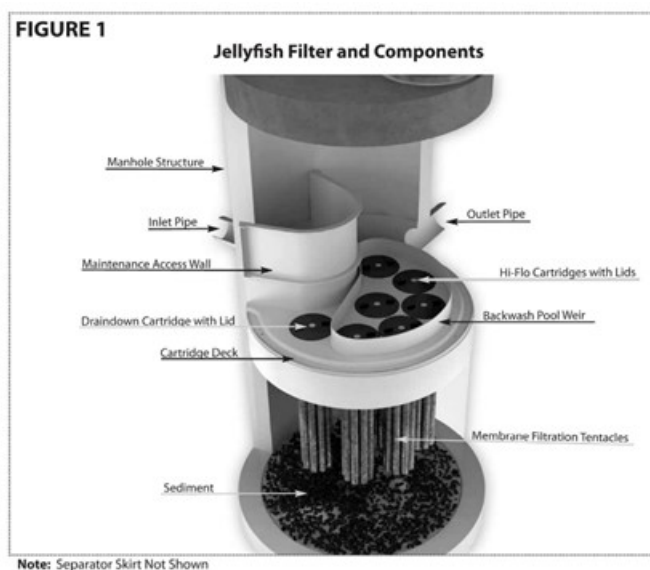
Below is a cut-away schematic of the Jellyfish Filter manhole with key components identified (6-ft. diameter manhole is depicted):

The Jellyfish Filter has no moving parts to wear out and therefore maintenance activities are generally focused on pollutant removal and filter cartridge service.

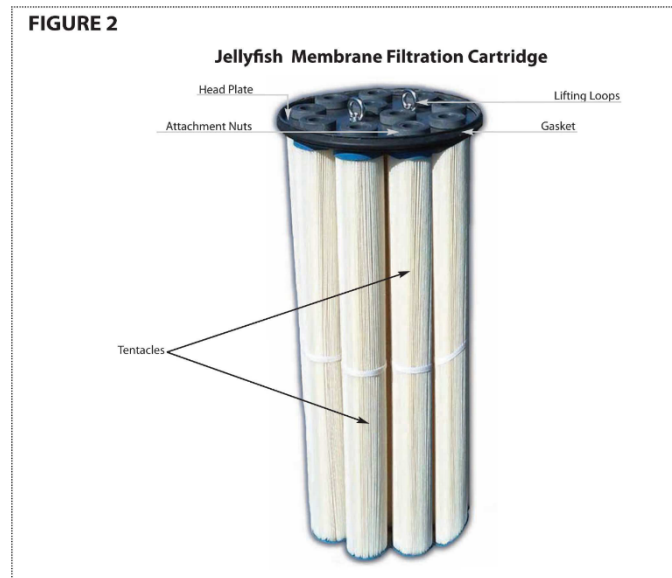
Below is a schematic of a Jellyfish Filter membrane filtration cartridge. Tentacles can be easily removed from the head plate and rinsed or replaced as needed.
