FIRE DEPARTMENT CHECKLIST

City of Portland
72 Bishop Street
Portland, Maine

Title:
 PRE-DEVELOPMENT
 STORMWATER PLAN

Title:
 POST DEVELOPMENT STORMWATER PLAN

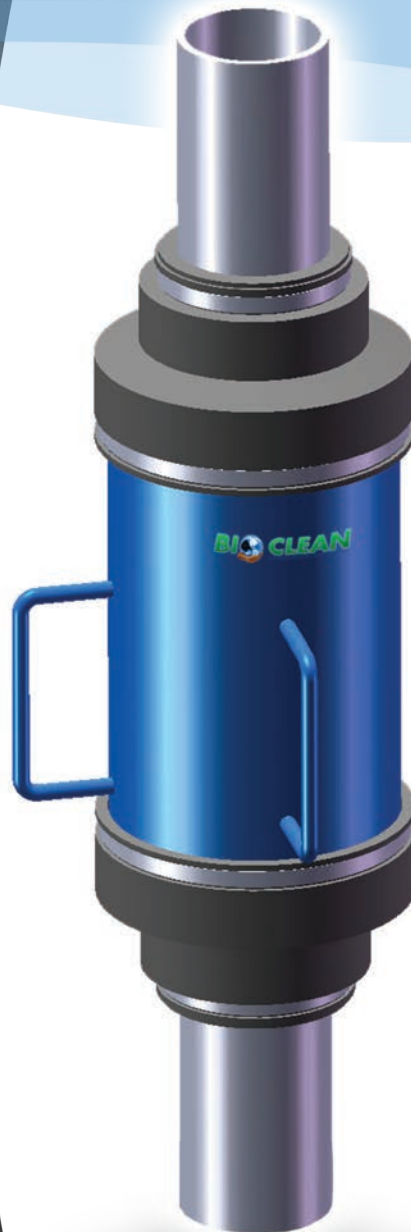
Proven since 2003, the Bio Clean Downspout Filter has been used on hundreds of installations throughout the United States. All internal components are constructed of stainless steel.

The sleek inline design allows the filter to be used in tight spaces. Approved by the IAPMO, this filter can meet all your needs.

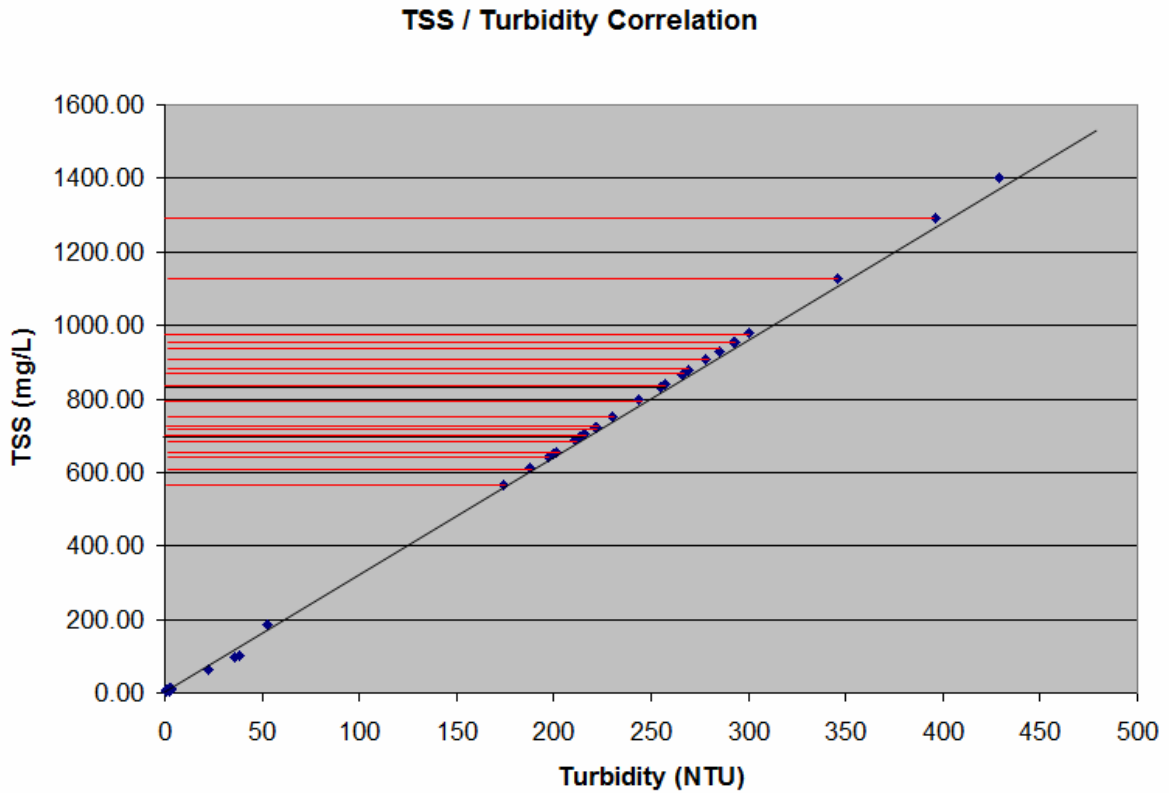
The Following Scatter Plot compiled from existing laboratory data was used to plot results of the grab samples (turbidity readings) in order to find the related TSS concentration in mg/L.

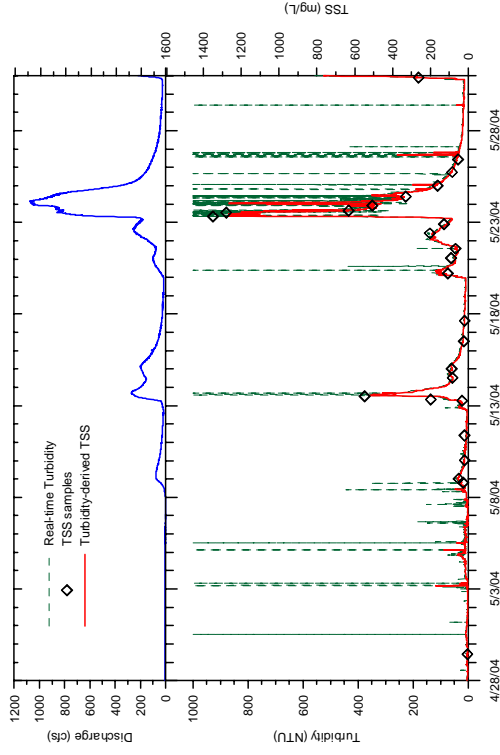
Figure 4. Discharge, TSS concentration, and turbidity data from 28 to 31 April 2004 at the Apple Creek USGS Station.

Figure 4 shows an example of the automated data and TSS event samples collected at each site. This figure illustrates:

- The dynamic real-time response and variability of turbidity in events.
- The close correlation between turbidity and TSS.
- The need for data processing to remove false-spikes and erratic responses of the optical sensor during high flows.

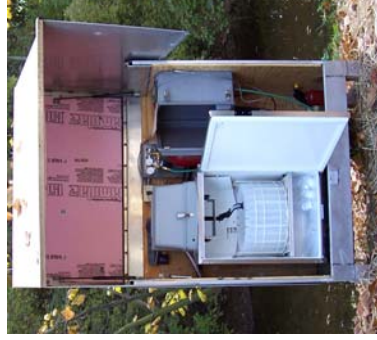
Figure 2. Refrigerated ISCO sampler.

Fully automated flow and water sampling stations were established in cooperation with the Wisconsin USGS Office in 2003. Standard methods were used for gaging streamflow and for collecting, processing, and analyzing water samples (Shelton 1994, Figure 2). Stage-triggered event samples were collected at the USGS gaging stations. In addition, a manually-activated sampler was located at a site upstream of the USGS station on the North Branch of Baird Creek. Biweekly low-flow samples were collected at each site using the equal width increment (EWI) method. YSI-6200 multi-parameter sondes were also deployed at each site and logged T, pH, DO, specific conductance, depth, and turbidity at 10 minute intervals (Figure 3). The optical turbidity sensors had automated wipers to reduce fouling.

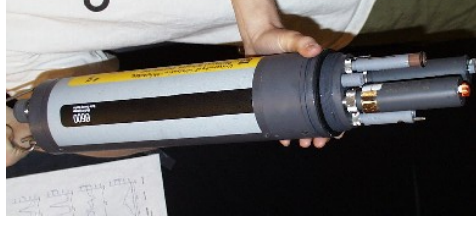
Figure 3. YSI-6200 sonde.

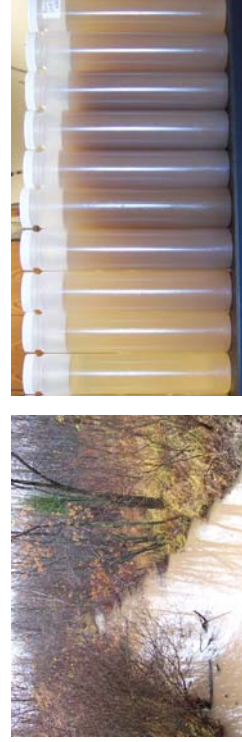
Figure 7. Event samples showing sediment concentration change during a storm.

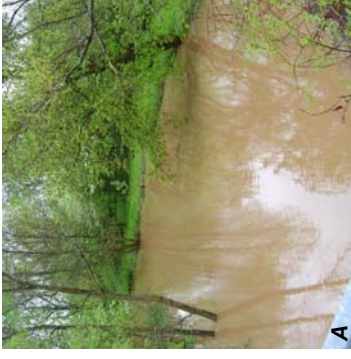
Figure 8. Ashwaubenon Creek during May 2004 storm events: (A) May 14, (B) May 23.
