RE: Response to Comments  
Level II Site Plan Application  
Academy for Active Learners  
134 Warren Avenue  
Portland, Maine

Date: December 01, 2015; Revised 1/29/16; Revised 02/19/16  
To: Academy for Active Learners  
From: Maureen P. McGlone, P.E.  
Peer Review: Stephen J. Bradstreet, P.E.  
Location: 134 Warren Avenue, Portland, Maine

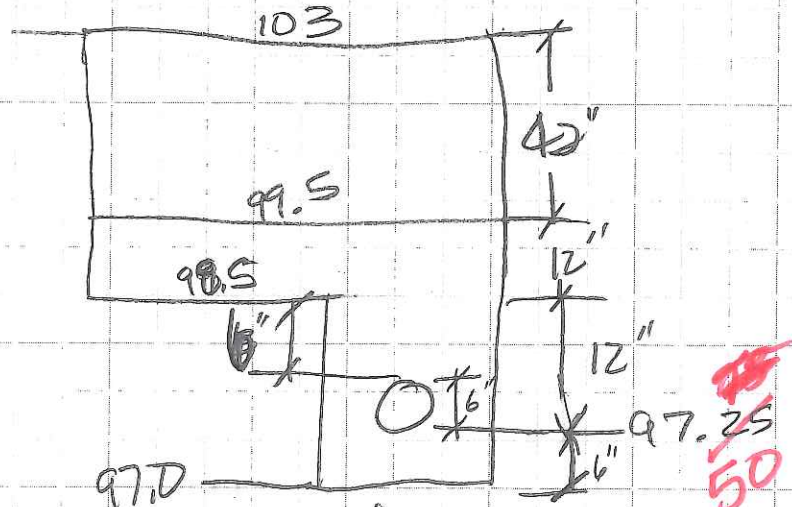
Pond / Reach 12": 6" HDPE solid l=25'  
 ↳ RTanks

Nyloplast

Inv. @ RTanks  
 = 96.0  
 $\therefore S = 0.06$  ft/ft

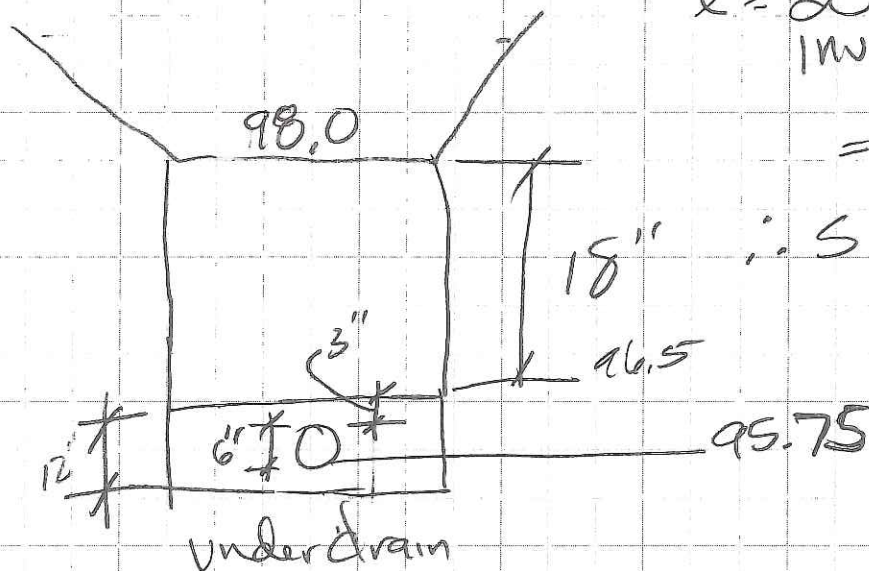
Pond/Reach 2R: Underdrain pipe to Nyloplast  
 w/ 6" solid to R tanks  
 Nyloplast

$l = 20'$   
 $1 \text{ in. in @ R tanks}$

$= 95.25$

$\therefore S = 0.025$

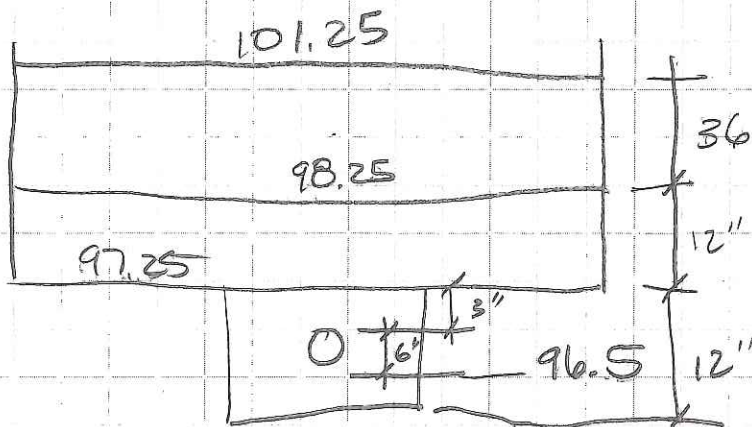
Pond/Reach 3R:  
 Nyloplast

6" HDPE solid:

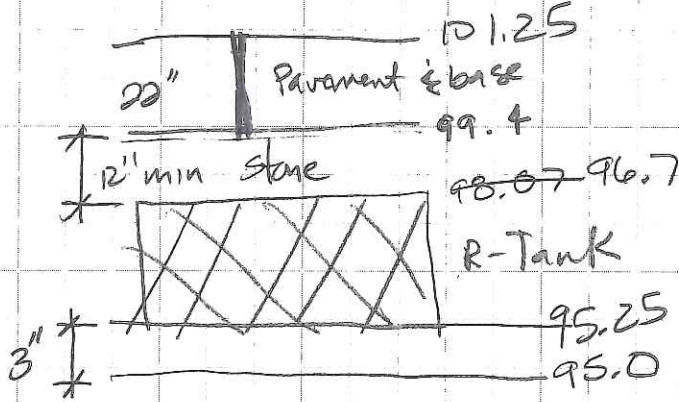
R Tank system:

Lowest point in parking lot = 101.25  
Lowest invert in = 95.25 (from #2) single  
using double tanks

$w = 15.75"$   
 $l = 28.15"$   
 $h = 33.86" (2.82')$   
 $= 17.32 (1.44')$

The use of the R-Tanks has been included to facilitate on-site detention of the stormwater so that runoff approximates the pre-development conditions. The proposed detention system connects all three treatment systems and is sited beneath the pavement in the rear of the building. Stormwater from the R-Tanks will flow into an outlet control structure that will control the flow with orifices and a weir. The stormwater then discharges to a rip rap slope and down the embankment to follow the current drainage path to the southwest corner of the site. During larger storm events the Nyloplast structures identified above will collect the additional stormwater and direct it into the R-Tank system for detention.

Inspection and Maintenance of the R-Tank shall be in accordance with the manufacturer's recommended practices to provide the performance required by the design. The R-Tank system includes inspection ports and maintenance ports, each of which has a cover at the surface. A visual inspection of all ports should be used to determine the depth of sediments deposited in the R-Tank system. The system should be back-flushed once the sediment accumulation has reached the manufacturer's limits. Once removed, sediment-laden water must be disposed of properly.

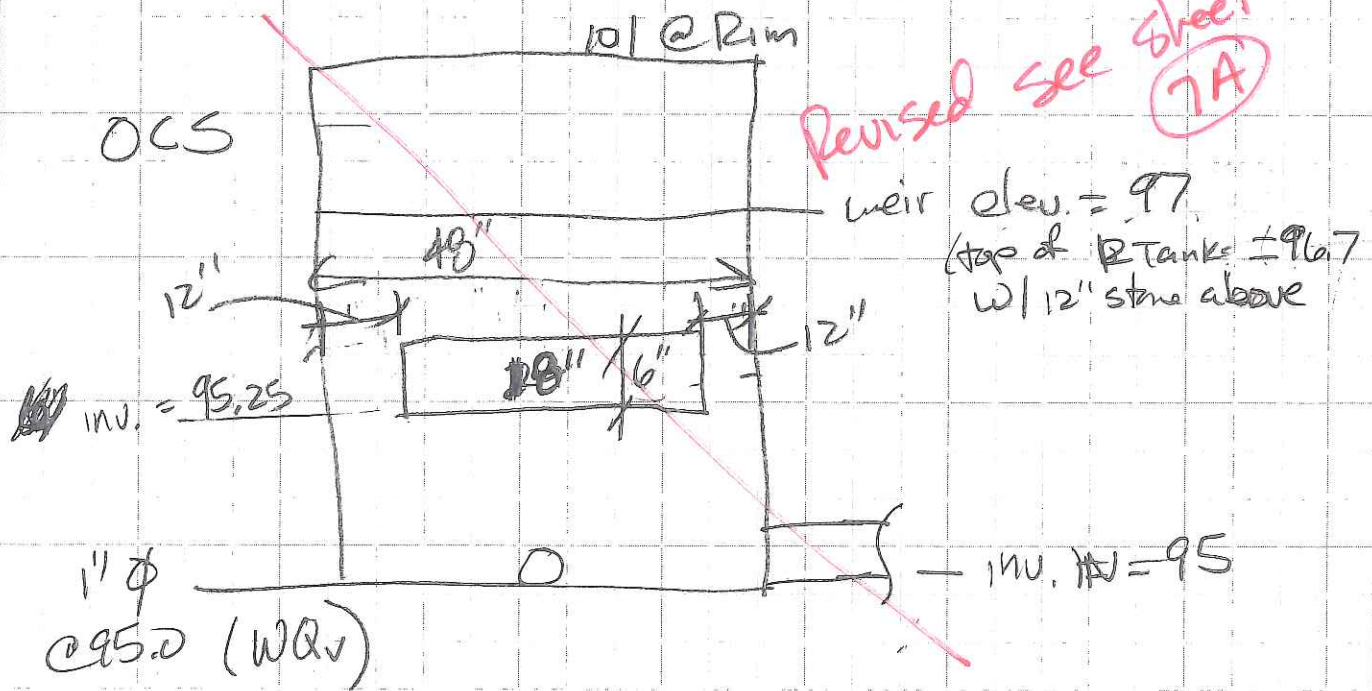
outlet to OCS: 95.25 out  
95.0 in @ OCS

$l = 25'$

Revised see sheet **7A**

weir elev. = 97  
(top of R Tanks = 96.7  
w/ 12" stone above)
