Stormwater Management Report

Acadia Lending Group Professional Office Building
Riverside Street
Portland, Maine 04103

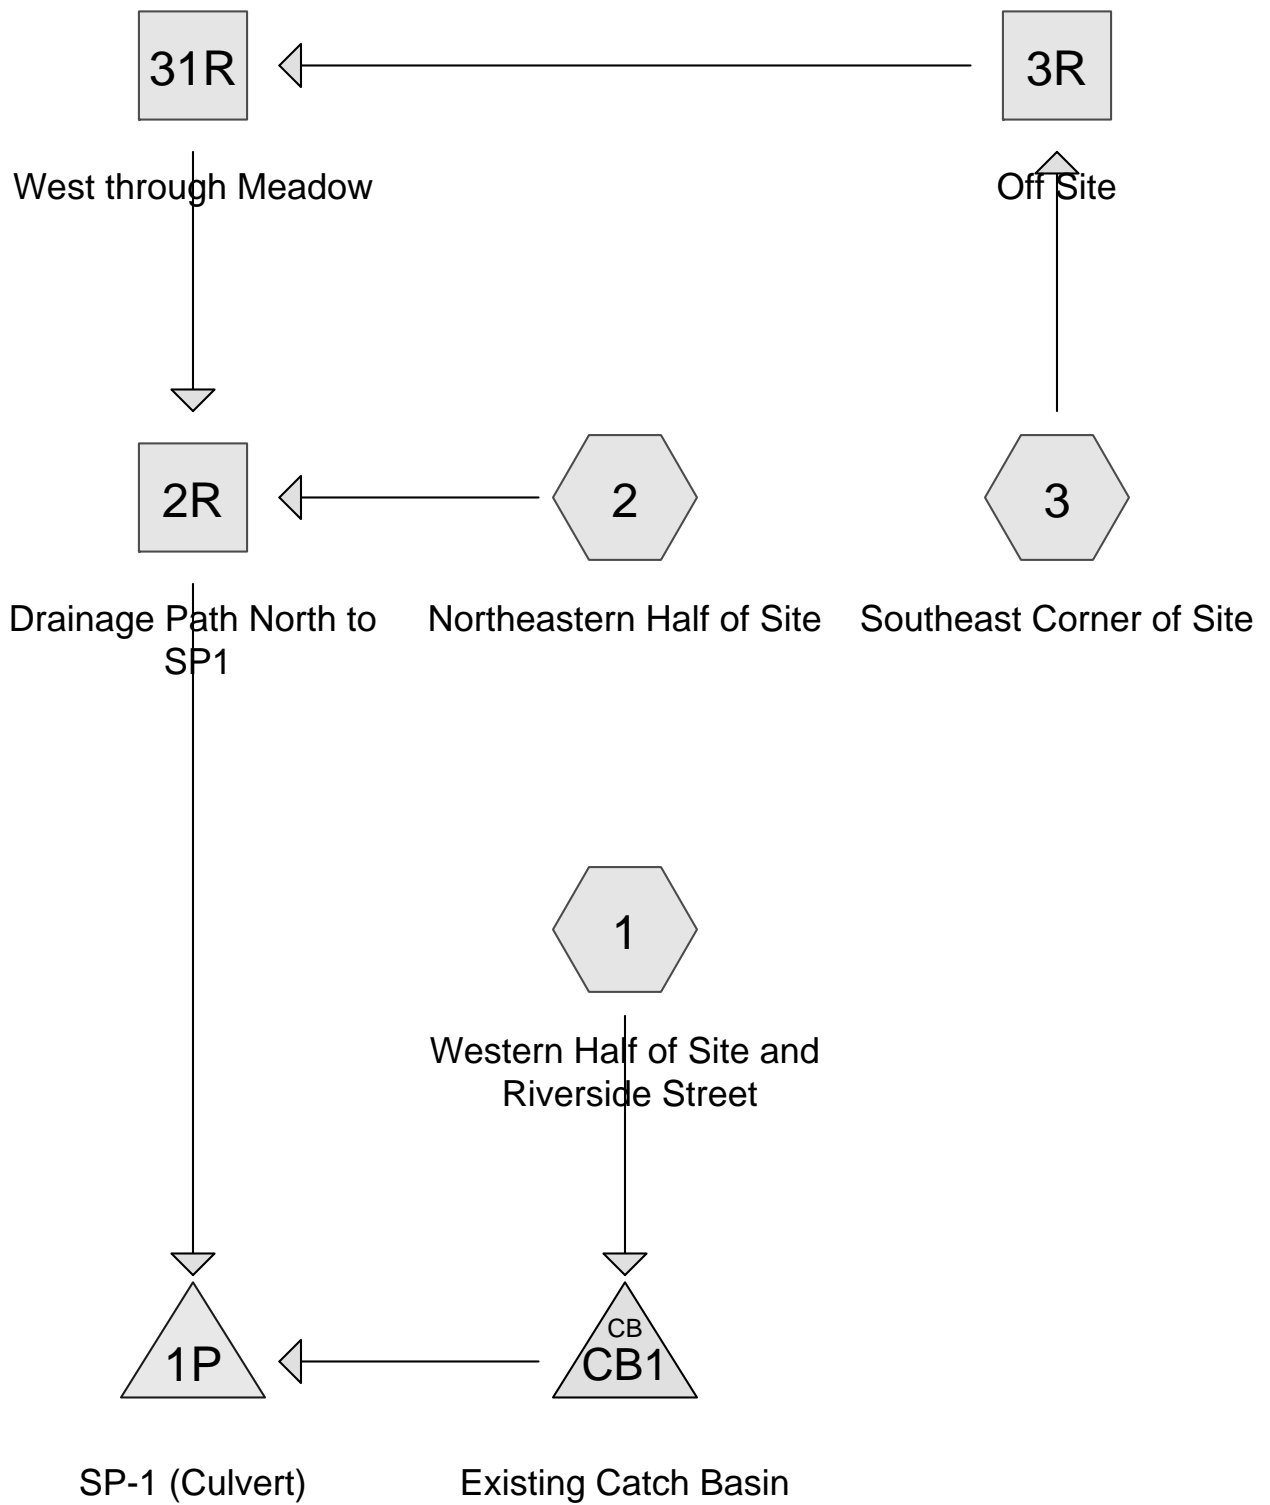
16078-PRE

Pre-Development Stormwater Modeling

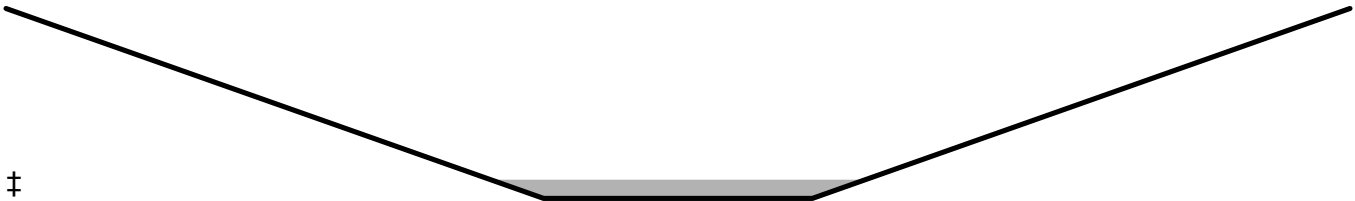
Peak Storage= 541 cf @ 12.35 hrs
 Average Depth at Peak Storage= 0.10'
 Bank-Full Depth= 1.00' Flow Area= 30.0 sf, Capacity= 180.97 cfs

10.00' x 1.00' deep channel, n= 0.030 Earth, grassed & winding
 Side Slope Z-value= 20.0 '/' Top Width= 50.00'
 Length= 460.0' Slope= 0.0293 '/'
 Inlet Invert= 71.50', Outlet Invert= 58.00'

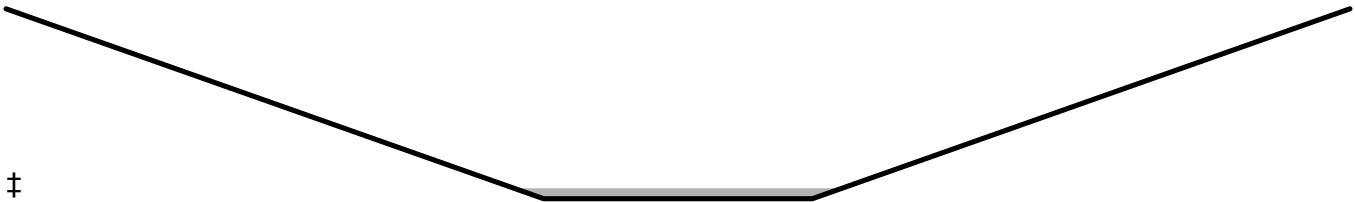
Peak Storage= 121 cf @ 12.27 hrs
Average Depth at Peak Storage= 0.05'
Bank-Full Depth= 1.00' Flow Area= 30.0 sf, Capacity= 94.97 cfs

10.00' x 1.00' deep channel, n= 0.035 Earth, dense weeds
Side Slope Z-value= 20.0 '/' Top Width= 50.00'
Length= 200.0' Slope= 0.0110 '/'
Inlet Invert= 74.00', Outlet Invert= 71.80'

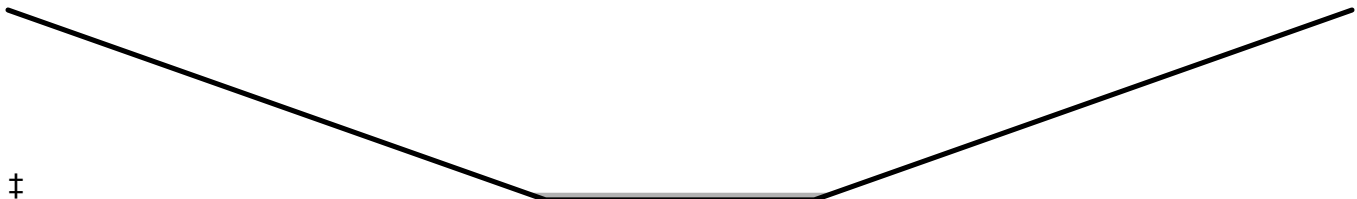
Length= 460.0' Slope= 0.0293 '/'

Inlet Invert= 71.50', Outlet Invert= 58.00'

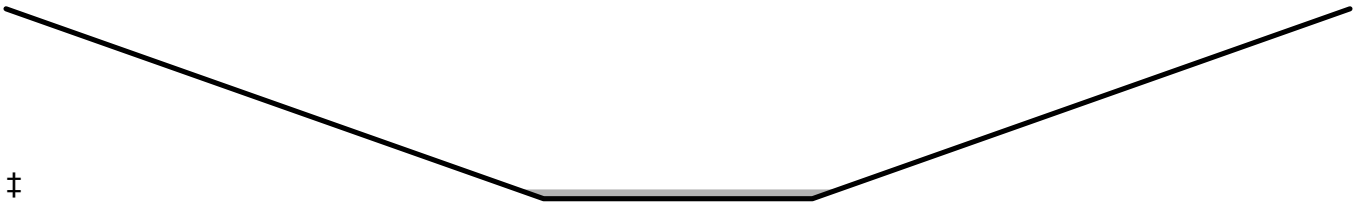
Peak Storage= 107 cf @ 12.28 hrs
Average Depth at Peak Storage= 0.05'
Bank-Full Depth= 1.00' Flow Area= 30.0 sf, Capacity= 94.97 cfs

10.00' x 1.00' deep channel, n= 0.035 Earth, dense weeds
Side Slope Z-value= 20.0 '/' Top Width= 50.00'
Length= 200.0' Slope= 0.0110 '/'
Inlet Invert= 74.00', Outlet Invert= 71.80'
