28 Whittier Street Portland

Your drawings seem to show you are removing an existing bearing wall between the kitchen and dining room and replace that bearing wall with a new manufactured beam.

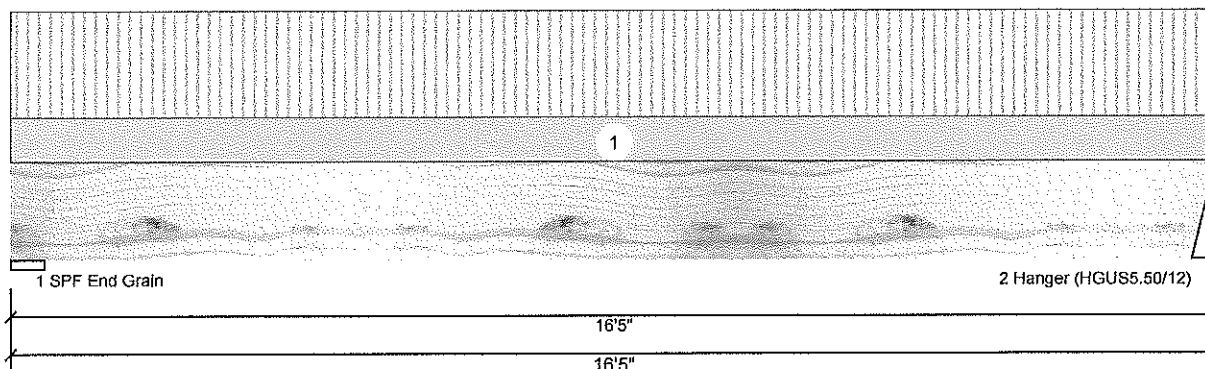
Member Information

Type:	Girder	Application:	Floor
Plies:	3	Design Method:	ASD
Moisture Condition:	Dry	Building Code:	IBC/IRC 2015
Deflection LL:	360	Load Sharing:	Yes
Deflection TL:	240	Deck:	Not Checked
Importance:	Normal		
Temperature:	Temp <= 100°F		
General Load			
Floor Live:	40 PSF		
Dead:	10 PSF

Analysis	Actual	Location	Allowed	Capacity	Comb.	Case
Moment	31359 ft-lb	8'3 1/4"	53922 ft-lb	0.582 (58%)	D+L	L
Unbraced	31359 ft-lb	8'3 1/4"	31477 ft-lb	0.996 (100%)	D+L	L
Shear	6609 lb	1'8 5/8"	17920 lb	0.369 (37%)	D+L	L
LL Defl inch	0.302 (L/627)	8'3 5/16"	0.526 (L/360)	0.570 (57%)	L	L
TL Defl inch	0.435 (L/435)	8'3 5/16"	0.789 (L/240)	0.550 (55%)	D+L	L

ID	Load Type	Location	Trib Width	Side	Dead	Live	Snow	Wind	Const.	Comments
1	Uniform			Top	290 PLF	700 PLF	0 PLF	0 PLF	0 PLF	F, W, C
	Self Weight				19 PLF

I need to know the design loading (uniform and point loads) and the approved size of the beam. I also need to know the required post sizes at each end of the beam with approved connections as well as how these new point loads will be carried to the foundation or footings in the basement below.
