**Marine Hospital Renovation**  
MARTIN'S POINT - PORTLAND, MAINE

TITLE  
EXIST THIRD  
FLOOR & ROOF  
FRAMING PLANS

S3

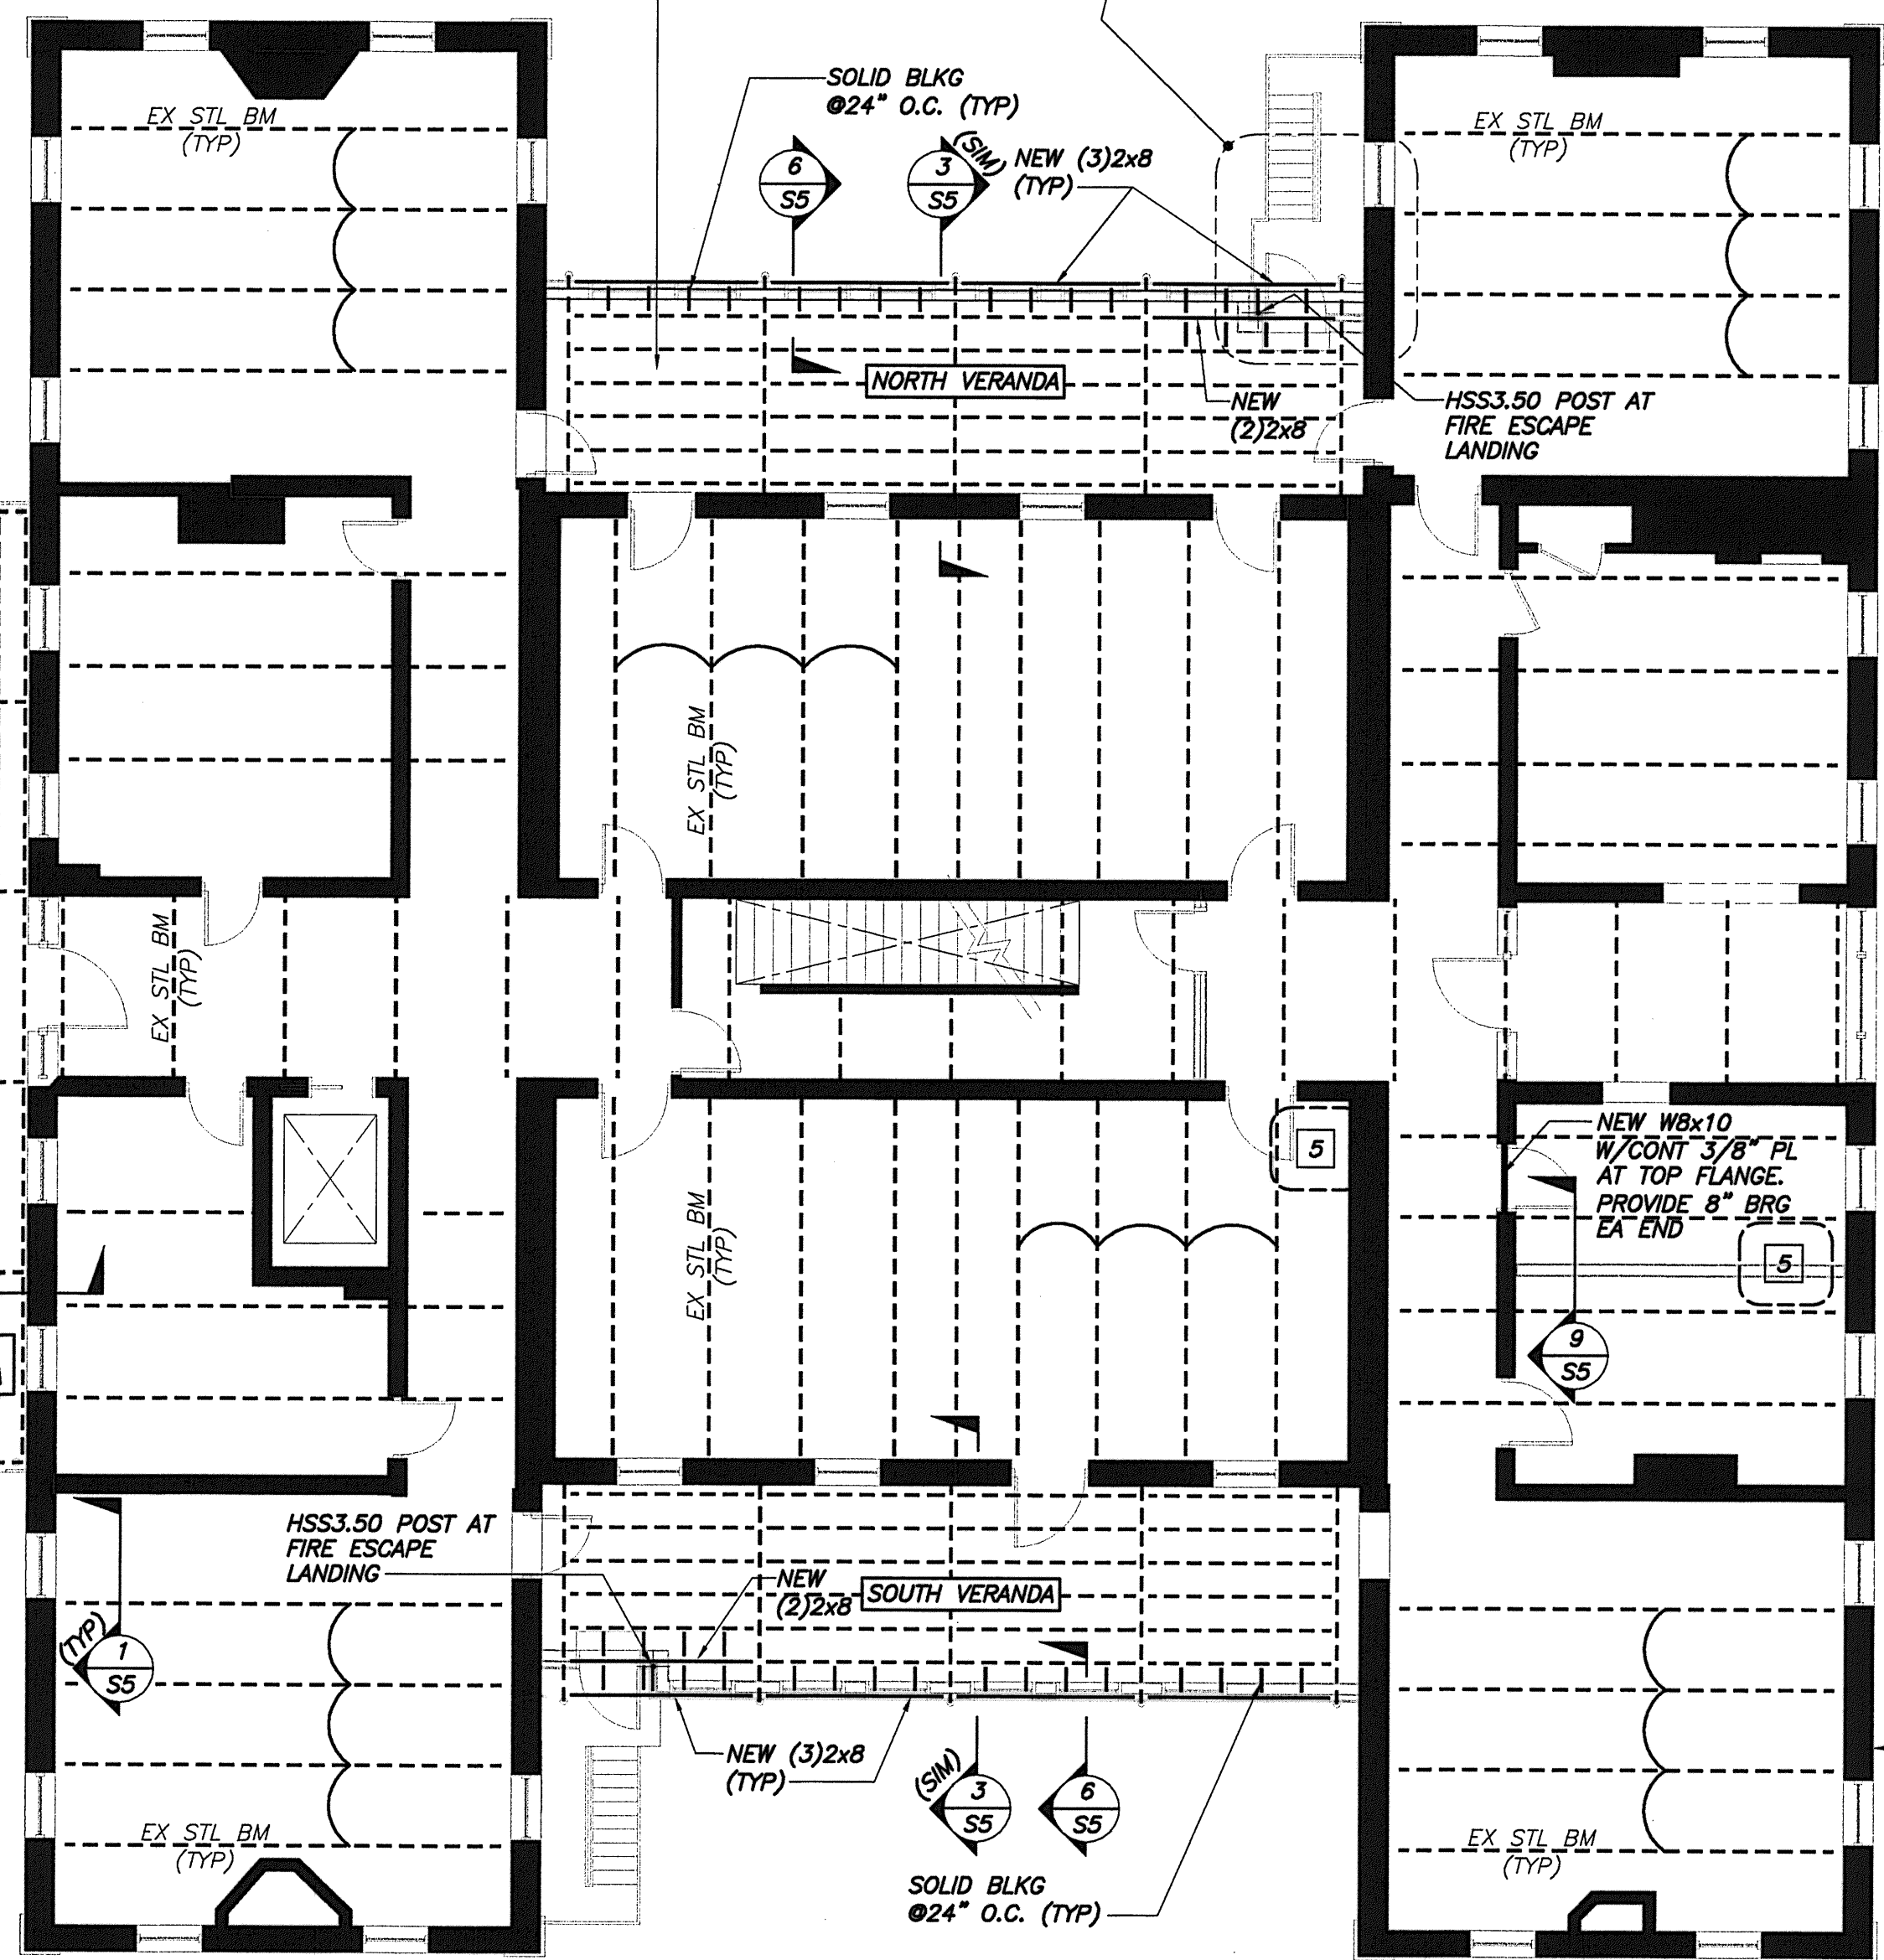
**EXIST THIRD FLOOR FRAMING PLAN**  
1/8"=1'-0"

NOTE: NEW STEEL LINTELS ARE REQD AT ALL LOCATIONS WHERE EXIST FLOOR BEAMS FRAME OVER EXIST WINDOWS. LOCATIONS AND FREQUENCY OF CONDITION UNKNOWN. G.C. SHALL EXPOSE FLOOR FRAMING OVER EACH WINDOW AT LOAD BEARING WALLS AND VERIFY LOCATION OF FLOOR BEAM. SEE SECT 1/SS FOR ADDL INFO. TYPICAL AT SECOND, THIRD & ATTIC LEVELS.

NOTE: REPLACE IN KIND, ANY DETERIORATED VERANDA MEMBERS (TYP). COORD REQD ALLOWANCE W/ARCH.

- 1. KEY NOTES (SEE SCHEDULE) INDICATE WORK BELOW INDICATED FRAMING LEVEL.
- 2. INDICATES SPAN OF EXIST BRICK ARCH FLOOR.

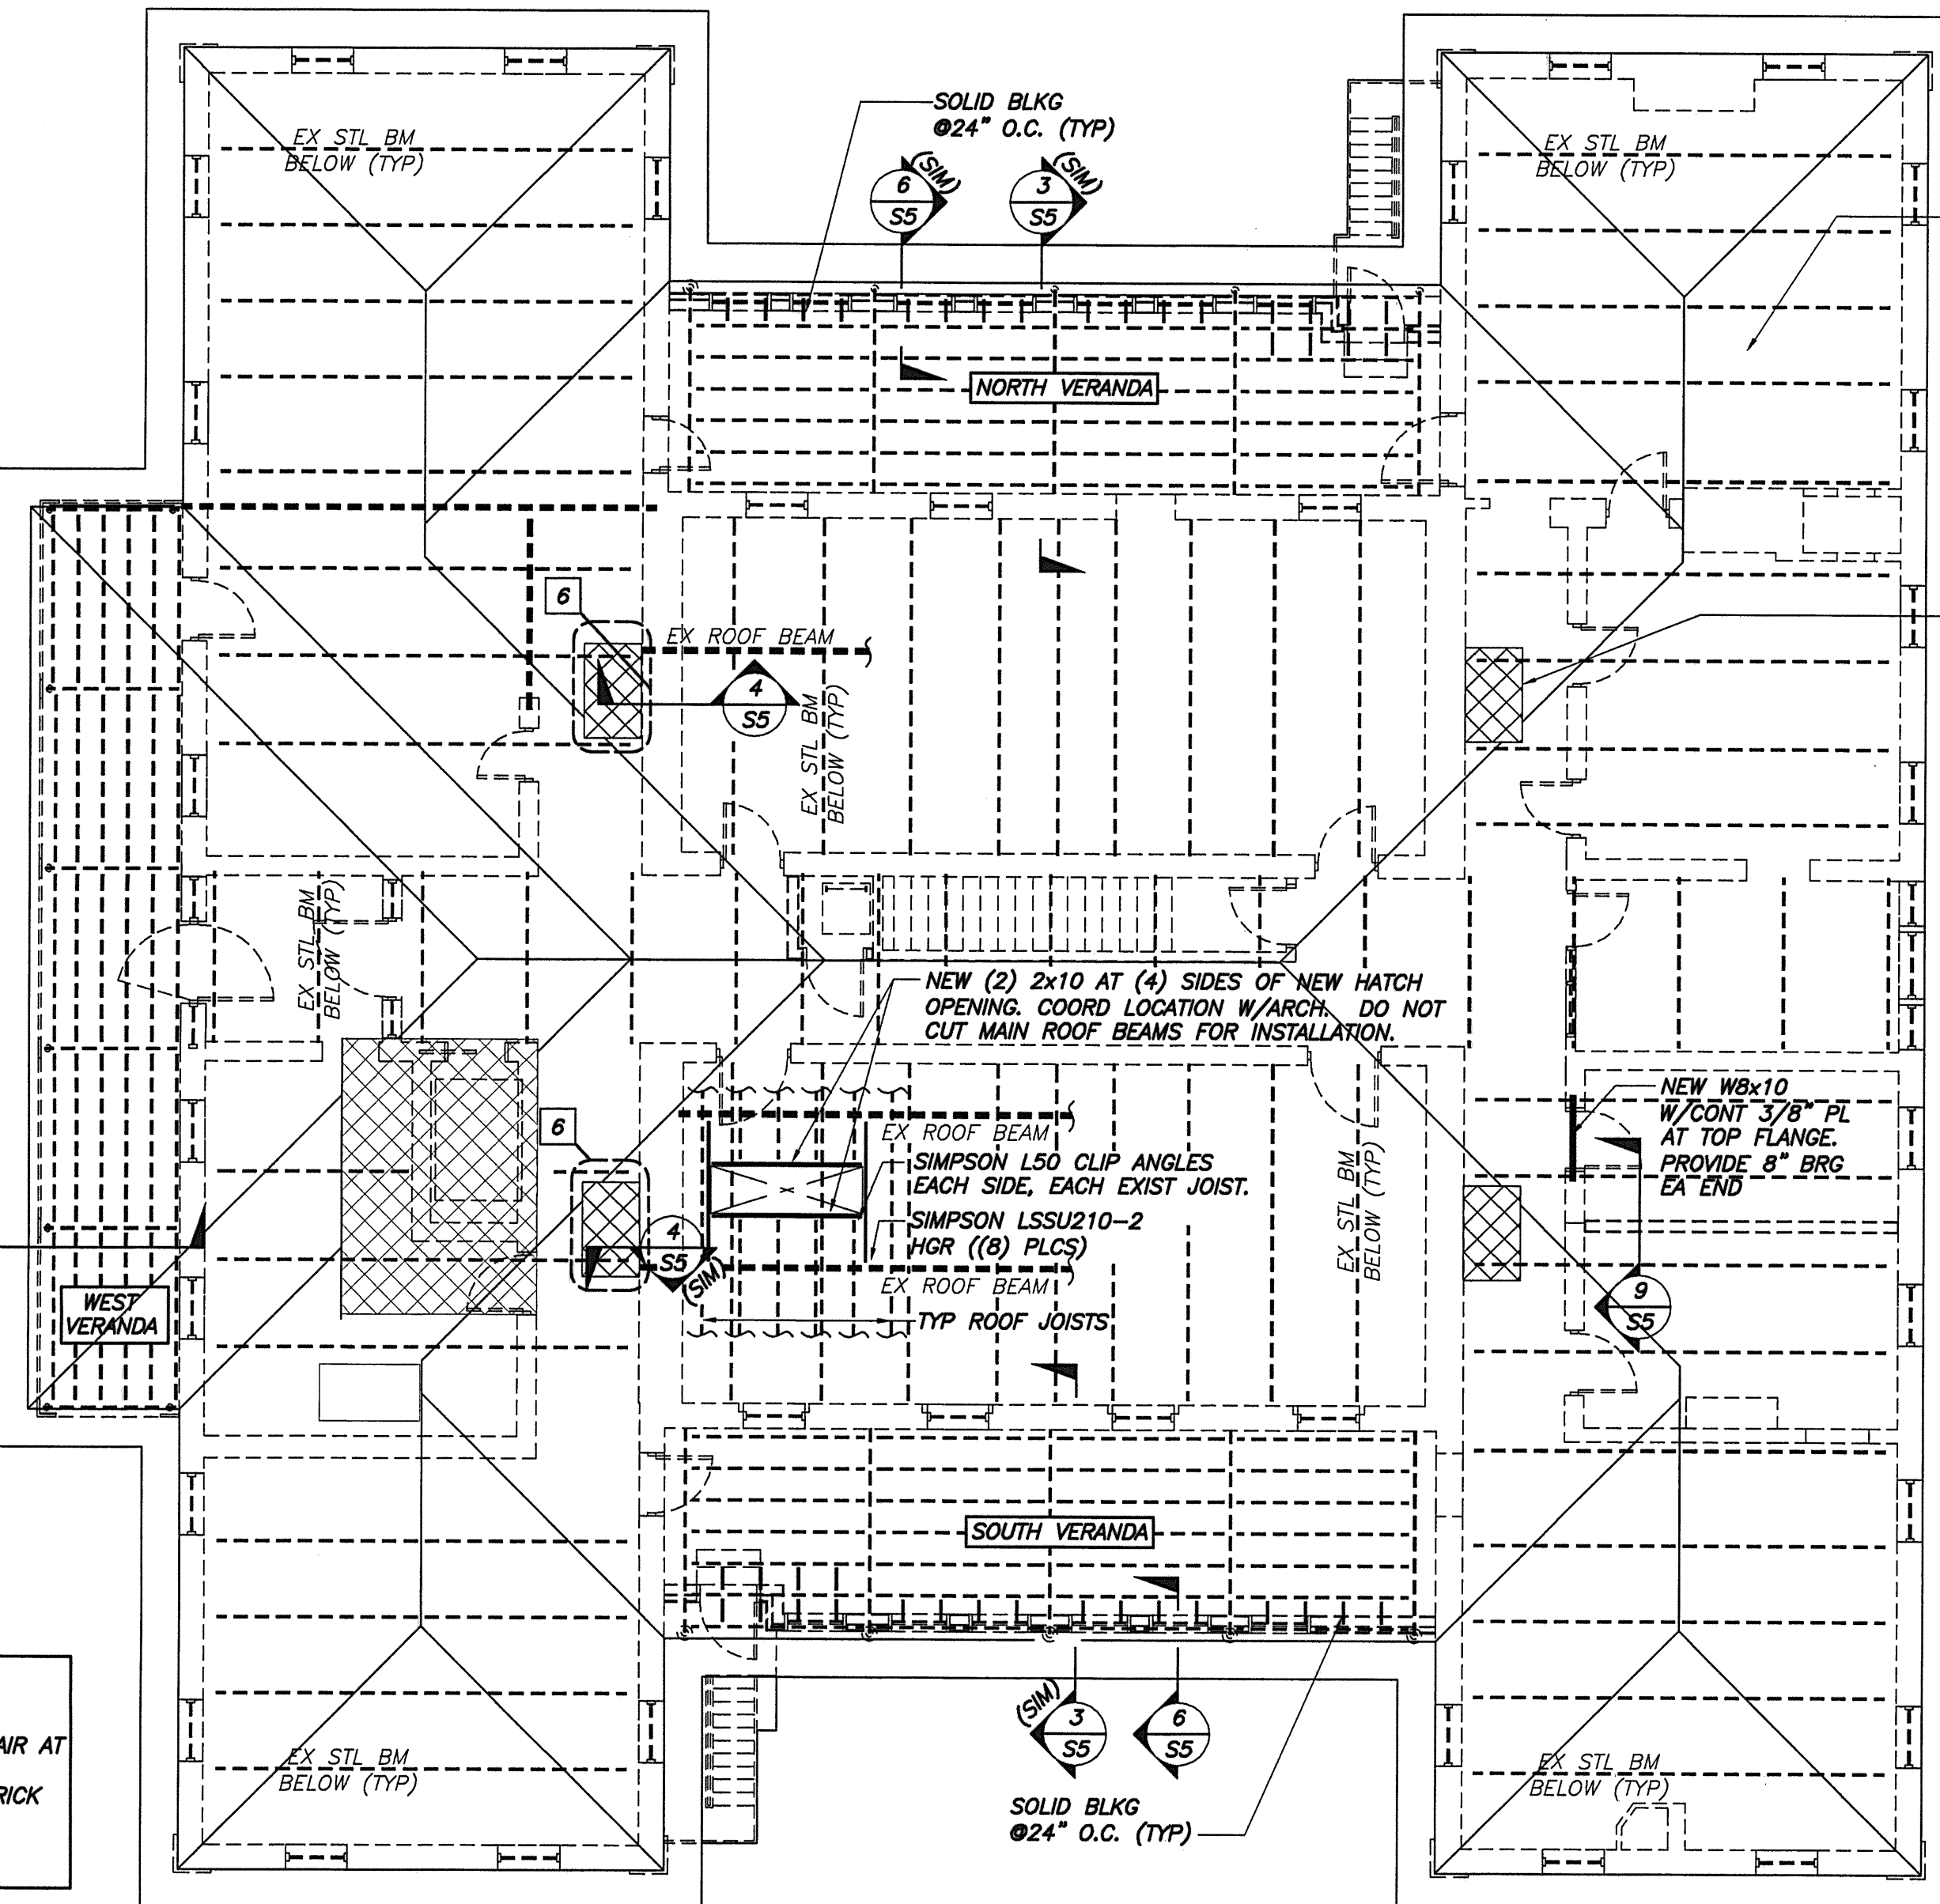
**EXIST ROOF FRAMING PLAN**  
1/8"=1'-0"

- 1. KEY NOTES (SEE SCHEDULE) INDICATE WORK BELOW INDICATED FRAMING LEVEL.
- 2. INDICATES SPAN OF EXIST BRICK ARCH FLOOR.

NOTE: ADD 6x6 WOOD POST BELOW CANTILEVERED ROOF BEAM TO BRICK FLOOR BELOW. TYPICAL ONE LOC. ONLY.

NOTE: PROVIDE SILOXANE WATER REPELLENT AT ALL CHIMNEYS ABOVE ROOFING. ENSURE ALL UNUSED CHIMNEYS ARE PROPERLY CAPPED & SEALED. COORD W/ ARCH. (TYP)
