**Structural Special Inspections Report**

**Bayside Village – A Student Housing Complex**

132 Marginal Way  
Portland, Maine  
July 31, 2008

Structural Engineer of Record  
Becker Structural Engineers, Inc.  
75 York Street  
Portland, Maine 04101

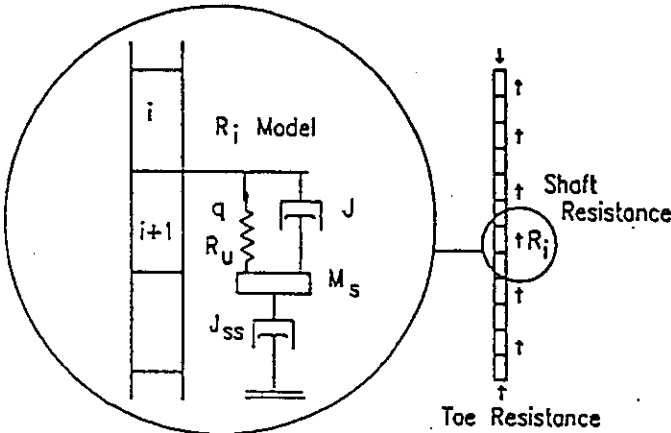
## The CAPWAPC Pile and Soil Model

The pile is modeled as a series of continuous segments (with impedances matching pile cross sectional changes) of approximately 1 m (3.3 ft) length. Concentrated soil resistance forces are attached to each or every second pile segment along the embedded pile. Major parameters of this model include at each segment,  $i$ , the ultimate resistance,  $R_u$ , the quake,  $q$ , the damper,  $J$ , and the radiation damping model consisting of  $J_{ss}$  and mass,  $M_s$ .

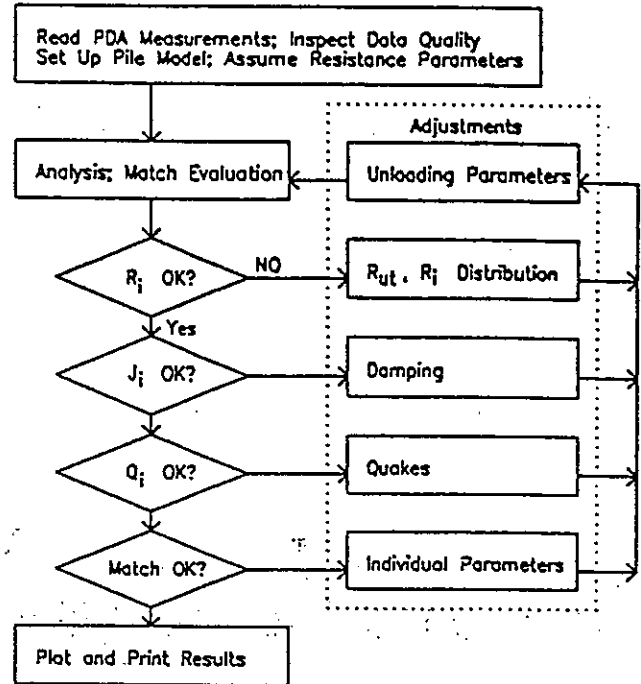
## The CAPWAP Procedure

The following block diagram outlines the basic procedure for iterative calculation of soil model parameters in CAPWAPC. Either the automatic or manual mode of CAPWAPC are utilized to perform the necessary calculations.

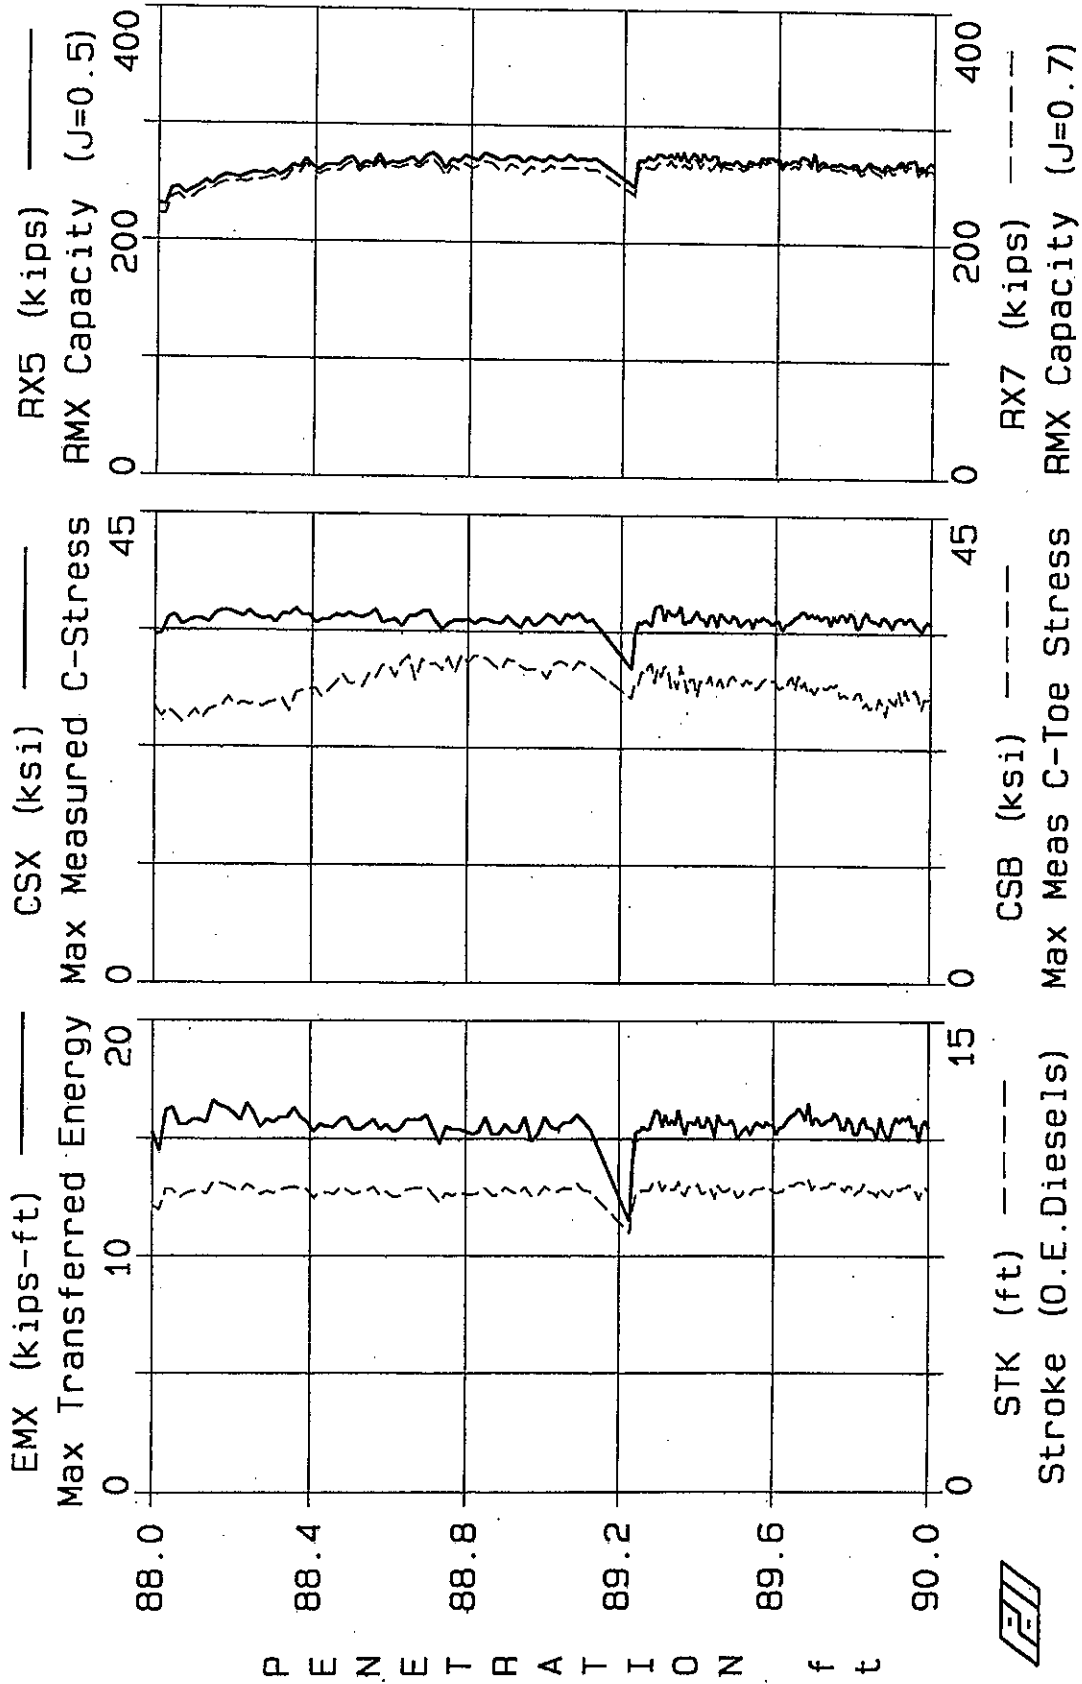
Bayside Village, #151, PP9.63x.352"

File: #151  
 Info: PP9.63x.352"  
 AR: 10.3 in<sup>2</sup>  
 LE: 107.0 ft

Proj: Bayside Village  
 SP: 0.492 k/ft<sup>3</sup>  
 WS: 16810 ft/s  
 EM: 30000 KSI
