PERMIT TO INSTALL PLUMBING

Address **204 Danforth St.** PERMIT NUMBER **1863**  
Installation for **single fam.**  
Owner of Bldg. **Peter Howe**  
Owner's Address **same**  
Plumber **Richard Profenno-58 Christy Rd.** Date **4-23-79**  
NEW REPEL

*Handwritten: 204-206 Danforth St*  
Re: Egress at 204-206 Danforth Street

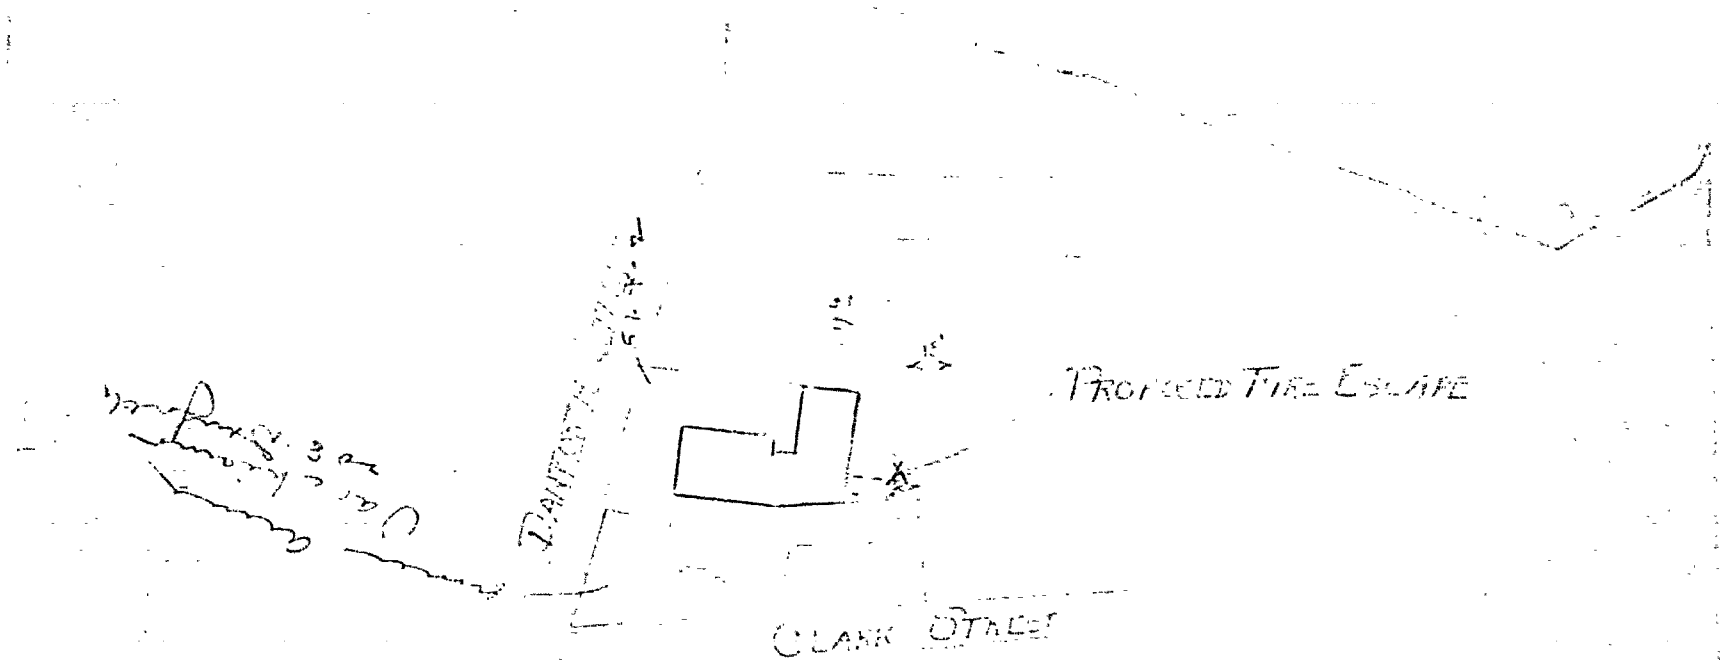
7'6"  
7'0"  
14'0"  
18'3"

An inspector from this office upon checking the location on the ground, reports that a substantial part of the proposed wooden fire escape has been completed, although the building permit is just now being issued. This is of course in violation of the law, but perhaps has caused no great trouble for anyone except for one point.

He noted that the foundation beneath the bottom of the lowest run of stairs has not been built according to the plan. The grade of the ground around the pier is higher than the top of the pier so that if the ground is filled in level, the wooden stairway would be surrounded by dirt. The plan shows and you are required to have the pier extending no less than 6" above the finished grade of the ground, and the woodwork of the stairway supported well above the top of the ground on the pier. The plan indicates that the pier is to be made high enough and long enough and wide enough to form the bottom step and at the same time the support for the wooden stringers of the stairs so that they will be well above the ground. This means that the present lower run of stairs (this has already been erected without a permit) are to be adjusted so that the arrangement shown on the plan is accomplished, even though it means removing the entire run and rebuilding them. At the same time care must be exercised that the height of risers and the width of treads of this run of stairs are kept uniform.
