**26 Moody Street**  
Condominium

Portland, Maine

**Proposed**  
**& Existing**  
**North**  
**Elevation**

**A2.1**

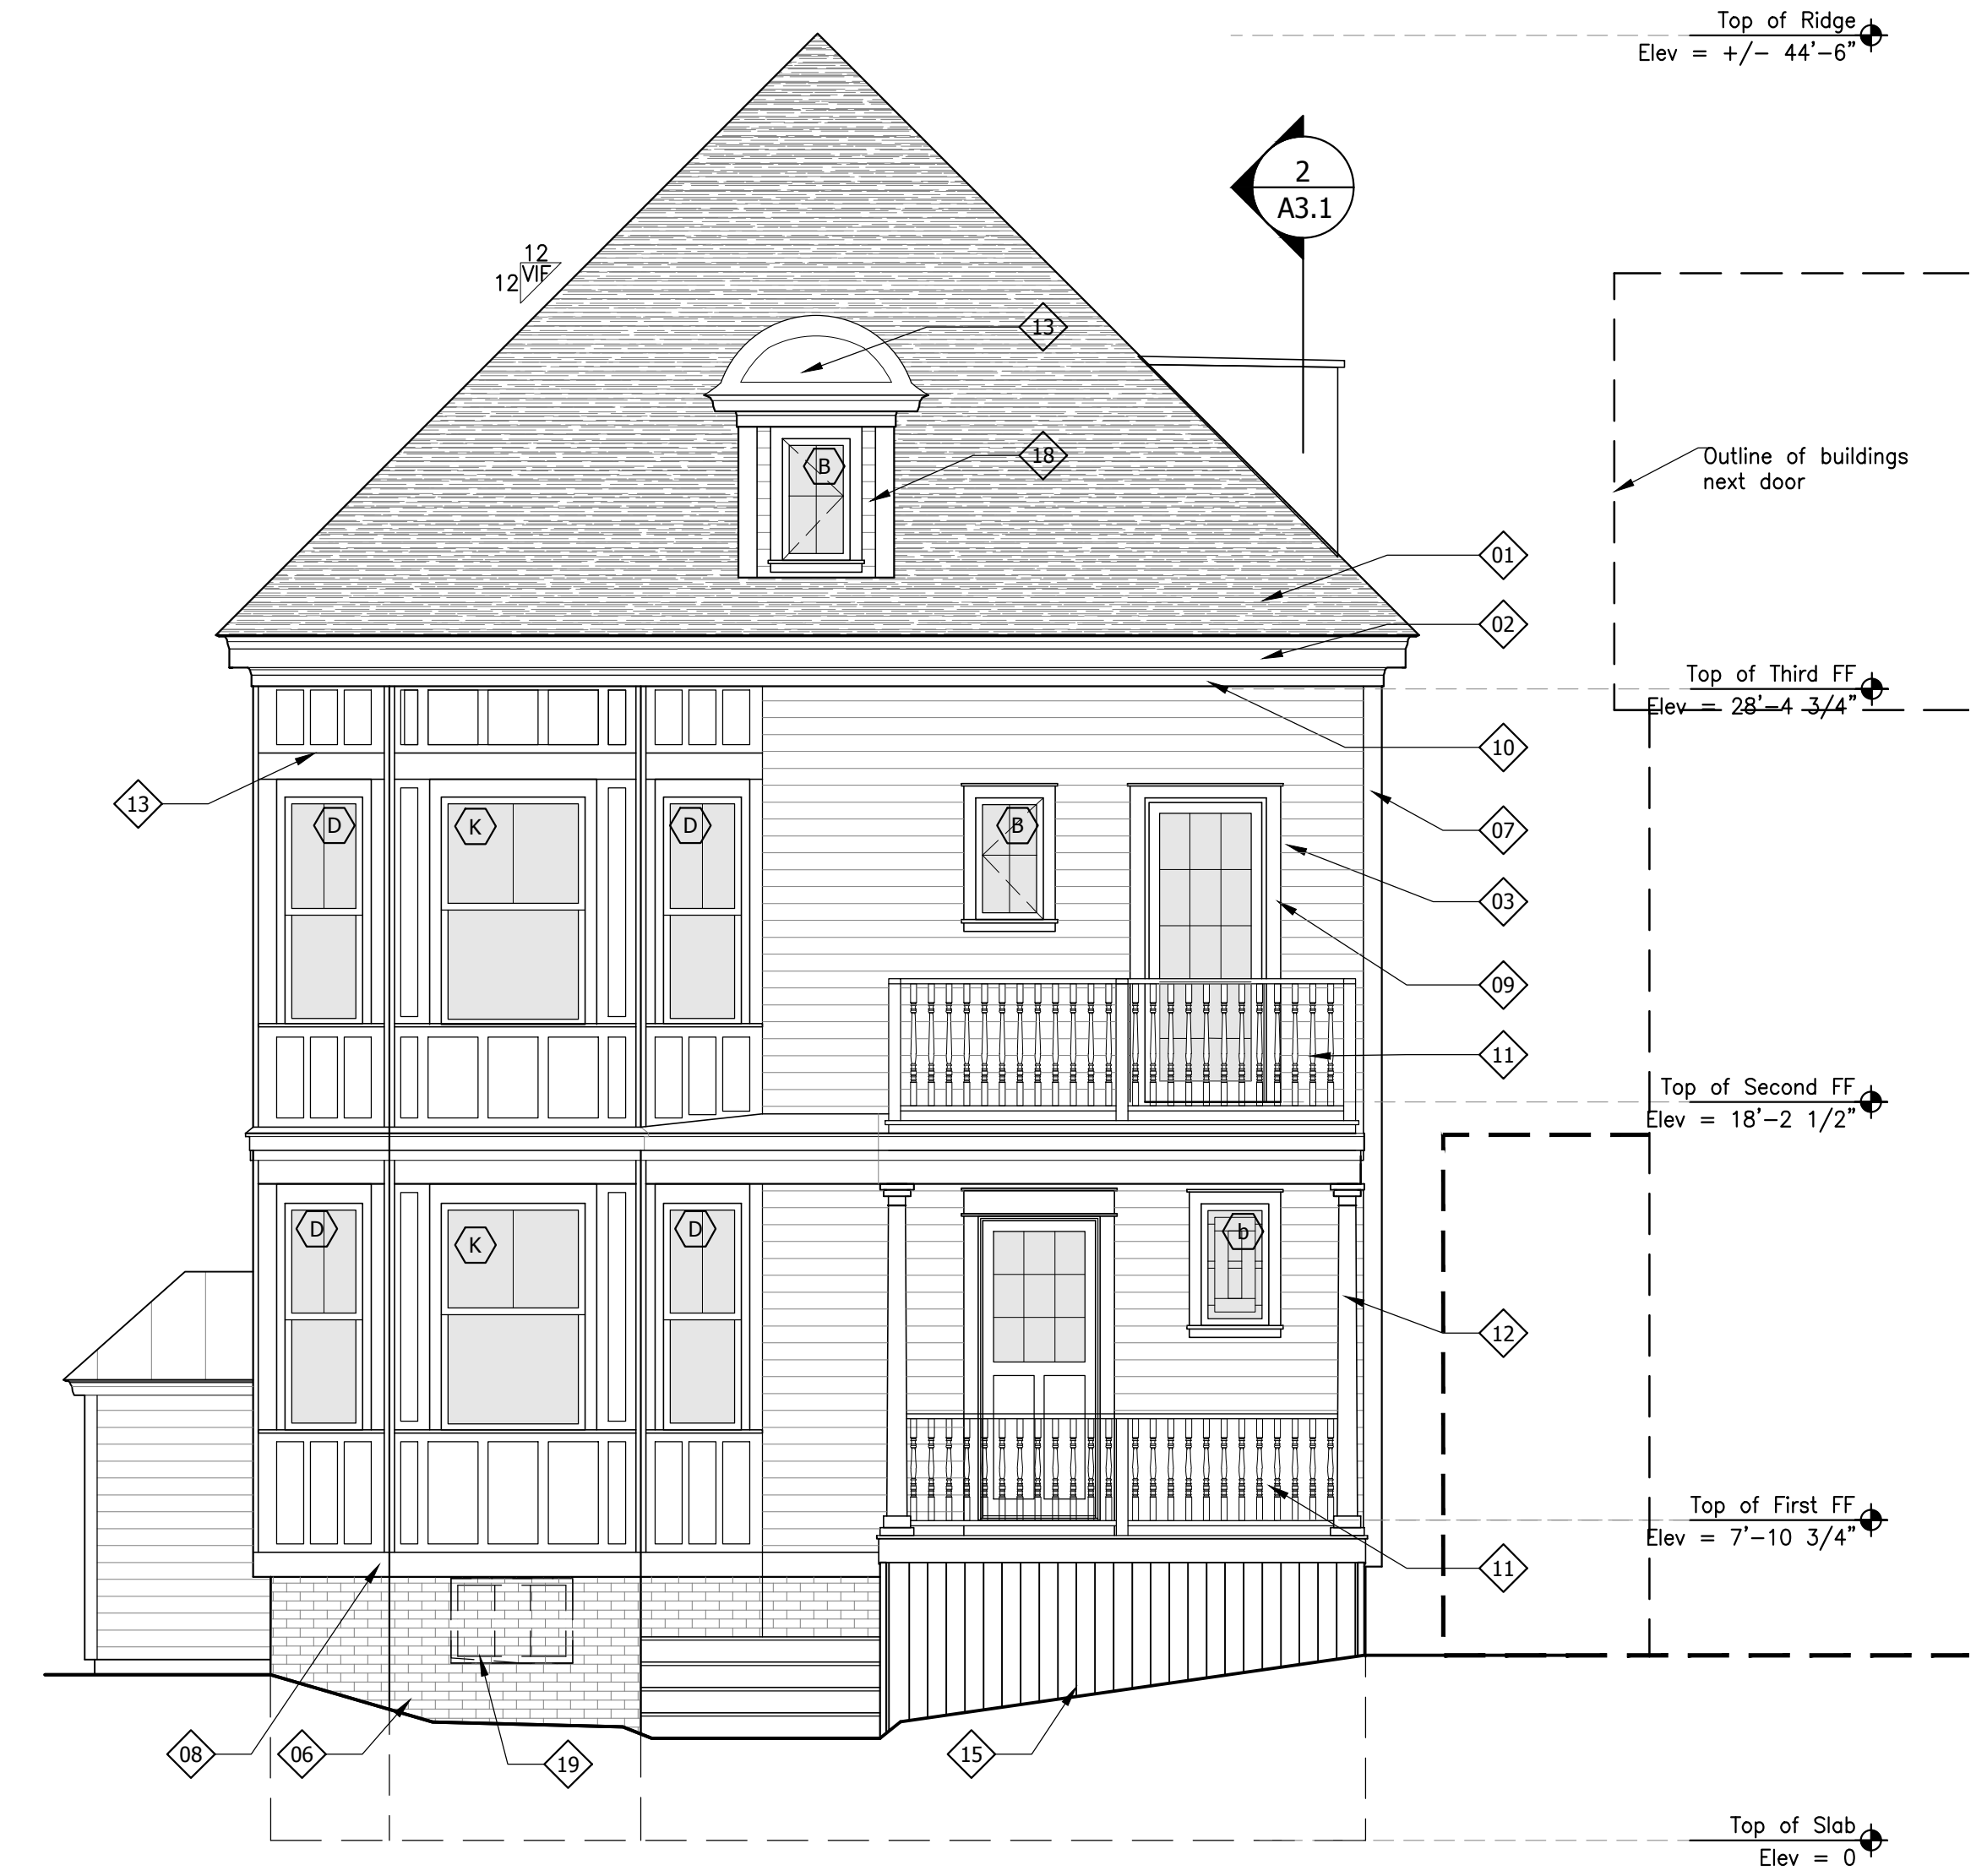
**1** Proposed North Elevation

- 01. Existing asphalt shingles, typ.
- 02. Smartside painted eave and rake trim w/crown
- 03. Smartside clapboard siding on WRB
- 04. Repair existing bracket.
- 05. High efficiency New window. typ.
- 06. Repoint, patch and infill brick to match existing
- 07. Smartside 5/4 x 6 Corner board
- 08. Smartside 5/4 x 8 Water table
- 09. 5/4 x 4 Smartside window/door casing, refer to detail C/A9.1
- 10. Refurbish existing dentil moulding replace as needed
- 11. Deck w/ Pre-primed railings and supports, pntd. (Baird Brothers LJ5004 Balusters or similar)
- 12. Repair existing Porch posts, pntd
- 13. Pre primed MDO panels w/ Smartside trim
- 14. PT Deck columns, joists, and supports
- 15. 1x6 PT Lattice, pntd.
- 16. Repair existing dormer as needed, Seal window
- 17. New door
- 18. Repair existing dormer, New windows
- 19. Remove existing window, infill to match existing
