ADAMS SCHOOL REDEVELOPMENT  
Portland, Maine

TITLE  
DOOR & WINDOW  
DETAILS

A505

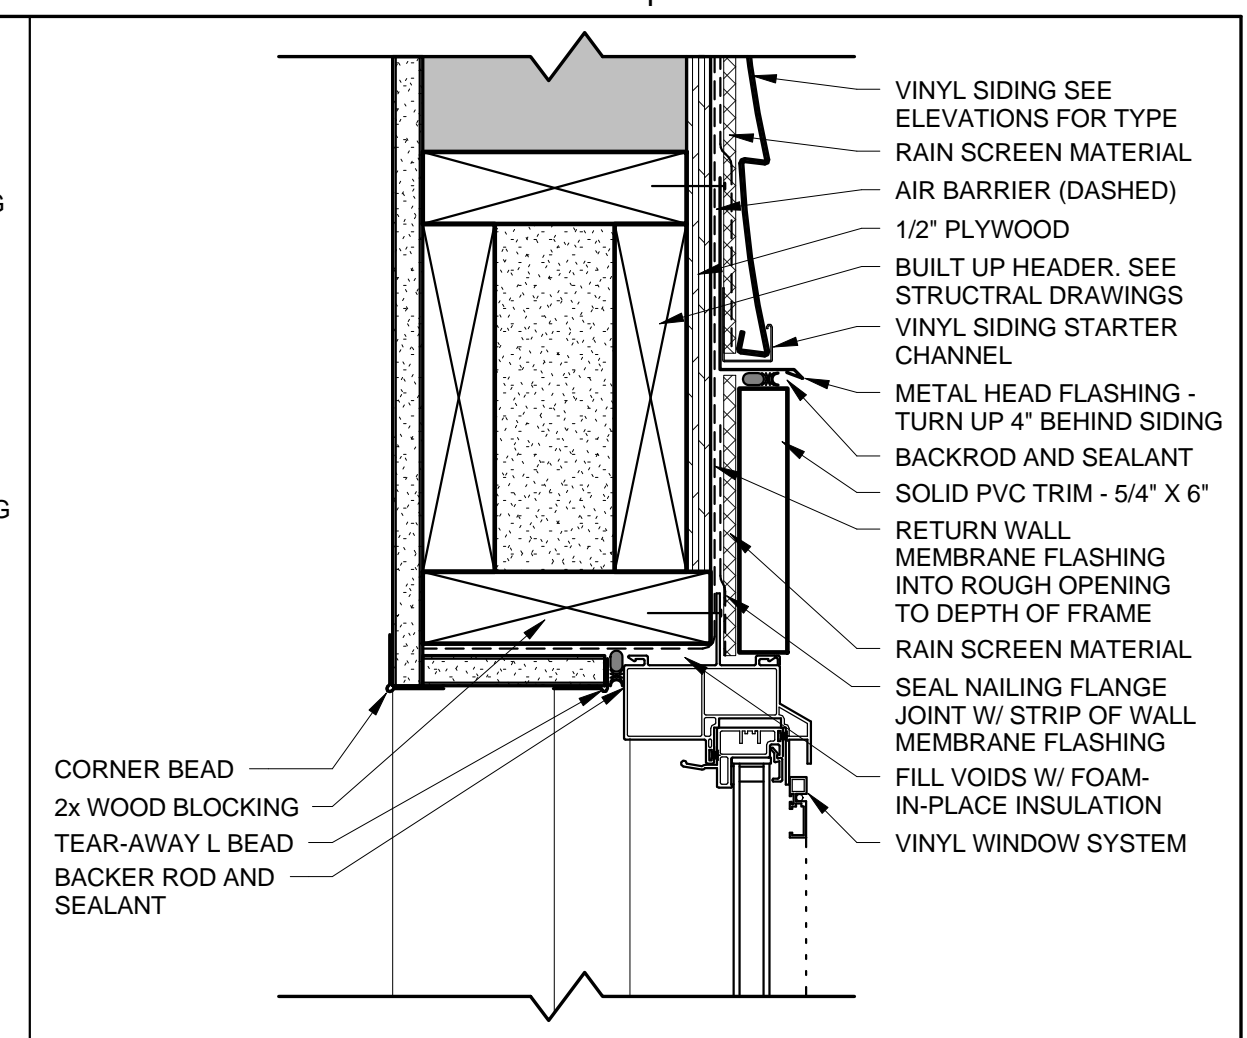
D1 WINDOW HEAD DETAIL  
3" = 1'-0"

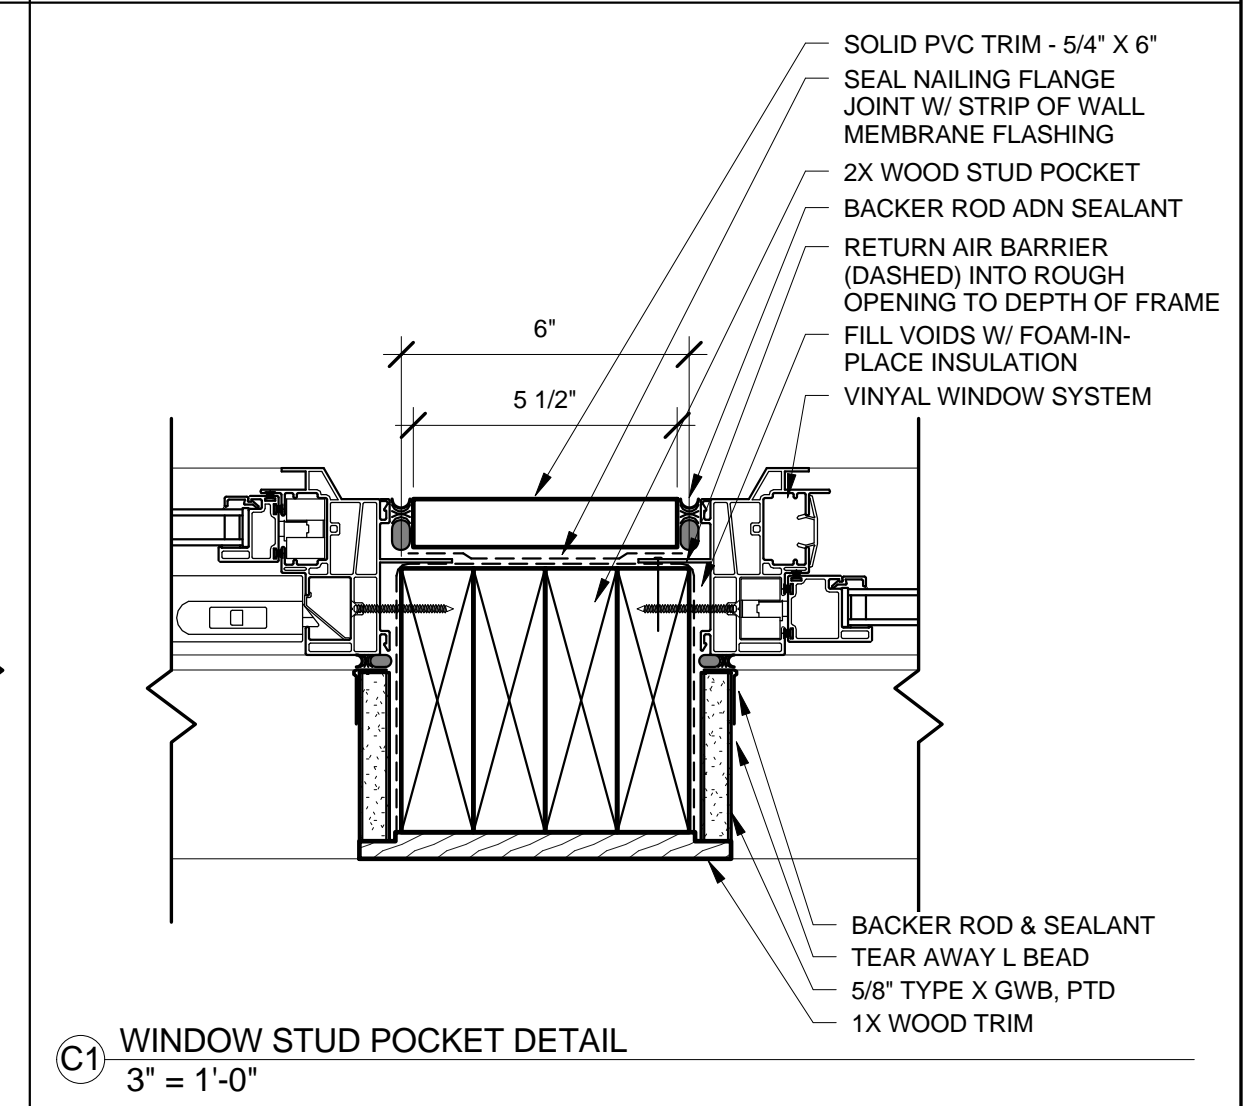
C1 WINDOW STUD POCKET DETAIL  
3" = 1'-0"

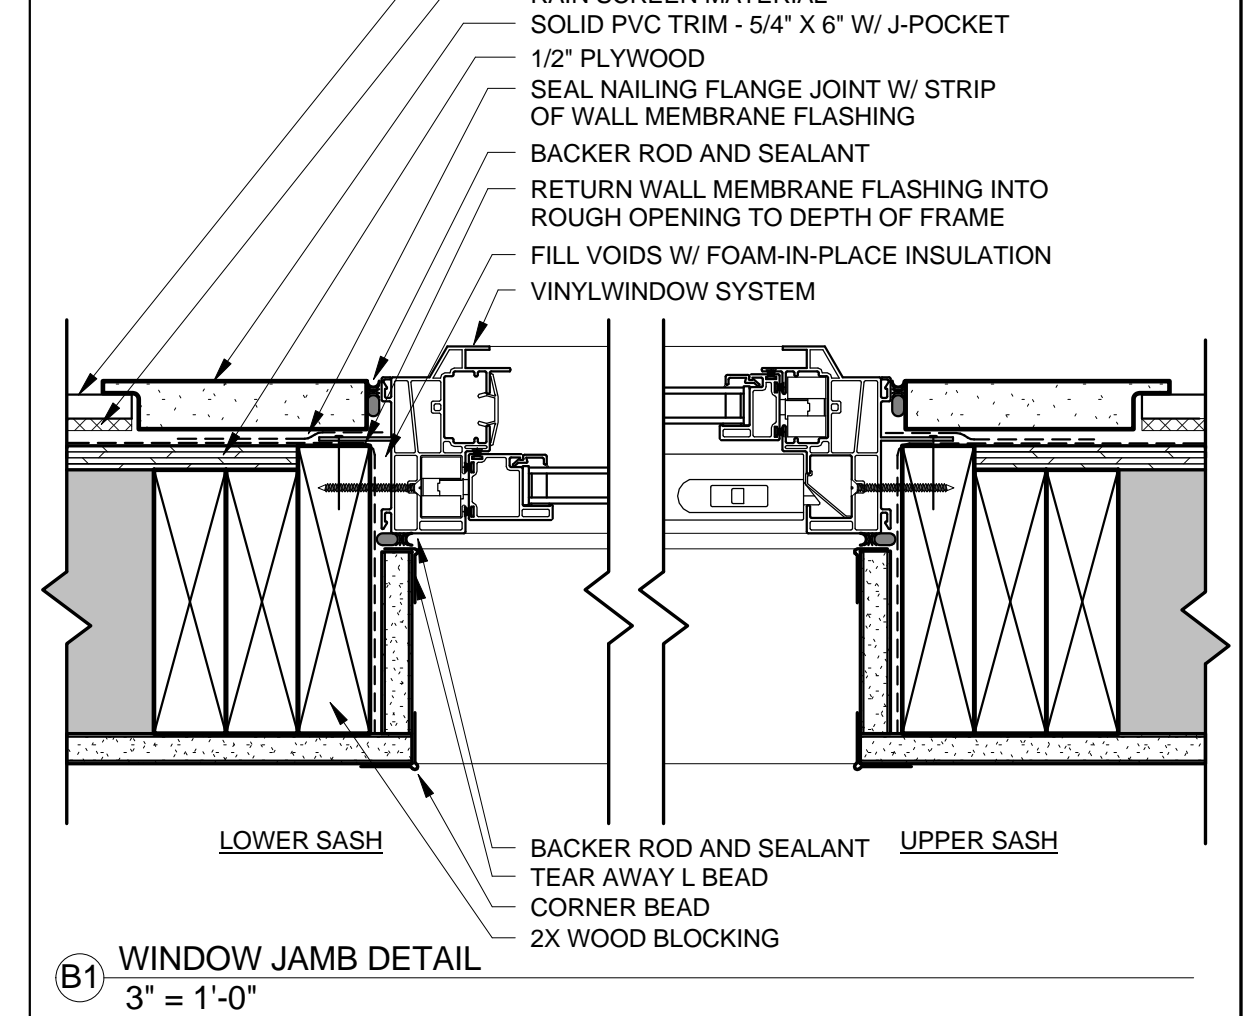
B1 WINDOW JAMB DETAIL  
3" = 1'-0"

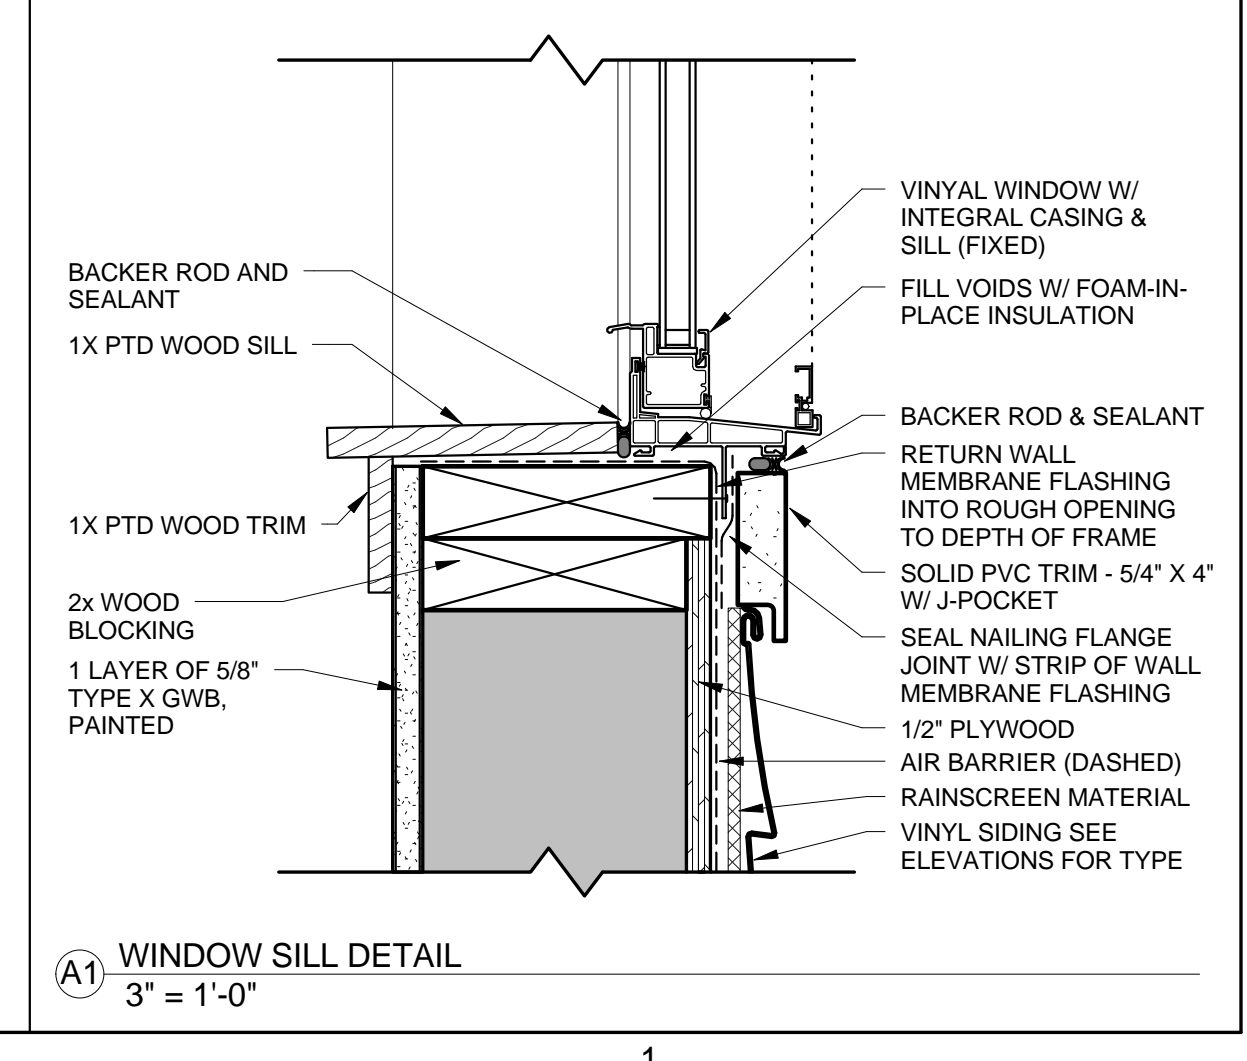
A1 WINDOW SILL DETAIL  
3" = 1'-0"

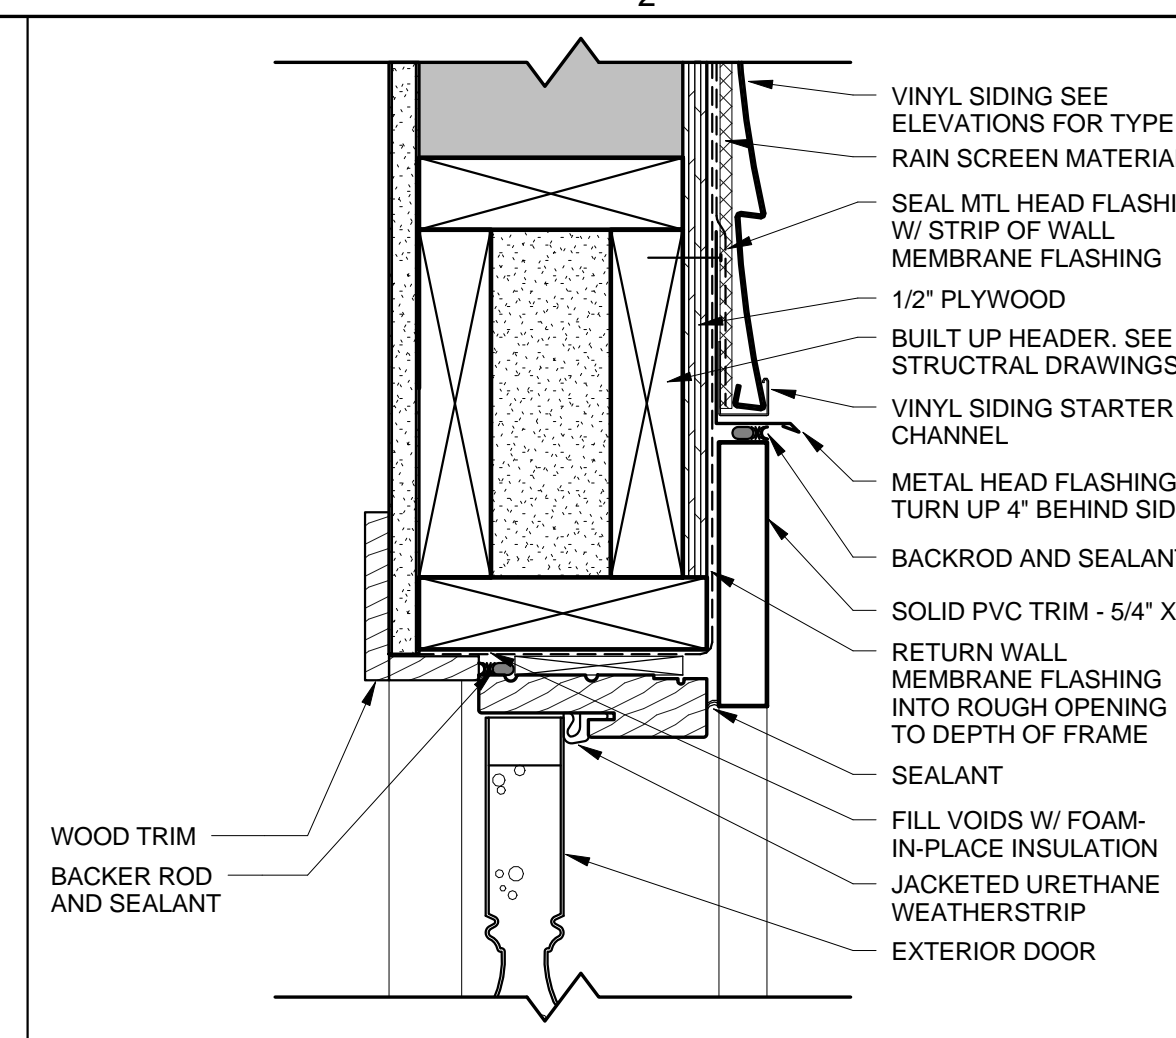
D2 EXTERIOR DOOR HEAD DETAIL  
3" = 1'-0"

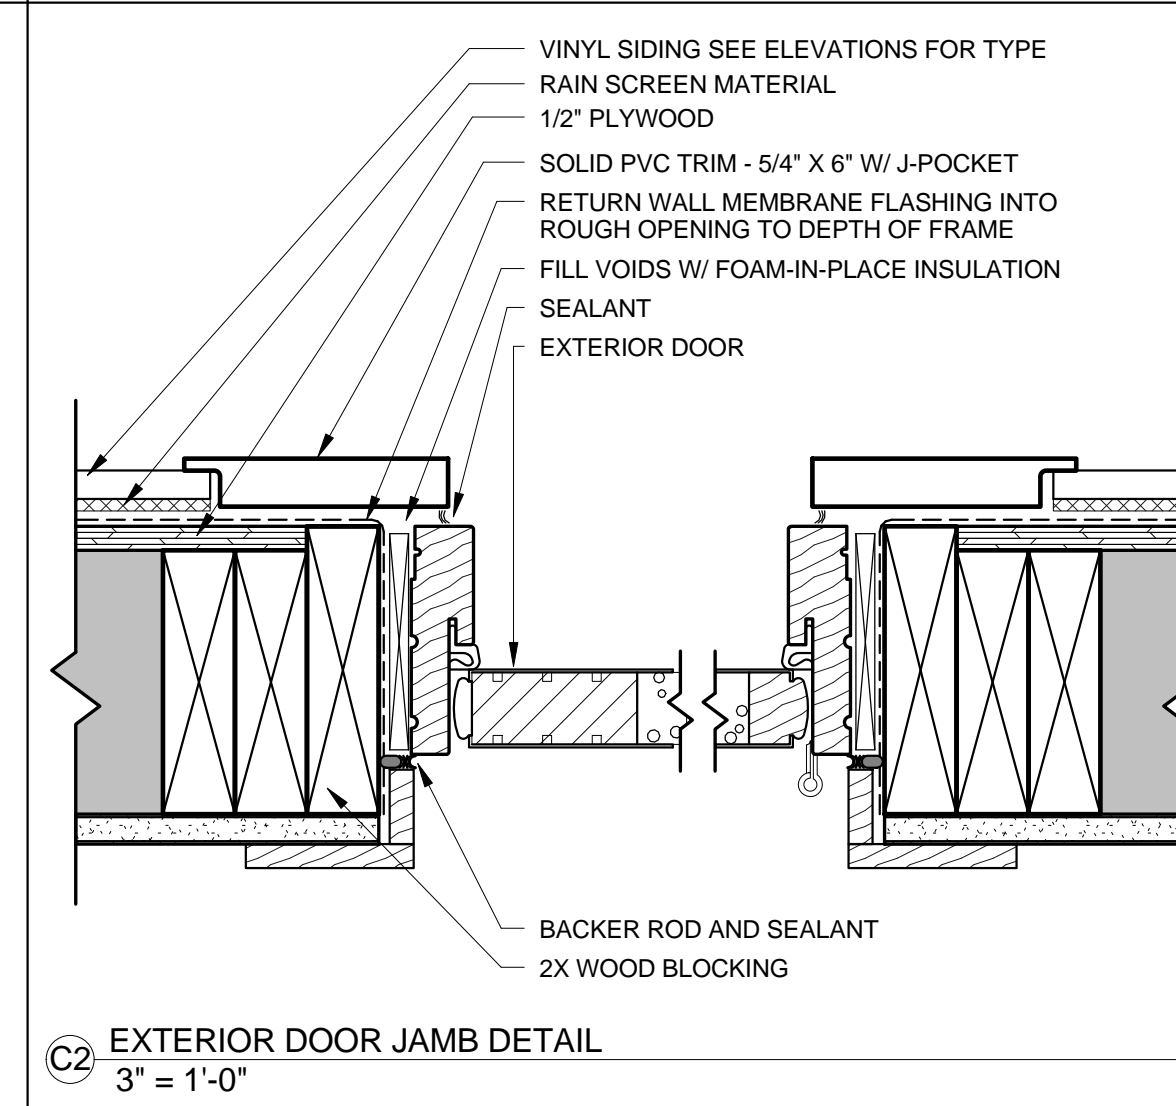
C2 EXTERIOR DOOR JAMB DETAIL  
3" = 1'-0"

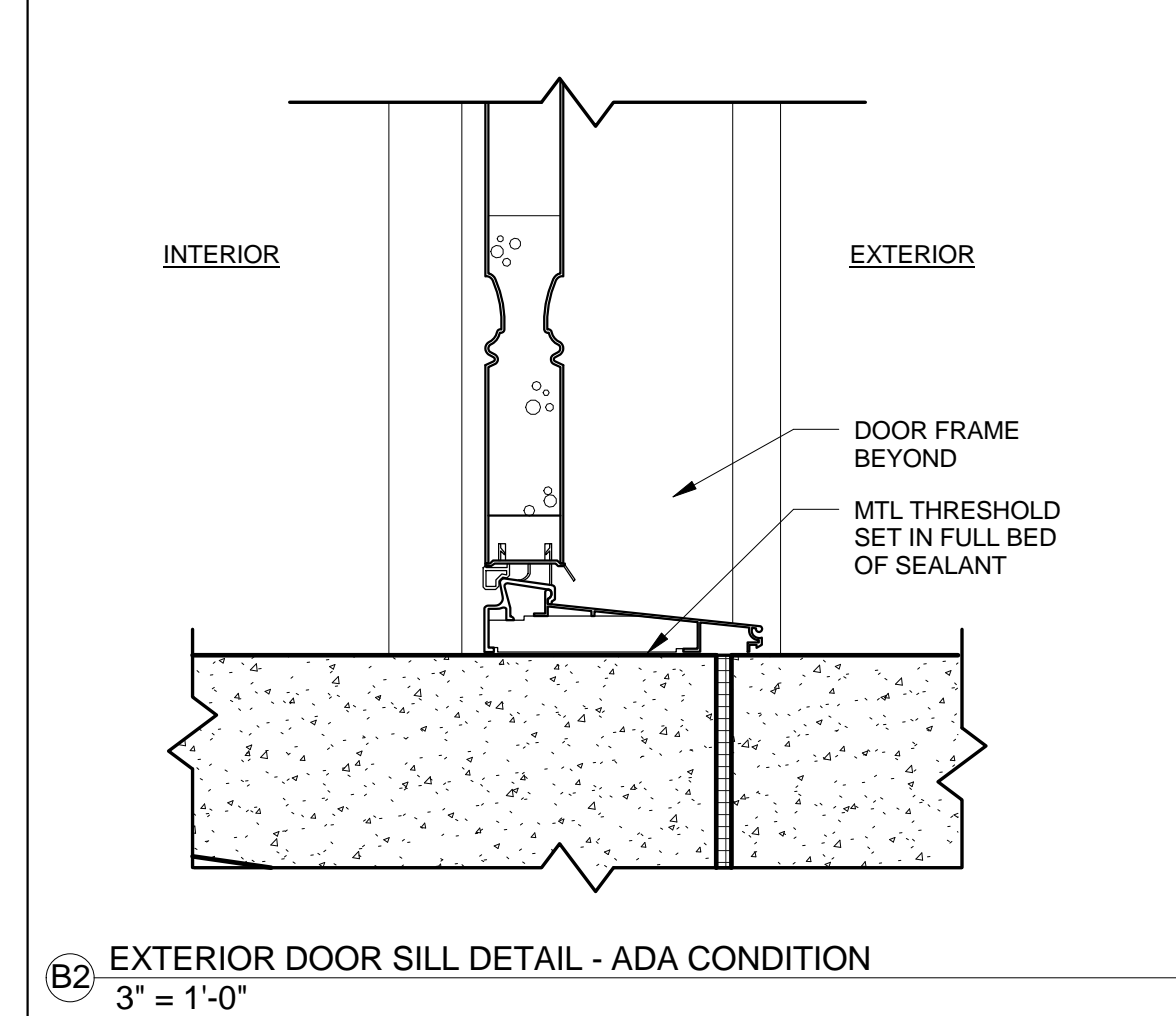
B2 EXTERIOR DOOR SILL DETAIL - ADA CONDITION  
3" = 1'-0"

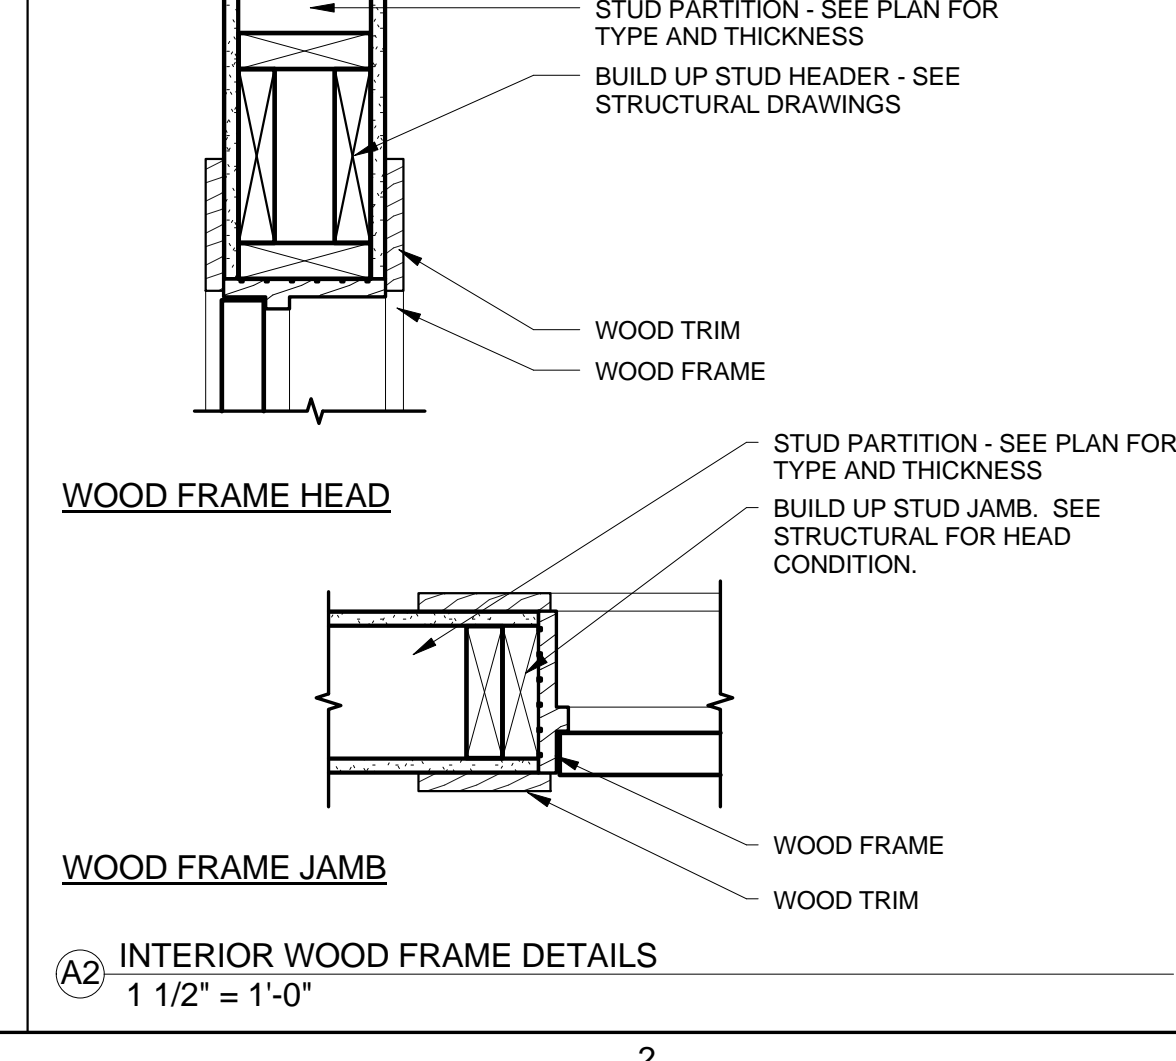
A2 INTERIOR WOOD FRAME DETAILS  
1 1/2" = 1'-0"

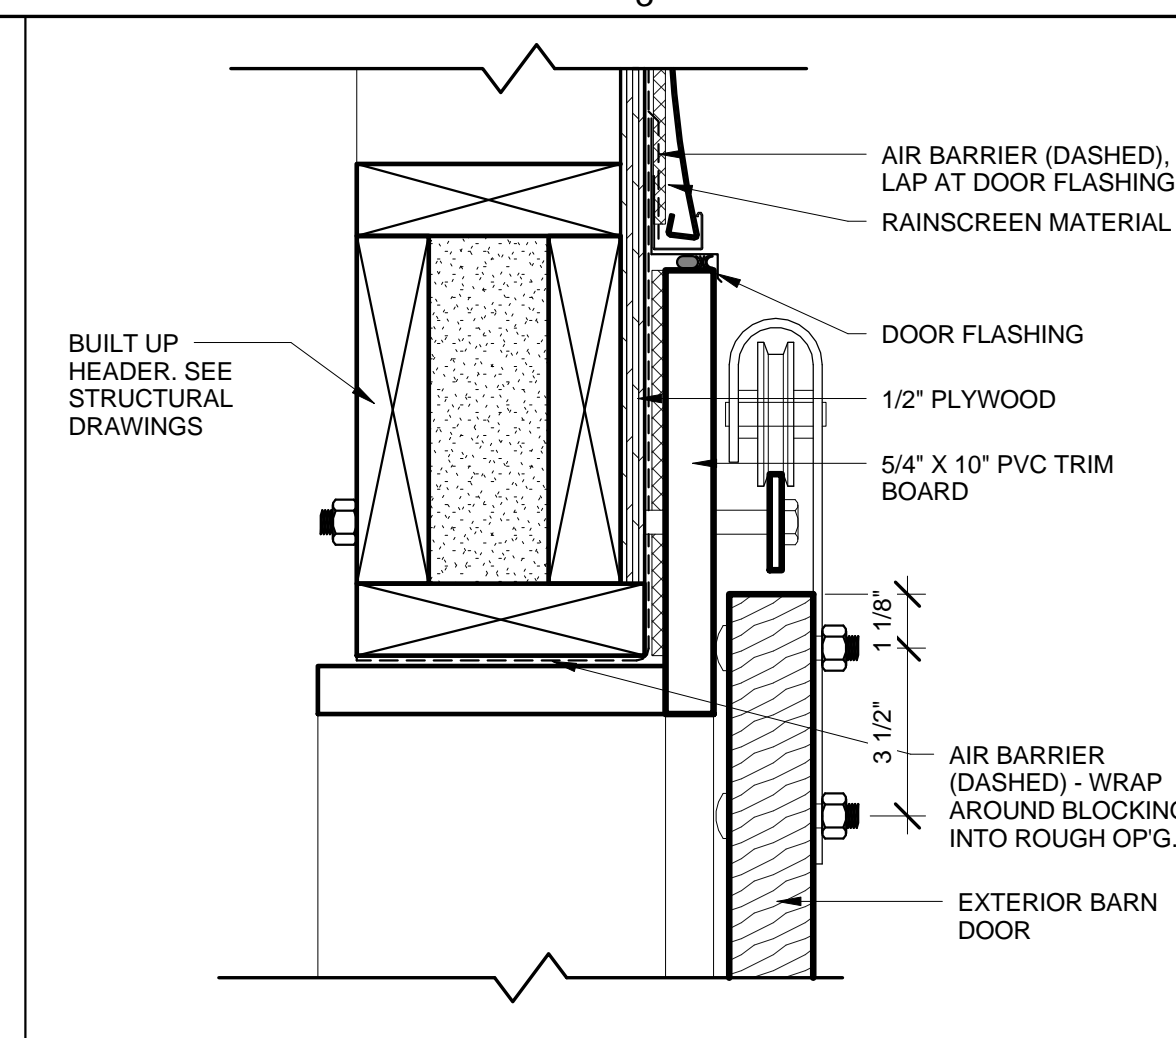
D3 BARN DOOR HEAD DETAIL  
3" = 1'-0"

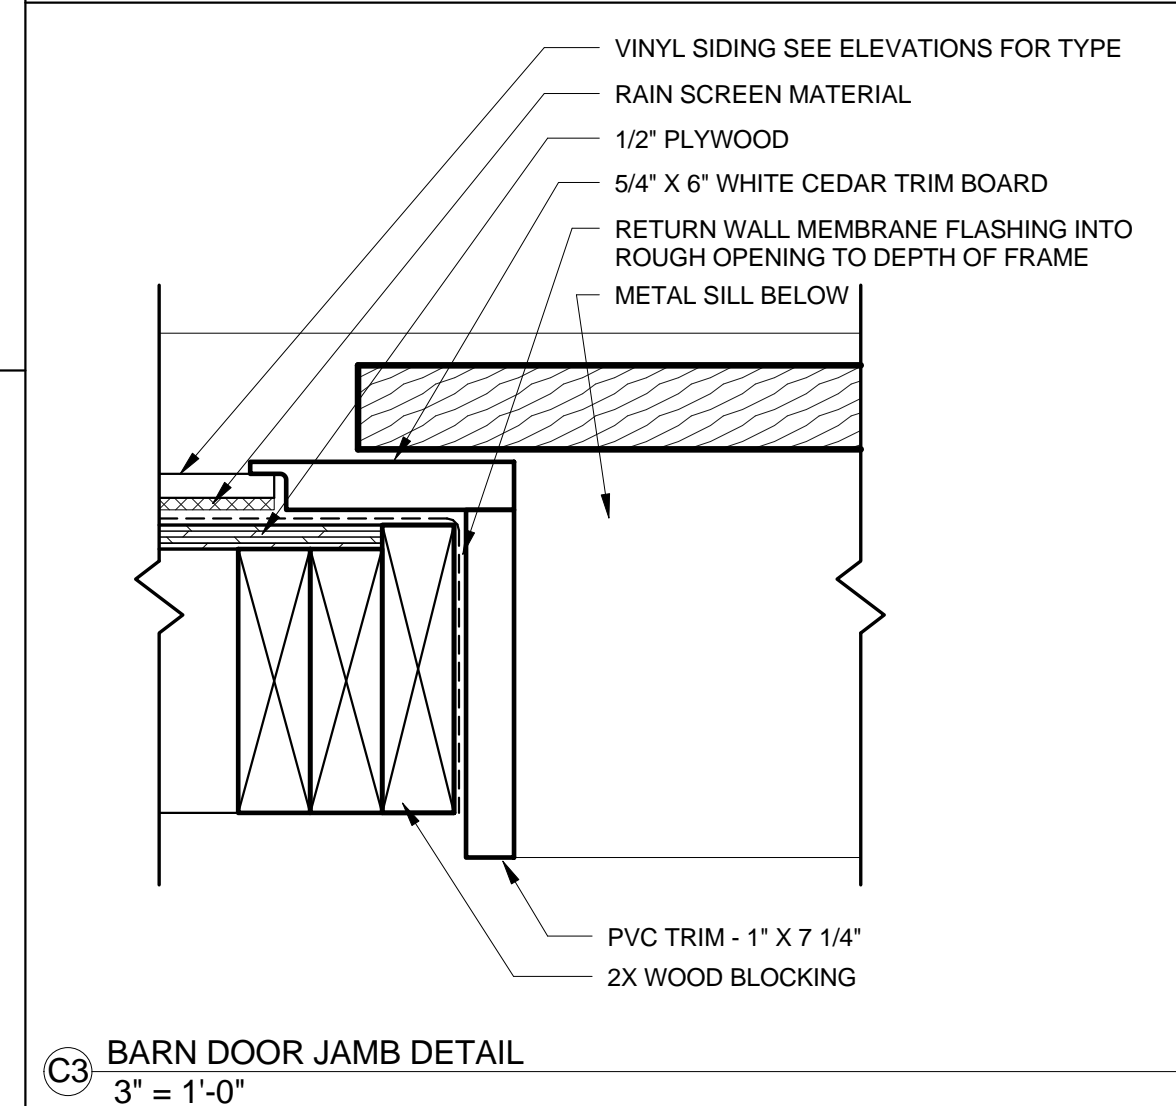
C3 BARN DOOR JAMB DETAIL  
3" = 1'-0"

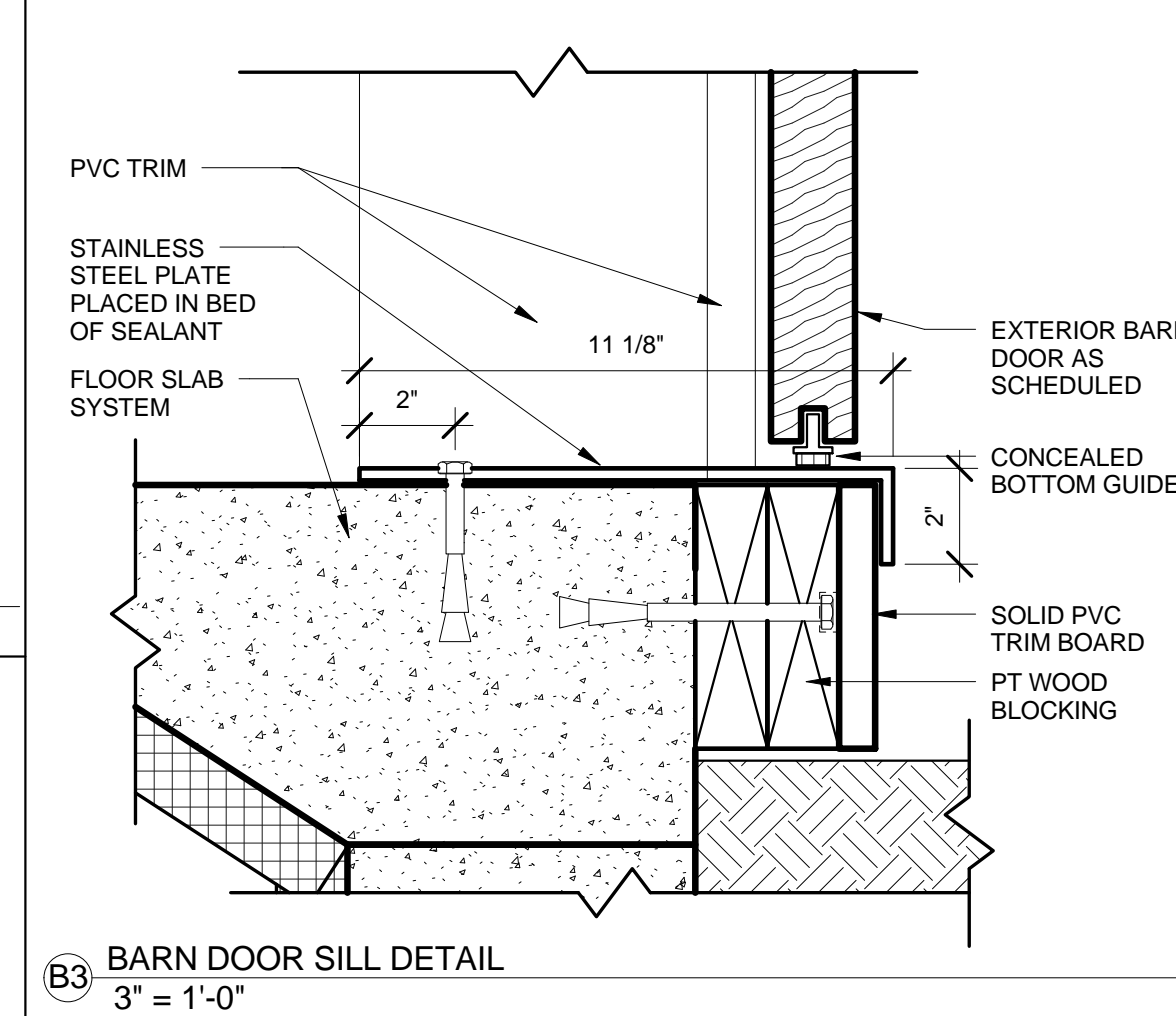
B3 BARN DOOR SILL DETAIL  
3" = 1'-0"

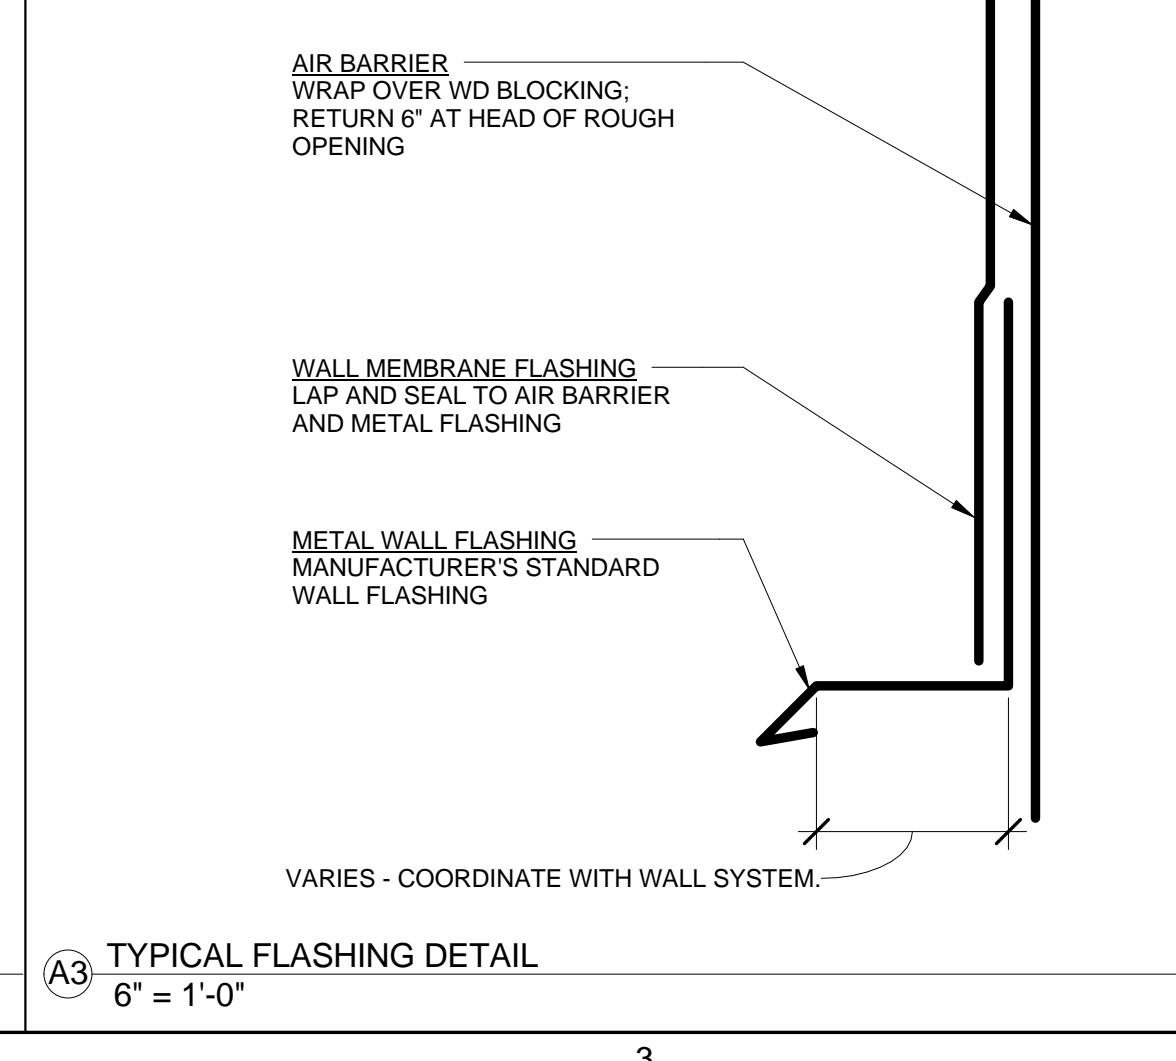
A3 TYPICAL FLASHING DETAIL  
6" = 1'-0"

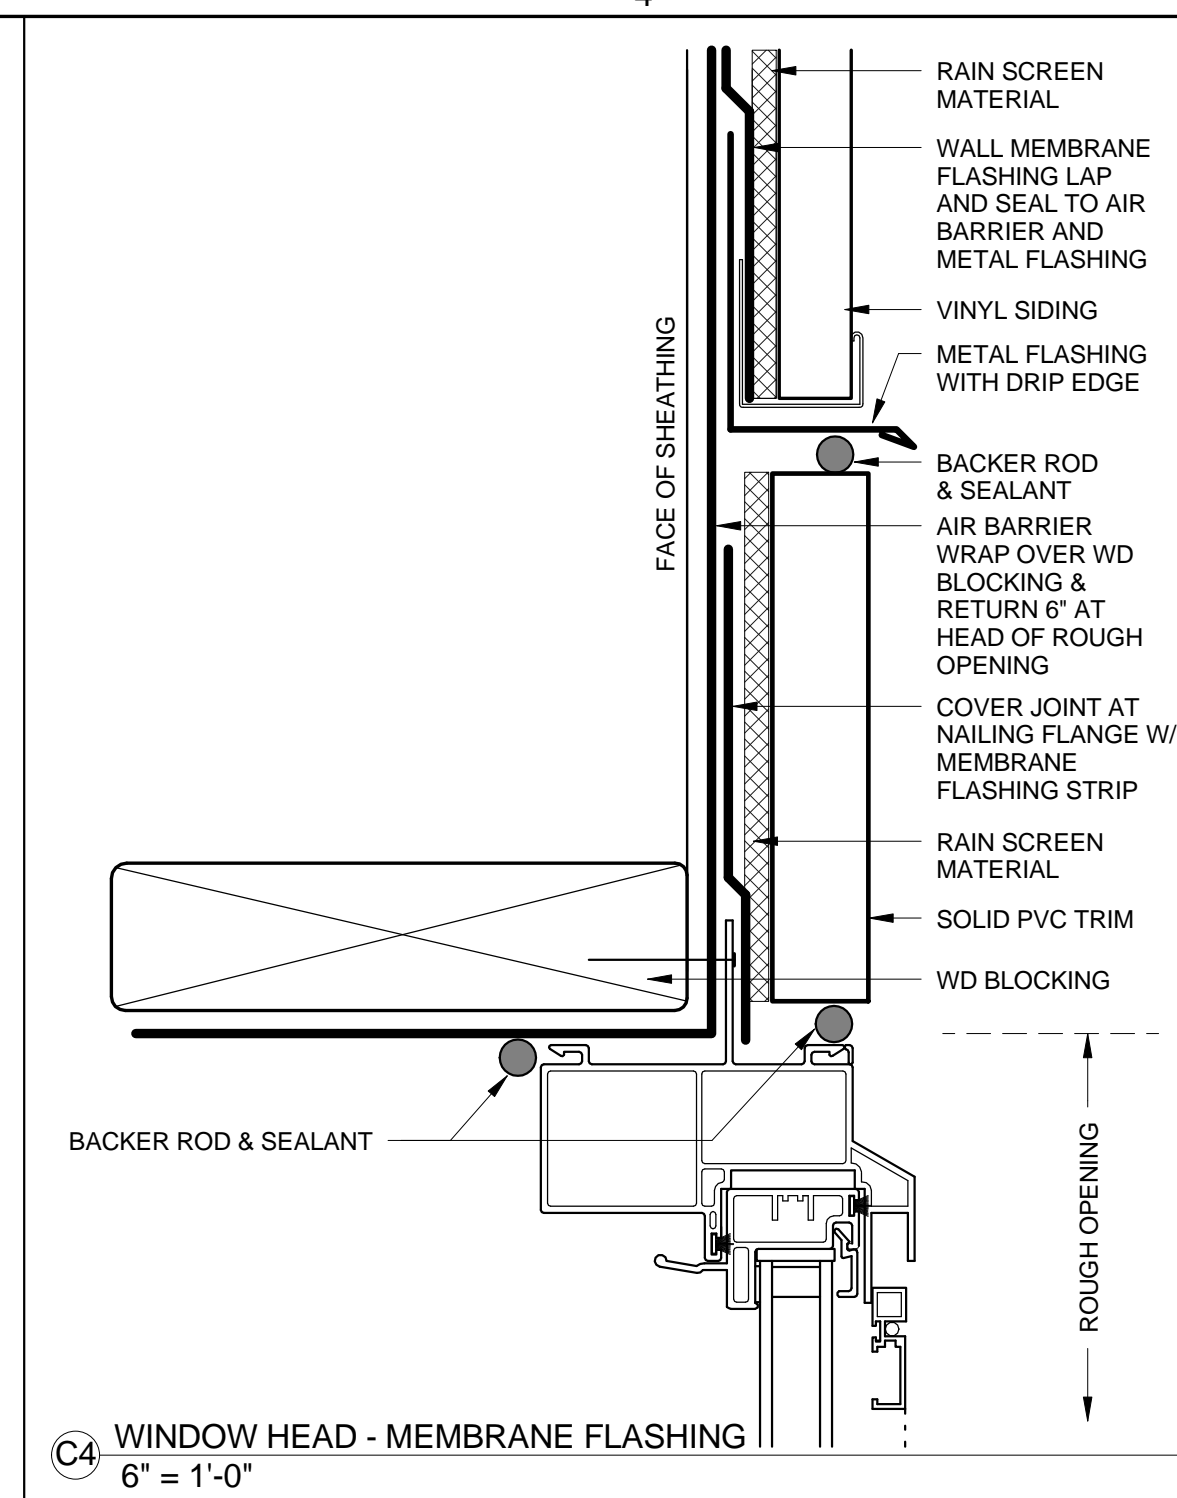
C4 WINDOW HEAD - MEMBRANE FLASHING  
6" = 1'-0"

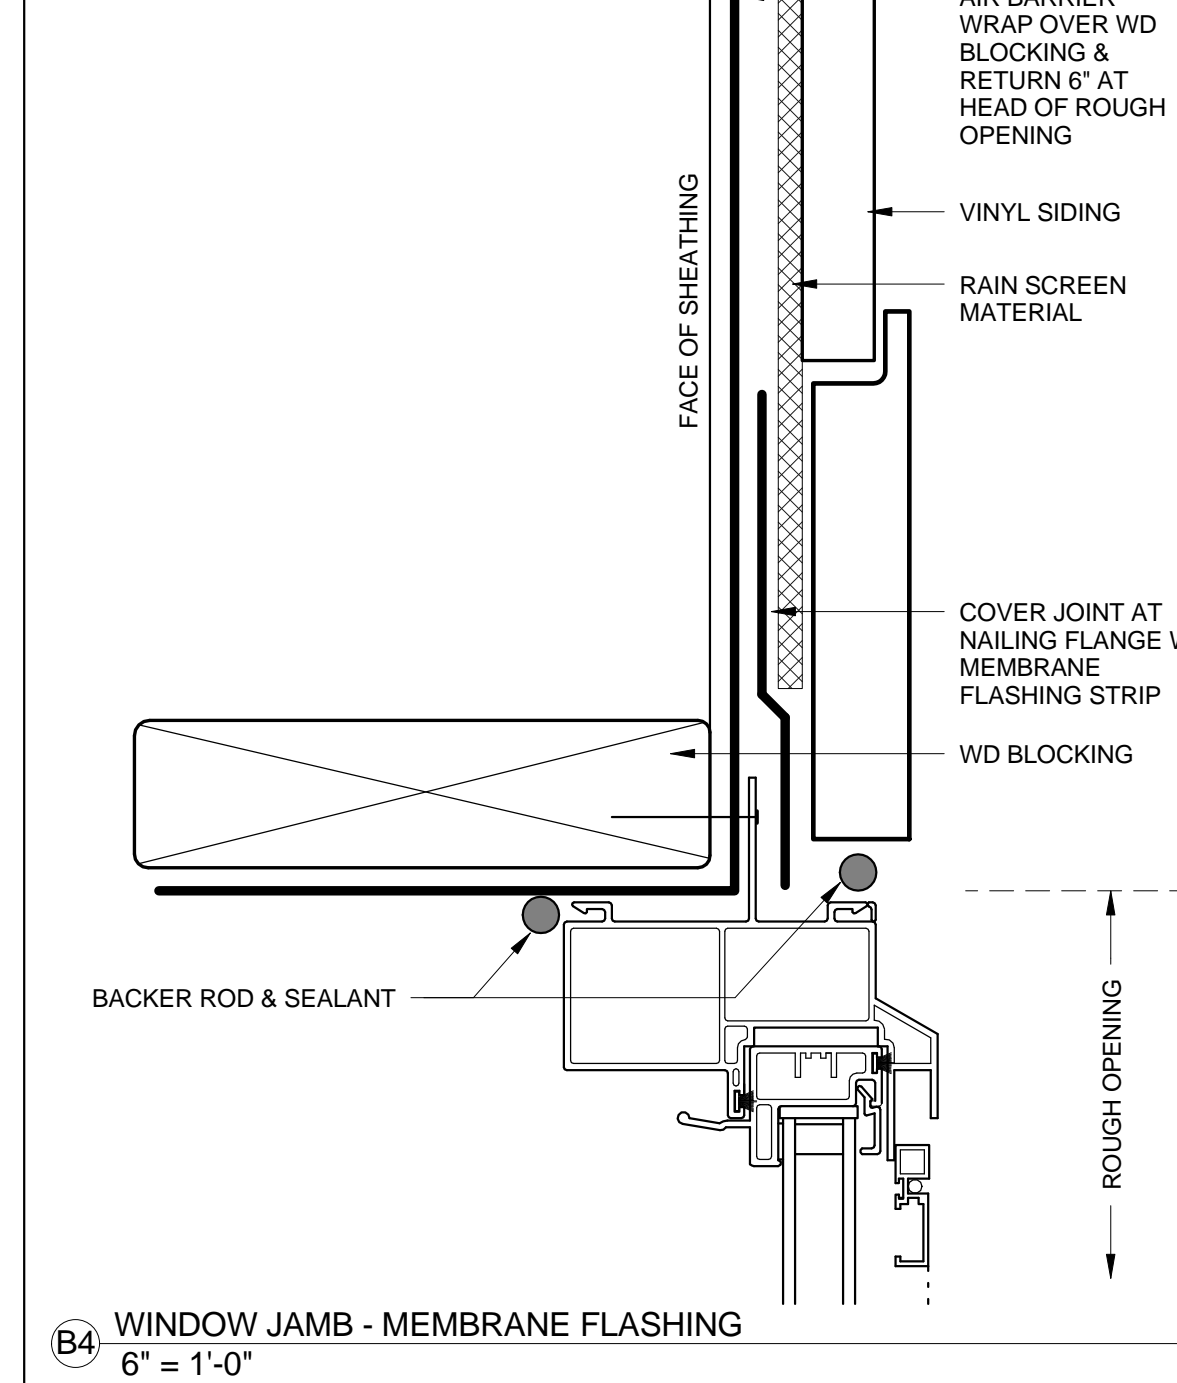
B4 WINDOW JAMB - MEMBRANE FLASHING  
6" = 1'-0"

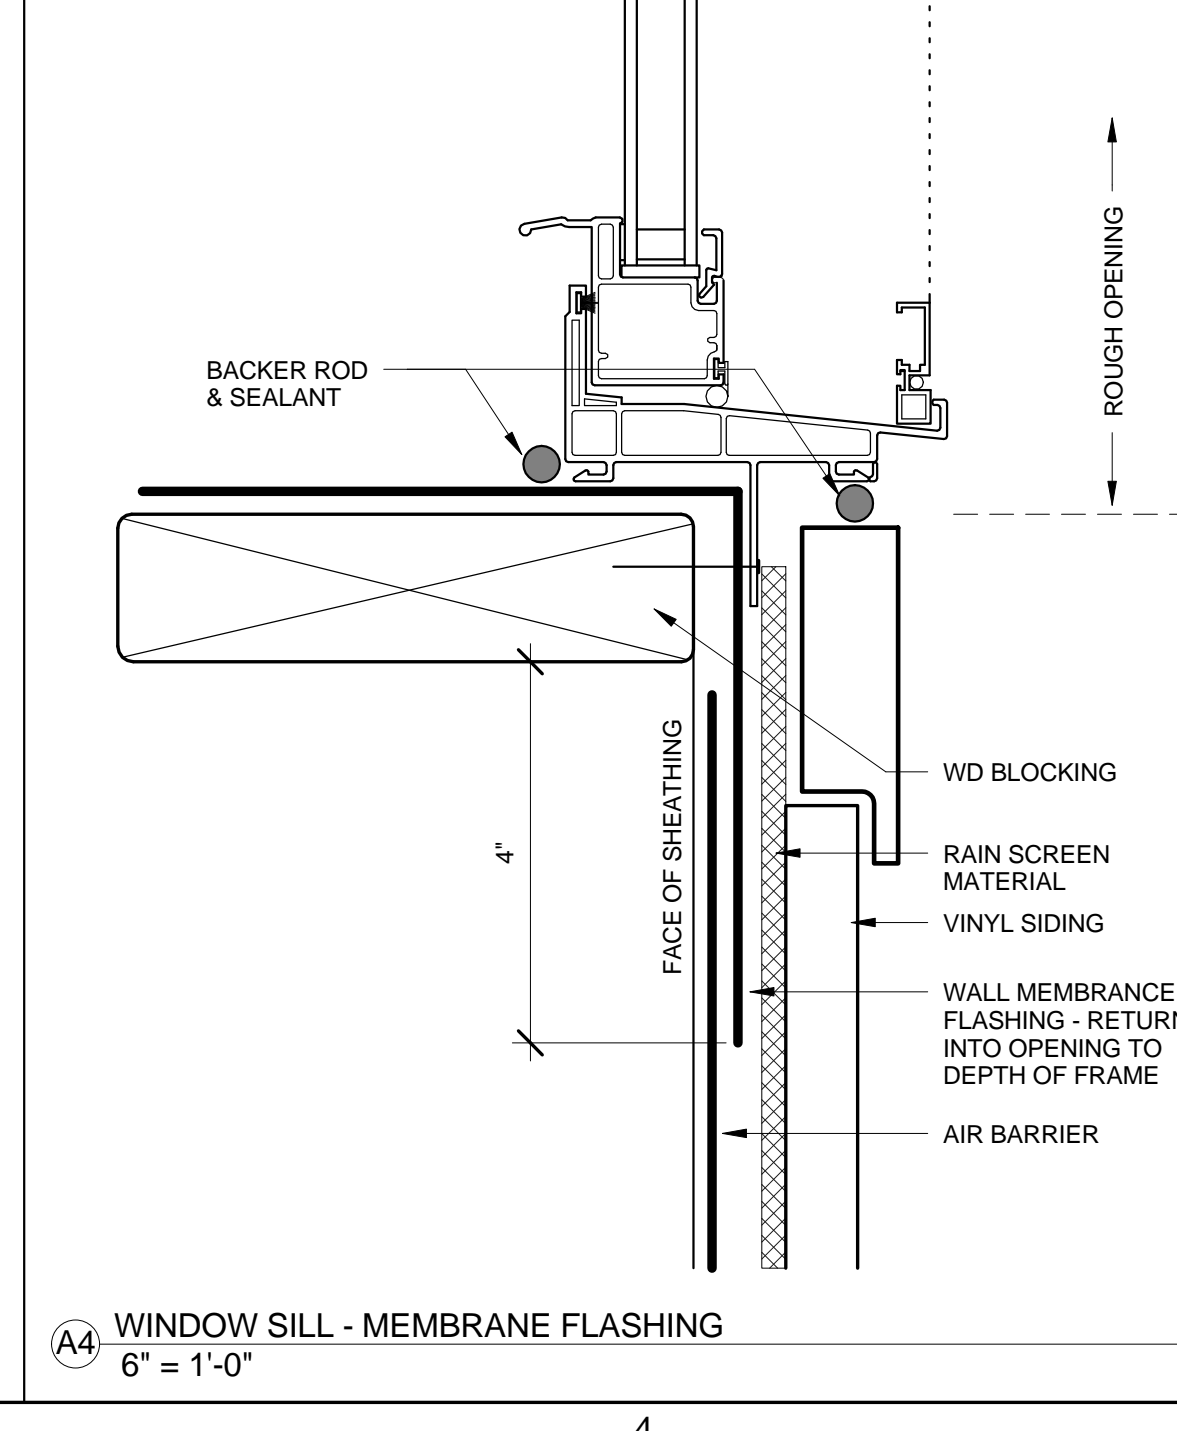
A4 WINDOW SILL - MEMBRANE FLASHING  
6" = 1'-0"

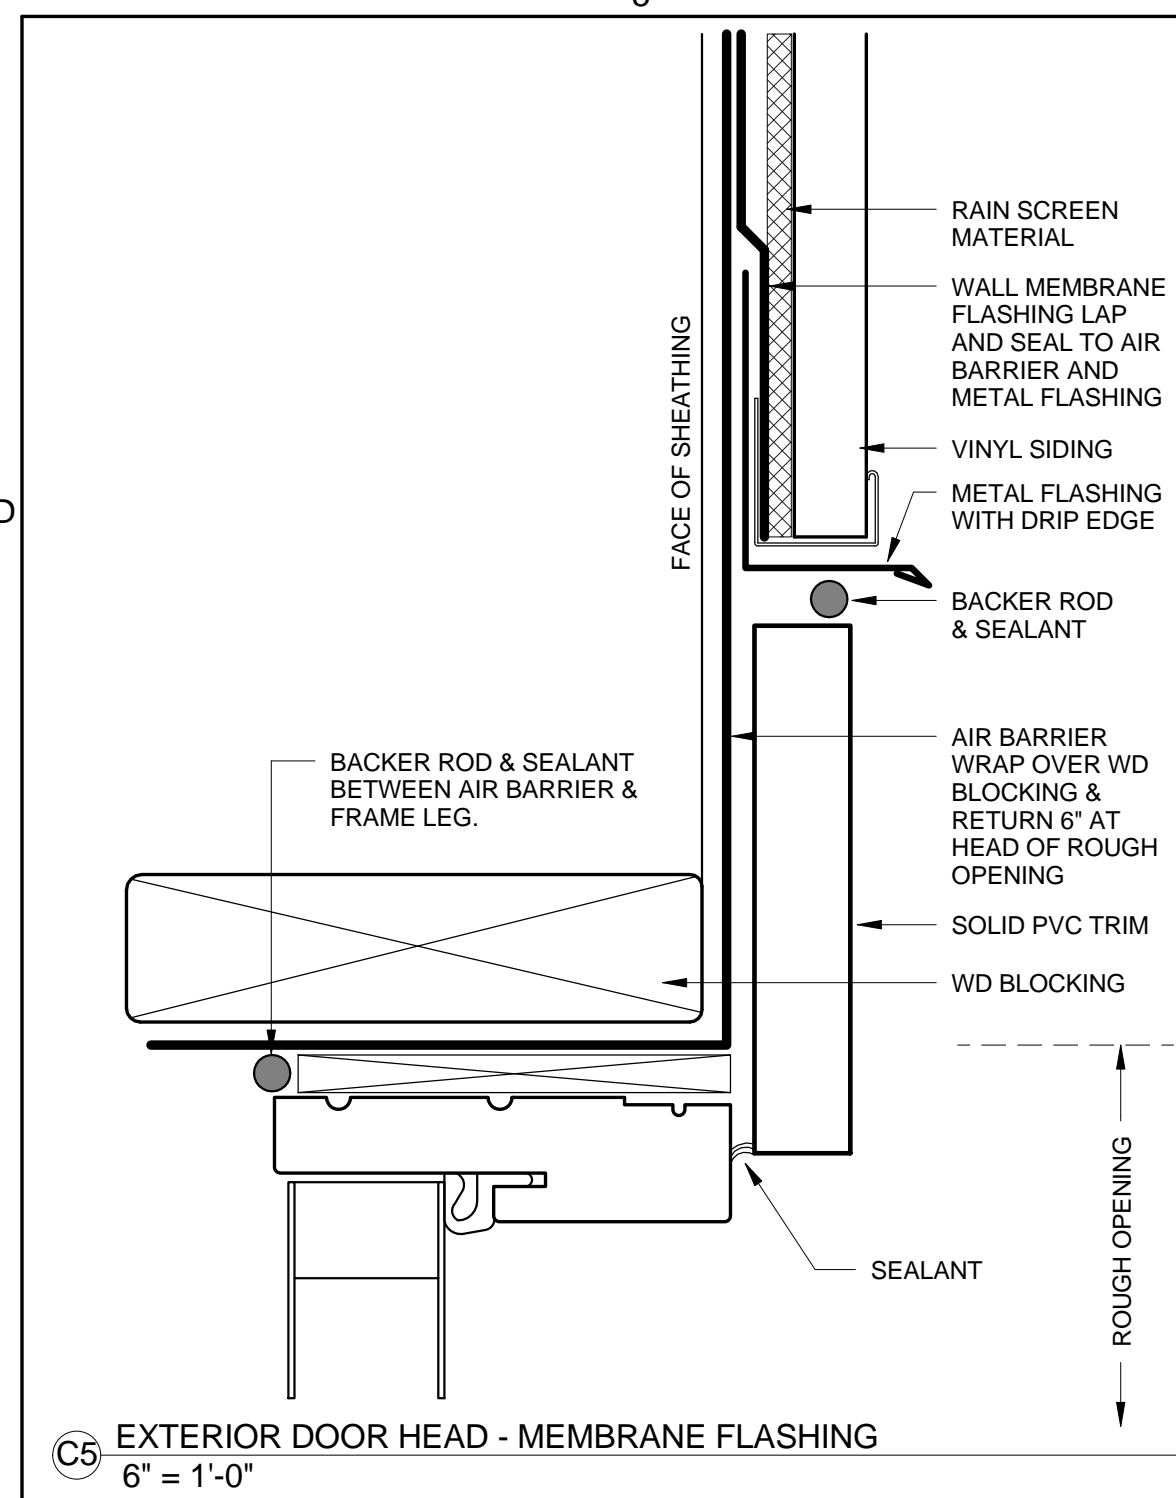
C5 EXTERIOR DOOR HEAD - MEMBRANE FLASHING  
6" = 1'-0"
