ADAMS SCHOOL REDEVELOPMENT  
Portland, Maine

TITLE  
DOOR & WINDOW  
DETAILS

A505

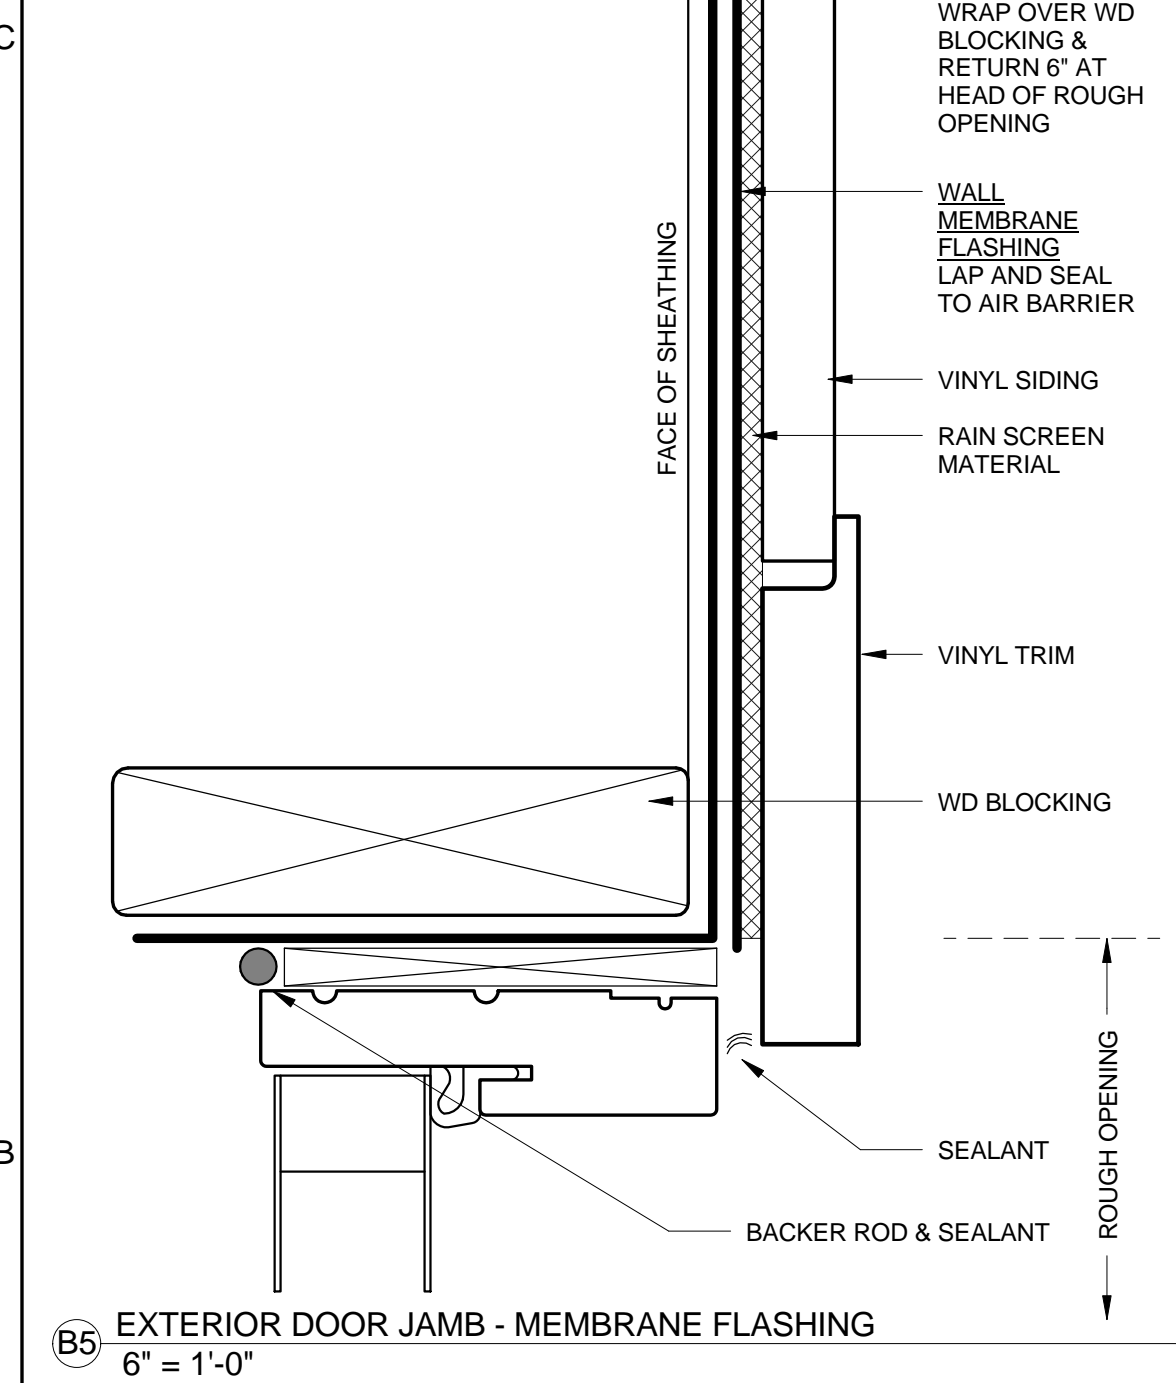
B5 EXTERIOR DOOR JAMB - MEMBRANE FLASHING  
6" = 1'-0"
