APARTMENTS  
89 ANDERSON STREET  
PORTLAND, MAINE

SHEET TITLE:  
DETAILS

A5-20

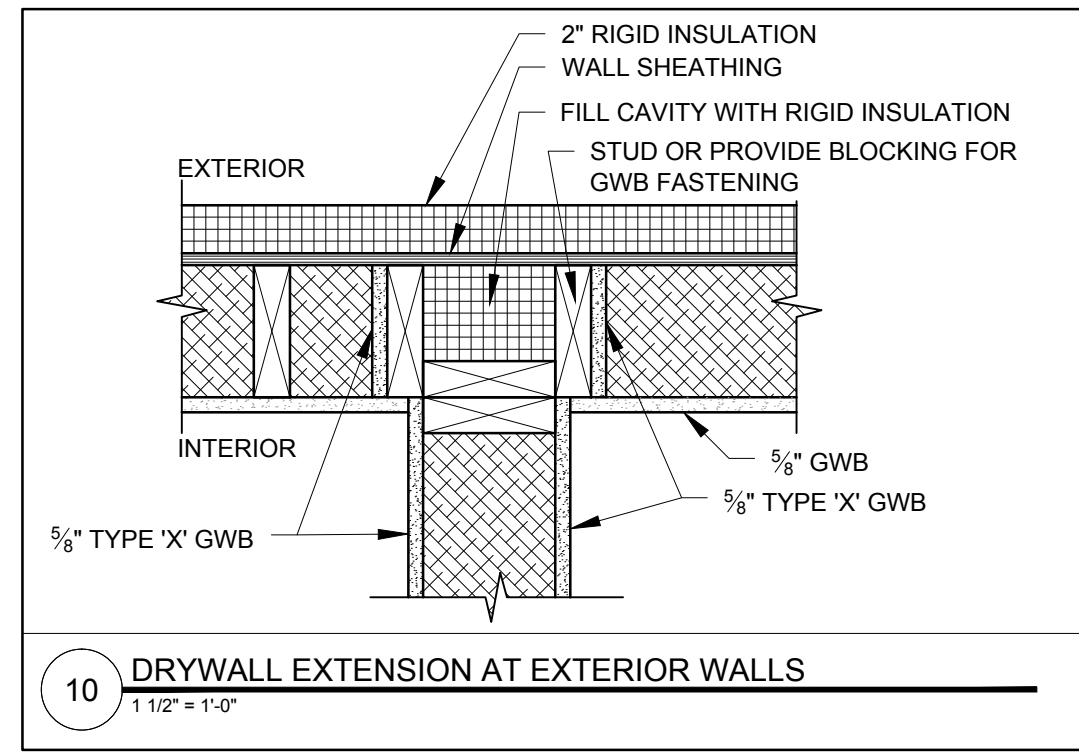
10 DRYWALL EXTENSION AT EXTERIOR WALLS  
1/12" = 1'-0"

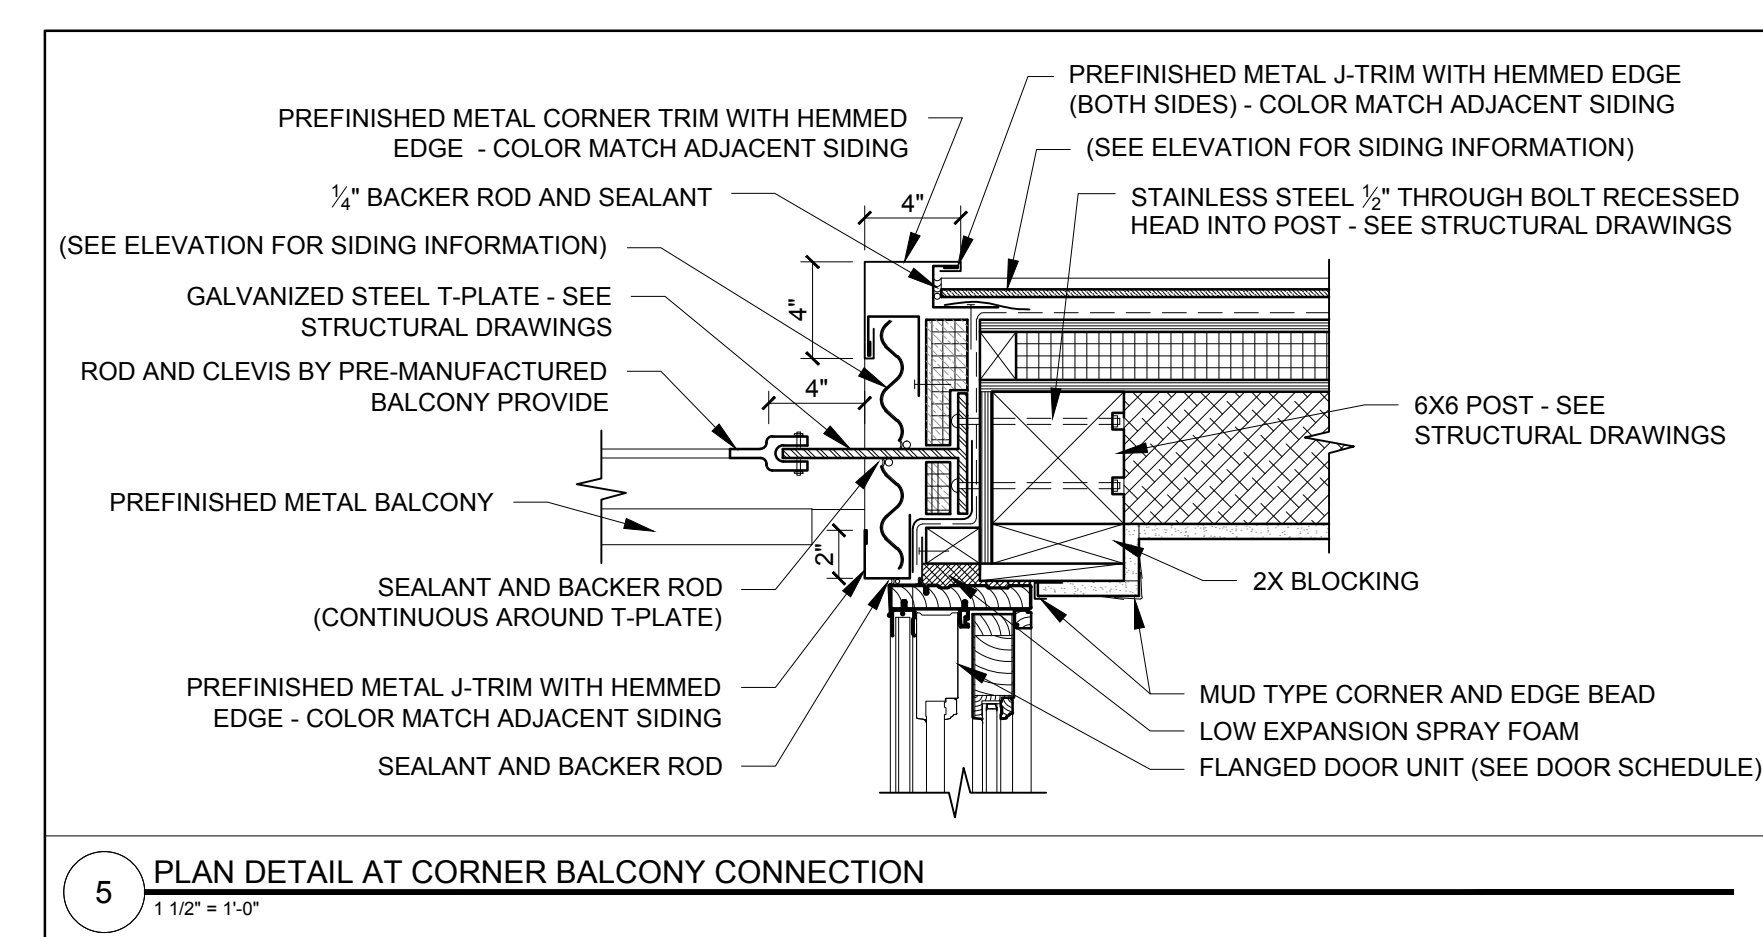
5 PLAN DETAIL AT CORNER BALCONY CONNECTION  
1/12" = 1'-0"
