PERMIT DRAWINGS
JULY 3, 2015

APARTMENTS
89 ANDERSON STREET
PORTLAND, MAINE

DETAILS

S2-2

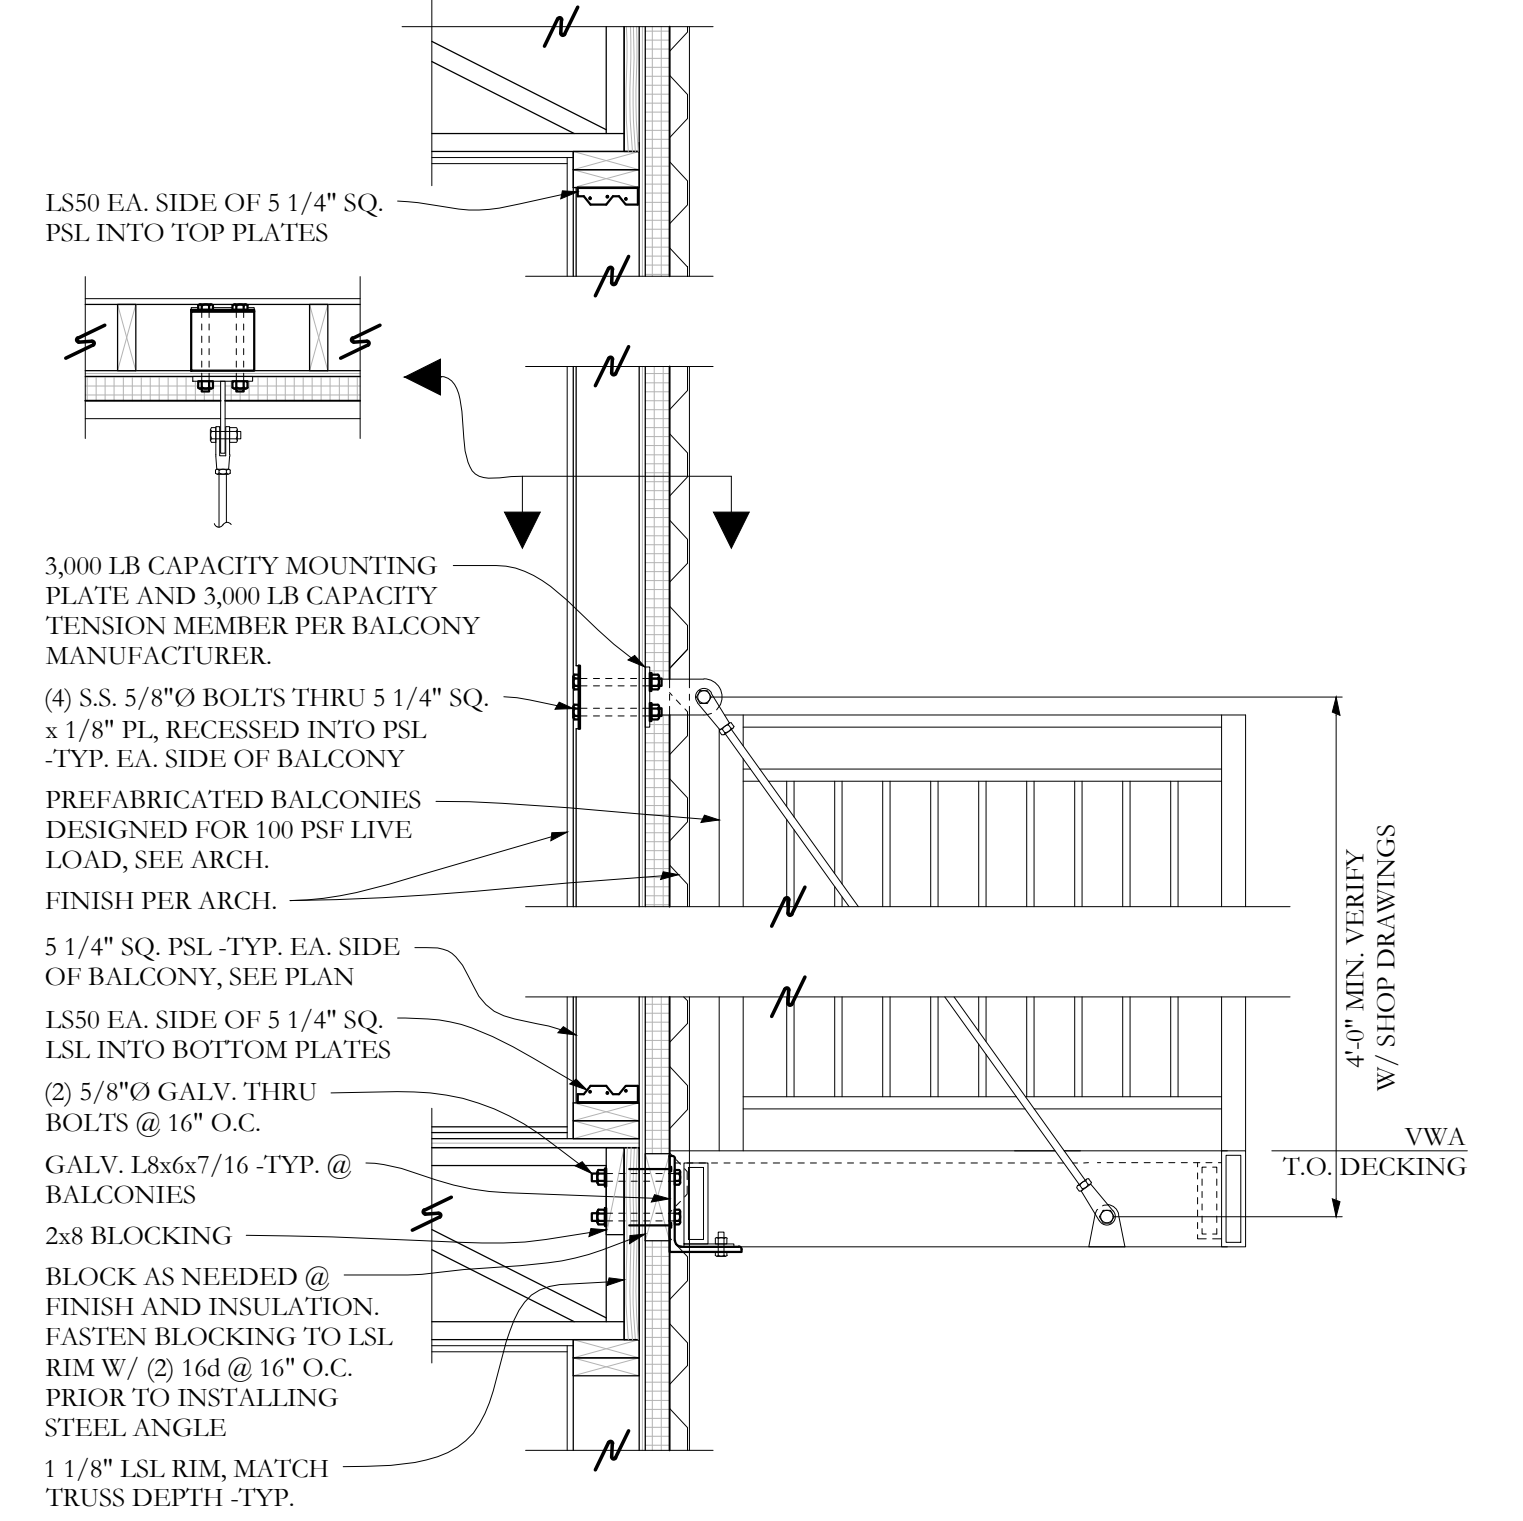
SECTION V S2-2 3/4"=1'-0"
TYPICAL BALCONY CONNECTIONS

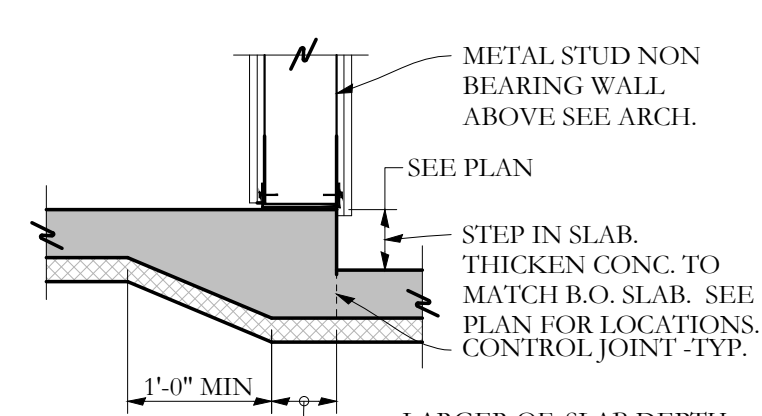
SECTION P S2-2 3/4"=1'-0"
TYPICAL SLAB STEP

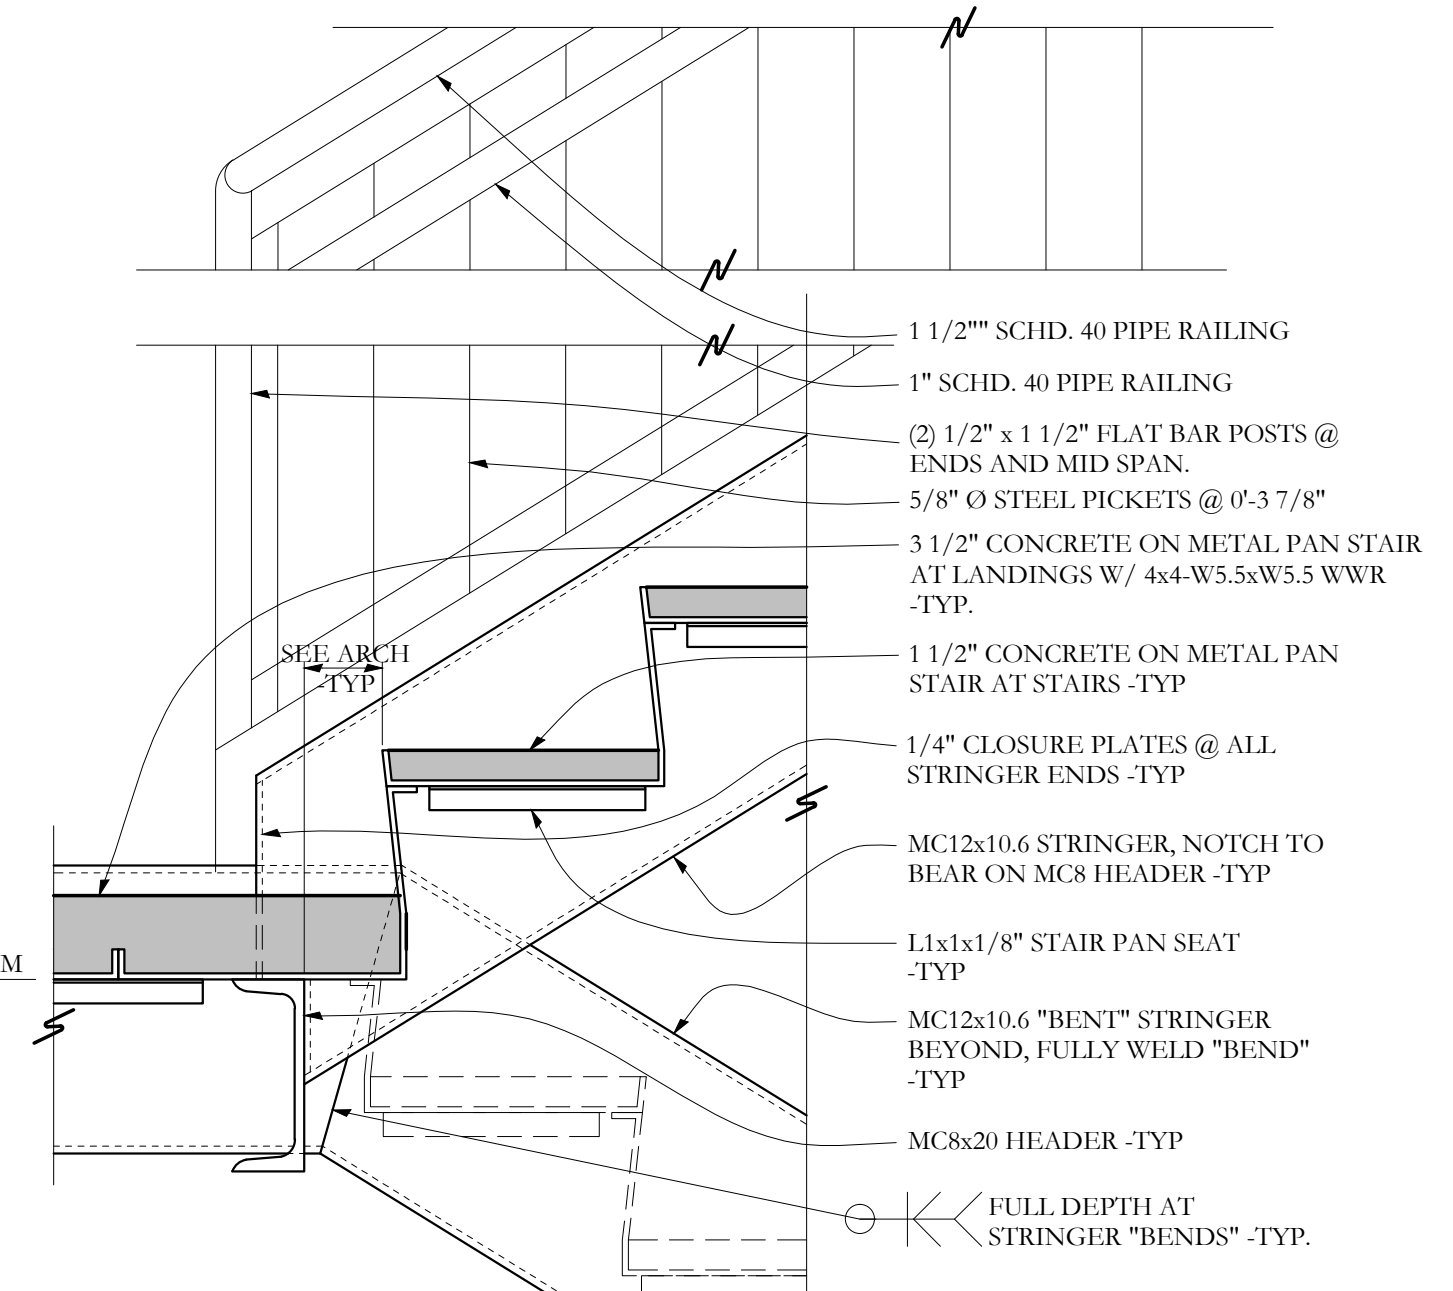
SECTION L S2-2 1 1/2"=1'-0"
TYPICAL STAIR FRAMING
