4 Meeting House Lane, WEST BATH, MAINE 04550  
JAMES HOARE Architectural Design  
Phone (207) 843-6251 cell 751-2134

HARRIS EVANS ASSOCIATES  
42 GREENLEAF STREET  
PORTLAND, MAINE

Remodeled Elevations

A-5

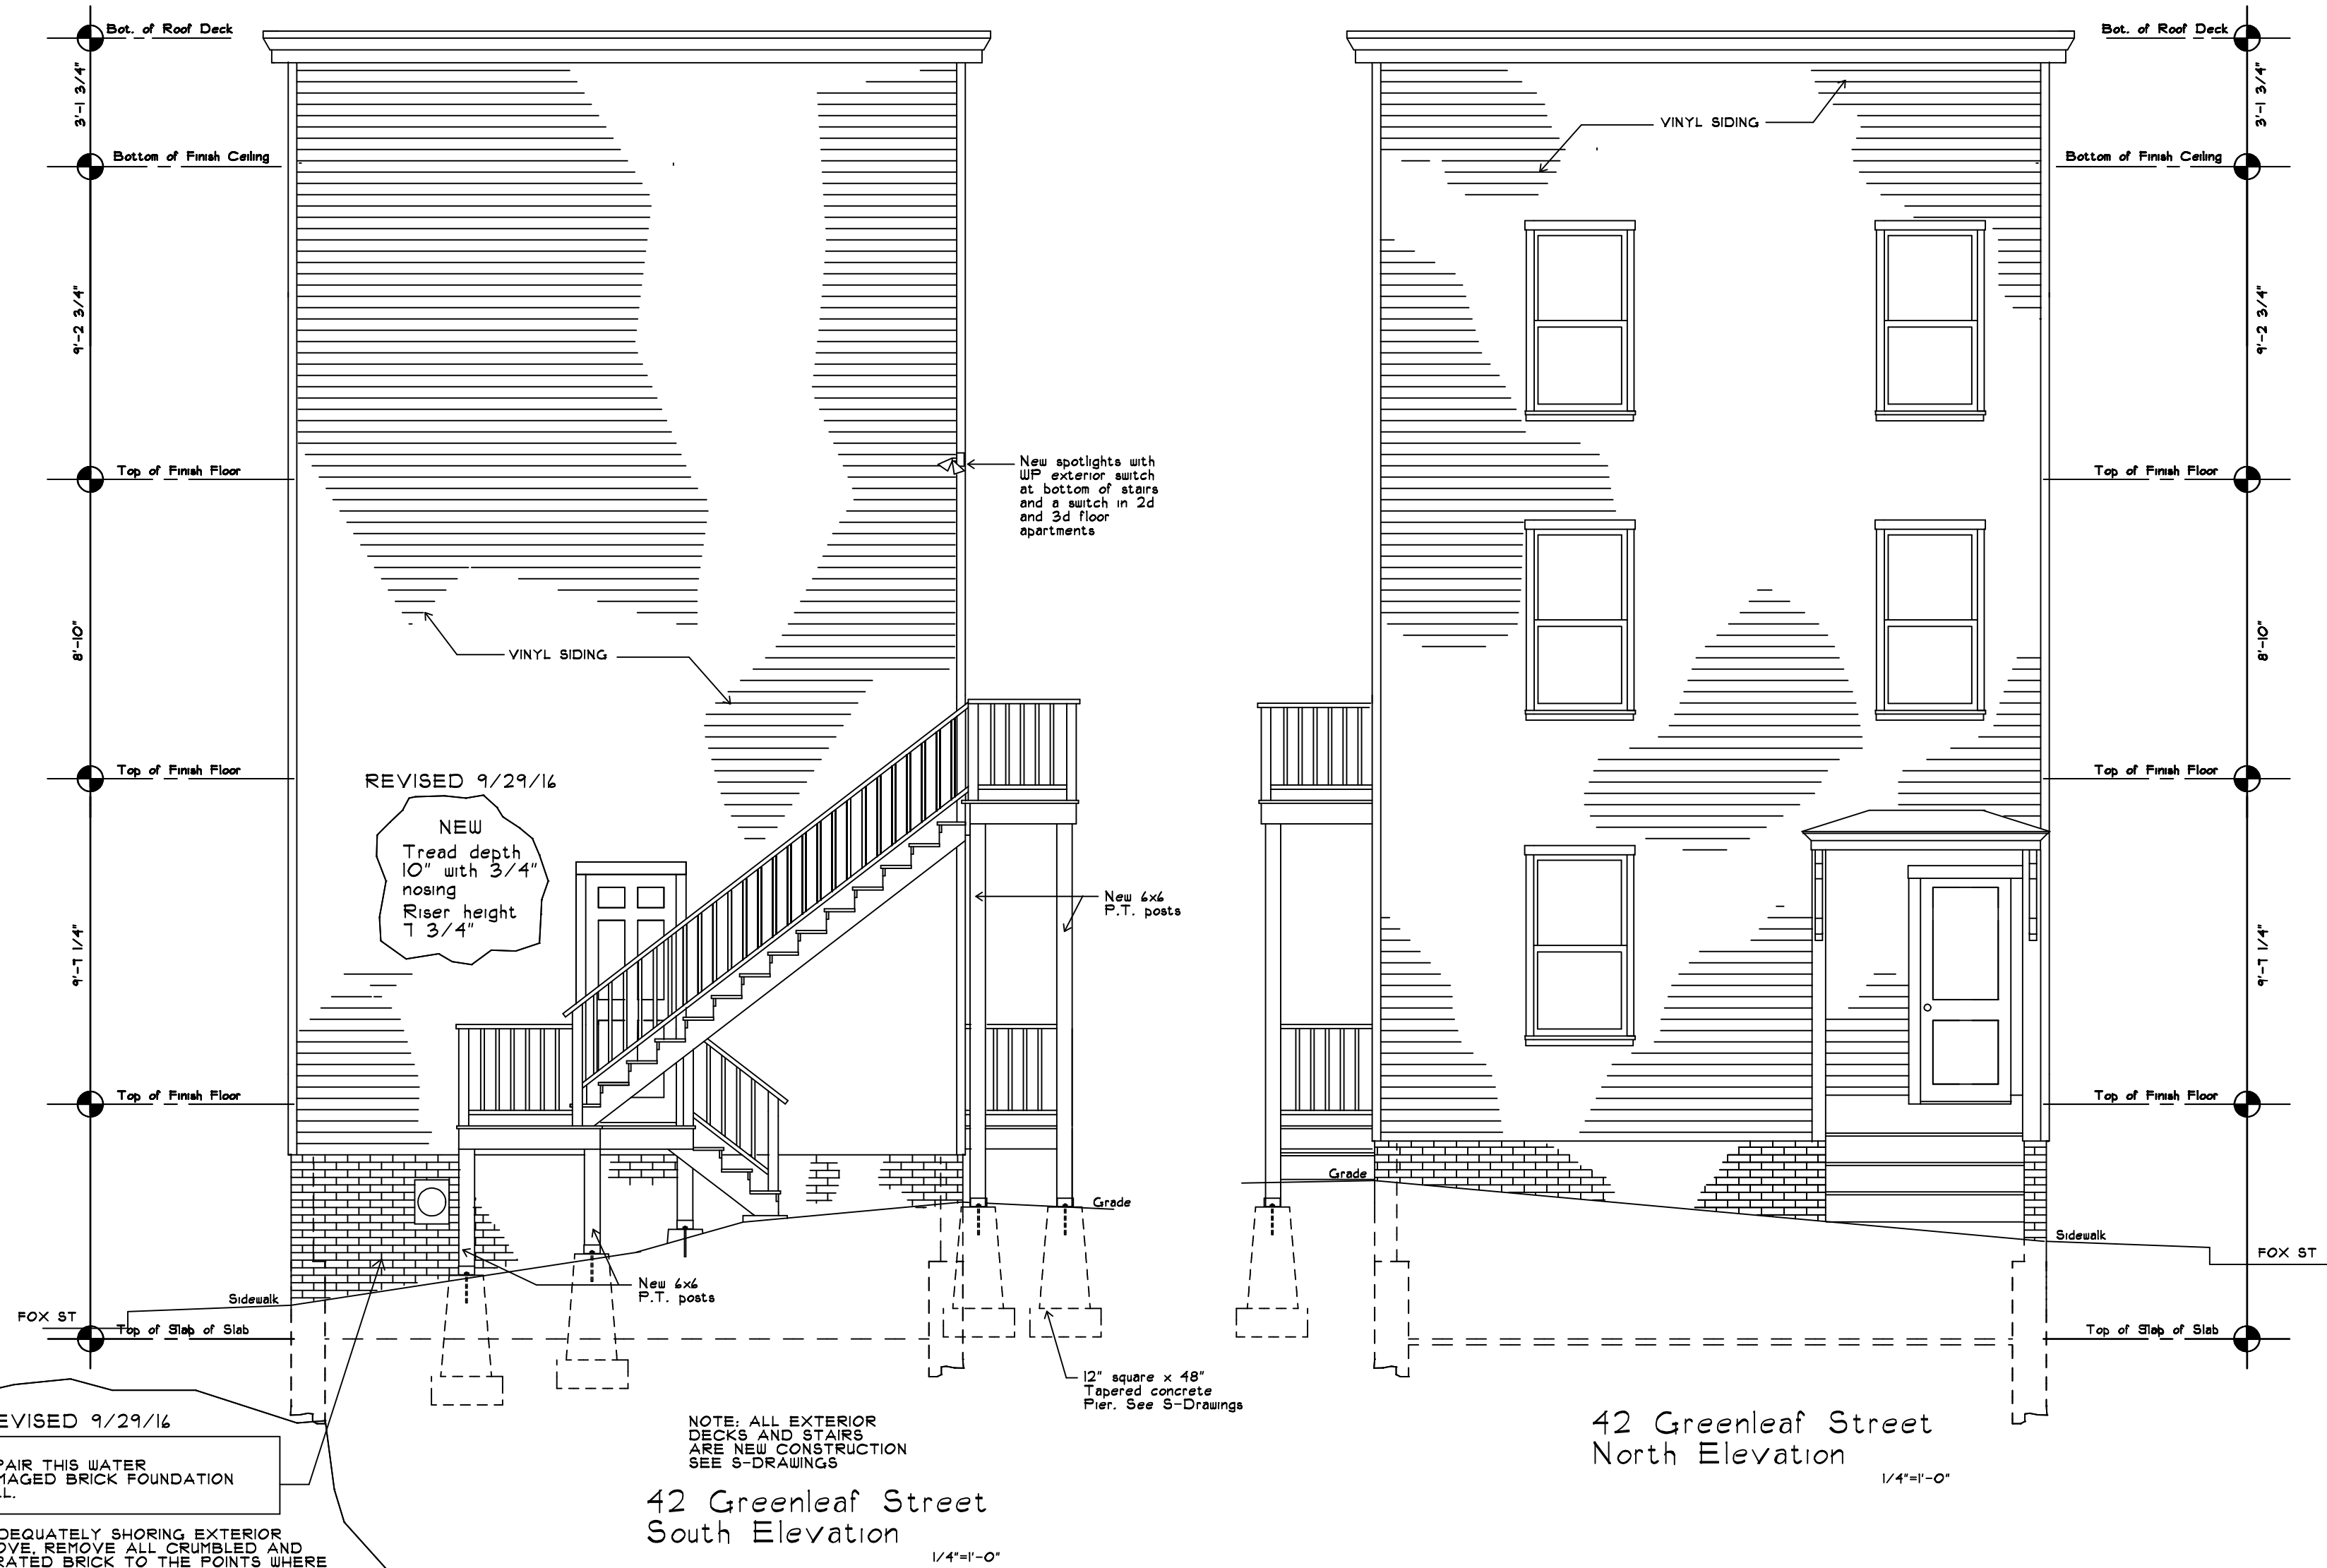
REPAIR THIS WATER DAMAGED BRICK FOUNDATION WALL.

AFTER ADEQUATELY SHORING EXTERIOR WALL ABOVE, REMOVE ALL CRUMBLING AND DETERIORATED BRICK TO THE POINTS WHERE SOLID UNDAUNAGED BRICK IS FOUND. REPLACE WITH NEW BRICK TO MATCH AND HI STRENGTH MORTAR. PAINT NEW BRICK TO MATCH EXISTING.

NEW  
Tread depth  
10" with 3/4" nosing  
Riser height  
7 3/4"

NOTE: ALL EXTERIOR DECKS AND STAIRS ARE NEW CONSTRUCTION SEE S-DRAWINGS

42 Greenleaf Street  
South Elevation 1/4"=1'-0"

42 Greenleaf Street  
North Elevation 1/4"=1'-0"

1 2nd 20% ADDED NOTES RE REPAIRS TO FOUNDATION WALL, AND STAIR TREAD DEPTH AND RISER HEIGHT INFORMATION.
