**From:** Timothy Lock <tim@gologic.us>  
**To:** Jean Fraser <JF@portlandmaine.gov>  
**Date:** 5/12/2014 11:22 AM  
**Subject:** Re: 97 Cumberland Avenue - level III Site Plan and Subdivision Review  
**Attachments:** 14-0512\_A606 CorTen\_Raw and Oxidized.JPG; 14-0512\_Rustwall Panel.JPG

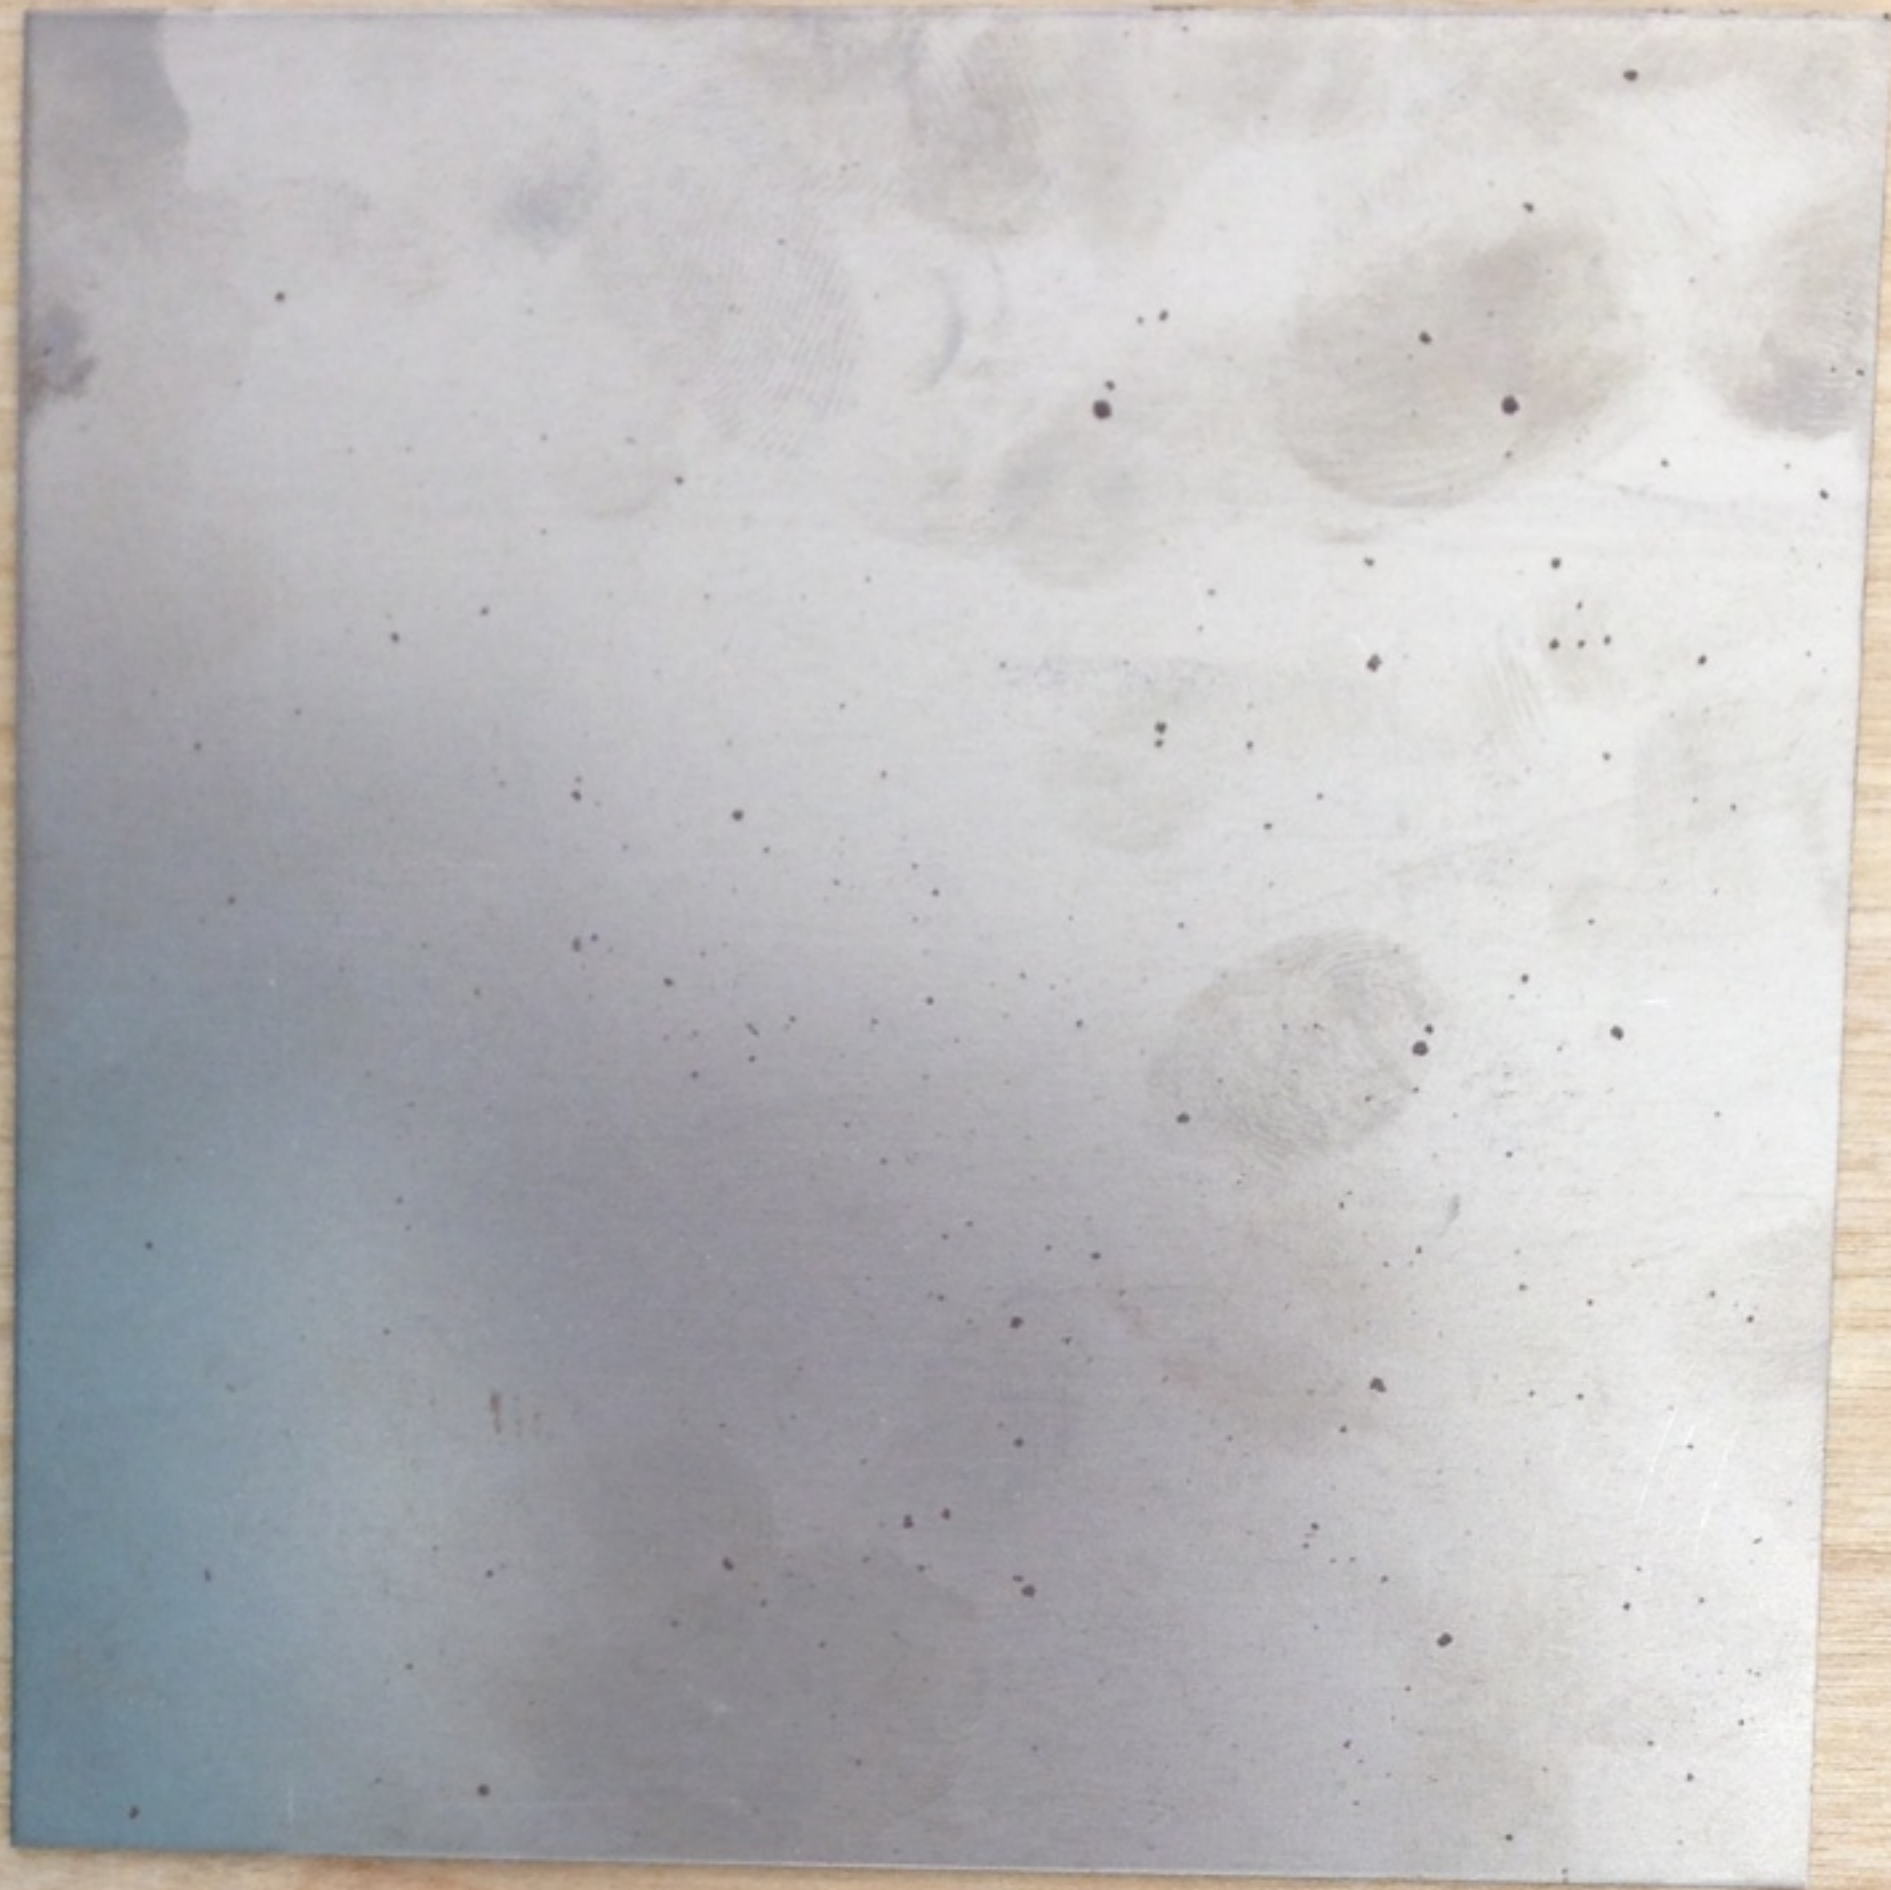
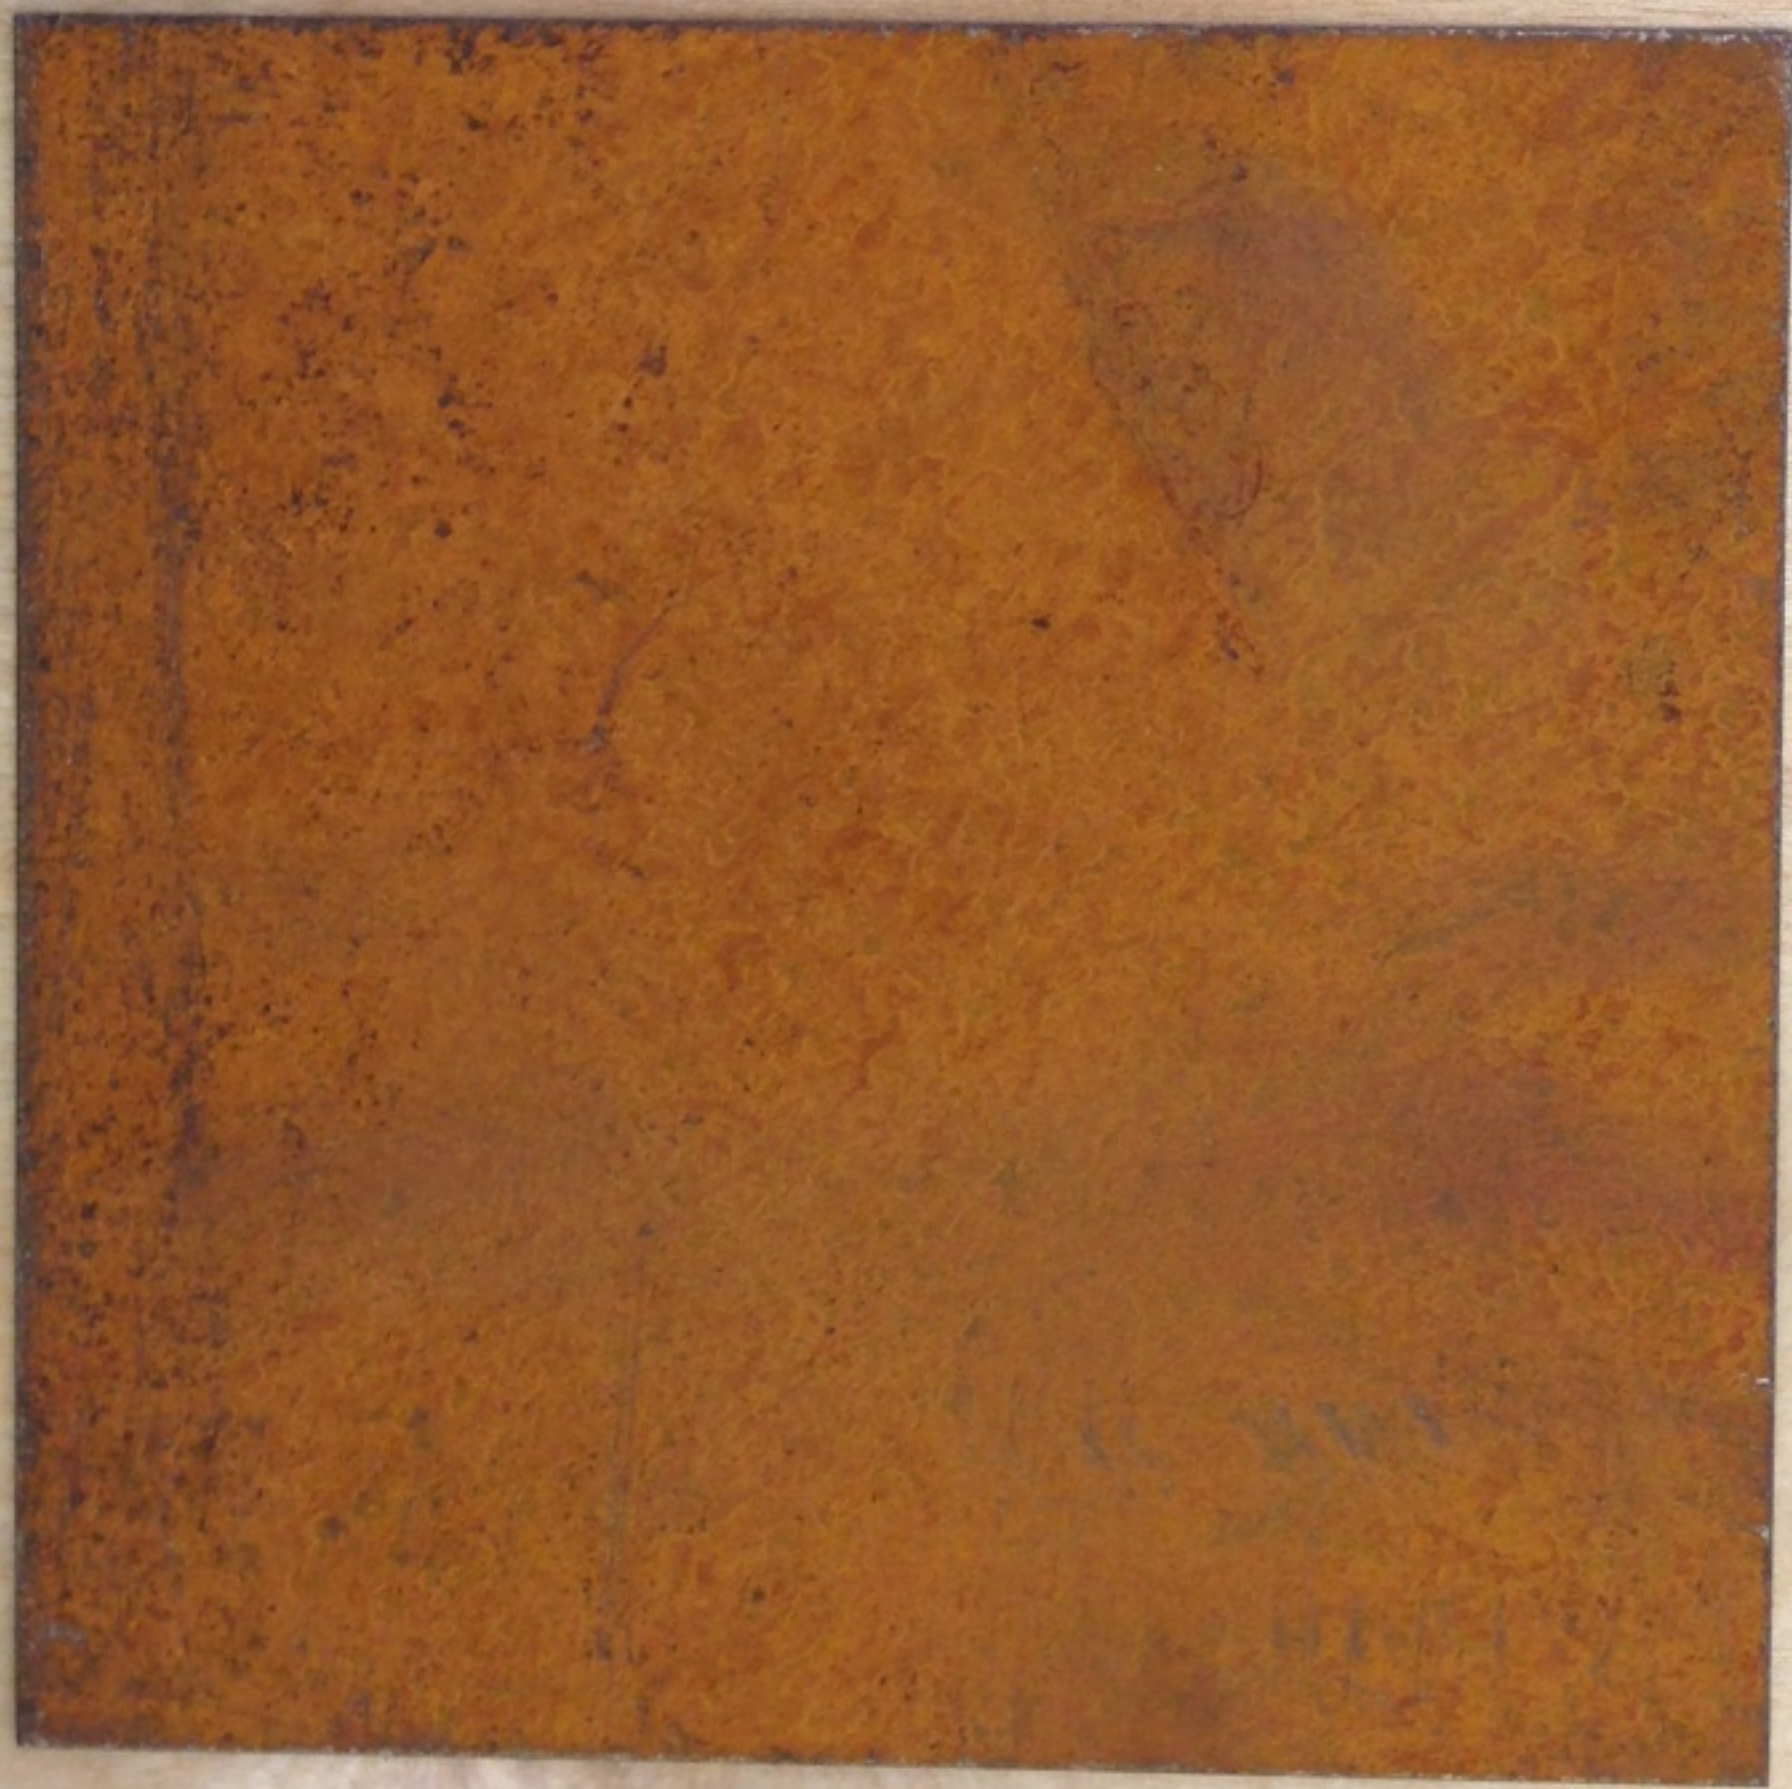
Also, I've attached a couple of images - the first is two A606-4 "Cor-Ten" Steel samples, one raw, the other fully oxidized. The second image is of a sample the Rust-Wall panel about two weeks into the oxidation process (same material, just pre-formed to the panel profile). After two months it will be fairly consistently the same color as the bottom sample in the first image.

A606-4 "Cor-Ten" steel is very simply a different steel alloy to standard structural carbon steel which promotes the natural development of consistent oxidation (rust) forming a protective, weatherproof film on the metal's surface which resists the corrosive effects of rain, snow, etc. negating the need for highly toxic paints and long term maintenance of said paints.
