S1

**Maine Mead
Nissen Building
75 Washington Ave.
Portland, Maine**

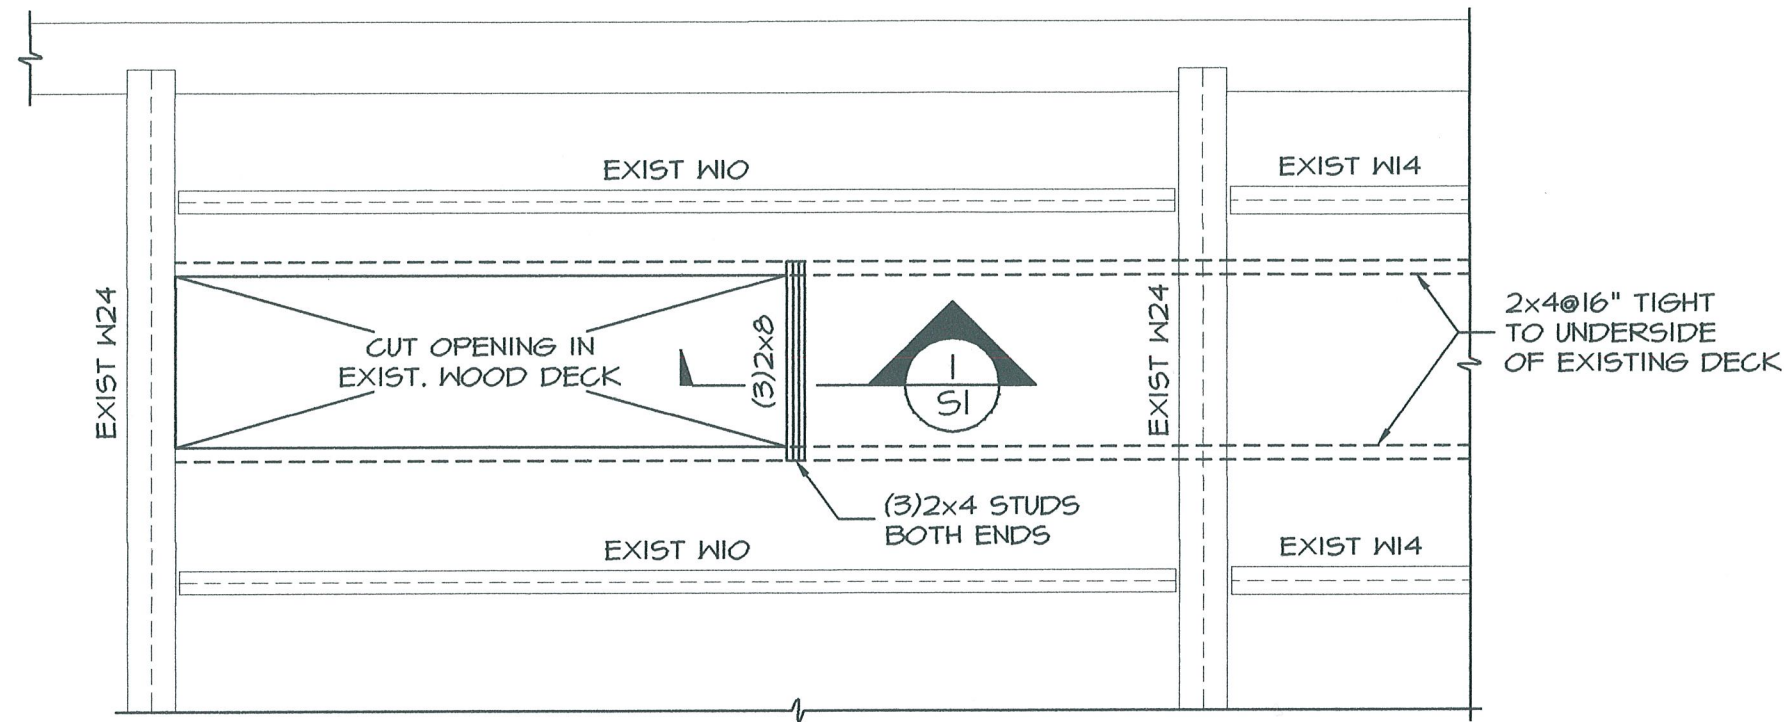
ROOF FRAMING AT REAR STAIR

SEE A1 FOR LOCATION AND ALL DIMENSIONS
