73 Melbourne St  
 Thomas Soekings  
 11/10/17  
 Exterior Support walls  
 B

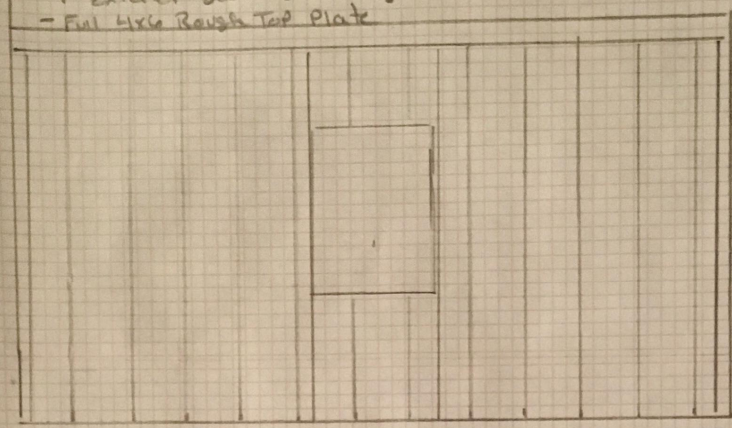
A3

- rear exterior wall
- Full Rough 2x4 Framing @ 16" OC
- 1" Exterior Board Sheathing
- Full 4x6 Rough Top Plate

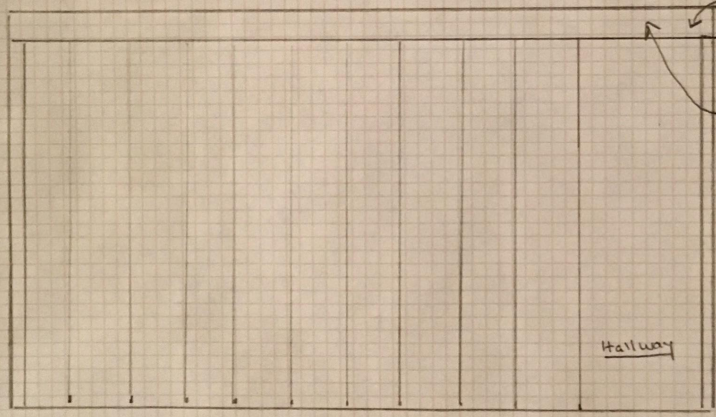
B3, C3

- (2) 7/4 LVL w/ continuous 4x4 support posts either side (B3)
- Existing Rough 4x6 sistered with new 2x6 SPF KD (C3)

- Interior Support wall
- Nom 2x4 SPF KD Wall Framing (B3)
- existing Full 2x3 Rough Framing sistered with new 2x4 SPF KD

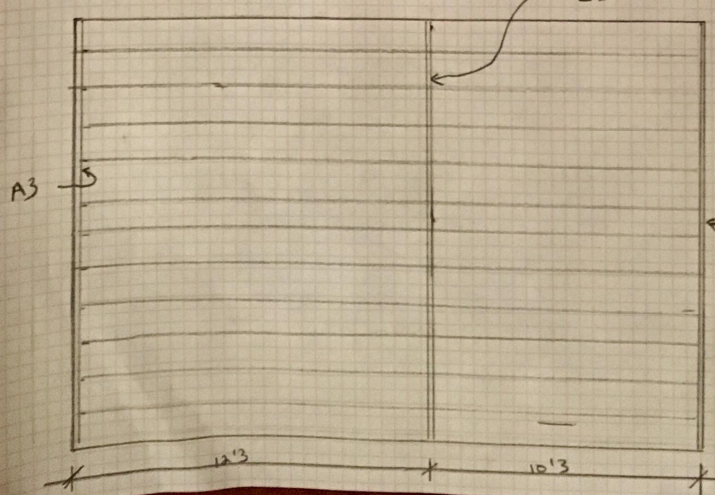
D3

- Roof Framing
- Existing Full 2"x6" Rafters
  - Sistered with new 2x6 SPF KD, Joints @ wall B3
  - 1" Board Sheathing
  - 4" Sprayed foam insulation
