Project:  
**118 ON MUNJOY HILL**  
118 CONGRESS STREET  
PORTLAND, MAINE

Date: 5 MAR 2014  
Scale: As indicated  
**Shear Wall Elevation & Shear Wall Details**

**S3.04**

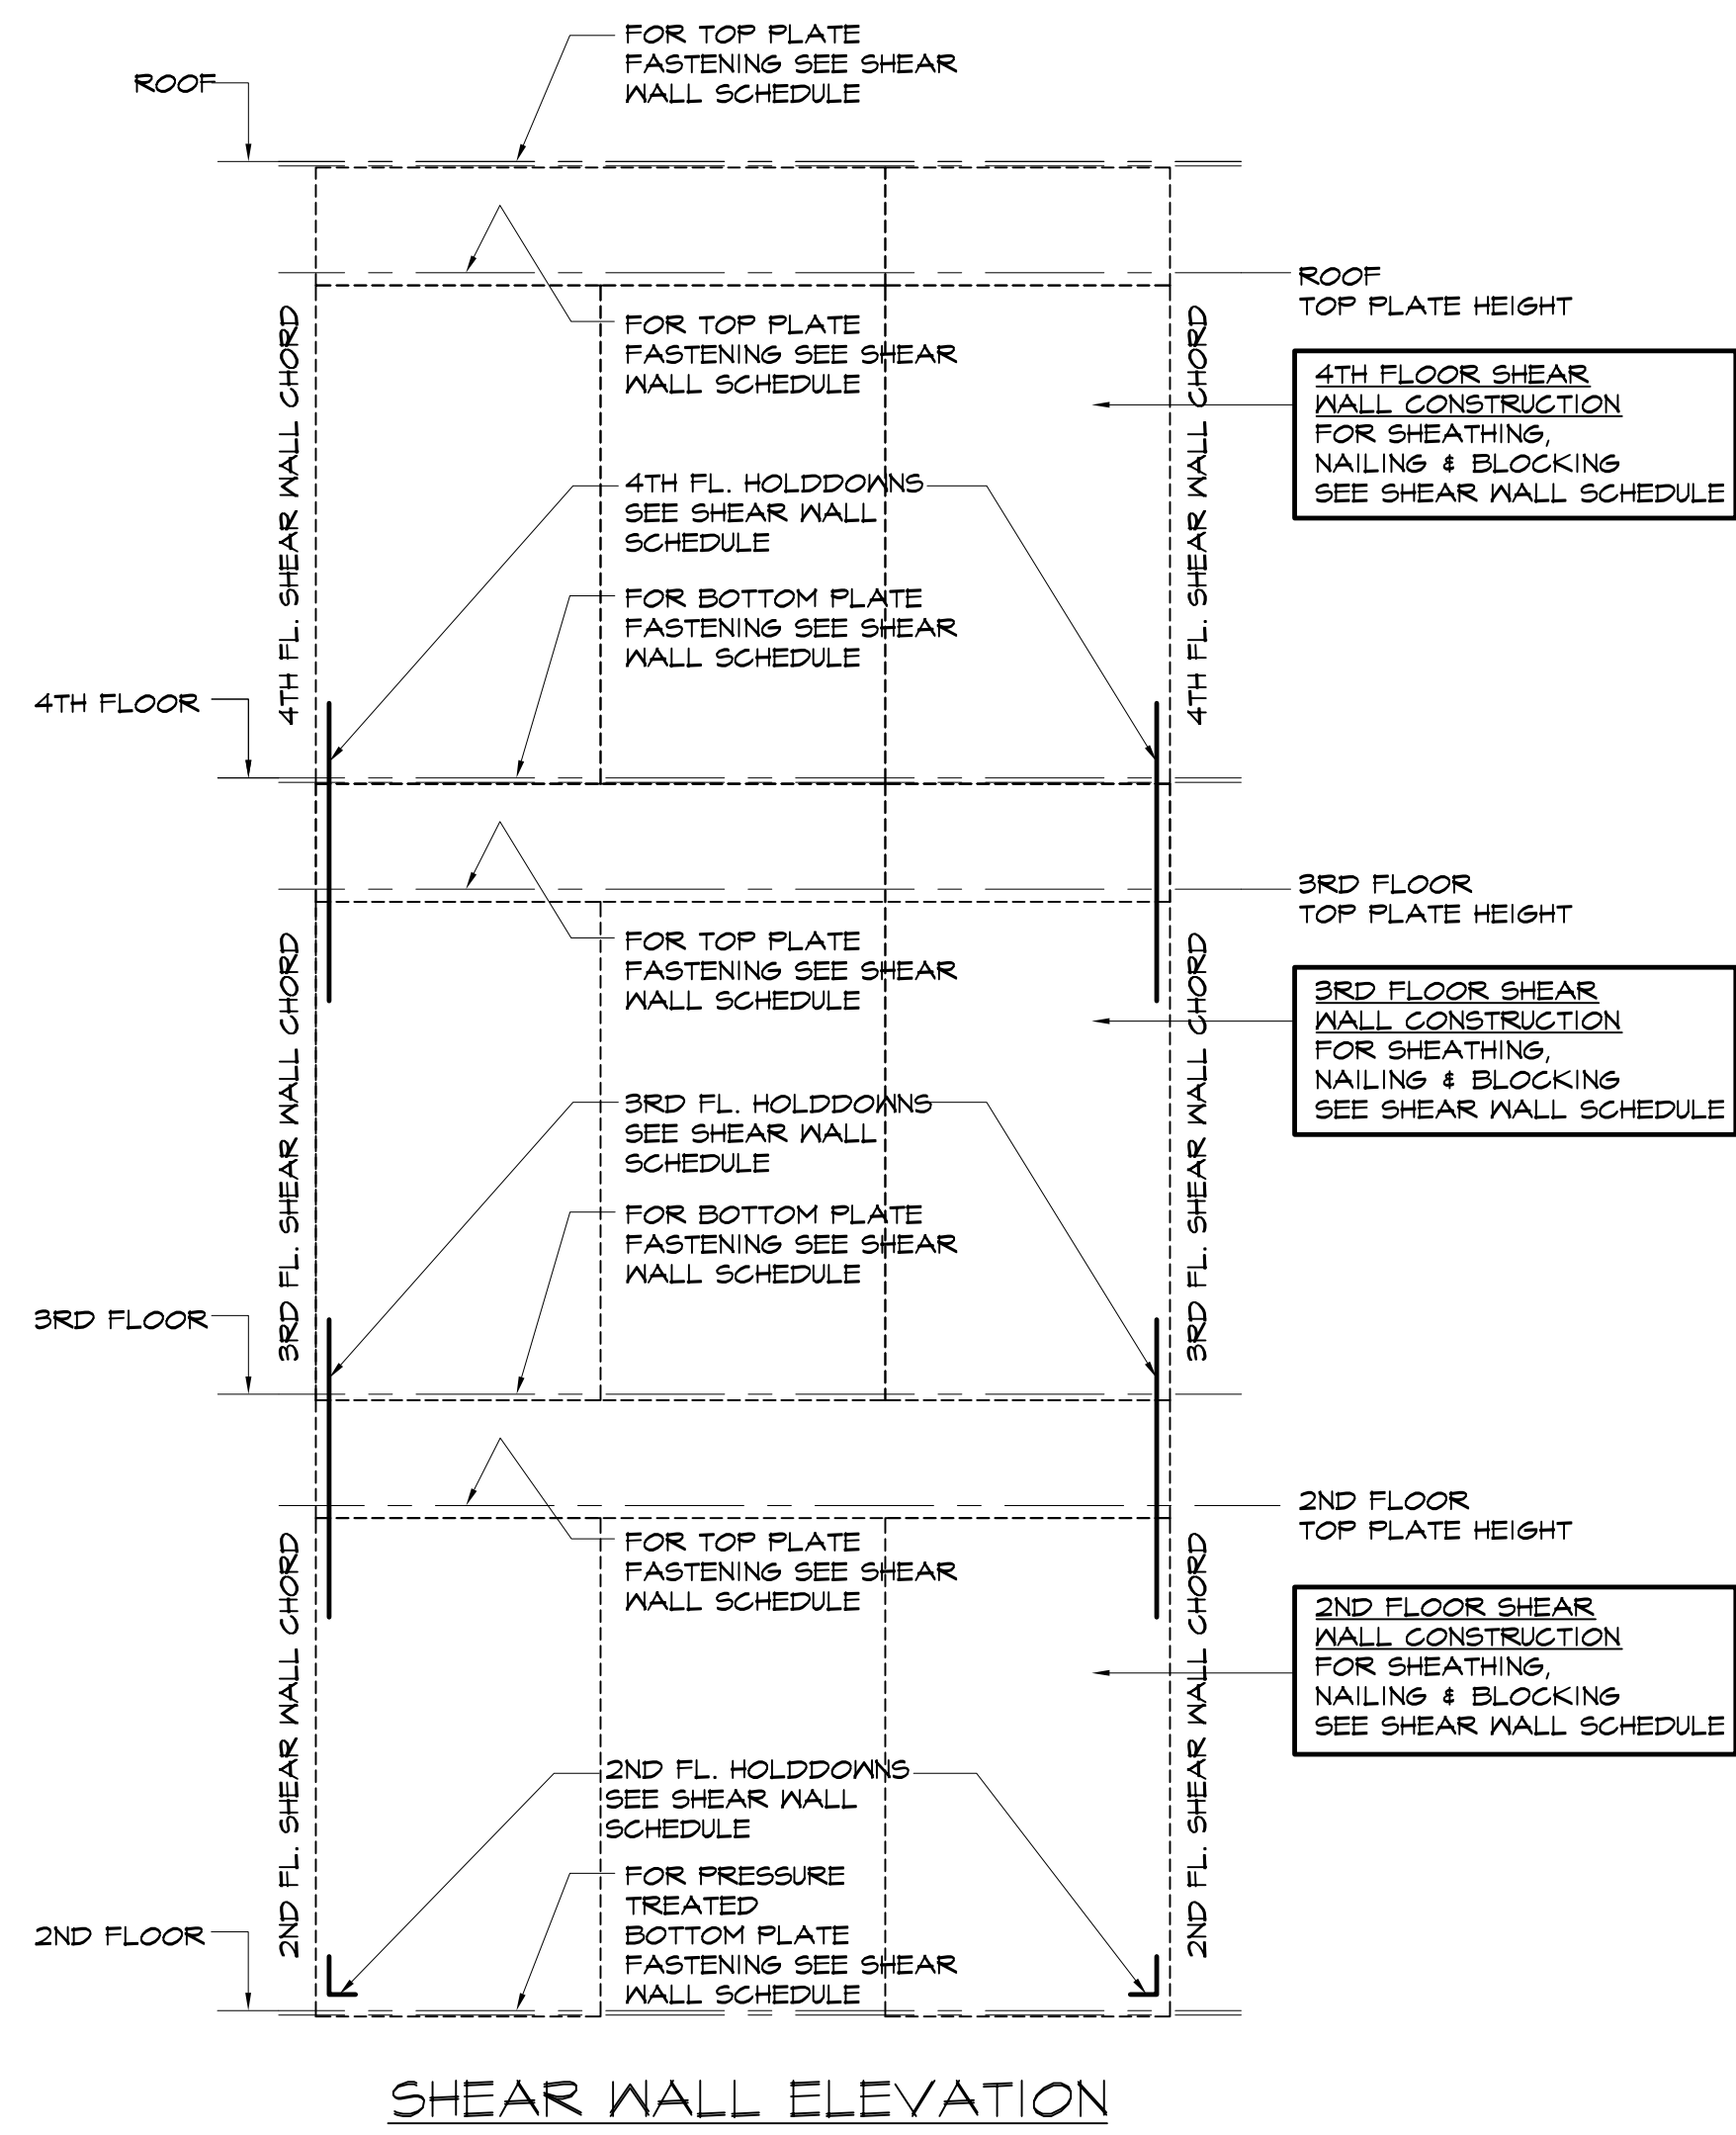
SHEAR WALL ELEVATION

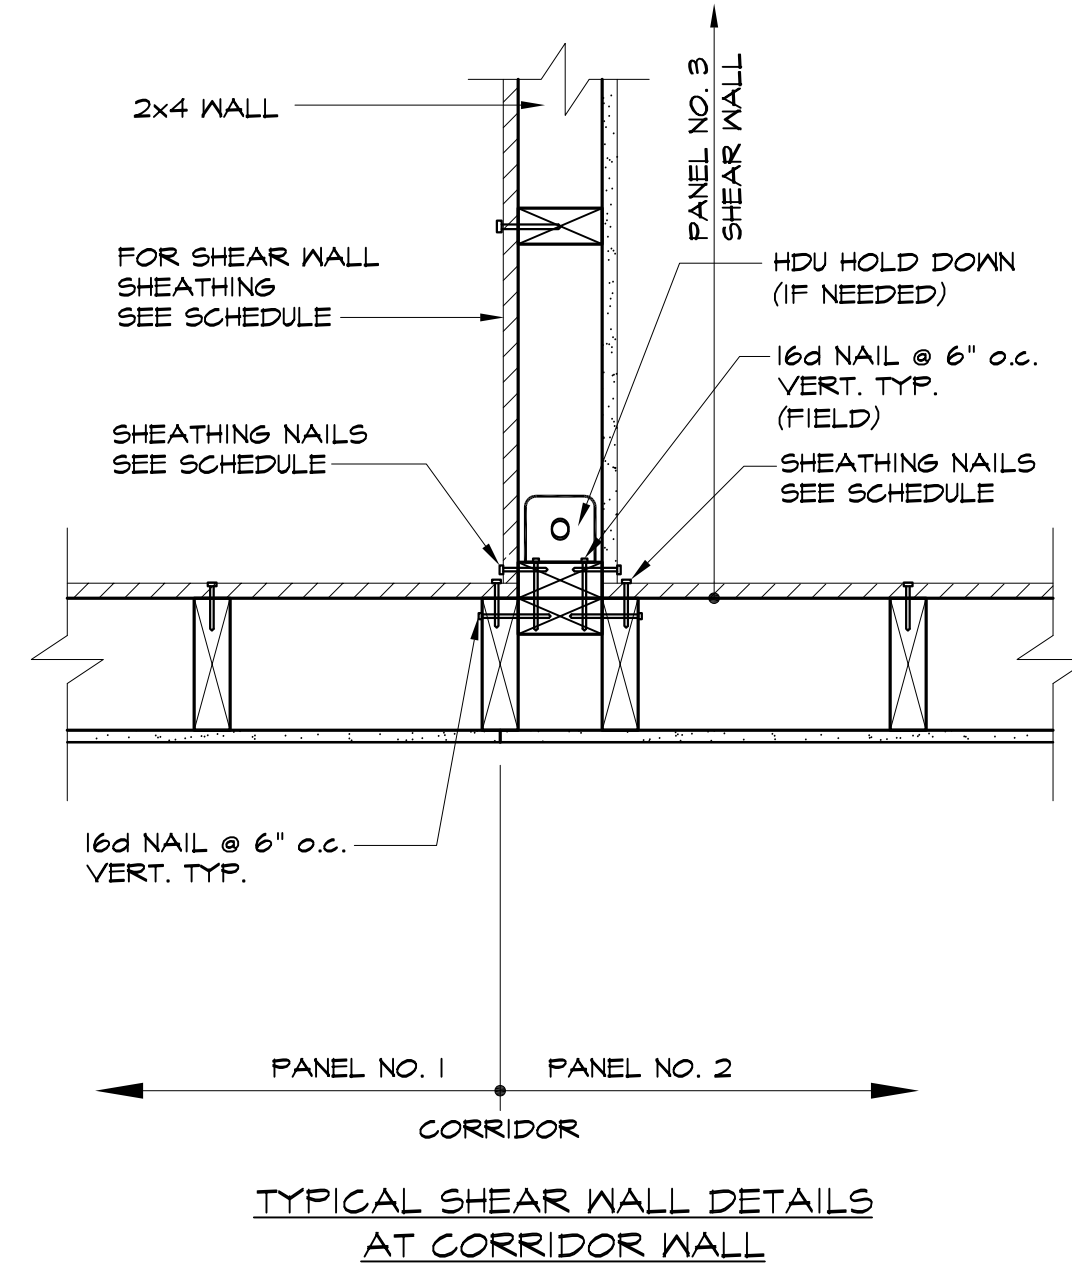
TYPICAL SHEAR WALL DETAILS AT CORRIDOR WALL

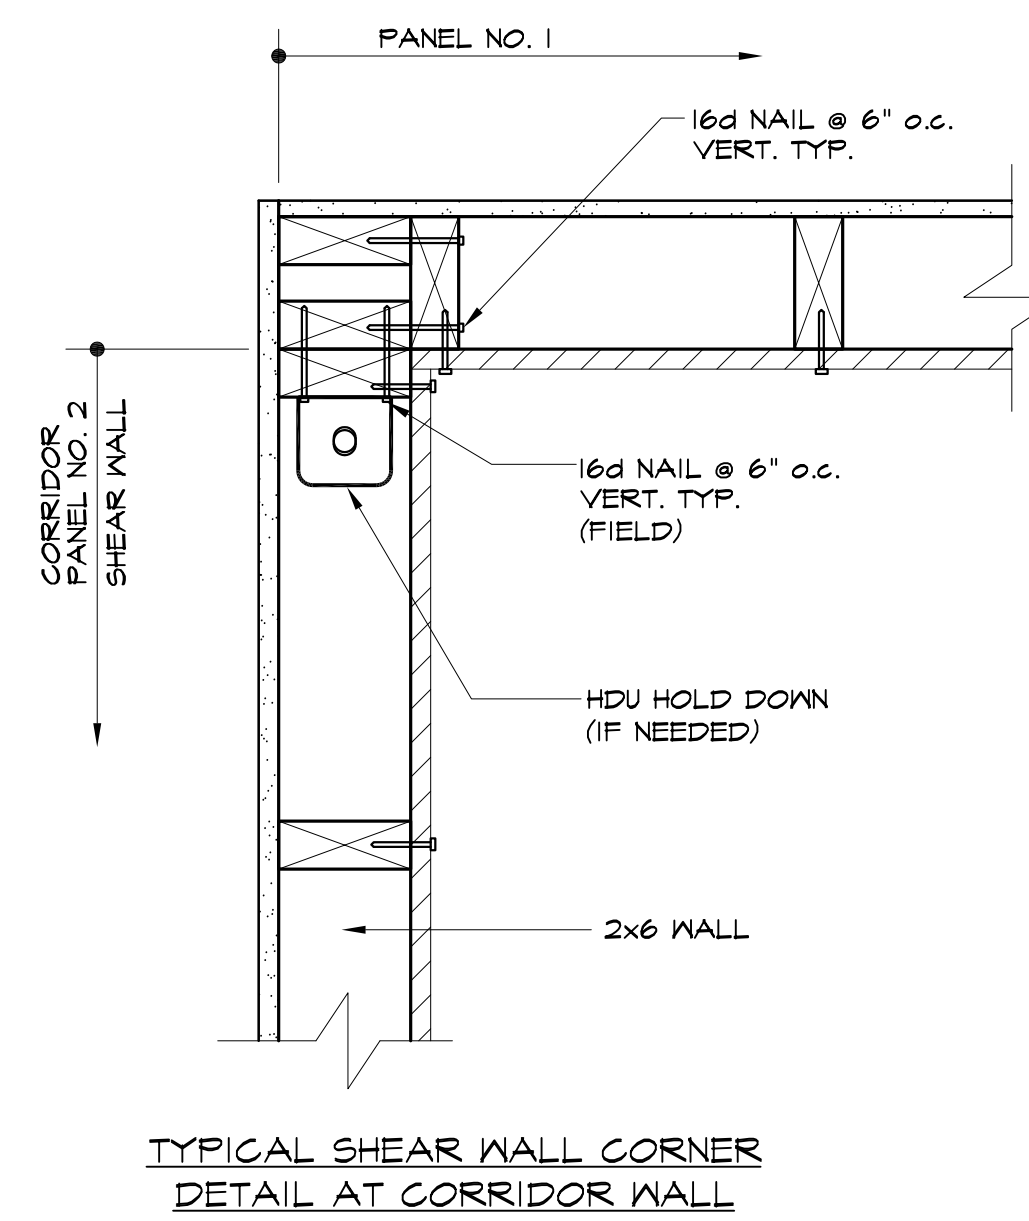
TYPICAL SHEAR WALL CORNER DETAIL AT CORRIDOR WALL

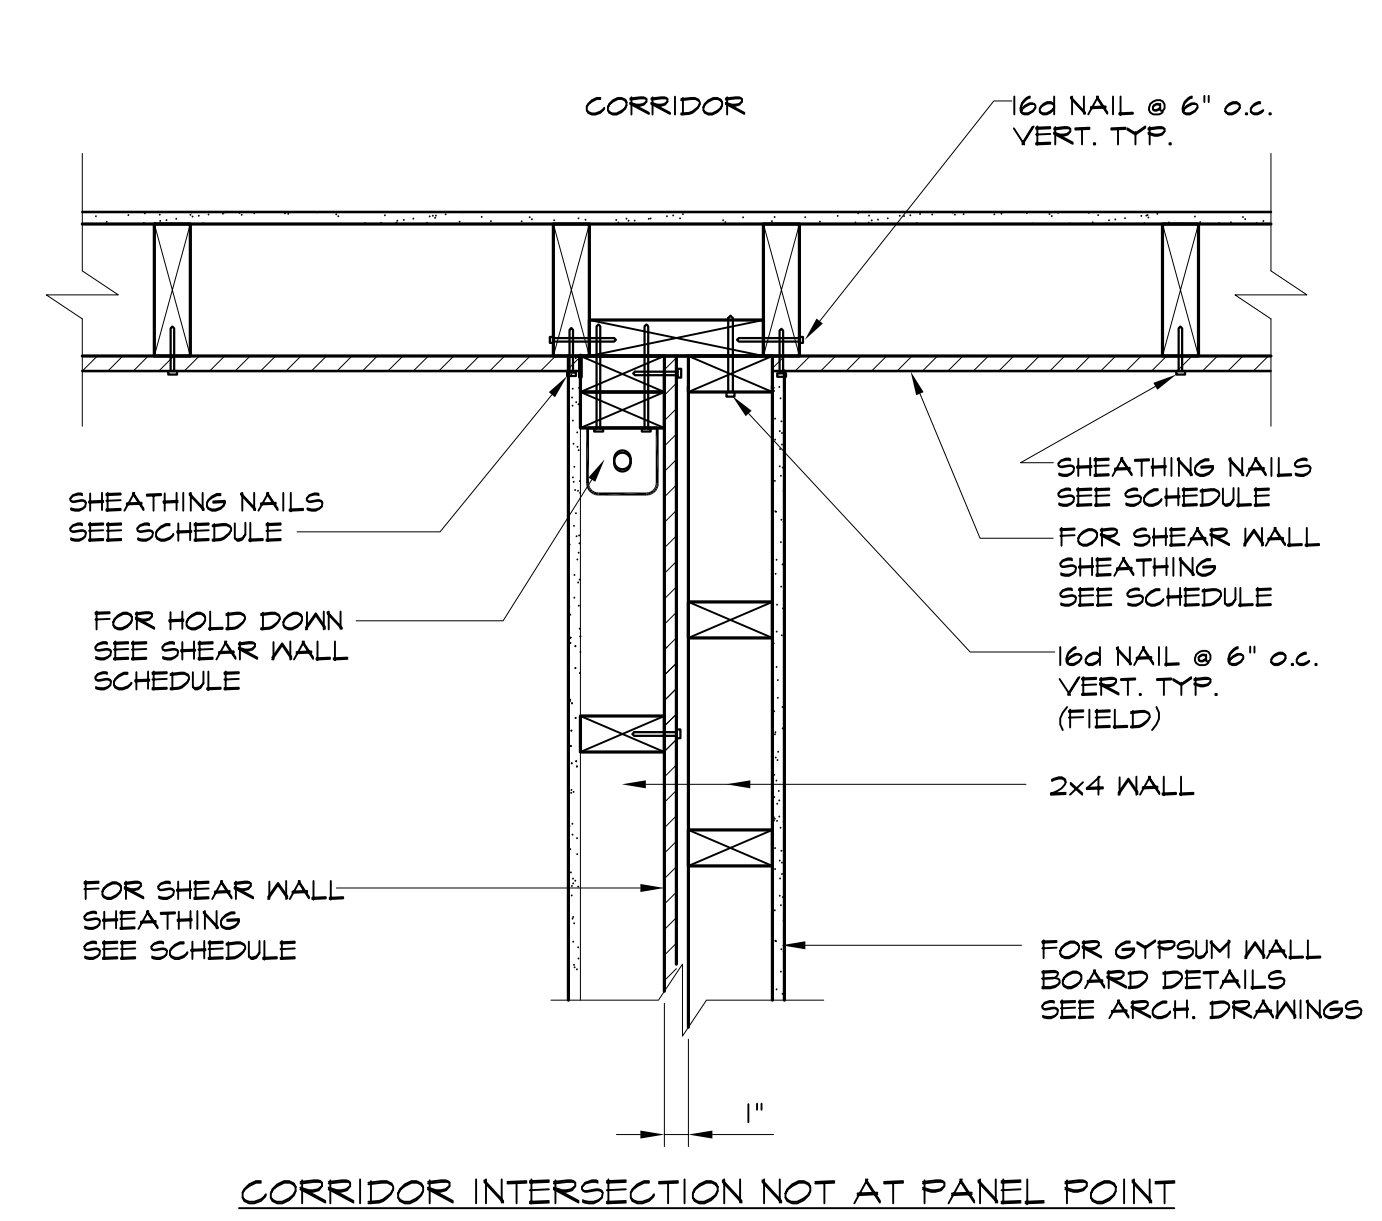
CORRIDOR INTERSECTION NOT AT PANEL POINT

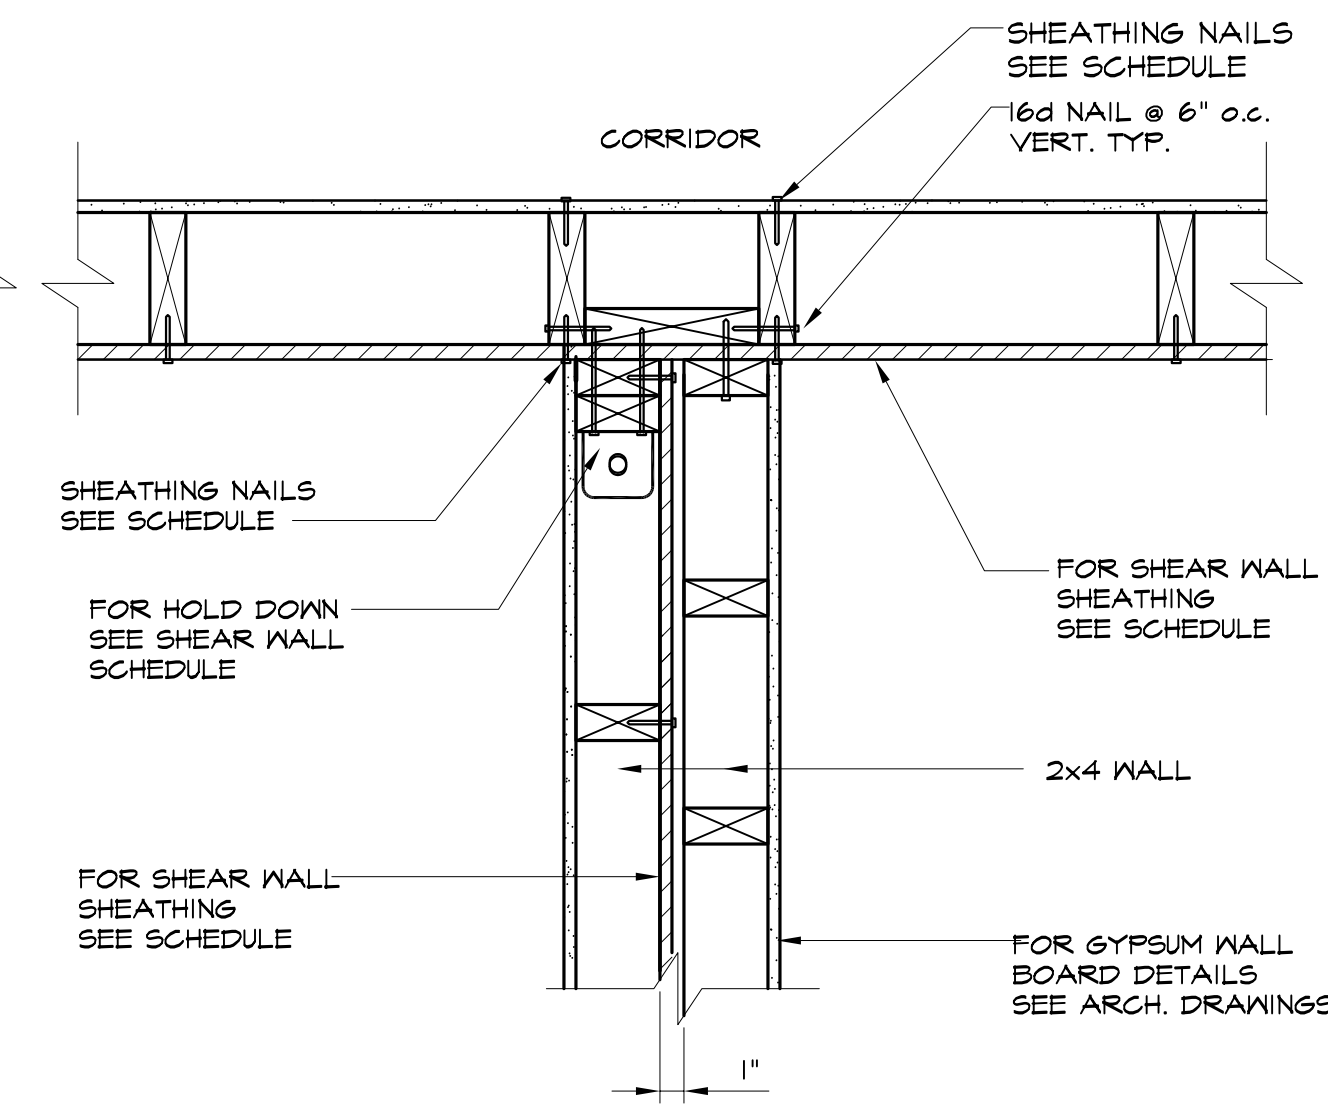
CORRIDOR INTERSECTION NOT AT PANEL POINT W/ OSB RUNNING THRU

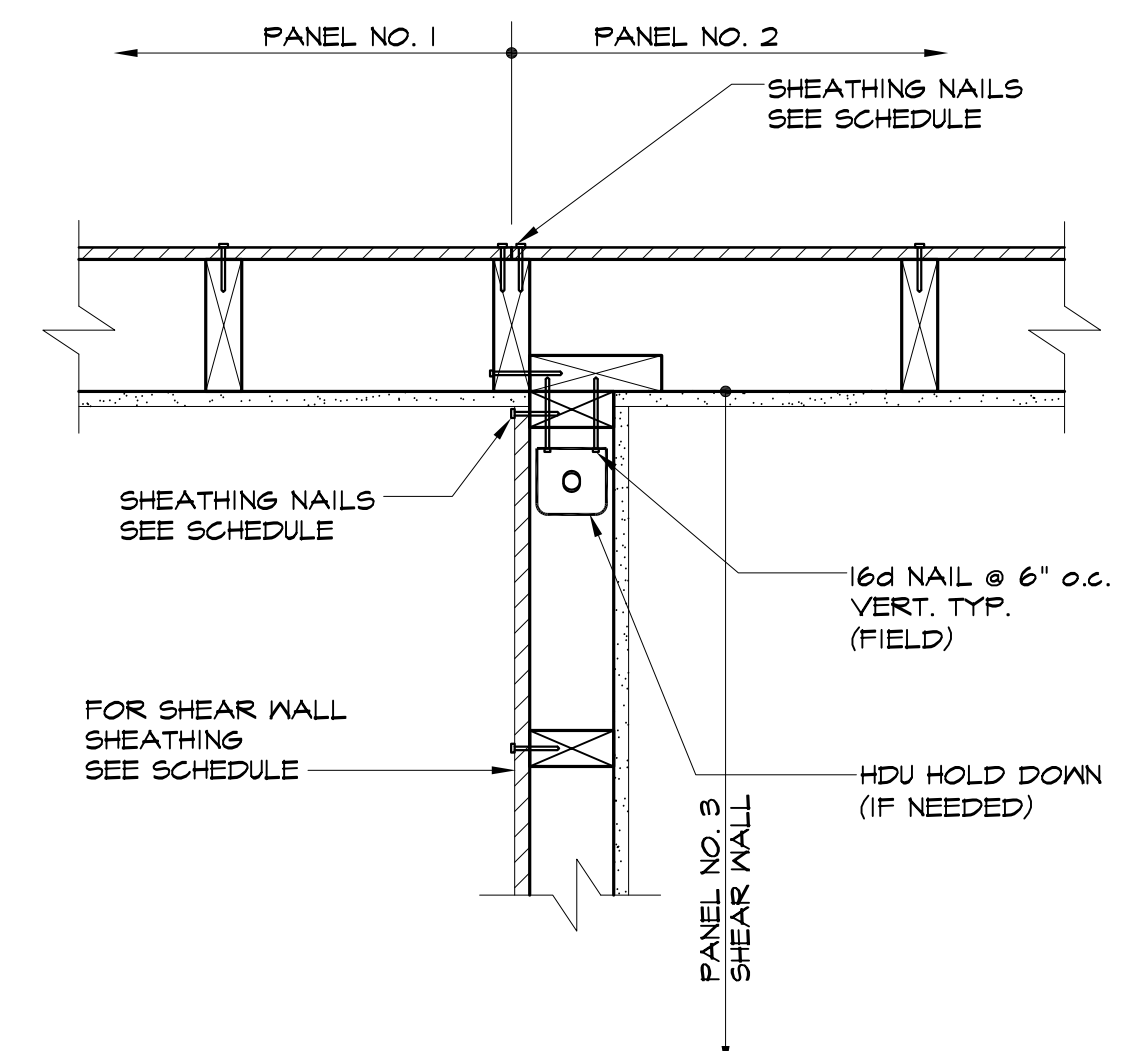
TYPICAL SHEAR WALL DETAILS AT EXTERIOR WALL

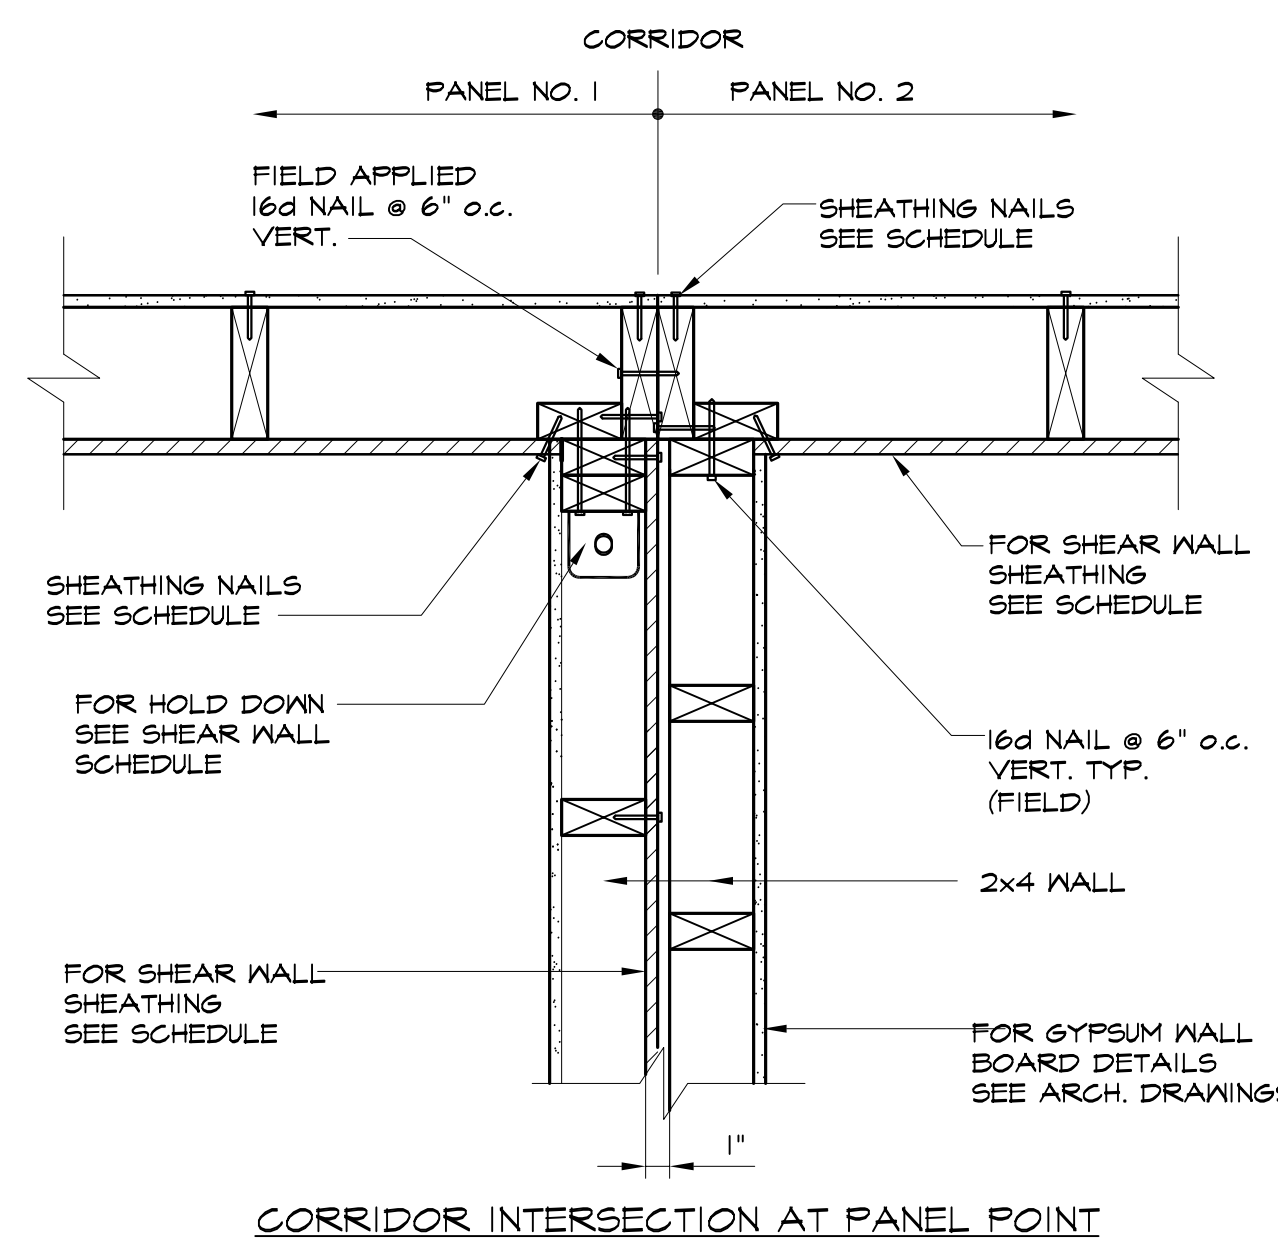
CORRIDOR INTERSECTION AT PANEL POINT

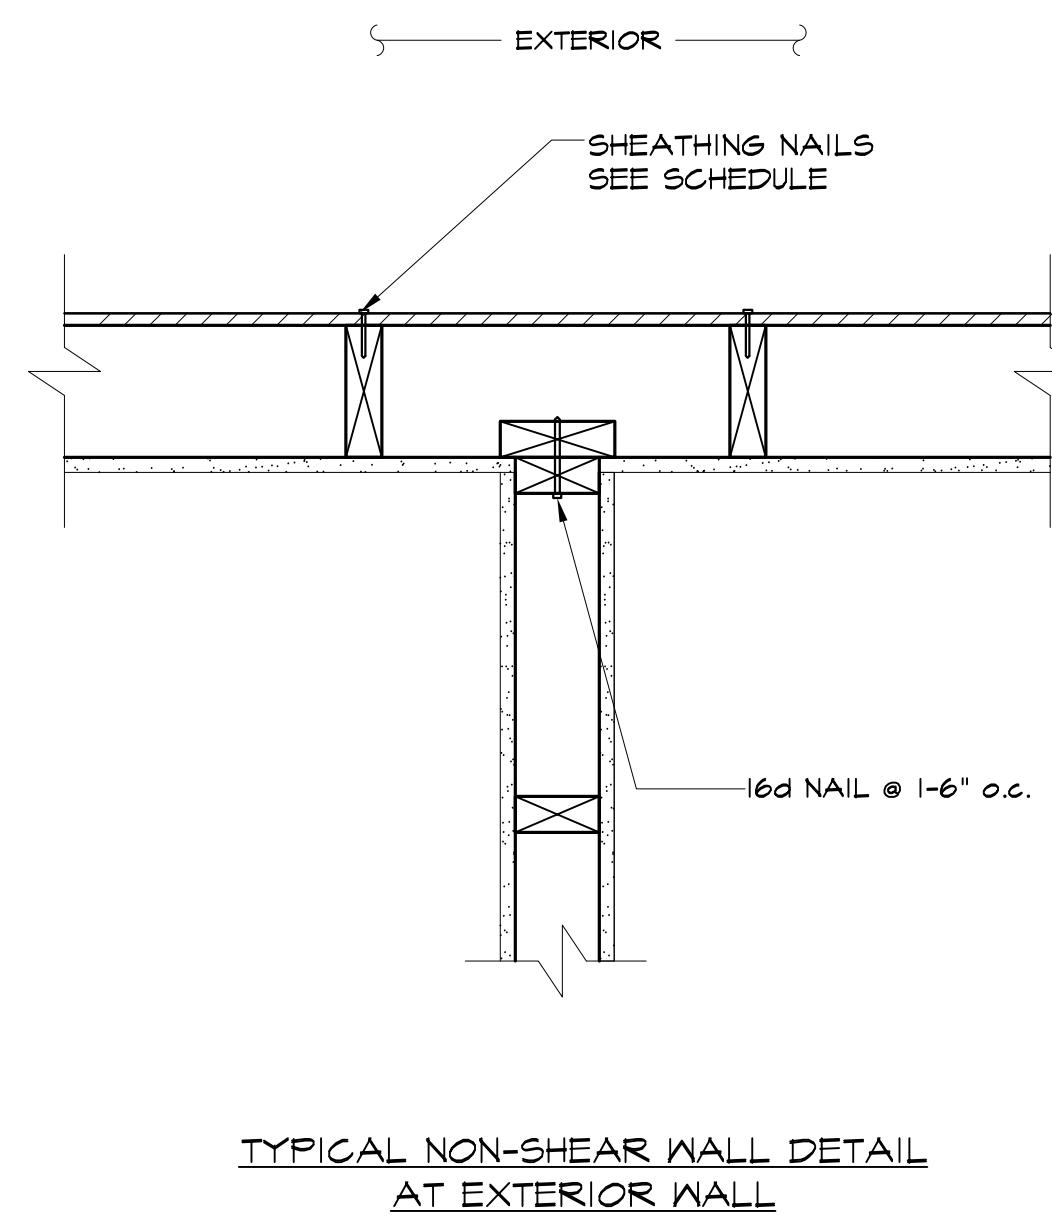
TYPICAL NON-SHEAR WALL DETAIL AT EXTERIOR WALL
