FIRE TEST REPORT: An Open Floor/Ceiling Assembly with 2 x 8 Pine, Wood Joists, 16" O.C., Subfloor - 3/4" x 6" T&G Oak, Finish Floor- 3/4" x 6" T&G Oak flooring; the Joists and Exposed Side Of The O.S.B. Were Coated With 27 mil Thick Intumescent Coating, ForceField FireGuard E 84.

MODEL, NAME & NUMBER: ForceField FireGuard E 84 Intumescent Coating,

STANDARDS TESTED TO: ASTM E-119-10B Floor/Ceiling; NFPA 251; UL 263;
ULC-S-101-07 With No Load Capacity, Small Scale Test.

REPORT NO: GL 115411

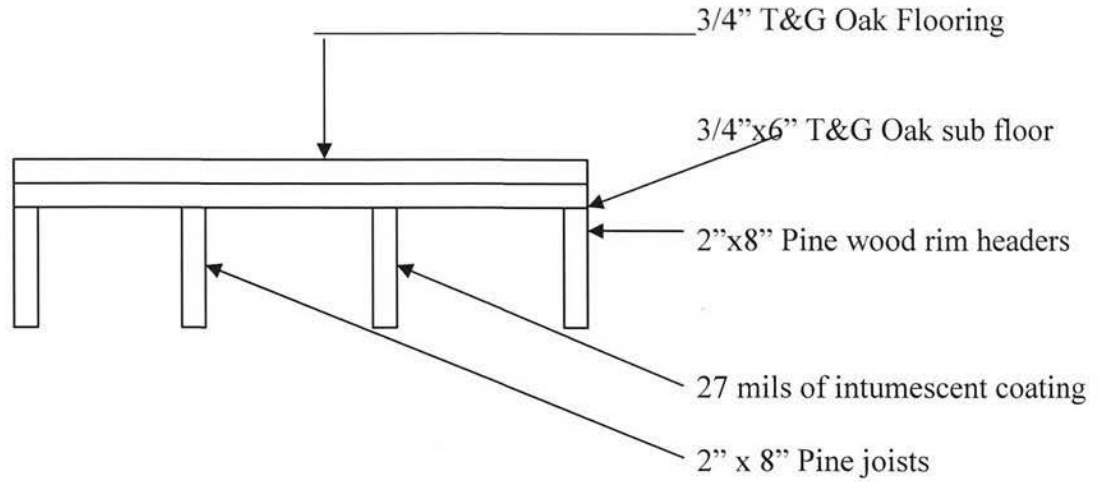
Assembly Drawing

Cross Sectional View

- a. Pine wood floor joists—2" x 8", spaced 16" O.C.; 2" x 8" pine rim headers;
- b. Subfloor-3/4" x 6" T&G Oak flooring.
- c. 3/4" x 6" T&G Oak finish flooring.
- d. 27-mil thickness of ForceField Fireguard E-84 Intumescent Coating applied to floor joists and exposed side of sub floor.

- 2.2a Wood joists were spaced 16" on center with a rim header, nailed together with 10d common nails.
- 2.2b The sub floor was placed on top of the joists on the unexposed side and was fastened with 1-5/8" screws. The test assembly was 4 feet x 4 feet.
- 2.2c 3/4" T&G oak hardwood flooring was attached to the unexposed side of the sub floor with 1 5/8" screws.
- 2.2d 27-mil thick coating of intumescent coating on the floor joists and exposed side of the O.S.B.

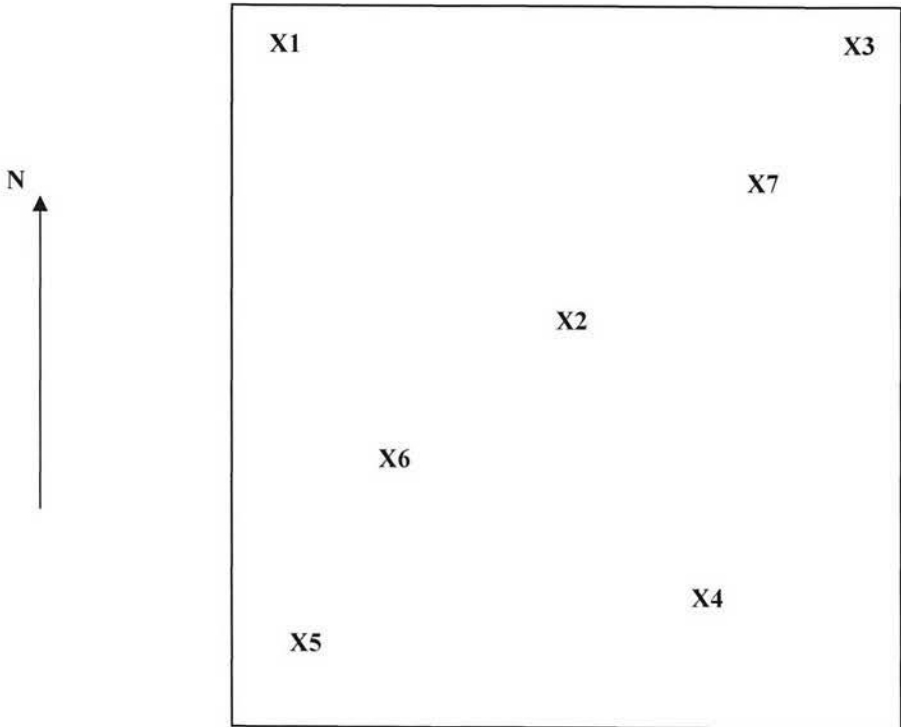
UNEXPOSED T/C LOCATIONS

- 3.1 The ASTM E-119 Tibor Harmathy design horizontal furnace was used for the fire endurance test.
- 3.2 Seven thermocouples were placed on the unexposed surface of the assembly one at the approximate center and four at the approximate center of its quarter sections, and 2 random locations.
- 3.3 The test unit was placed on the top surface of the horizontal furnace.
- 3.4 The furnace was ignited, and the temperature curve complied with the standard. The furnace average temperature followed the standard temperatures curve's nomenclature.
- 3.5 The furnace was shut off at 67 minutes.
- 3.6 The unit was left on the furnace and covered with gypsum wallboard to cool down.

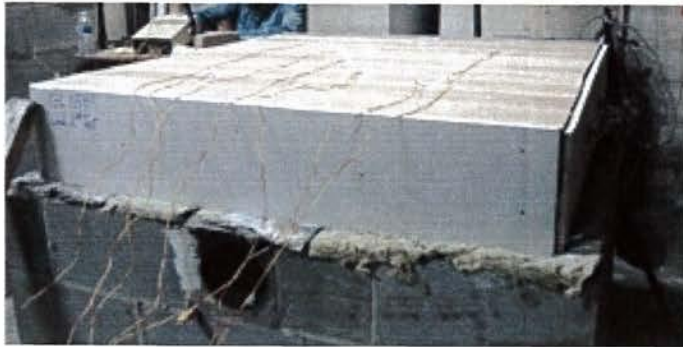
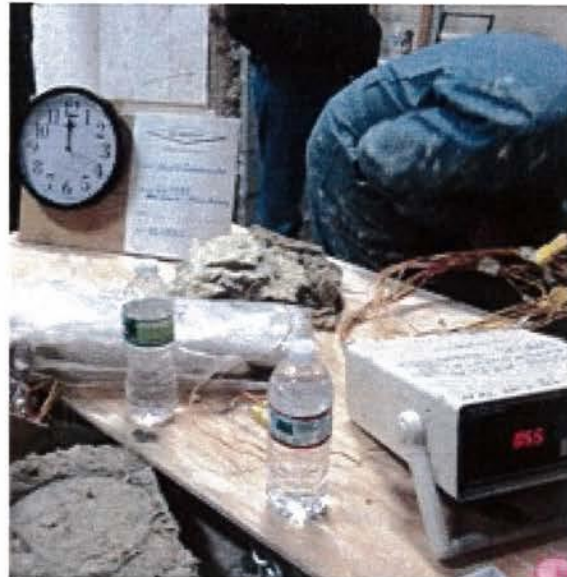
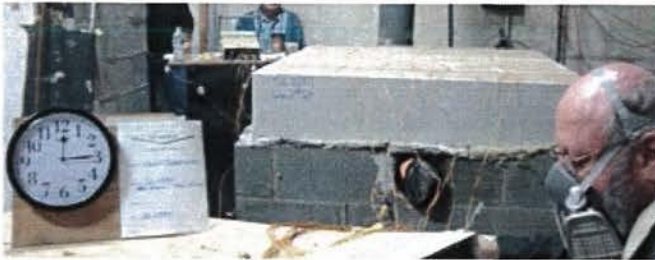
Before Test

Gas on

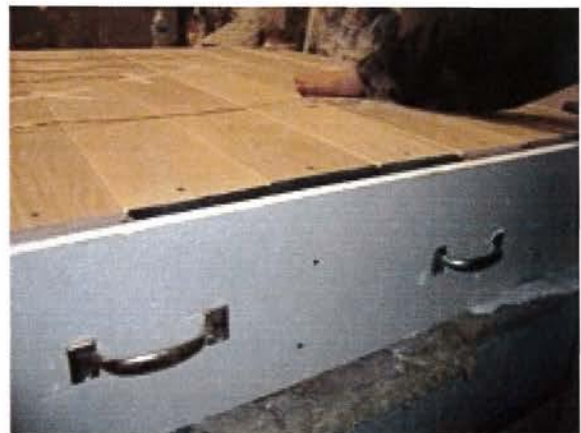
00:35: smoke appears in upper corner

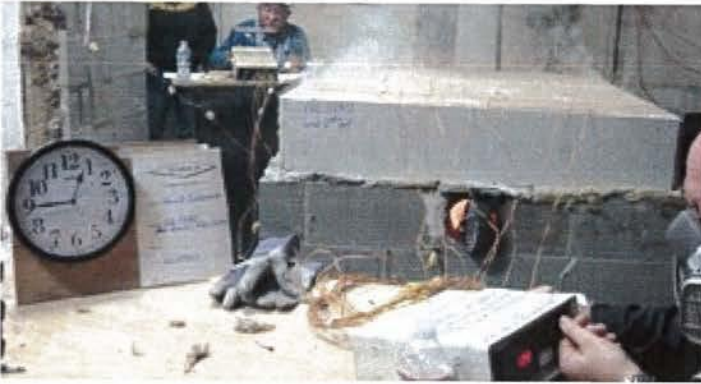
00:36: surface mildly warm to the touch

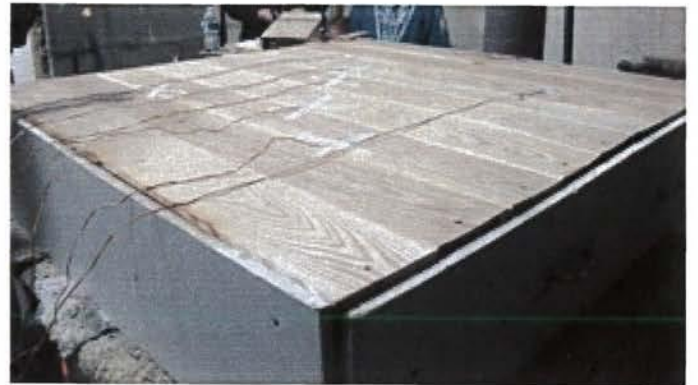
01:05: gas off

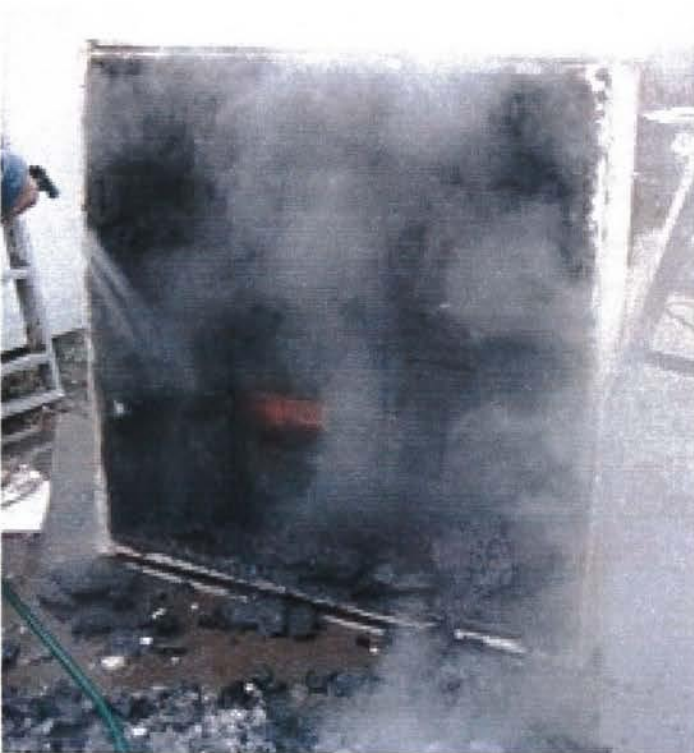
After test: unexposed side—no flame through

Thick chunks of intumesced coating
sprayed off exposed sub-floor & floor
joists.

The 27 mil thickness of ForceField Fireguard E-84 intumescent coating applied to the floor joists and exposed side of the 3/4" Sub-floor resisted flame-through for 60 minutes.

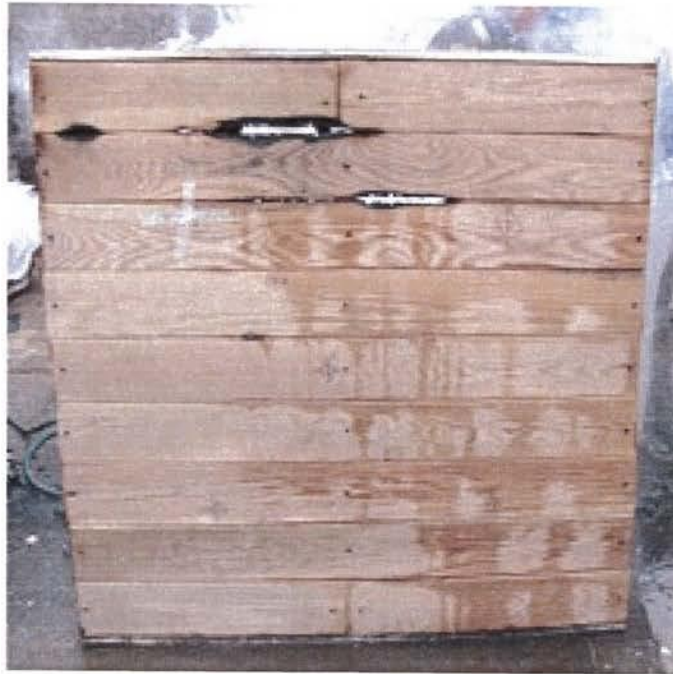
After test: unexposed side

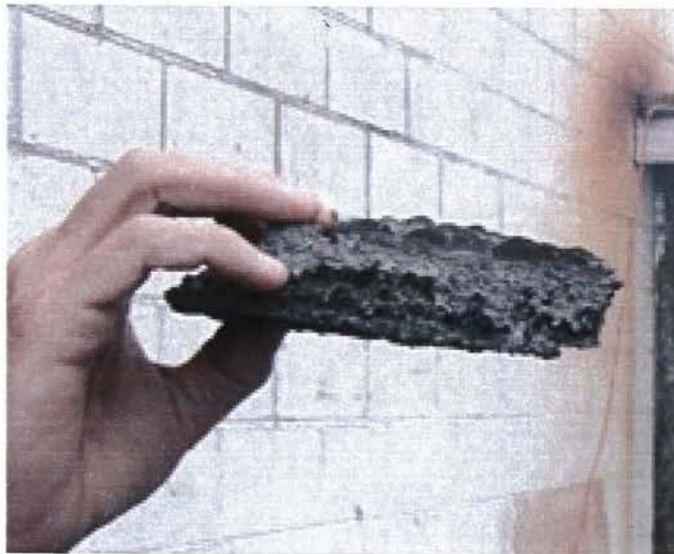
Illustrating thickness of intumesced coating
