Bild Architecture Box 8235
Portland, ME 04104
207.408.0168

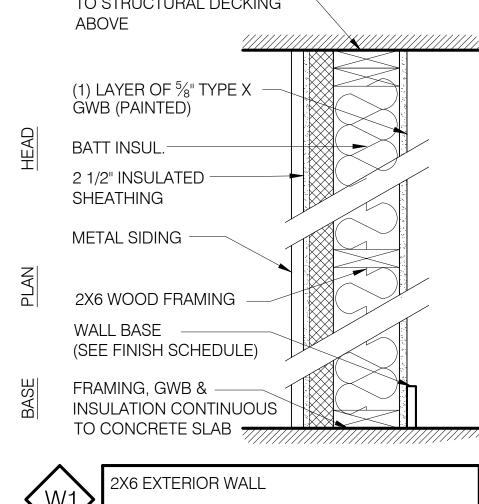
9 5/8" ACTUAL WALL THICKNESS

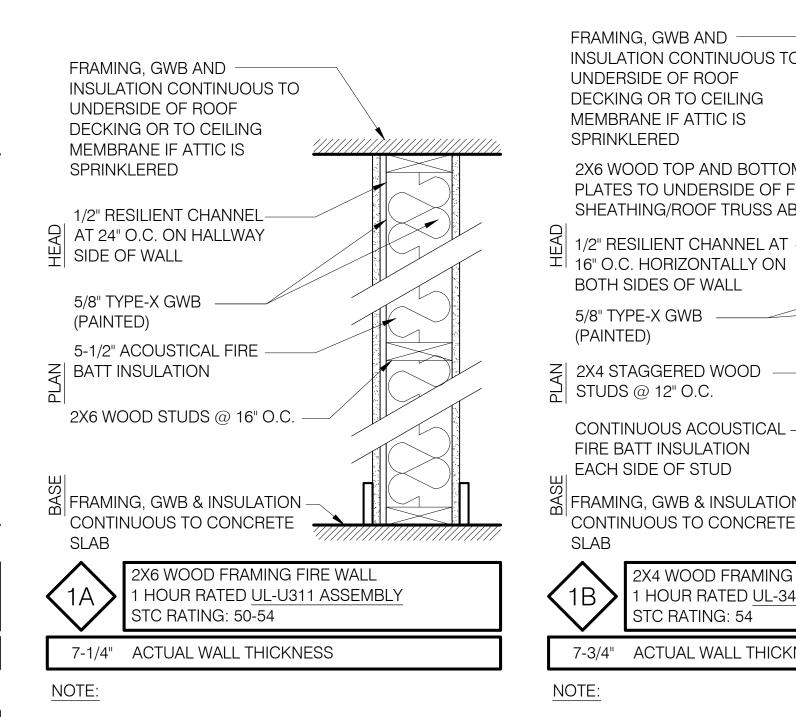
2X4 WOOD FRAMING FIRE WALL

CONTINUOUS ACOUSTICAL

STC RATING: 54

7-3/4" ACTUAL WALL THICKNESS

FIRE BATT INSULATION

EACH SIDE OF STUD

5/8" TYPE-X GWB

INSULATION CONTINUOUS TO

2X6 WOOD TOP AND BOTTOM -

PLATES TO UNDERSIDE OF FLOOR

SHEATHING/ROOF TRUSS ABOVE

1 HOUR RATED UL-340 ASSEMBLY
