TYPICAL NEW FENCE POST DETAILS

LINCOLN PARK IRON FENCE RESTORATION

Project # 17-019 Date: 1/29/18 Issued for: HP REVIEW

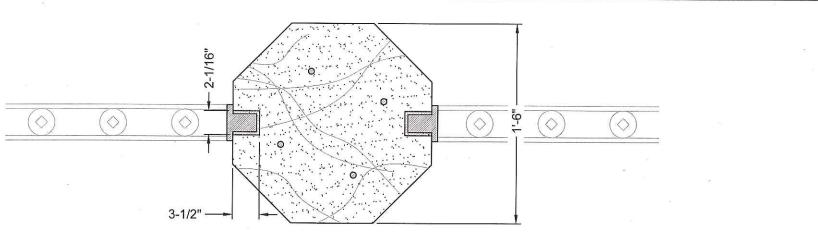
TOP VIEW OF GRANITE POST CAP

NEW REPLICA, OCTAGONAL GRANITE POST CAP. GRANITE TO

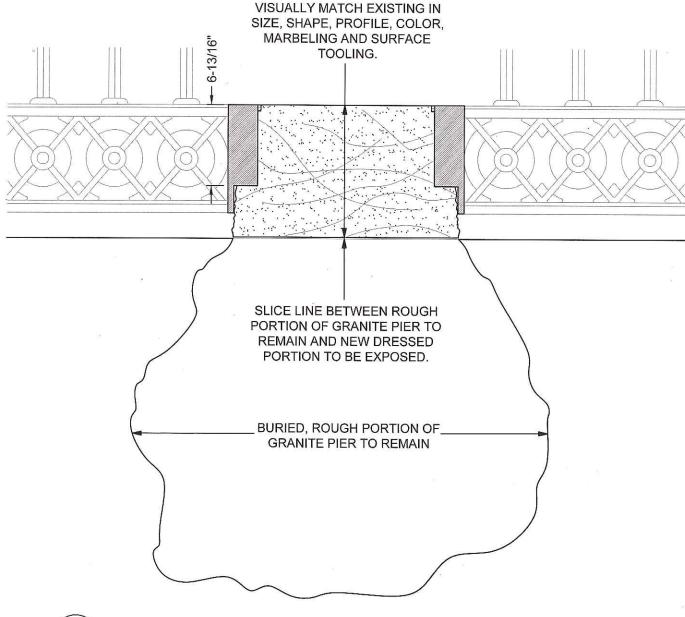
SECTION DETAIL AT NEW GRANITE POST CAP

AFTER OBTAINING SURVEY AND ORDER TO PROCEED WITH DEMOLITION, MASON TO SEVER THE TOP, DRESSED PORTION OF EACH OCTAGONAL GRANITE PIER POST AS INDICATED. THE INTENT IS TO REMOVE THE TOP SECTION AT THE JUNCTURE BETWEEN THE **EXPOSED DRESSED PORTION AND** THE BURIED ROUGH PORTION OF ATTACHED GRANITE FOUNDATION.
