LINCOLN PARK IRON FENCE RESTORATION

GRANITE ENTRY PIER TREATMENTS

Project # 17-019
 Date: 1/29/18
 Issued for: HP REVIEW

SHEET
 S-3.1

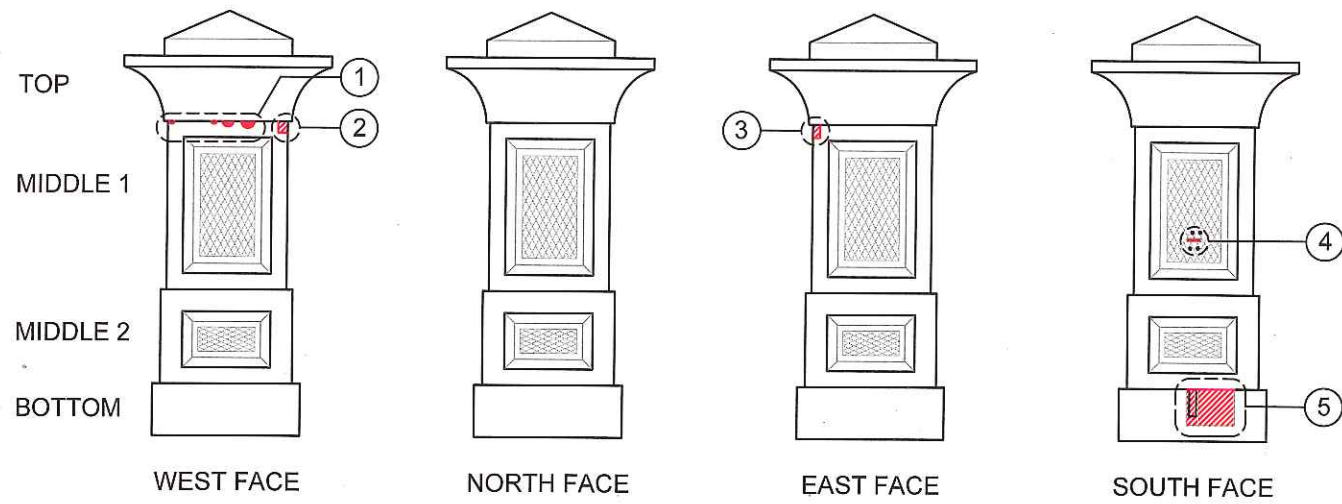
GRANITE ENTRY PIER 1 - REPAIR SCHEDULE								(SEE PHOTOS 1-1 THROUGH 1-8)
NO.	FACE	BLOCK	TYPE	AREA	DEPTH	PINS	PHOTO	
1.	WEST	MIDDLE 1	SECTION REPAIR	7 CUBIC INCHES	N/A	0	1-2 WEST	
2.	WEST	MIDDLE 1	DUTCHMAN REPAIR	3" WIDE X 3" TALL	2"	0	1-2 WEST	
3.	EAST	MIDDLE 1	DUTCHMAN REPAIR	2" WIDE X 4" TALL	2"	0	1-5 EAST	
4.	SOUTH	MIDDLE 1	SECTION REPAIR	4 CUBIC INCHES	N/A	0	1-7 SOUTH	
5.	SOUTH	BOTTOM	DUTCHMAN REPAIR	12" WIDE X 9.5" TALL	4"	0	1-8 SOUTH

1 BASE BID - GRANITE ENTRY PIER - 1
 S3.1 1/4" = 1'-0" (ON 22 X 34 SHEET) LIFT, SHIM AND REPOSITION ENTIRE PIER ASSEMBLY TO SQUARE AND PLUMB.

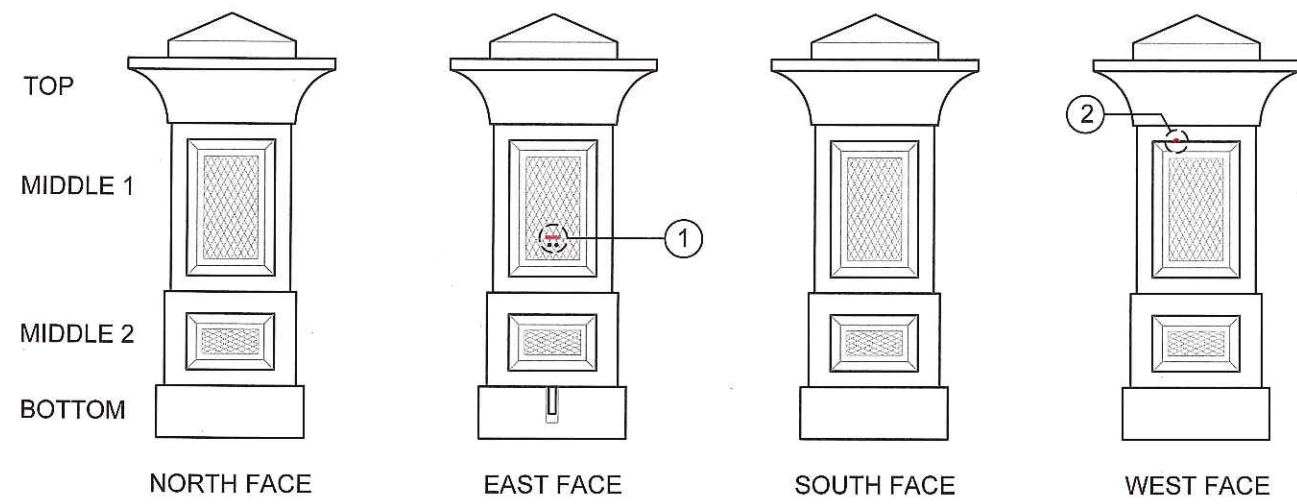
GRANITE ENTRY PIER 2 - REPAIR SCHEDULE								(SEE PHOTOS 2-1 THROUGH 2-9)
NO.	FACE	BLOCK	TYPE	AREA	DEPTH	PINS	PHOTO	
1.	EAST	MIDDLE 1	SECTION REPAIR	2 CUBIC INCHES	N/A	0	2-3 EAST	
2.	WEST	MIDDLE 1	SECTION REPAIR	1 CUBIC INCH	N/A	0	2-8 WEST

2 BASE BID - GRANITE ENTRY PIER - 2
 S3.1 1/4" = 1'-0" (ON 22 X 34 SHEET) LIFT, SHIM AND REPOSITION ENTIRE PIER ASSEMBLY TO SQUARE AND PLUMB.

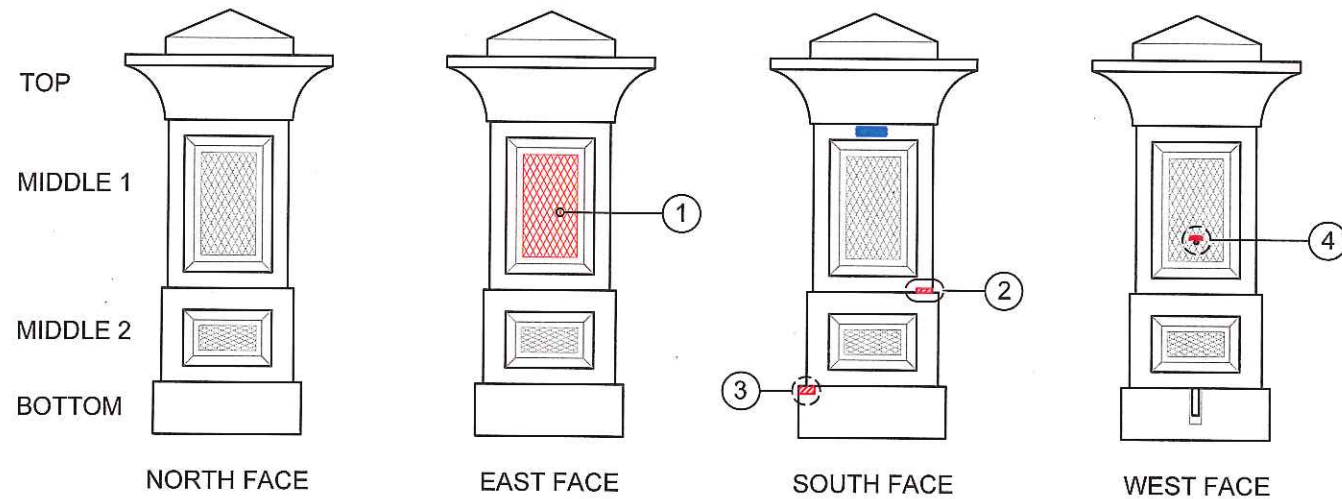
GRANITE ENTRY PIER 3 - REPAIR SCHEDULE								(SEE PHOTOS 3-1 THROUGH 3-9)
NO.	FACE	BLOCK	TYPE	AREA	DEPTH	PINS	PHOTO	
1.	EAST	MIDDLE 1	RETOOL PATTERN	14" WIDE X 26" TALL	3/32"	0	3-3 EAST	
2.	SOUTH	MIDDLE 1	DUTCHMAN REPAIR	4" WIDE X 3" TALL	1"	0	3-6 SOUTH	
3.	SOUTH	BOTTOM	DUTCHMAN REPAIR	4" WIDE X 2" TALL	4"	0	3-6 SOUTH	
4.	WEST	MIDDLE 1	SECTION REPAIR	2 CUBIC INCHES	N/A	0	3-8 WEST

3 BASE BID - GRANITE ENTRY PIER - 3
 S3.1 1/4" = 1'-0" (ON 22 X 34 SHEET) LIFT, SHIM AND REPOSITION ENTIRE PIER ASSEMBLY TO SQUARE AND PLUMB.

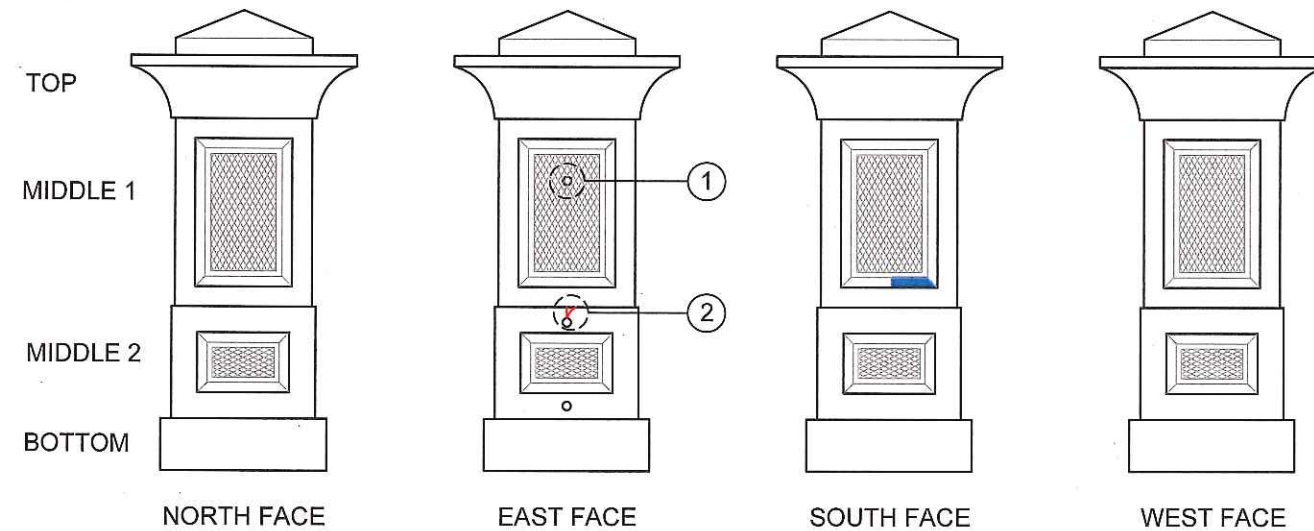
GRANITE ENTRY PIER 4 - REPAIR SCHEDULE								(SEE PHOTOS 4-1 THROUGH 4-11)
NO.	FACE	BLOCK	TYPE	AREA	DEPTH	PINS	PHOTO	
1.	EAST	MIDDLE 1, 2	CLEAN ANCHOR HOLE	(3) - 2" DIAMETER	12"	0	4-4 EAST	
2.	EAST	MIDDLE 2	CRACK REPAIR	4" WIDE X 3" TALL	1"	0	4-5 EAST

4 BASE BID - GRANITE ENTRY PIER - 4
 S3.1 1/4" = 1'-0" (ON 22 X 34 SHEET) LIFT, SHIM AND REPOSITION ENTIRE PIER ASSEMBLY TO SQUARE AND PLUMB.
