ADDENDA SET: AUGUST 04, 2014
BUILDING PERMIT SET: JULY 01, 2013

ANTHROPOLOGIE
66 PEARL STREET
PORTLAND, MAINE

EXISTING CONDITIONS

EC-1.1

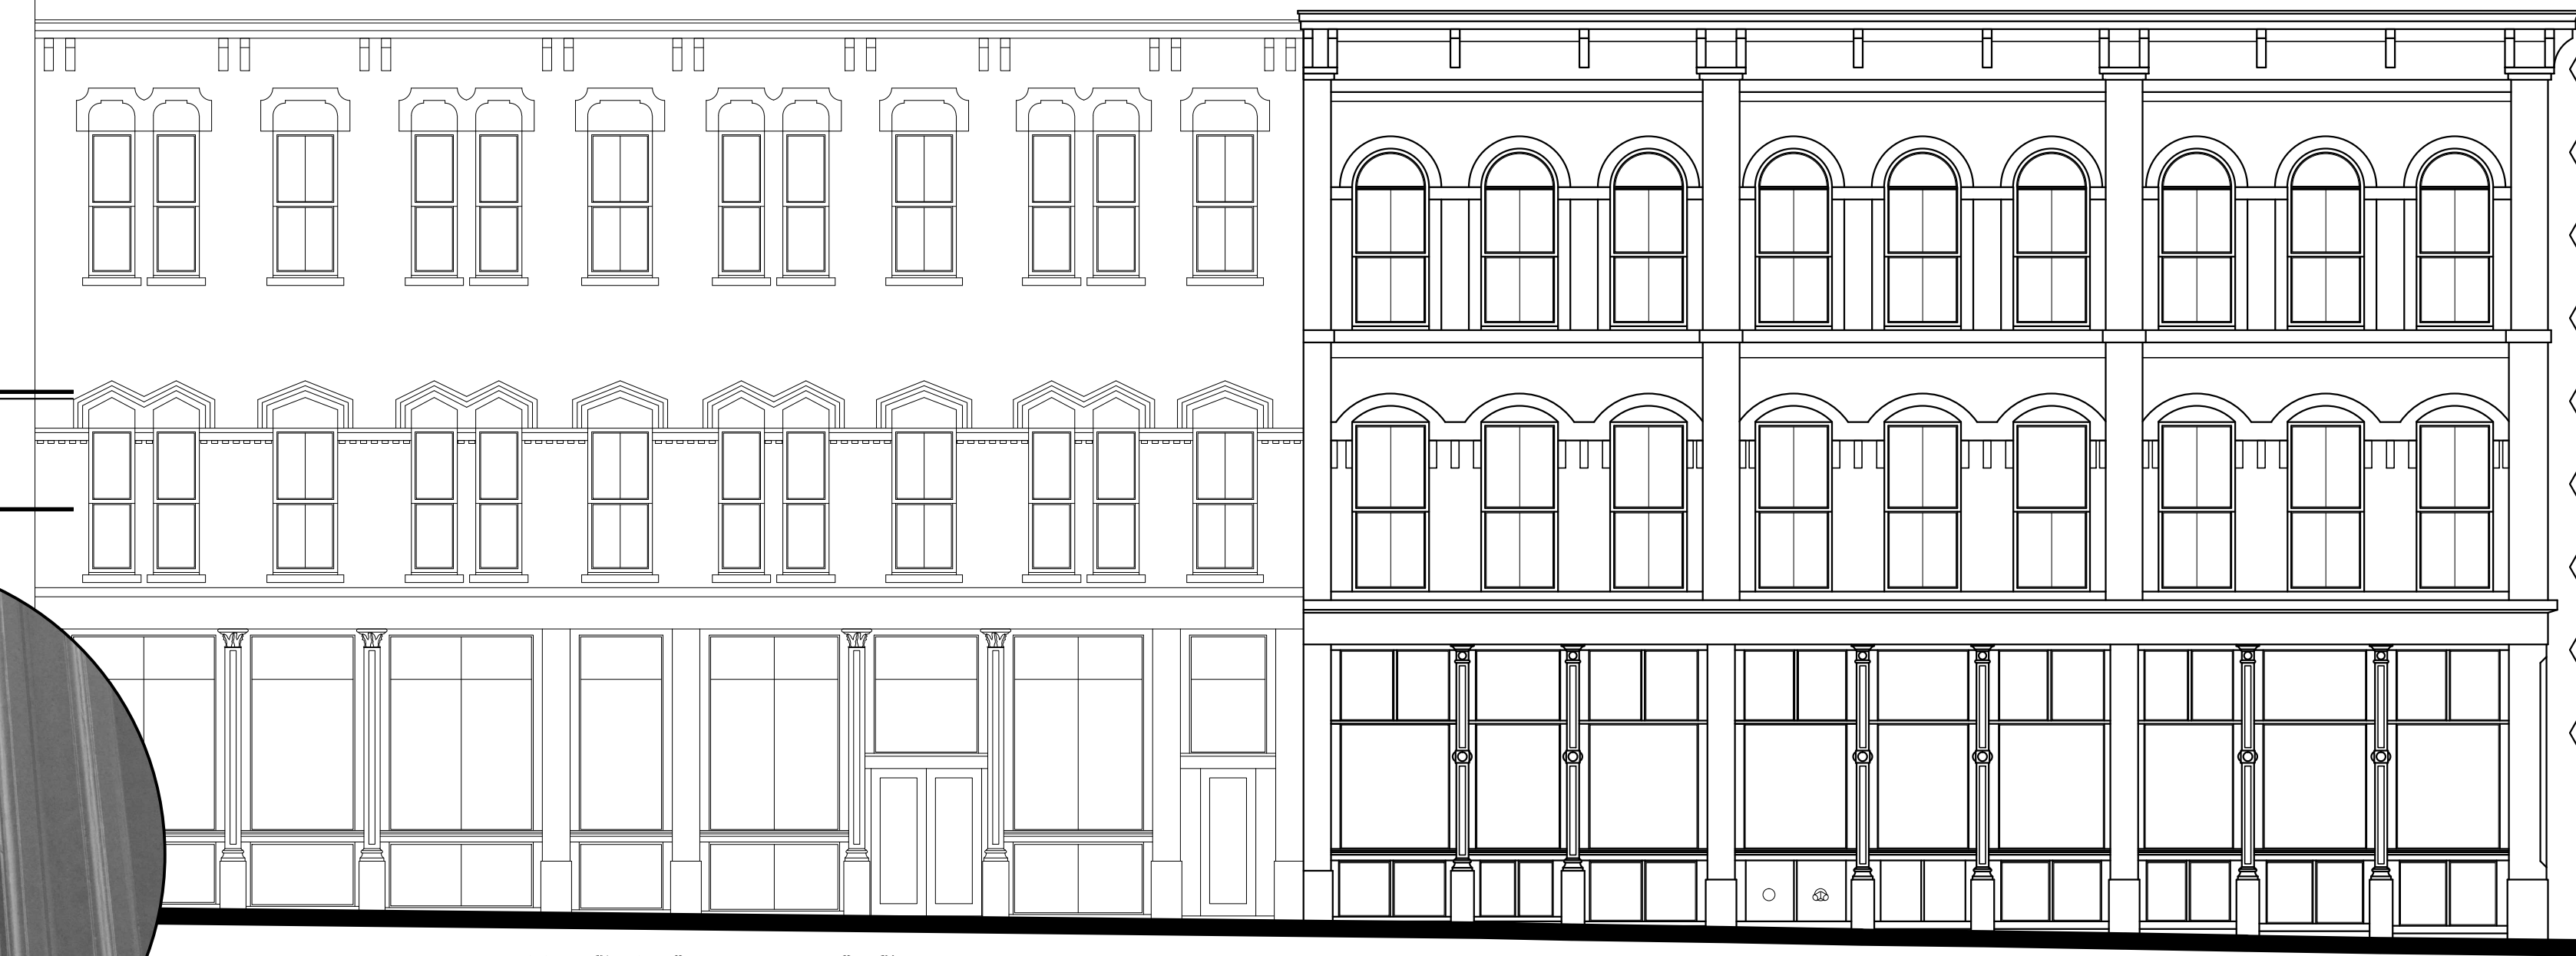
EXISTING ELEVATION
1/8"=1'-0"

- (A) GRANITE PIERS TO REMAIN
- (B) METAL DECORATIVE COLUMNS WITH GRANITE BASES TO REMAIN
- (C) GLASS STOREFRONT TO REMAIN, TYP.
- (D) GLASS STOREFRONT TO BE REMOVED
- (E) GRANITE FREEZE TO REMAIN
- (F) NO WORK AT BRICK FACADE
- (G) EXISTING FIRE DEPARTMENT CONNECTION EQUIPMENT TO REMAIN
- (H) PRESERVE GRANITE BASES, TYP.
- (I) EXISTING PANEL MOTIF TO BE REMOVED

BERRY SHOE BLOCK **EMERY WATERHOUSE BLOCK**

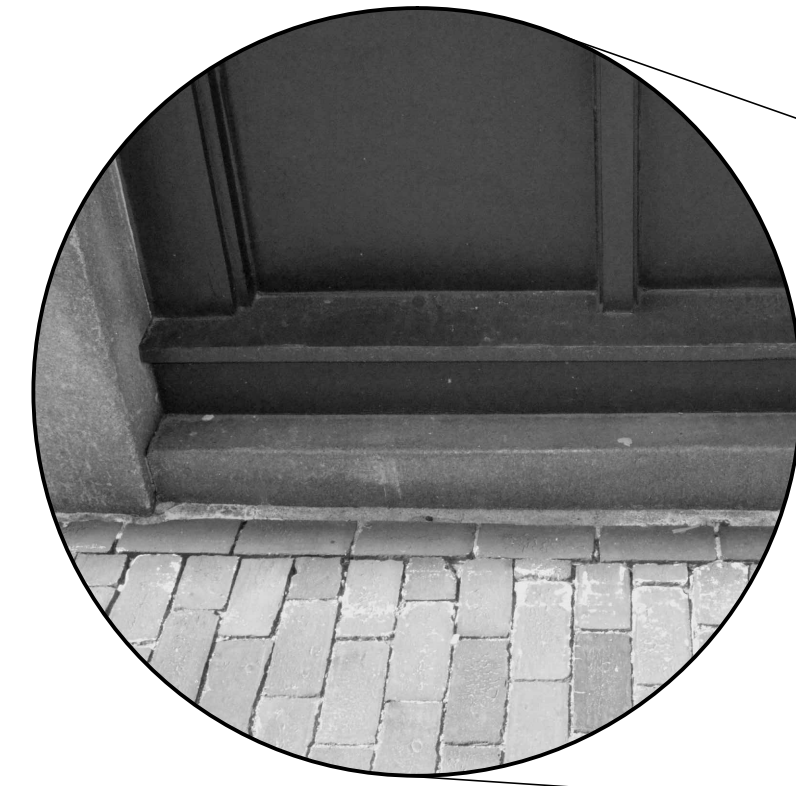
EXISTING WALL SECTION
3/4"=1'-0"

EXISTING FLOOR SYSTEM

EXISTING GRANITE STEPS AS PART OF ORIGINAL FACADE ENTRY

EXISTING SIDEWALK W/ 'OLD PORT' BRICK PAVERS
