BERRY SHOE BLOCK
 66 PEARL STREET
 PORTLAND, MAINE

ENTRY DOOR VESTIBULE:

EXISTING CONDITIONS
 & DEMOLITION

EC-1.2

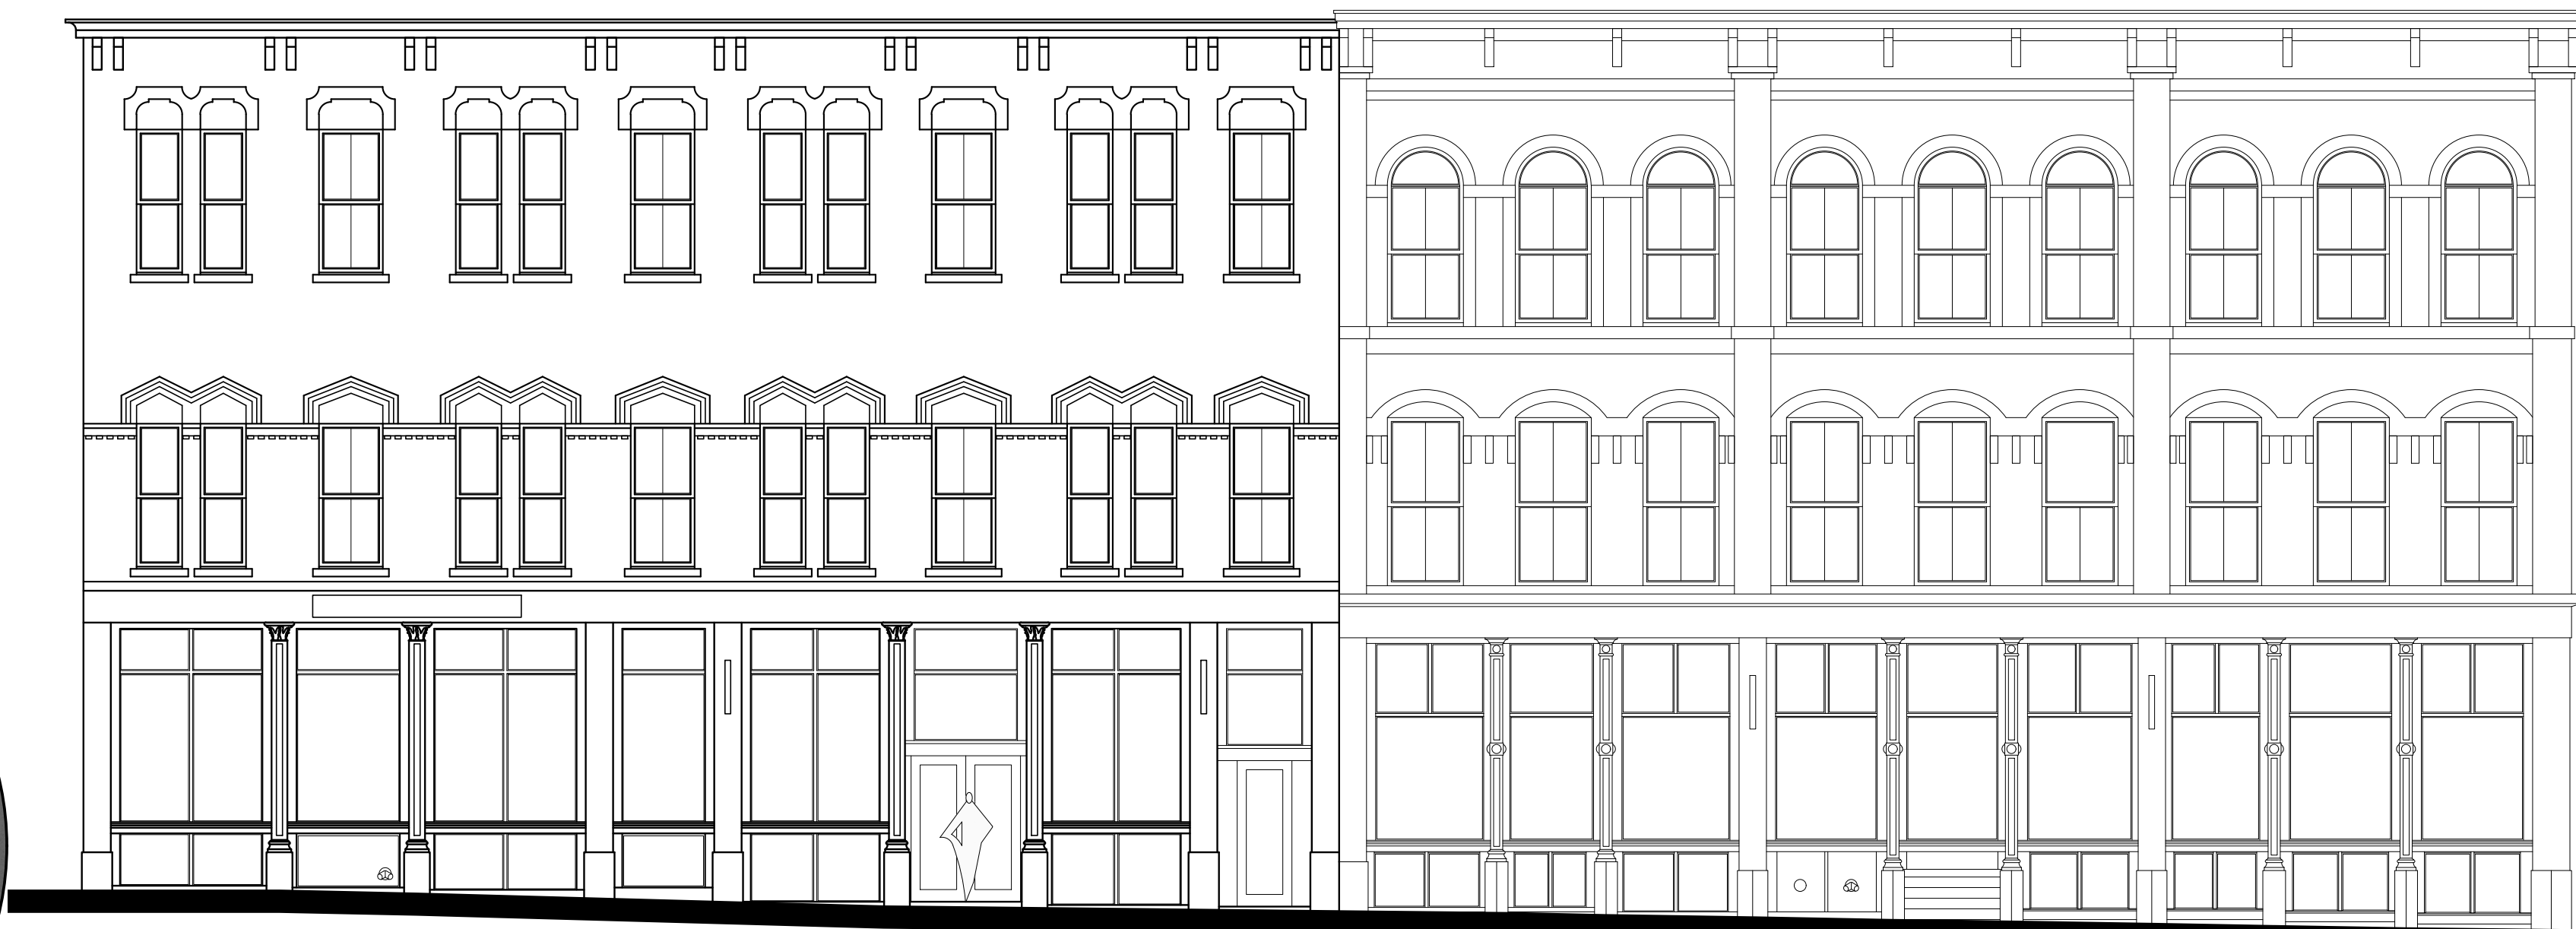
EXISTING ELEVATION
