GEOTECHNICAL REPORT

**50 - 62 INDIA STREET
PORTLAND, MAINE**

GSI Project No. 212234A

**RE: Geotechnical Report Addendum
Proposed Residential Development
50-62 India Street
Portland, ME**

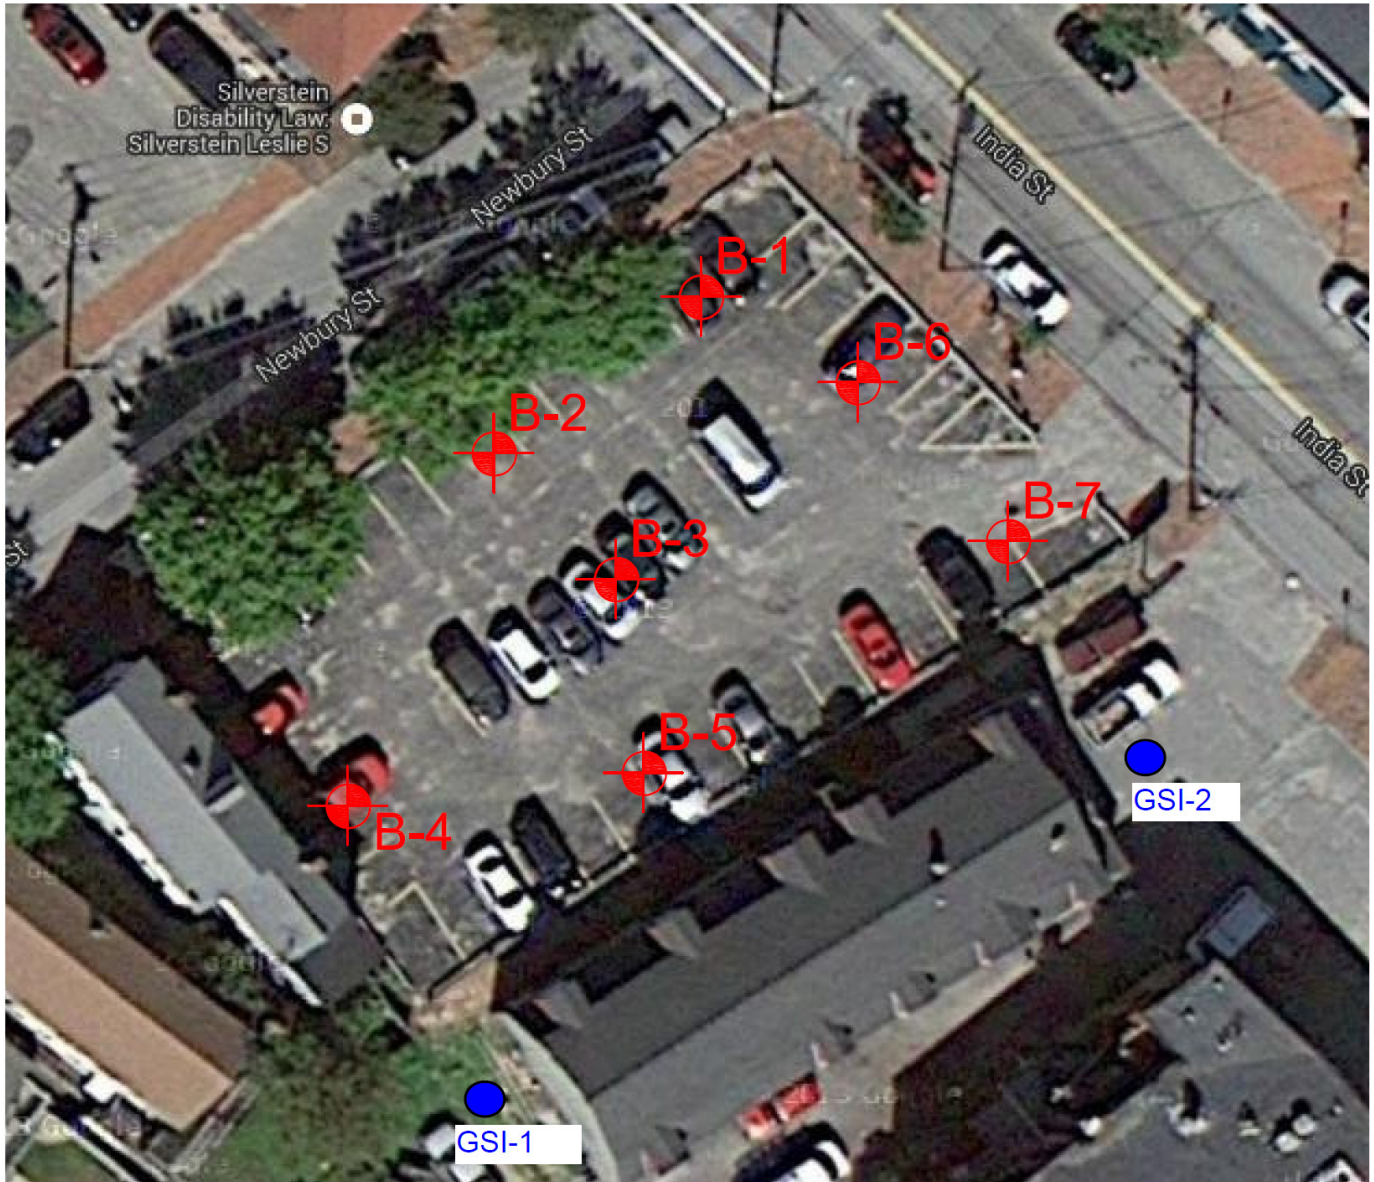
GSI-1 Test Boring Location (Approximate)

During the supplemental exploration program two, 2.8-inch diameter undisturbed shelly tube samples were retrieved using a standard push sampler. The samples were retrieved within the cohesive silty clay deposit at varying depths. The shelly tube samples were sealed within the tube with wax upon removal from the ground to protect against moisture loss. All samples were transported in an upright position such that minimal disturbance was imparted to the tube. The exploration locations were determined in the field by taping from existing site features. The test boring locations are illustrated on Figure 2.

1. Review of available project plans and documents.
2. Coordination and observation of test borings at the locations illustrated on Figure 2.
The soil exploration program was observed by a field representative from GSI.
3. Preparation of recommendations for foundation support of the proposed structure, including estimated bearing capacity and settlement values.
4. Preparation of recommendations regarding seismic considerations for the site and the proposed development.

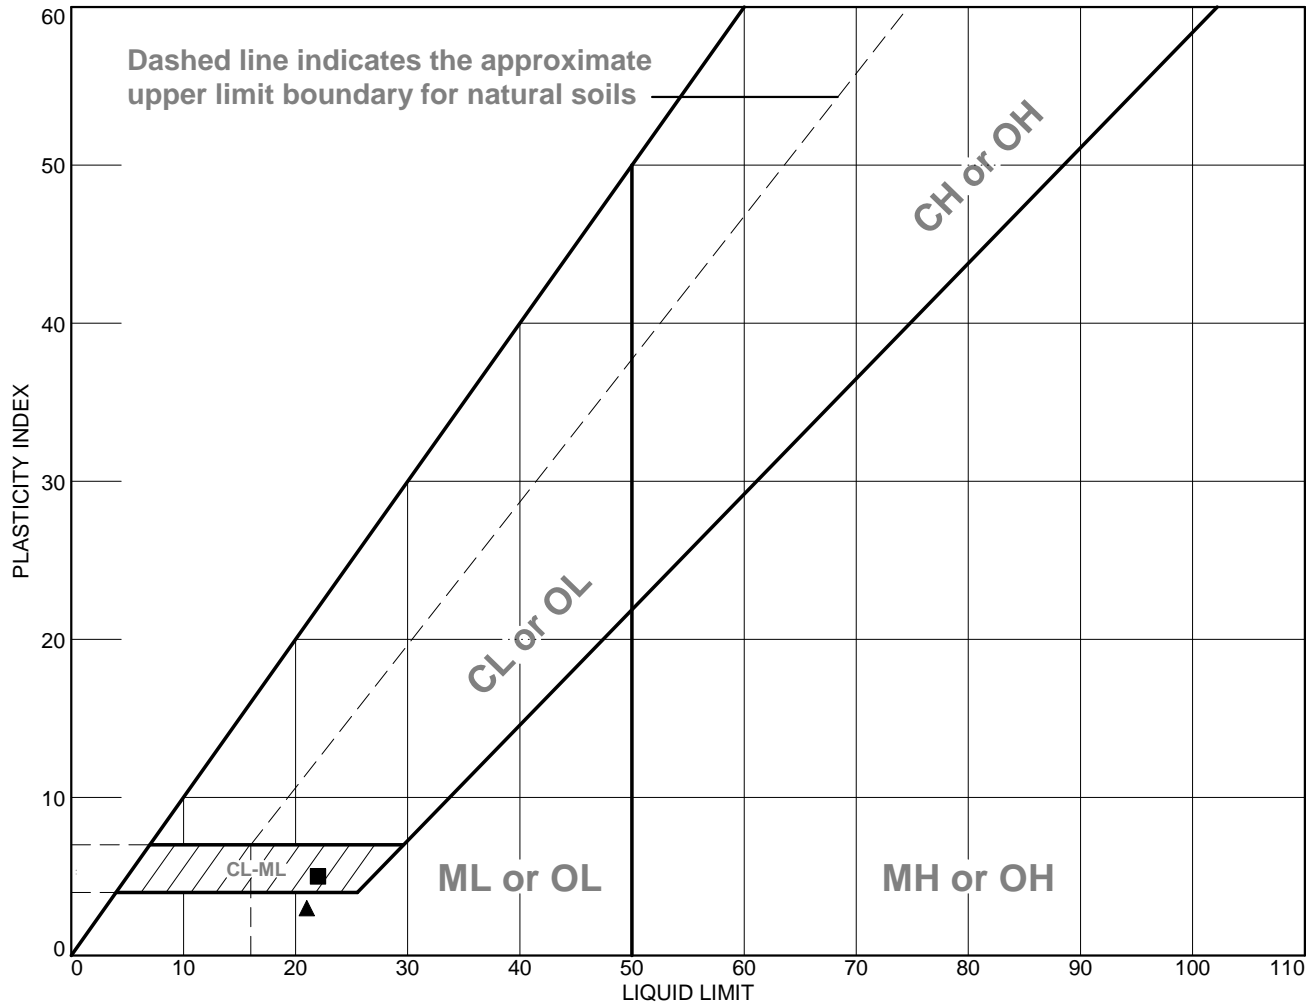
LIQUID AND PLASTIC LIMITS TEST REPORT

MATERIAL DESCRIPTION	LL	PL	PI	%<#40	%<#200	USCS
●		NV	NP	NP			
■		22	17	5			
▲		21	18	3			
◆		NV	NP	NP

Four Atterberg limit tests per ASTM-D 4318 were performed in order to determine the liquid limit (LL), plastic limit (PL) and natural moisture content (W_n) of the sample tested. From these values the plasticity index (PI) can be determined and this value is used to infer soil properties, particularly as they relate to published values for the Presumptscott Formation. In addition, moisture content determinations were performed to compare the insitu conditions to the Atterberg Limits particularly with respect to the liquid limit.

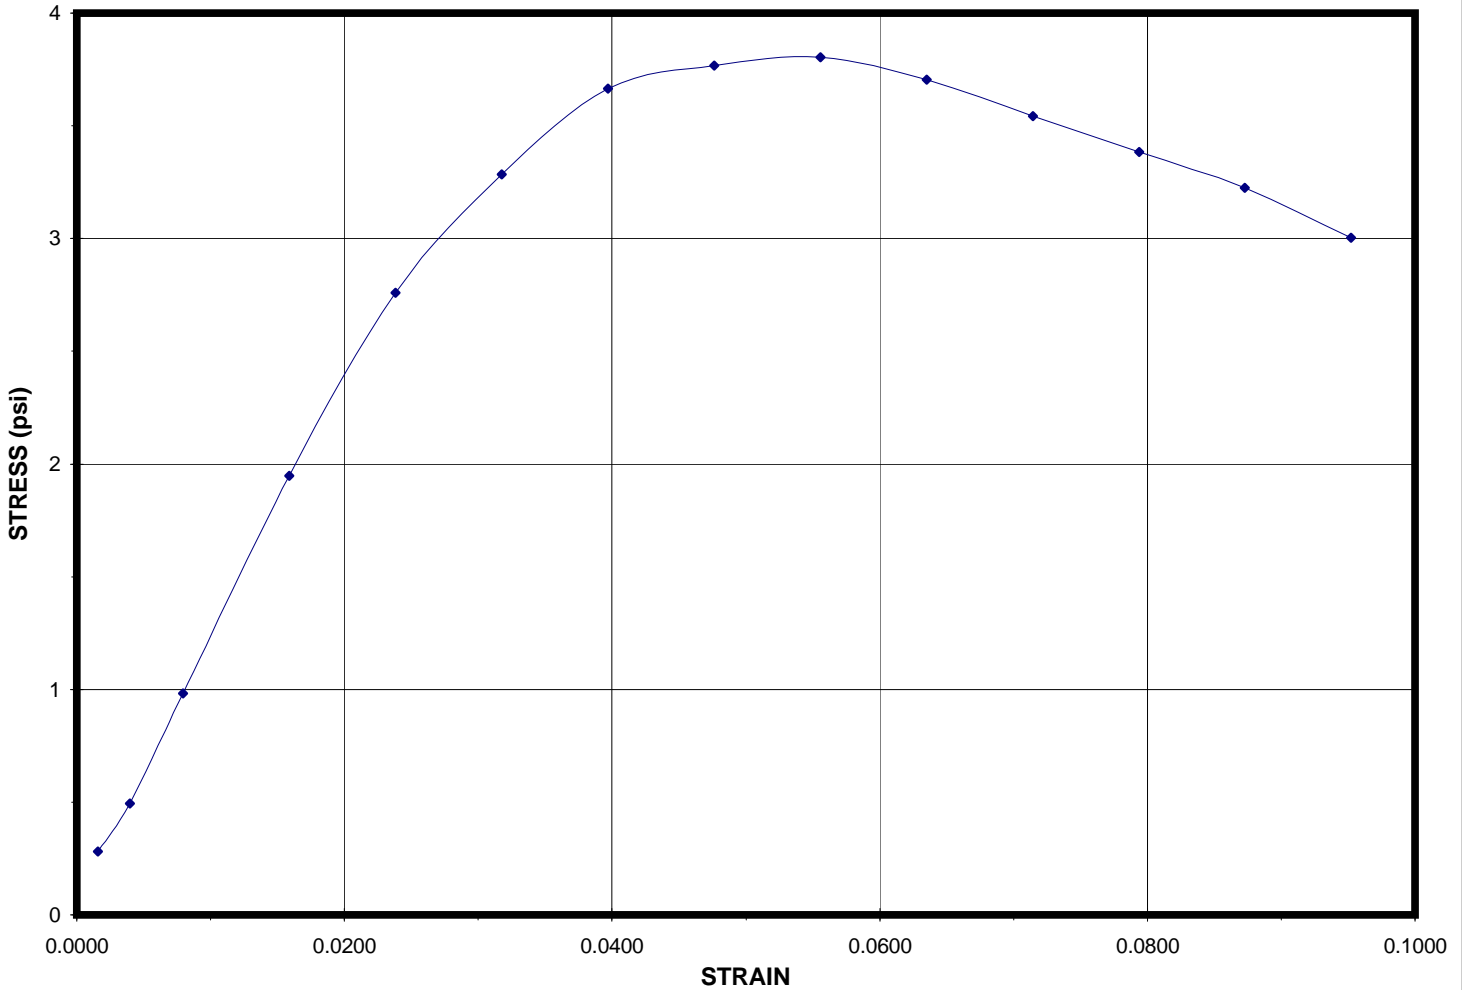
UNCONFINED COMPRESSIVE STRENGTH
STRESS vs. STRAIN

Unconfined Compressive Strength (psi) / (psf)= 3.8

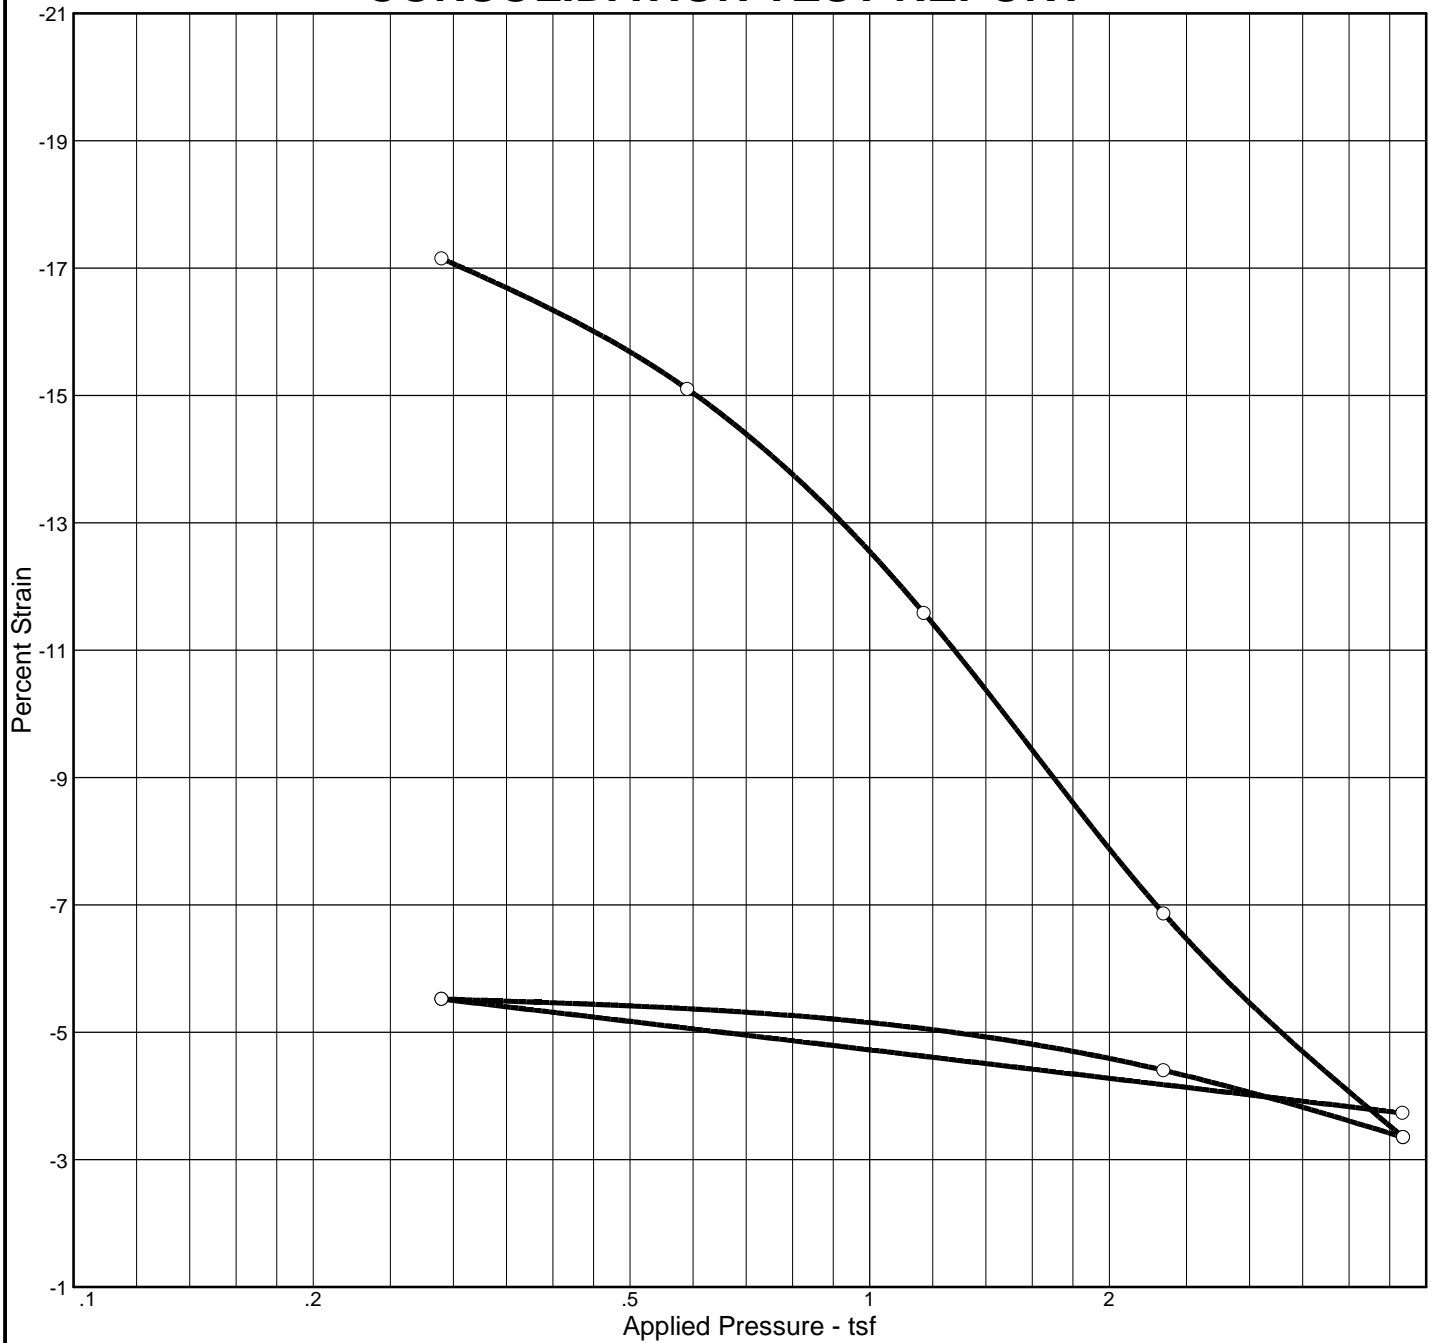
CONSOLIDATION TEST REPORT

Natural	Dry Dens. (pcf)	LL	PI	Sp. Gr.	Overburden (tsf)	P_c (tsf)	C_c	C_r	Initial Void Ratio
Saturation									
		22	5			0.34

Project No. 214131 Client: Atlas Investment Group Project: India Road 62 Portland, Maine Location: GSI-1	Remarks: L-146-16 A
GEOTECHNICAL SERVICES, INC. Weare, New Hampshire	
Plate

GSI modeled and analyzed the anticipated foundation settlements based on loading from the foundation loads based on an 8 foot square footing with an allowable bearing pressure of 3000 pounds per square foot. The calculated primary consolidation settlement for the model is estimated to be 5 to 8 inches. Secondary compression is based on a 100 year design life and the resulting settlement from secondary compression is calculated to be 0.2 inches. This estimate was determined by obtaining the coefficient of secondary compression from the time versus deformation graphs created during the consolidation tests. The coefficient of secondary compression appeared comparable to published values for coefficient of secondary compression versus natural water content (Mesri, 1971).

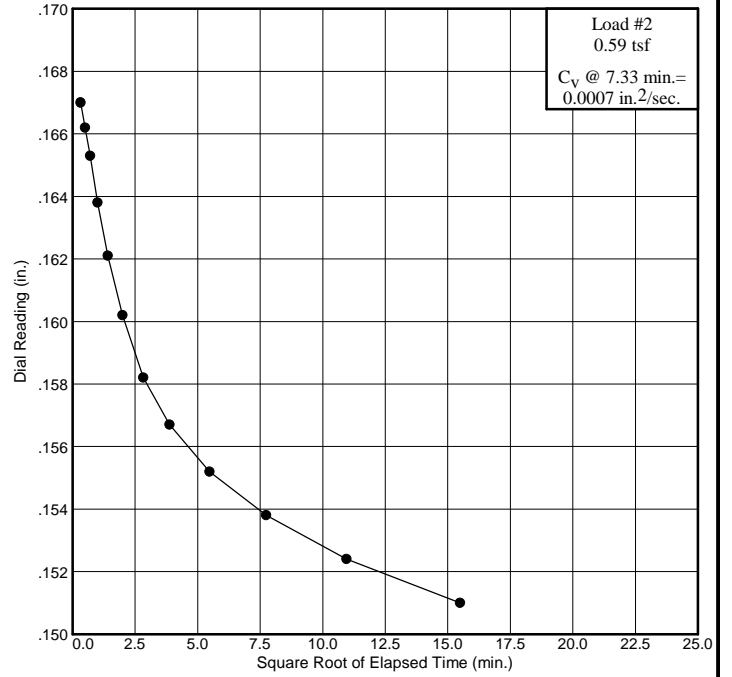
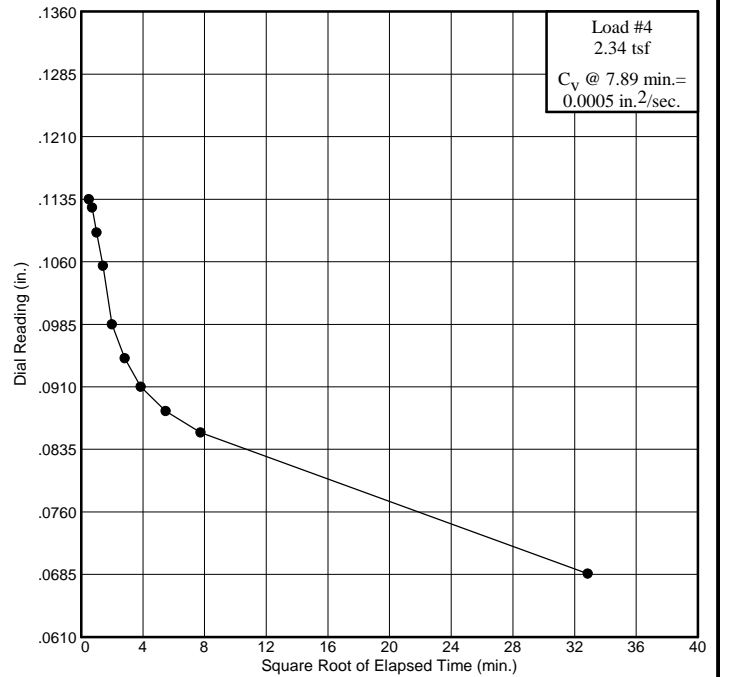
Dial Reading vs. Time

Project No.: 214131
 Project: India Road 62
 Portland, Maine
 Location: GSI-1

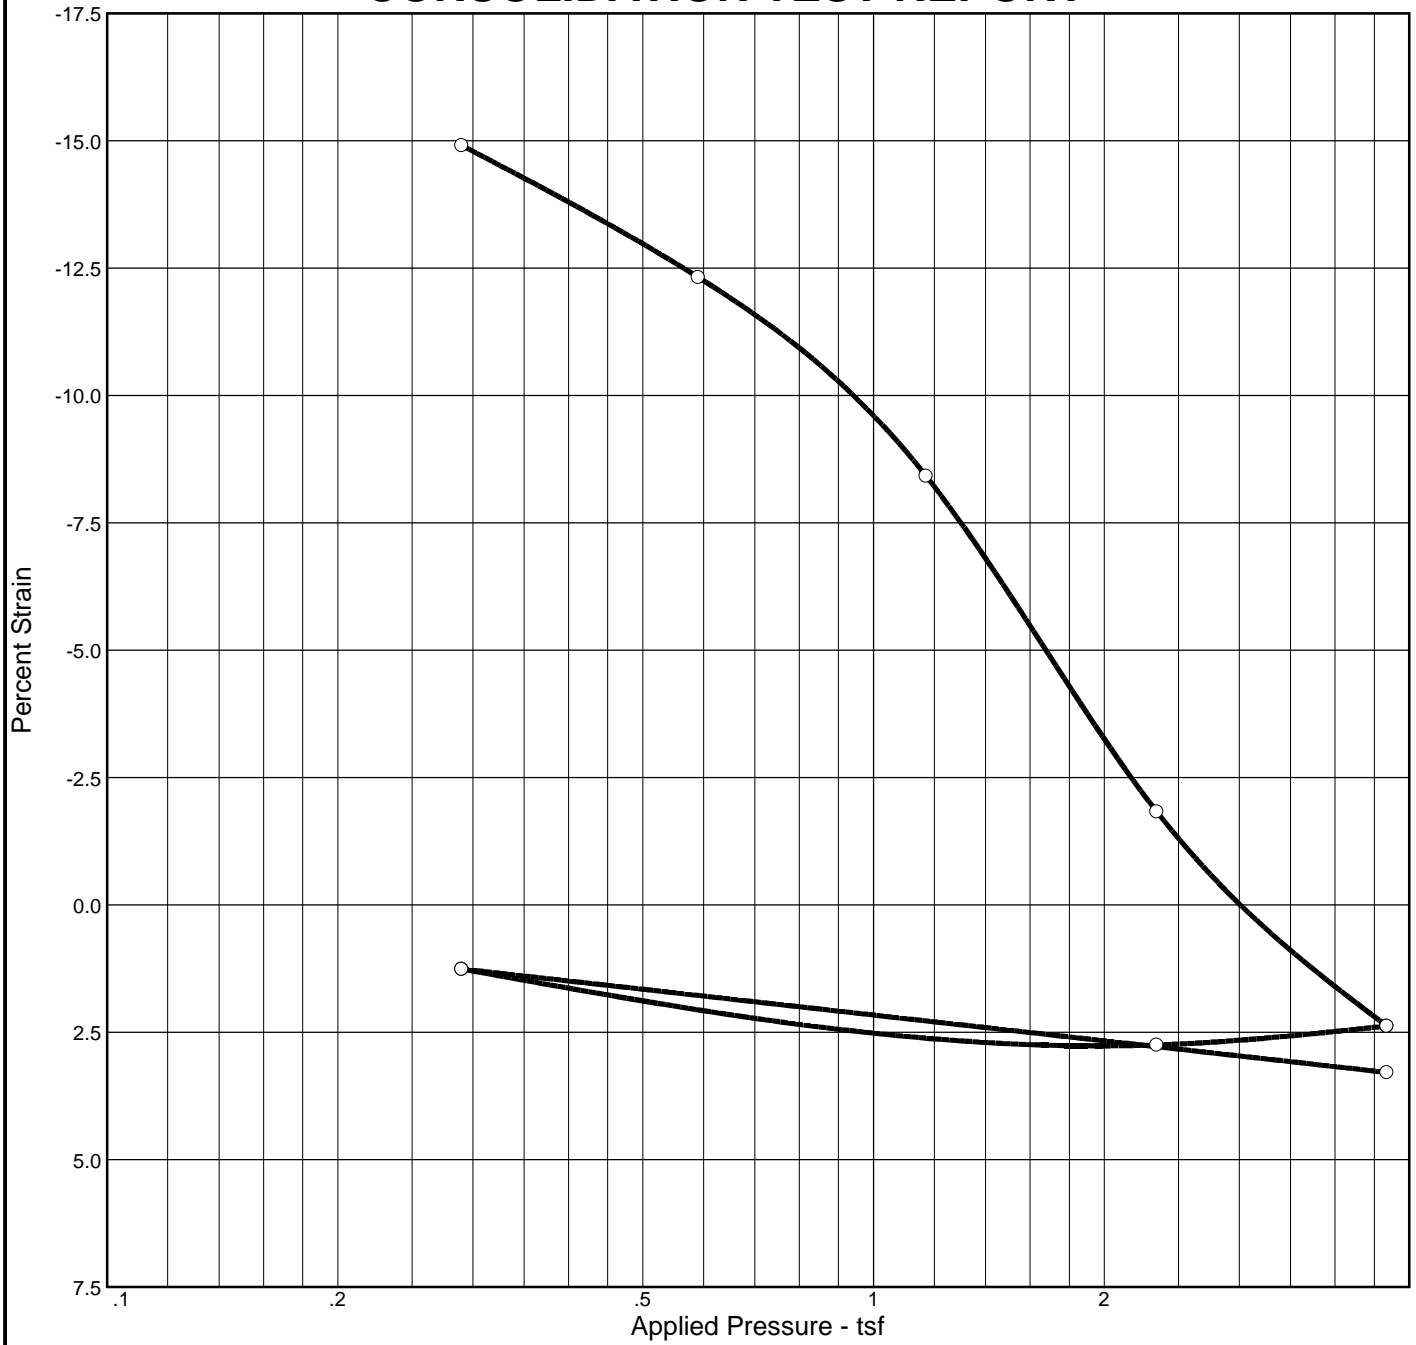
CONSOLIDATION TEST REPORT

Natural	Dry Dens. (pcf)	LL	PI	Sp. Gr.	Overburden (tsf)	P_c (tsf)	C_c	C_r	Initial Void Ratio
Saturation									
		21	3			0.28

Project No. 214131 Client: Atlas Investment Group Project: India Road 62 Portland, Maine Location: GSI-1	Remarks: L-146-16 B
GEOTECHNICAL SERVICES, INC. Weare, New Hampshire	
Plate

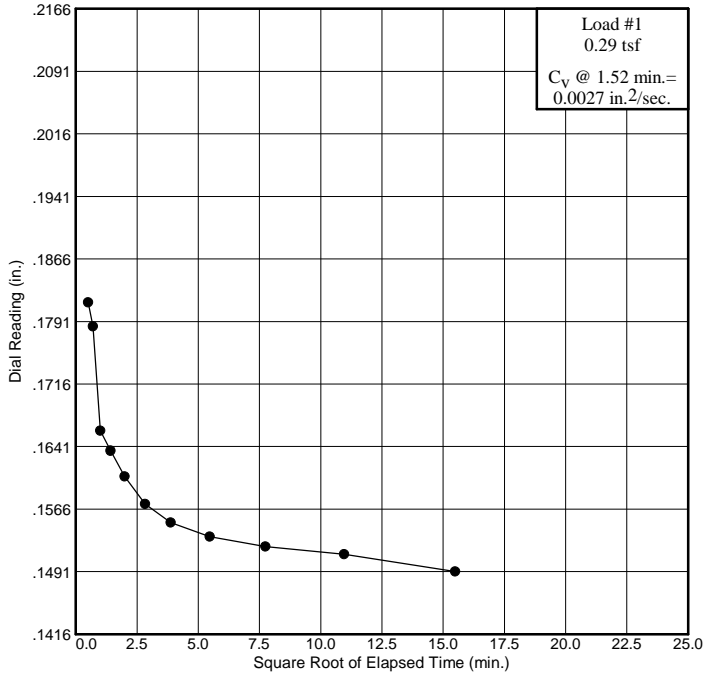
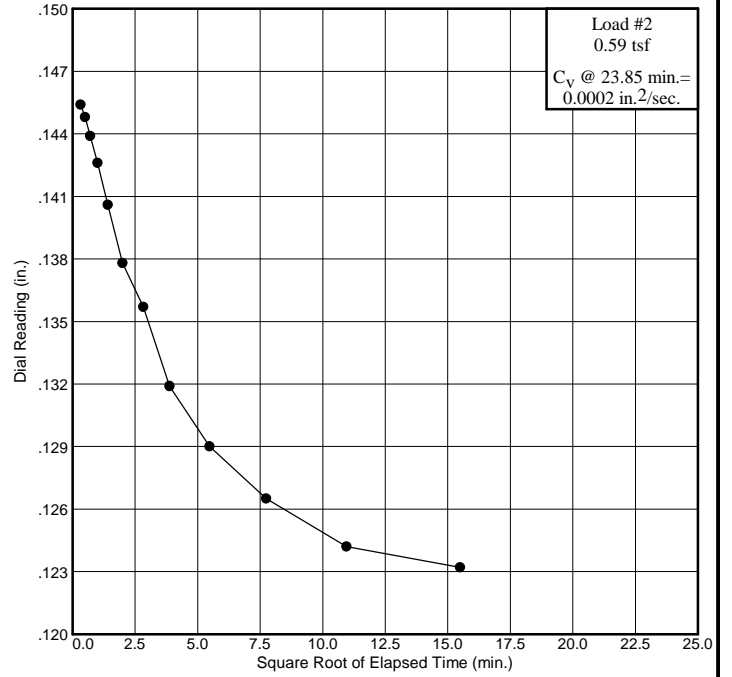
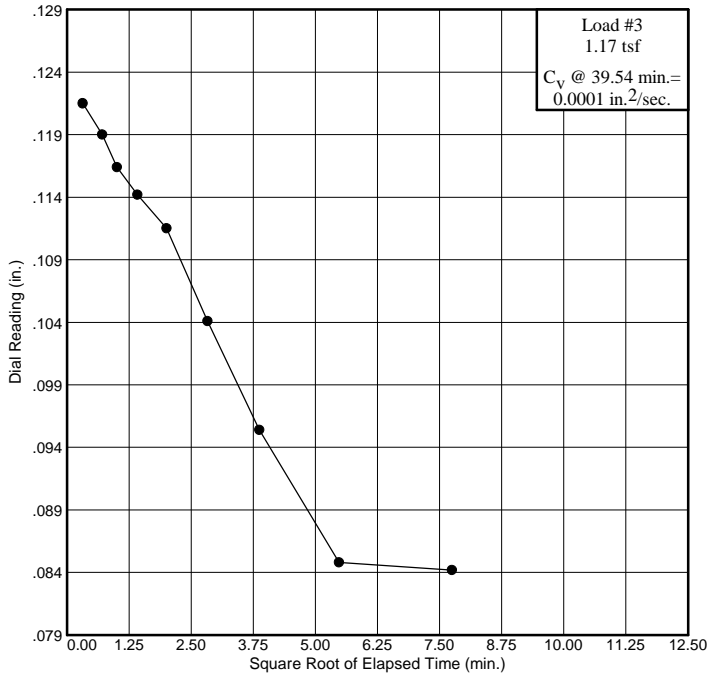
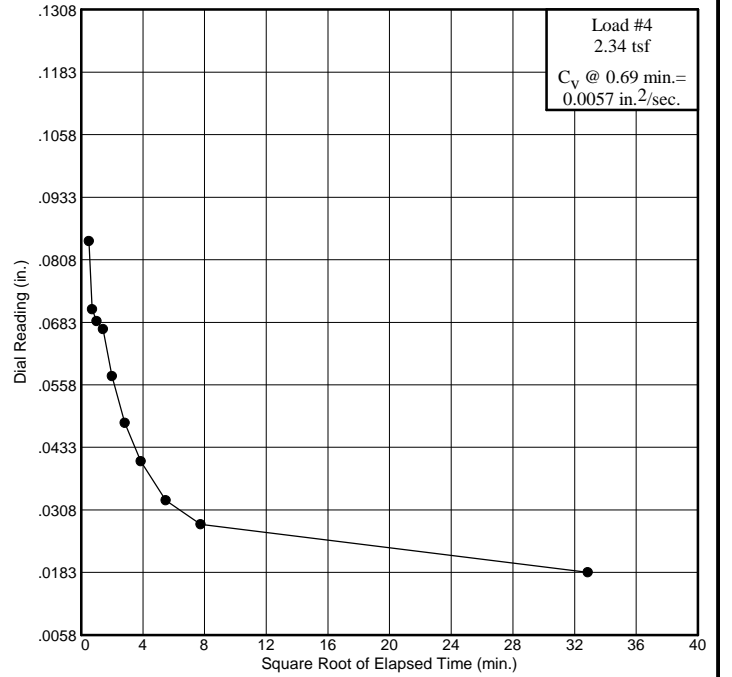
Dial Reading vs. Time

Project No.: 214131
 Project: India Road 62
 Portland, Maine
 Location: GSI-1

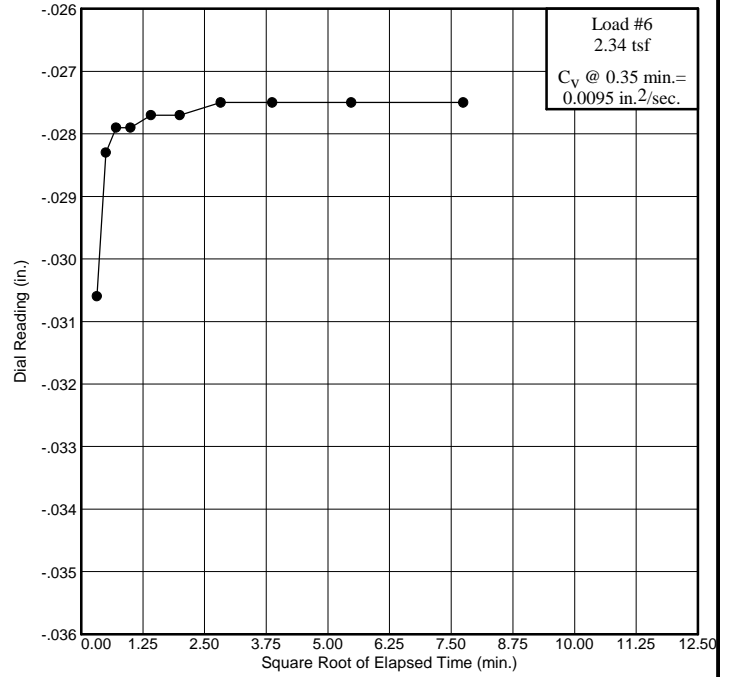
Dial Reading vs. Time

Project No.: 214131
 Project: India Road 62
 Portland, Maine
 Location: GSI-1

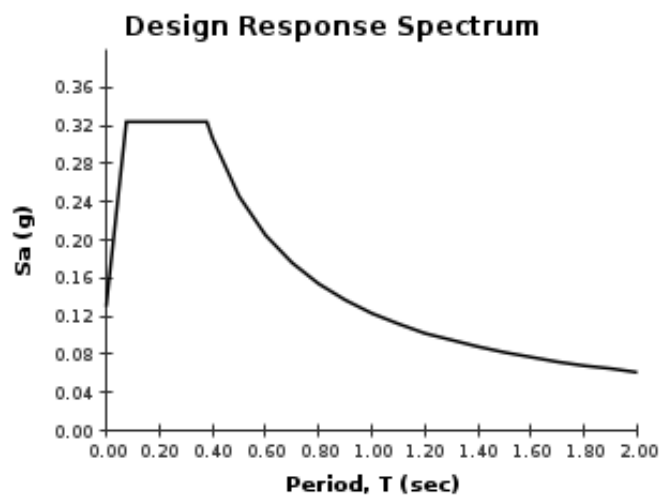
USGS-Provided Output

$S_s = 0.314 \text{ g}$ $S_{MS} = 0.486 \text{ g}$ $S_{DS} = 0.324 \text{ g}$
 $S_1 = 0.077 \text{ g}$ $S_{M1} = 0.184 \text{ g}$ $S_{D1} = 0.123 \text{ g}$
