RENOVATION TO
FUJI RESTAURANT
29 EXCHANGE STREET
PORTLAND, MAINE 04101

EXISTING
CONDITIONS &
DEMOLITION PLAN

AD-1

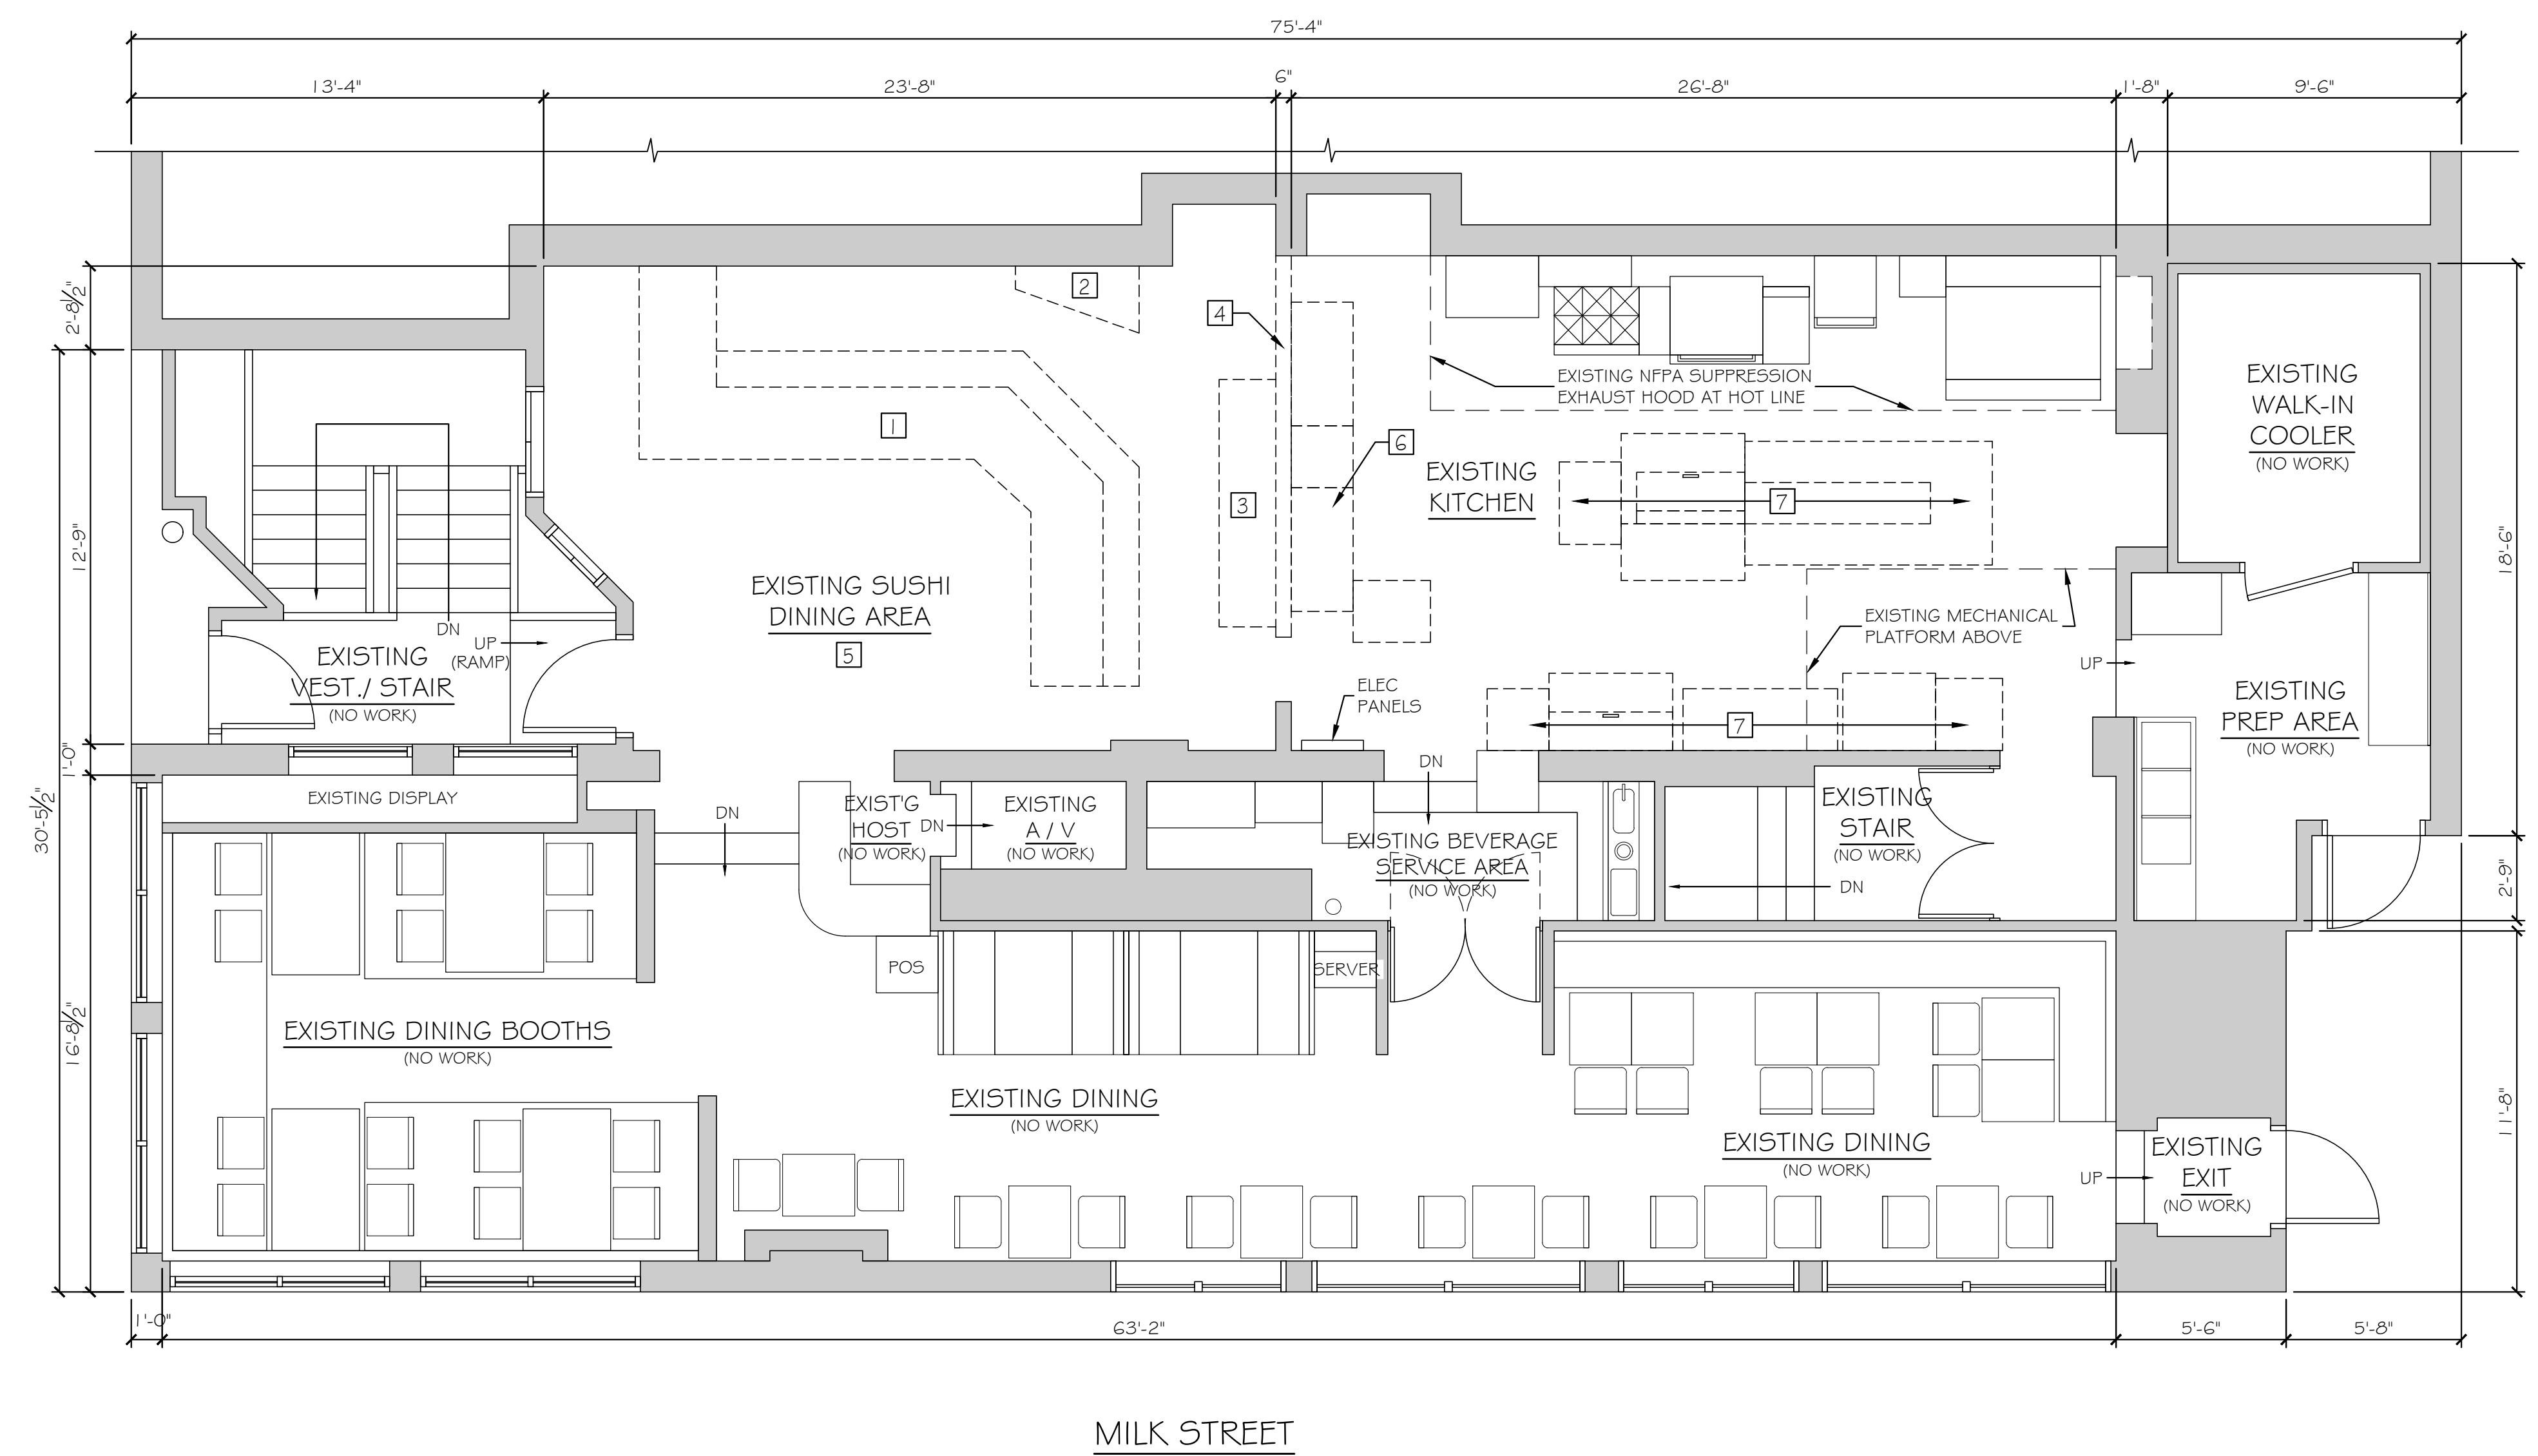
EXISTING CONDITIONS / DEMOLITION PLAN

- 1 REMOVE EXISTING SERVING COUNTER AND RELATED SUPPORTS, RESTAURANT EQUIPMENT TO BE REMOVED & SALVAGED BY OWNER.
- 2 REMOVE STORAGE CASEWORK.
- 3 REMOVE STORAGE CASEWORK, RESTAURANT EQUIPMENT AND AV UNITS TO BE REMOVED & SALVAGED BY OWNER.
- 4 REMOVE NON-LOAD BEARING PARTITION.
- 5 REMOVE SUSPENDED CEILING (+/- 9'-0" A.F.F.) COORDINATE RECONFIGURATION OF PIPES / DUCTWORK / SPRINKLERS FOR NEW FINISHES.
- 6 OWNER TO REMOVE & SALVAGE DISHWASHING EQUIPMENT. COORDINATE PLUMBING REQUIREMENTS.
- 7 OWNER TO REMOVE & SALVAGE EXISTING RESTAURANT EQUIPMENT (COOLERS, SHELVING, ETC.)
