FACADE RENOVATION NOTES:

Port Property
MANAGEMENT

MARK
MUELLER
ARCHITECTS

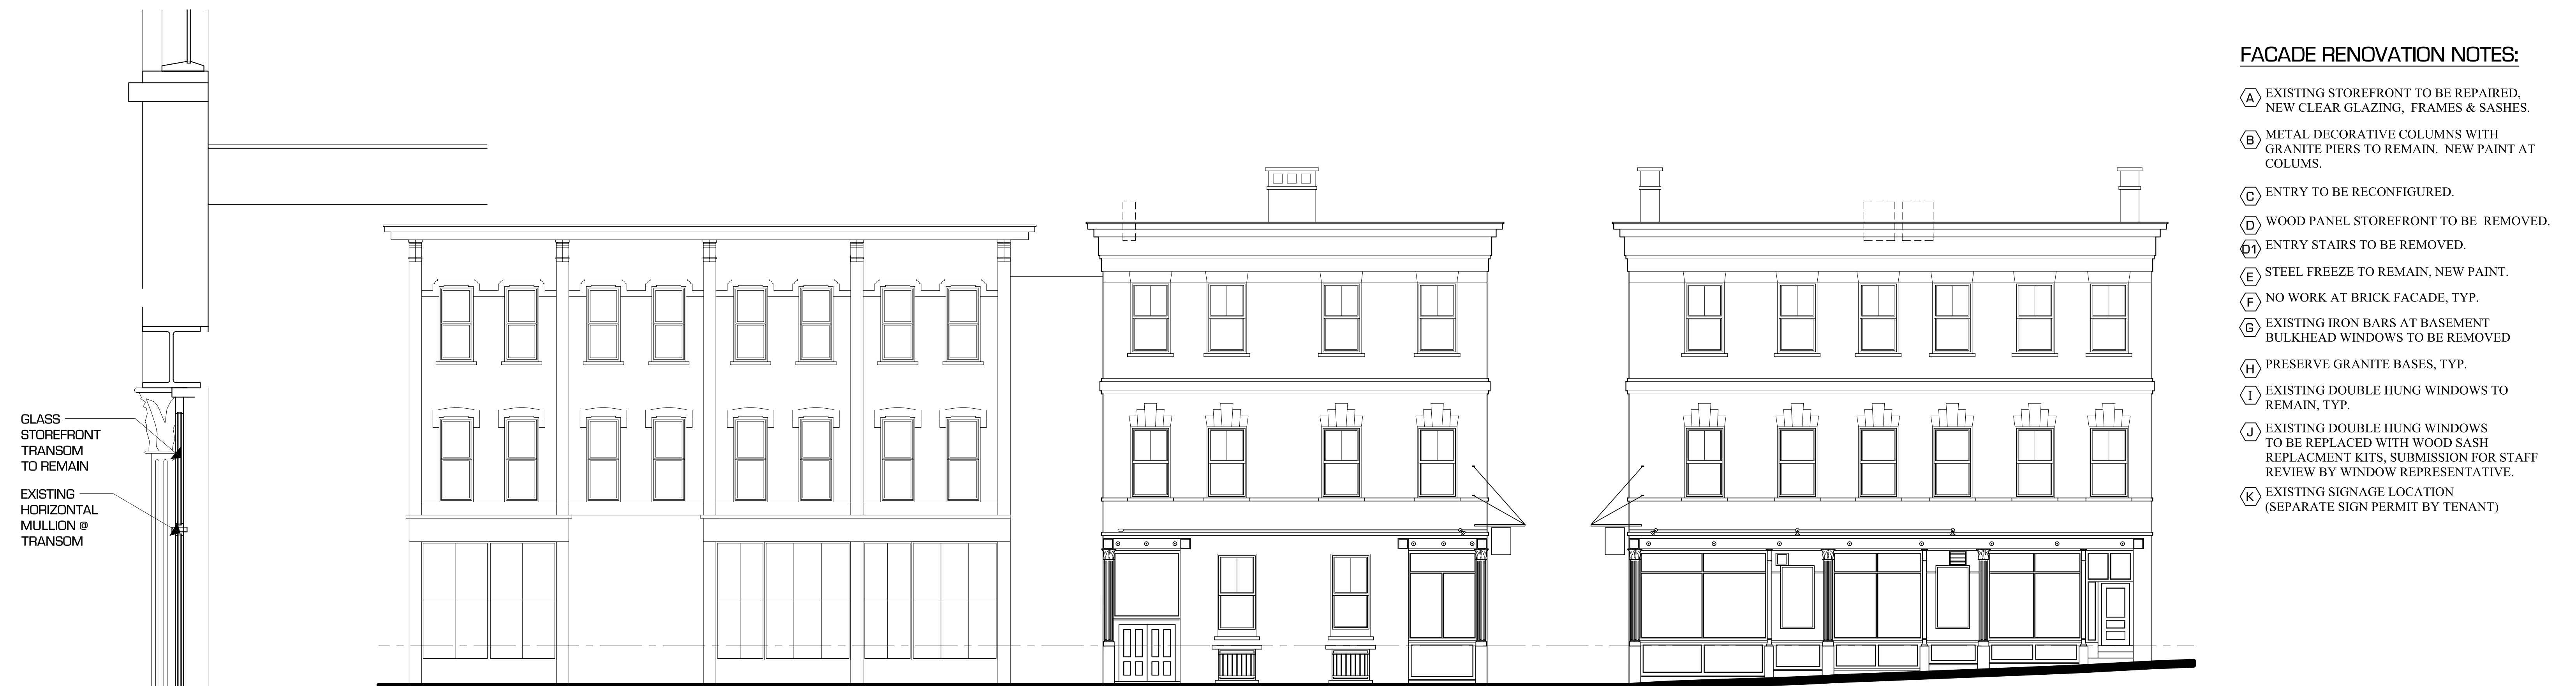
WS1
HP-1.1
3/4"=1'-0"

- (A) EXISTING STOREFRONT TO BE REPAIRED, NEW CLEAR GLAZING, FRAMES & SASHES.
- (B) METAL DECORATIVE COLUMNS WITH GRANITE PIERS TO REMAIN. NEW PAINT AT COLUMNS.
- (C) ENTRY TO BE RECONFIGURED.
- (D) WOOD PANEL STOREFRONT TO BE REMOVED.
- (E) ENTRY STAIRS TO BE REMOVED.
- (F) STEEL FREEZE TO REMAIN, NEW PAINT.
- (G) NO WORK AT BRICK FACADE, TYP.
- (H) EXISTING IRON BARS AT BASEMENT BULKHEAD WINDOWS TO BE REMOVED.
- (I) PRESERVE GRANITE BASES, TYP.
- (J) EXISTING DOUBLE HUNG WINDOWS TO REMAIN, TYP.
- (K) EXISTING DOUBLE HUNG WINDOWS TO BE REPLACED WITH WOOD SASH REPLACEMENT KITS, SUBMISSION FOR STAFF REVIEW BY WINDOW REPRESENTATIVE.
- (L) EXISTING SIGNAGE LOCATION (SEPARATE SIGN PERMIT BY TENANT)
