BANK OF AMERICA - 9TH & 10TH FLOORS

BANK OF AMERICA
1 MONUMENT SQUARE
Portland, ME

TITLE
TYPICAL DETAILS

DRAWING NO. **A8.04**

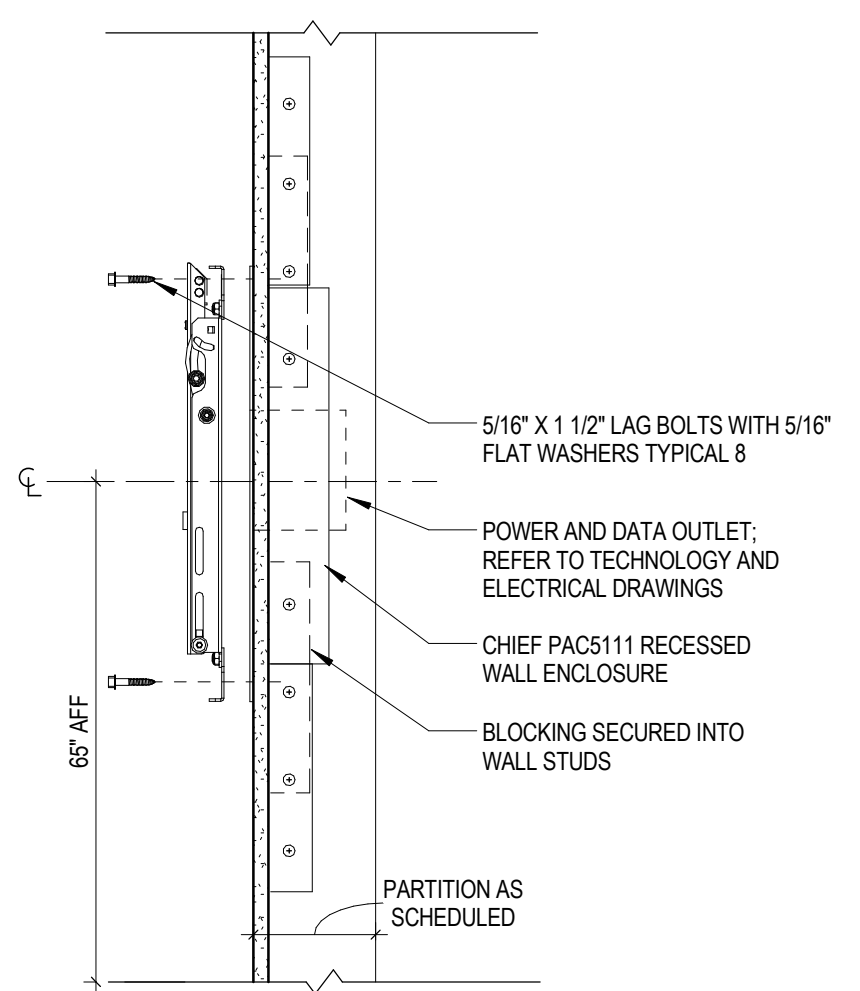
11 LCD MOUNTING BRACKET
1 1/2" = 1'-0"

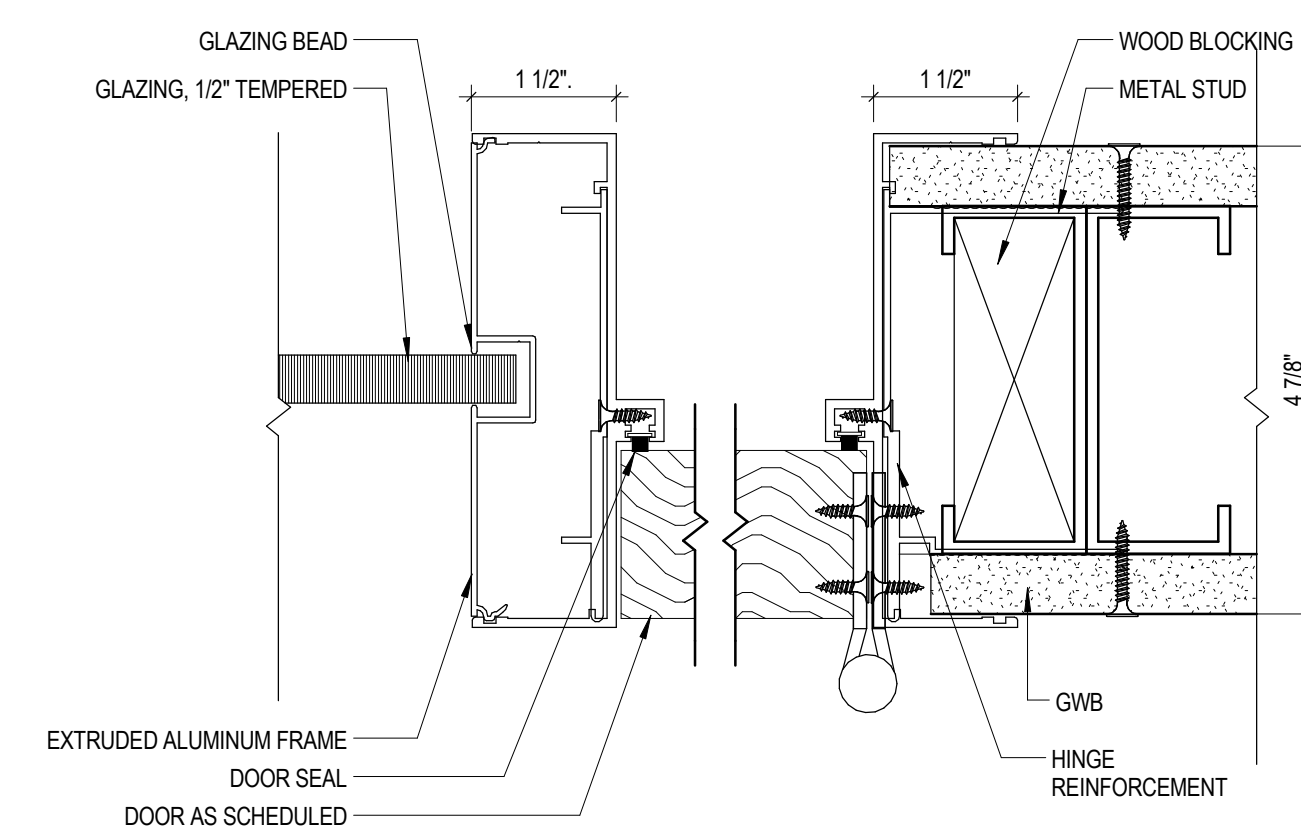
3 TYP. DETAIL AT DOOR/SIDELIGHT - ALUM. FRAME
6" = 1'-0"
