Schlotterbeck Block

117 Preble Street
Portland, Maine

masonry repair elevations

A2.4

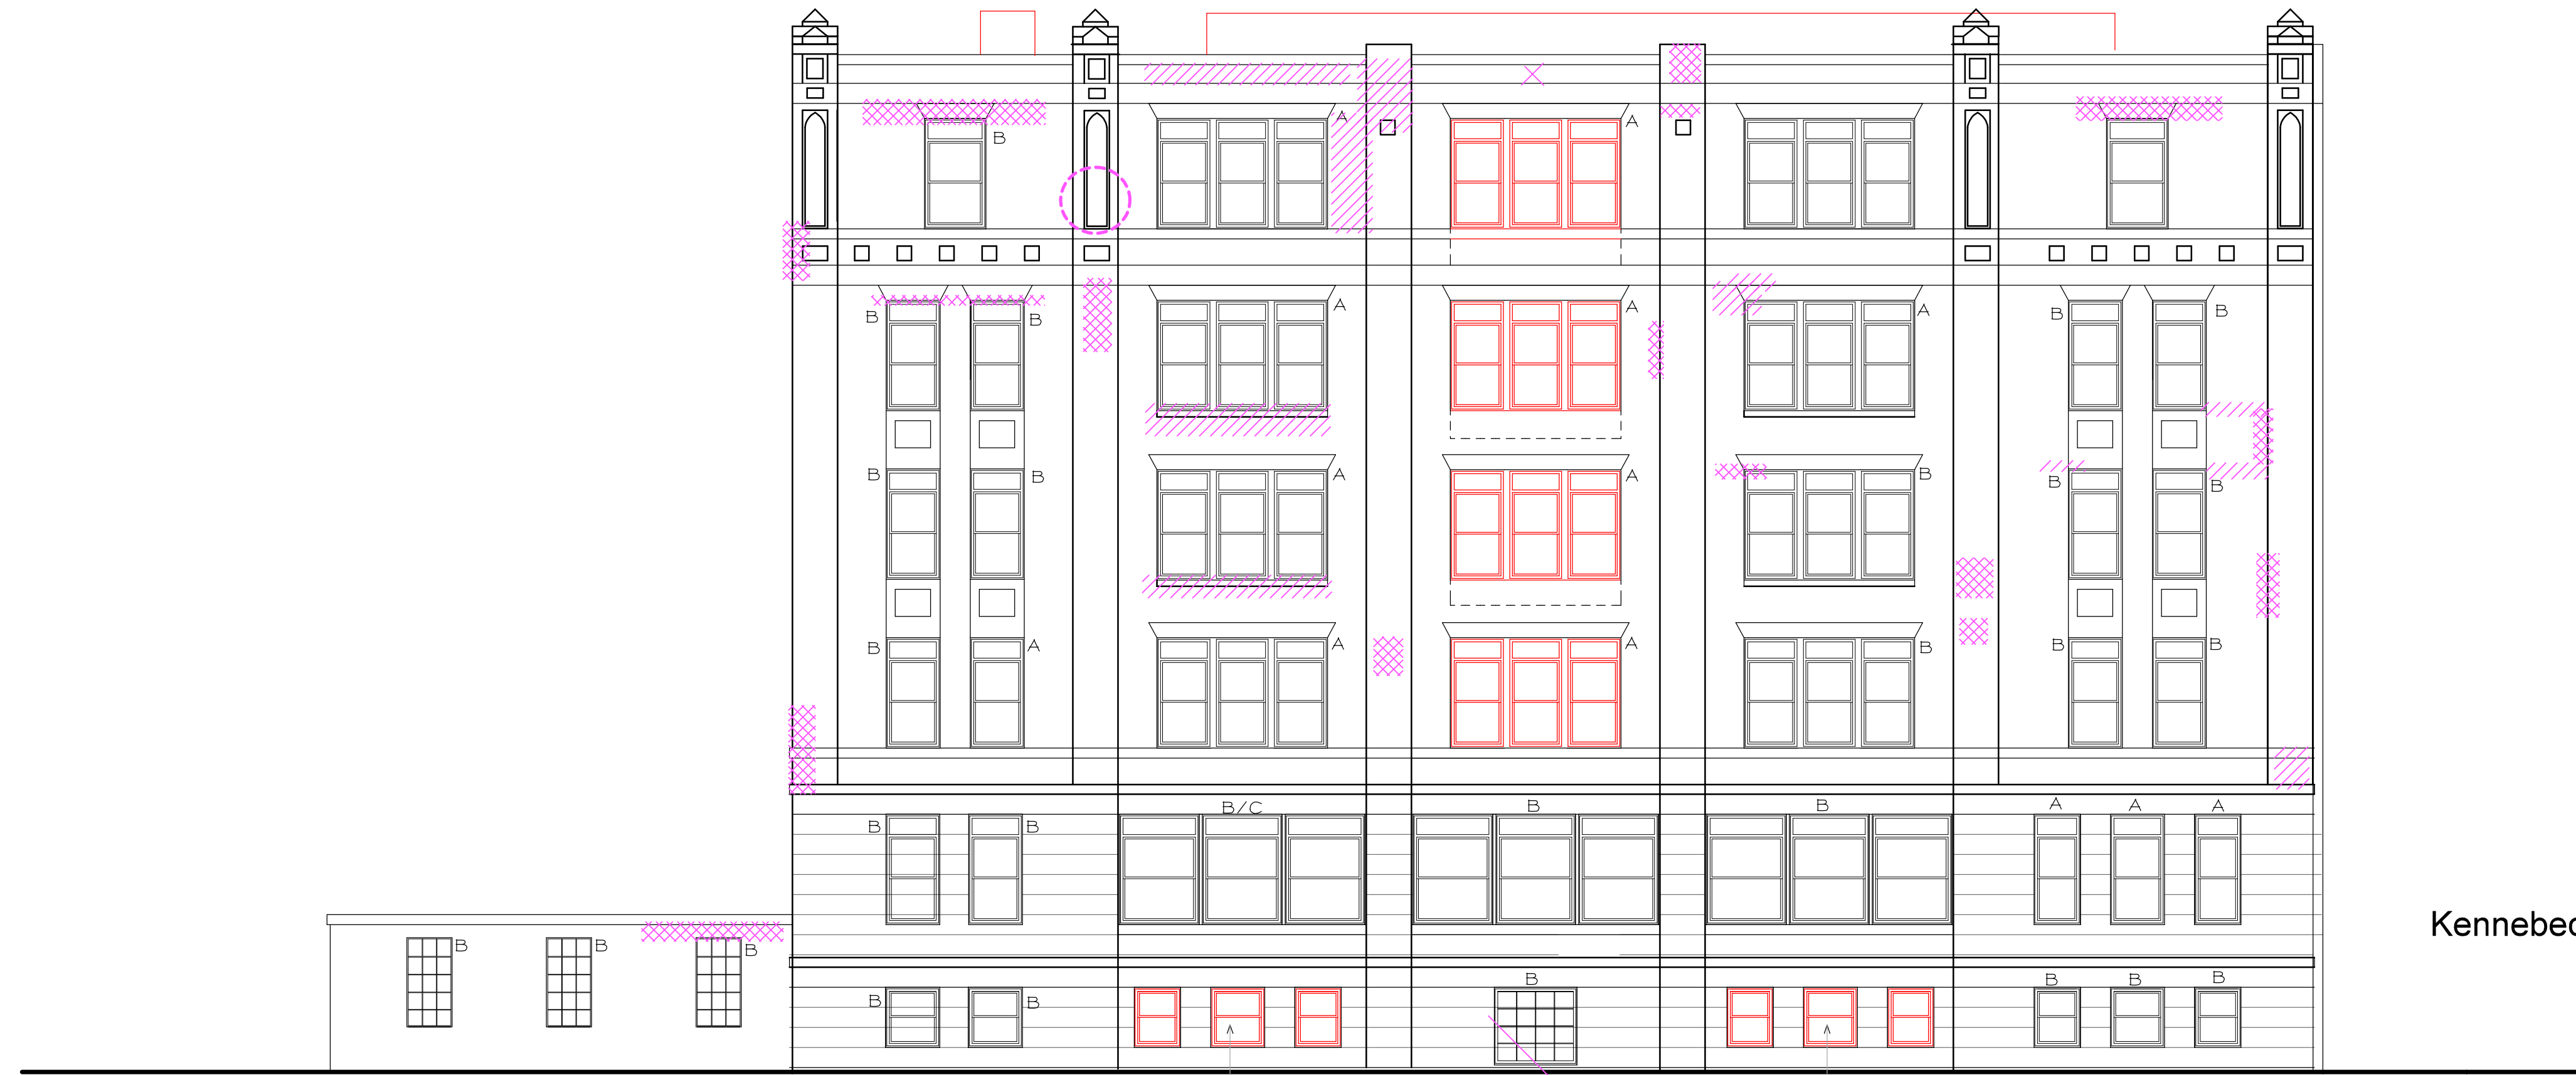
Kennebec St. elevation

hatch indicates area where masonry needs to be cut and repaired
see detail O sheet A5.O

hatch indicates area where masonry needs to be repaired and reported
see detail O sheet A5.O

repair spalled cast stone

spalled cement coating repair

WINDOW STEEL LINTEL SCHEDULE
type A: original lintel has been replaced
no work necessary
type B: original lintel in place
repair, replace
type C: replace existing lintel
with new galvanized lintel
type B/C: either repair or replace
inspect with lift

NOTES:
1. wash all brick
product: Eco Chem, Restore One
2. remove all loose cement based waterproof coating
on existing cast stone
apply new coating layer over all existing cast stone
3. cut and paint all brick to cast stone joints
and all cast stone to cast stone joints
