FOR PERMIT

Structural Integrity
 Consulting Engineers, Inc.
 77 Oak Street
 Portland, ME, 04101
 p. 207-774-4614
 f. 866-793-7835
 www.structuralintegrity.com
 BUILD WITH CONFIDENCE
 © 2012 Structural Integrity Consulting Engineers, Inc.
 SI # 15-0058

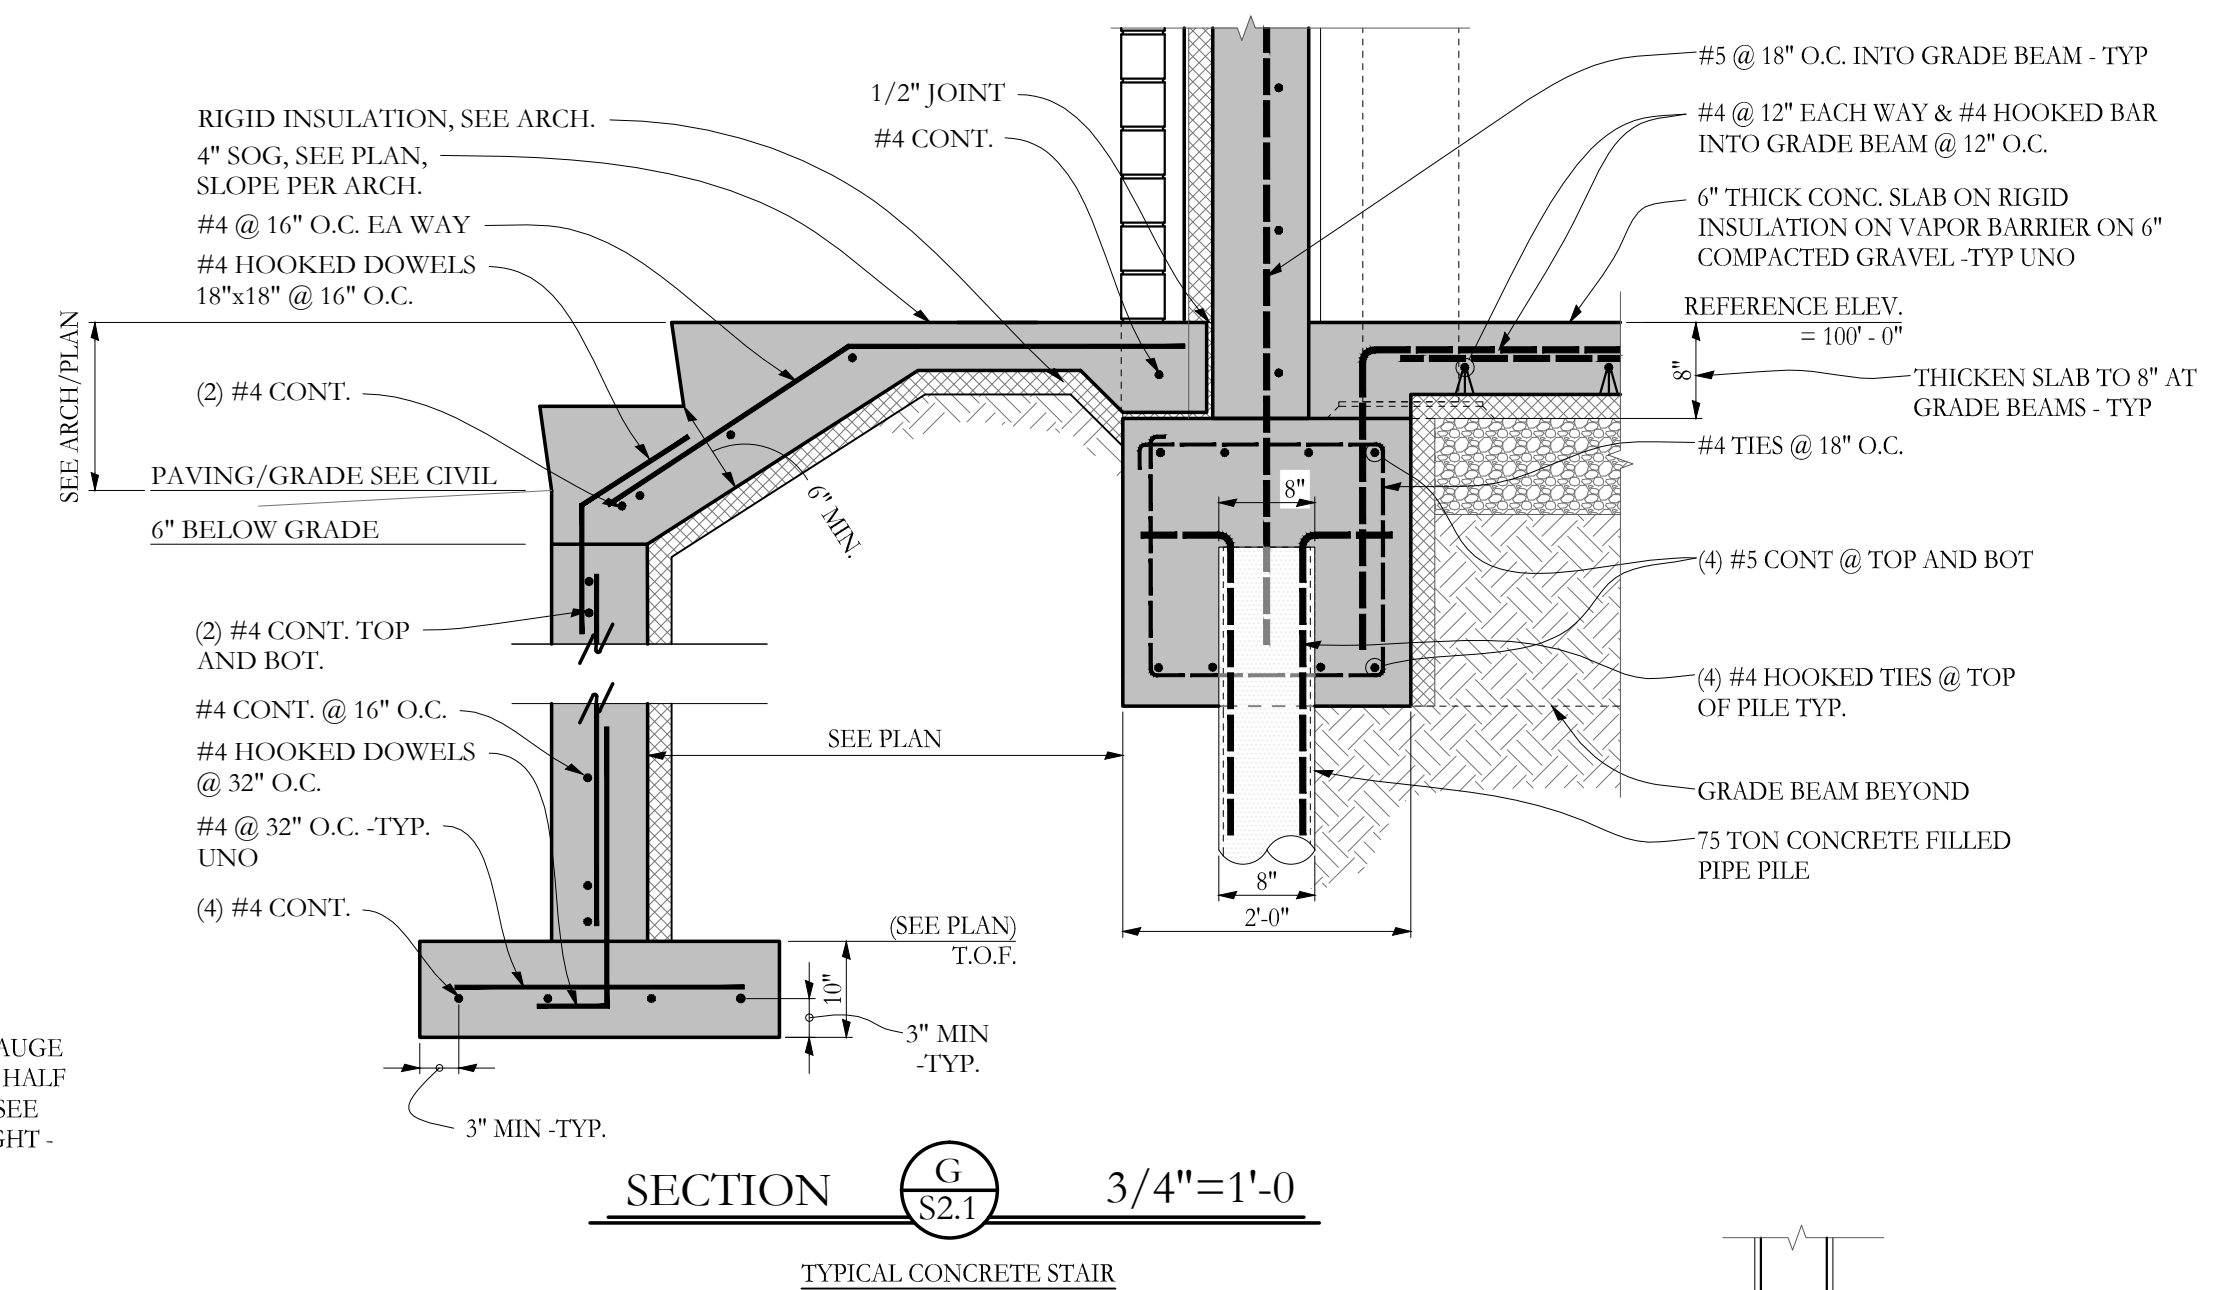
SECTION G S2.1 3/4"=1'-0
 TYPICAL CONCRETE STAIR

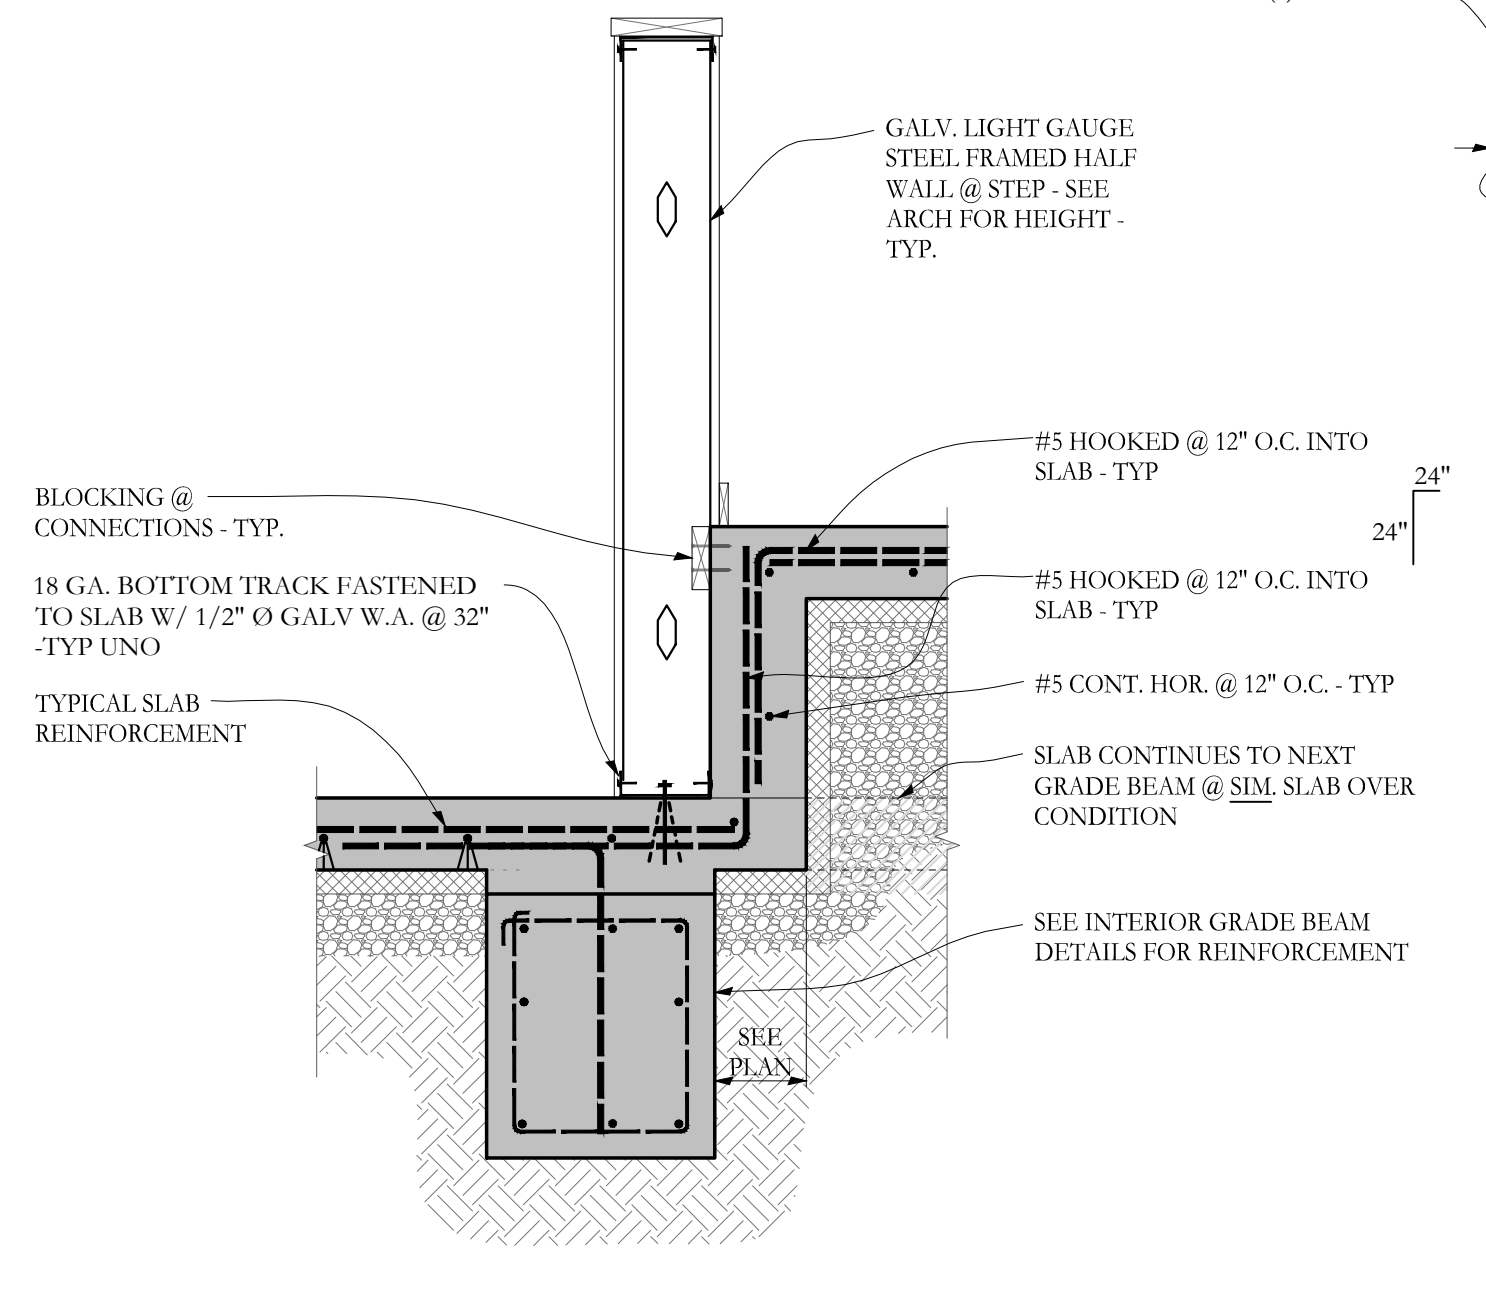
SECTION D S2.1 3/4"=1'-0
 CAST IN PLACE WALL OVER CANTILEVERED SLAB

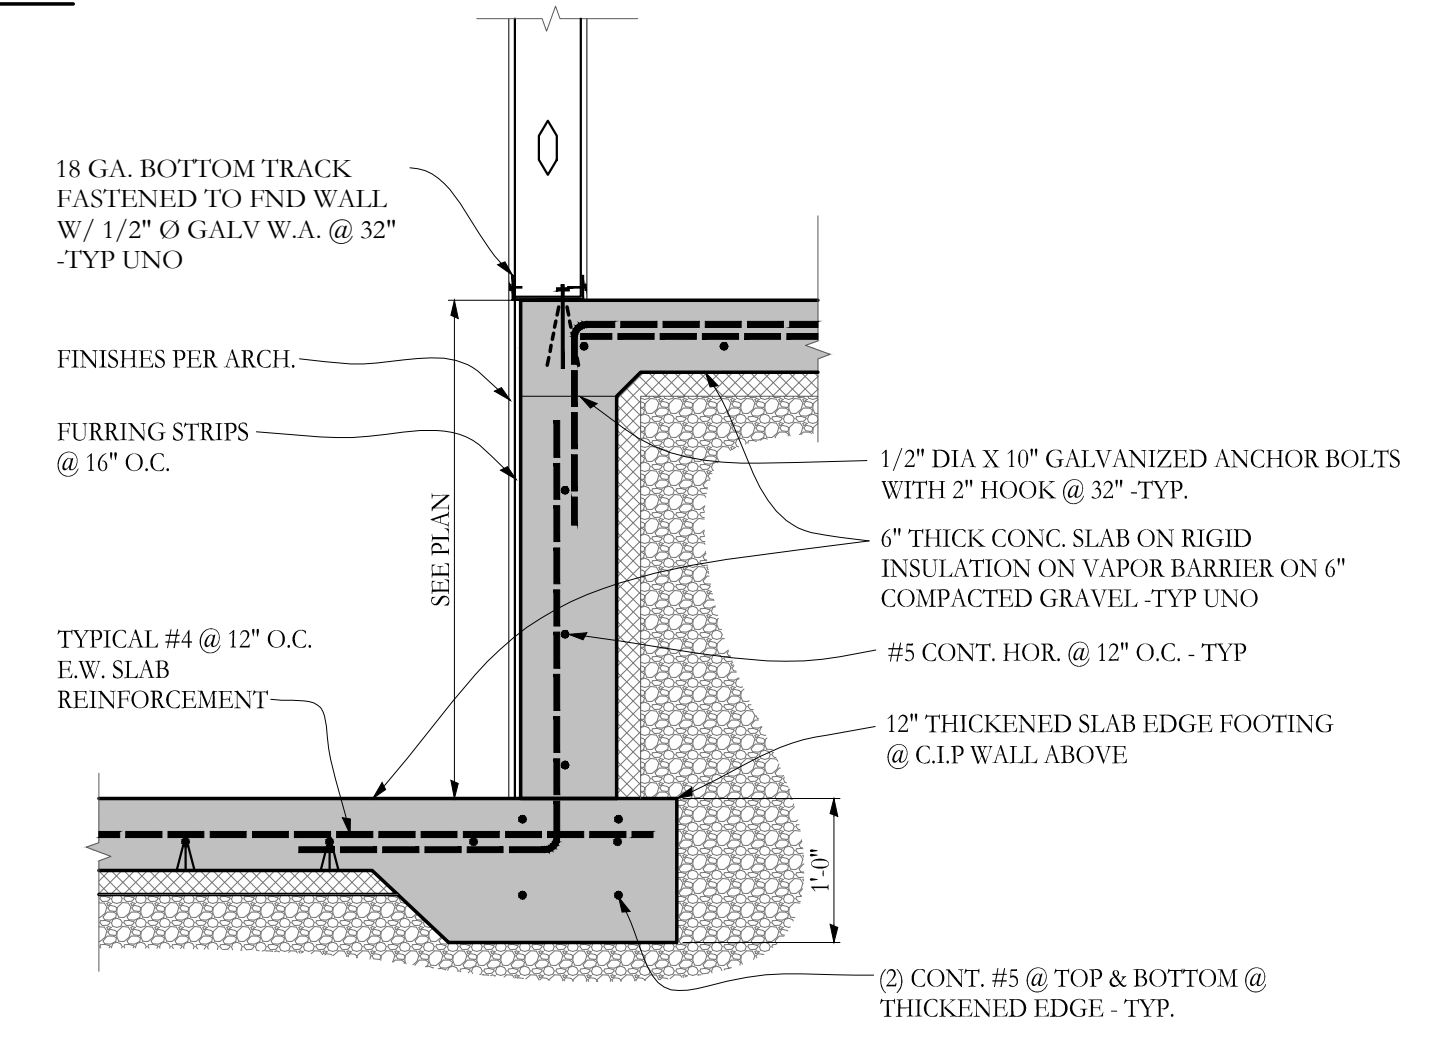
SECTION E S2.1 3/4"=1'-0
 CAST IN PLACE WALL OVER THICKENED SLAB EDGE

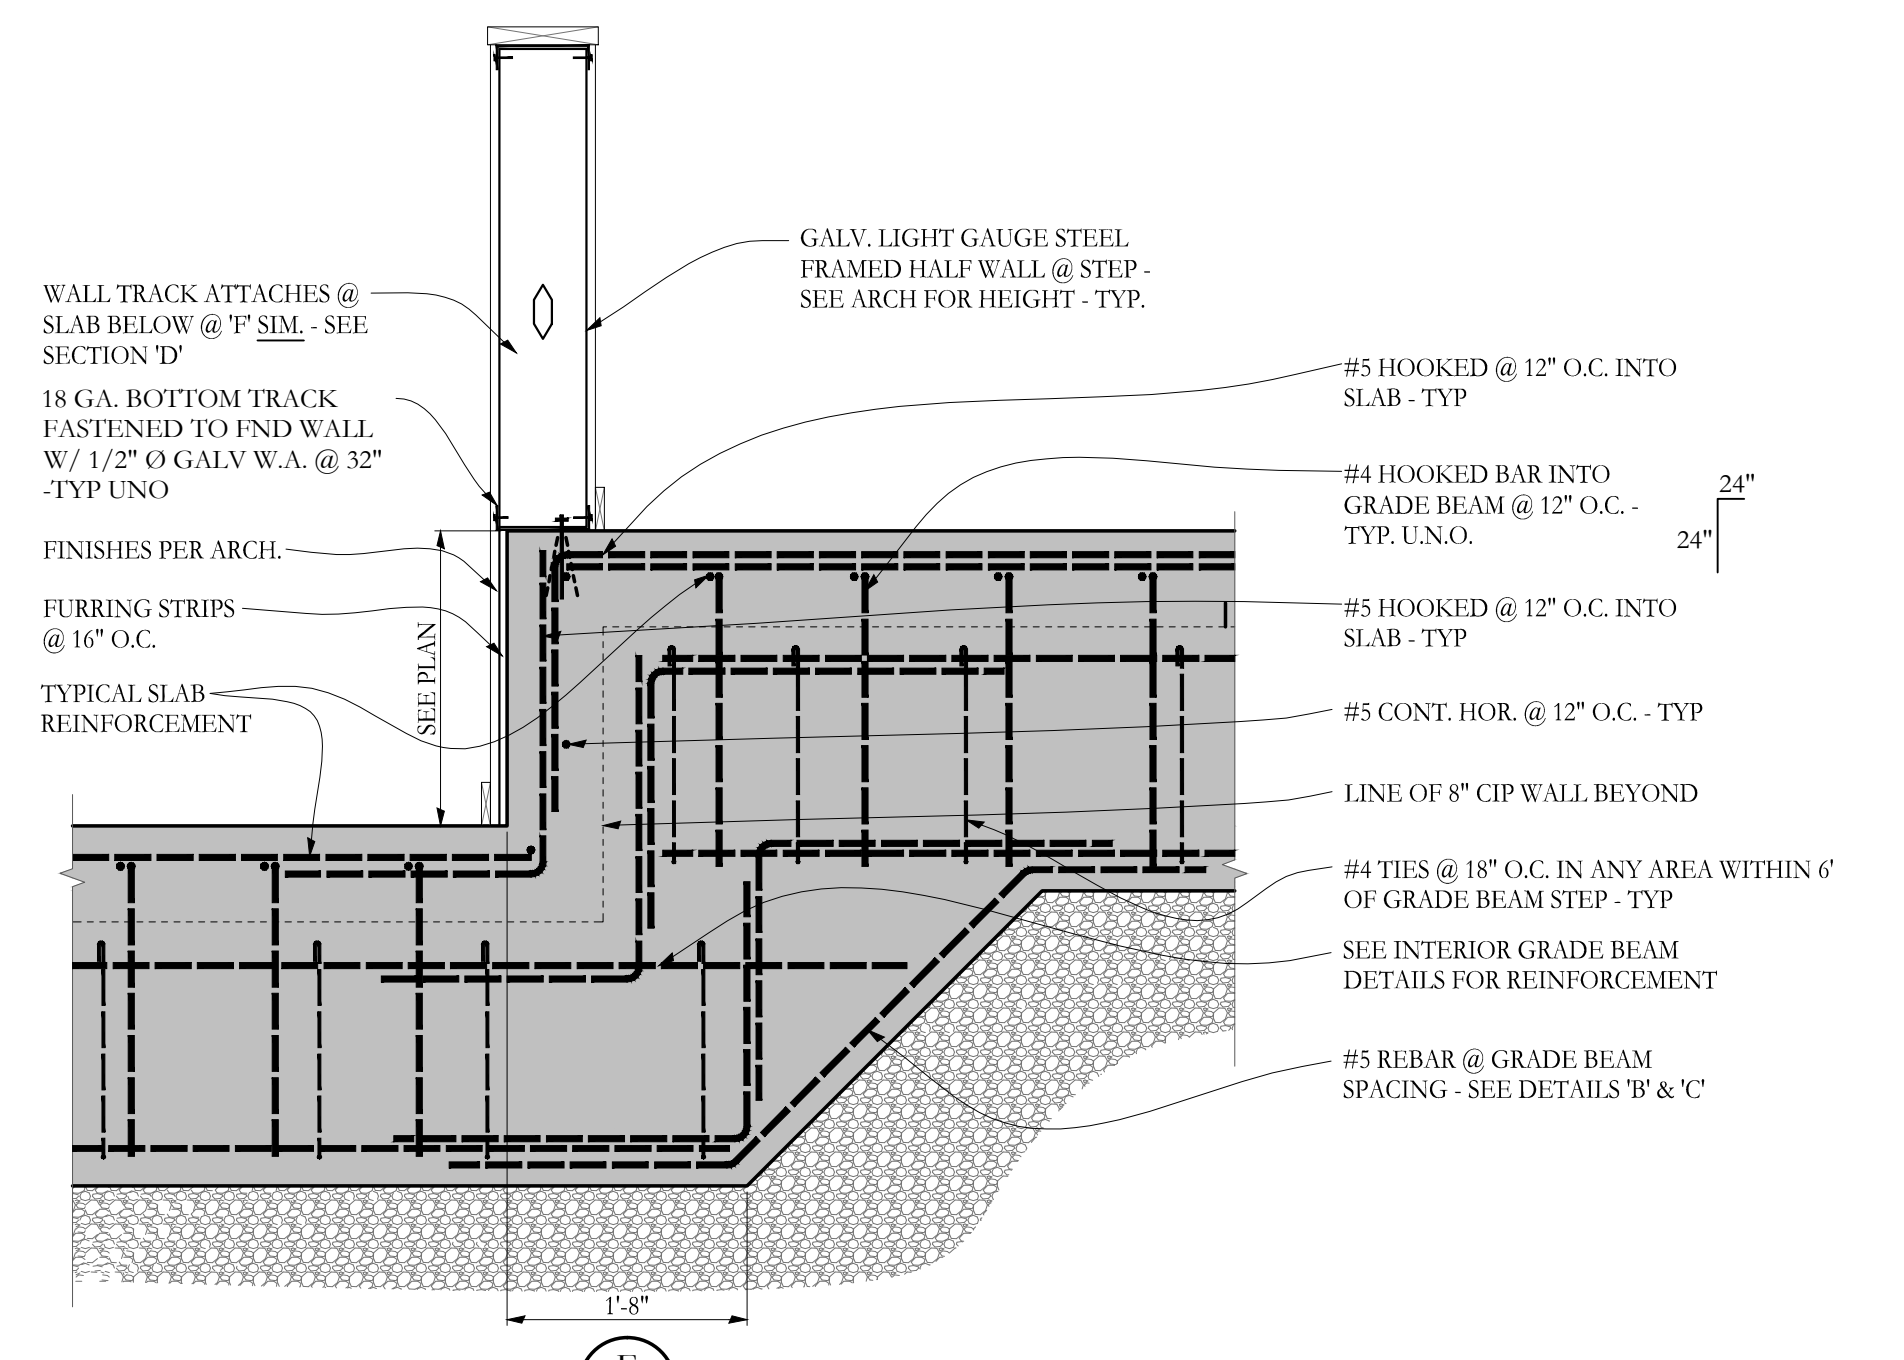
SECTION F S2.1 3/4"=1'-0
 STEPPED GRADE BEAM @ SLAB ELEVATION CHANGE

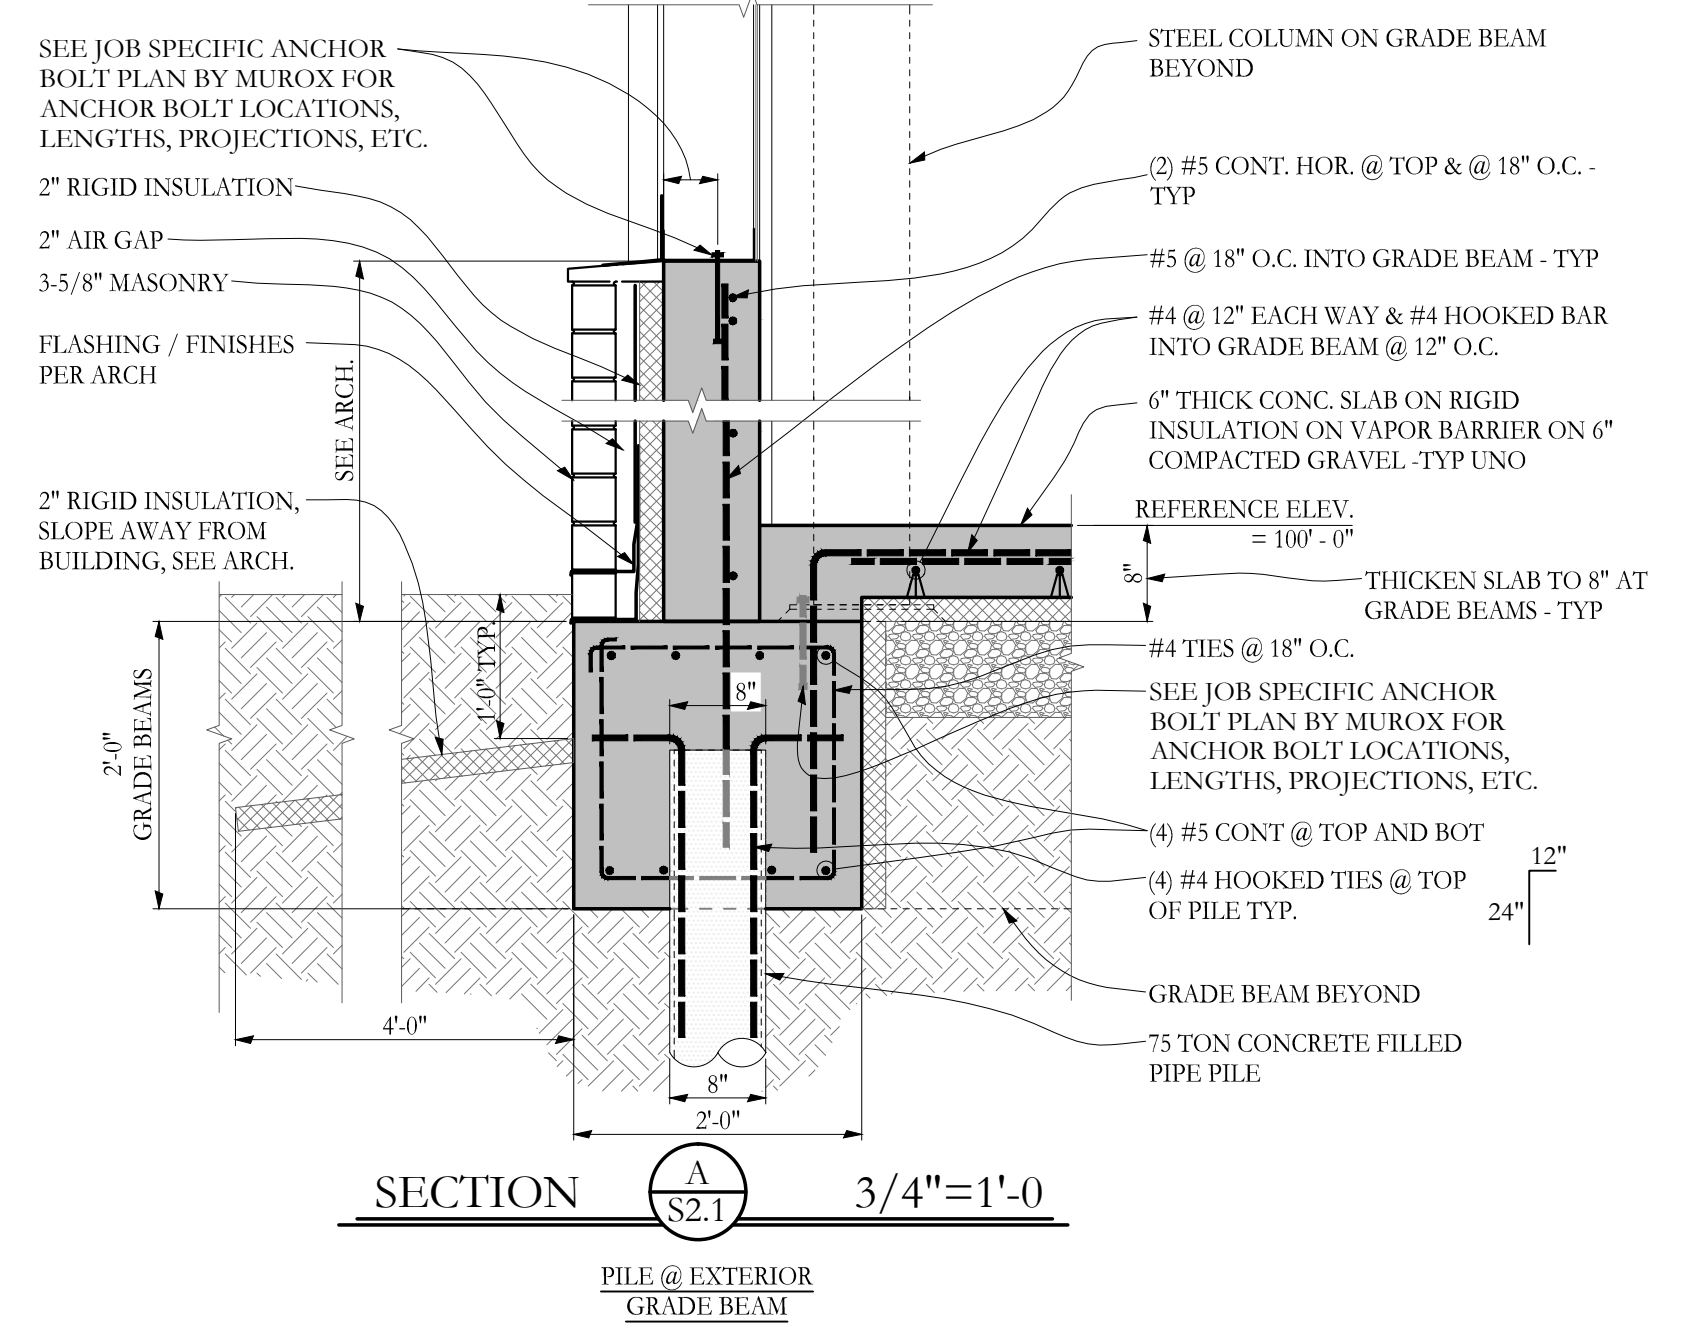
SECTION A S2.1 3/4"=1'-0
 PILE @ EXTERIOR GRADE BEAM

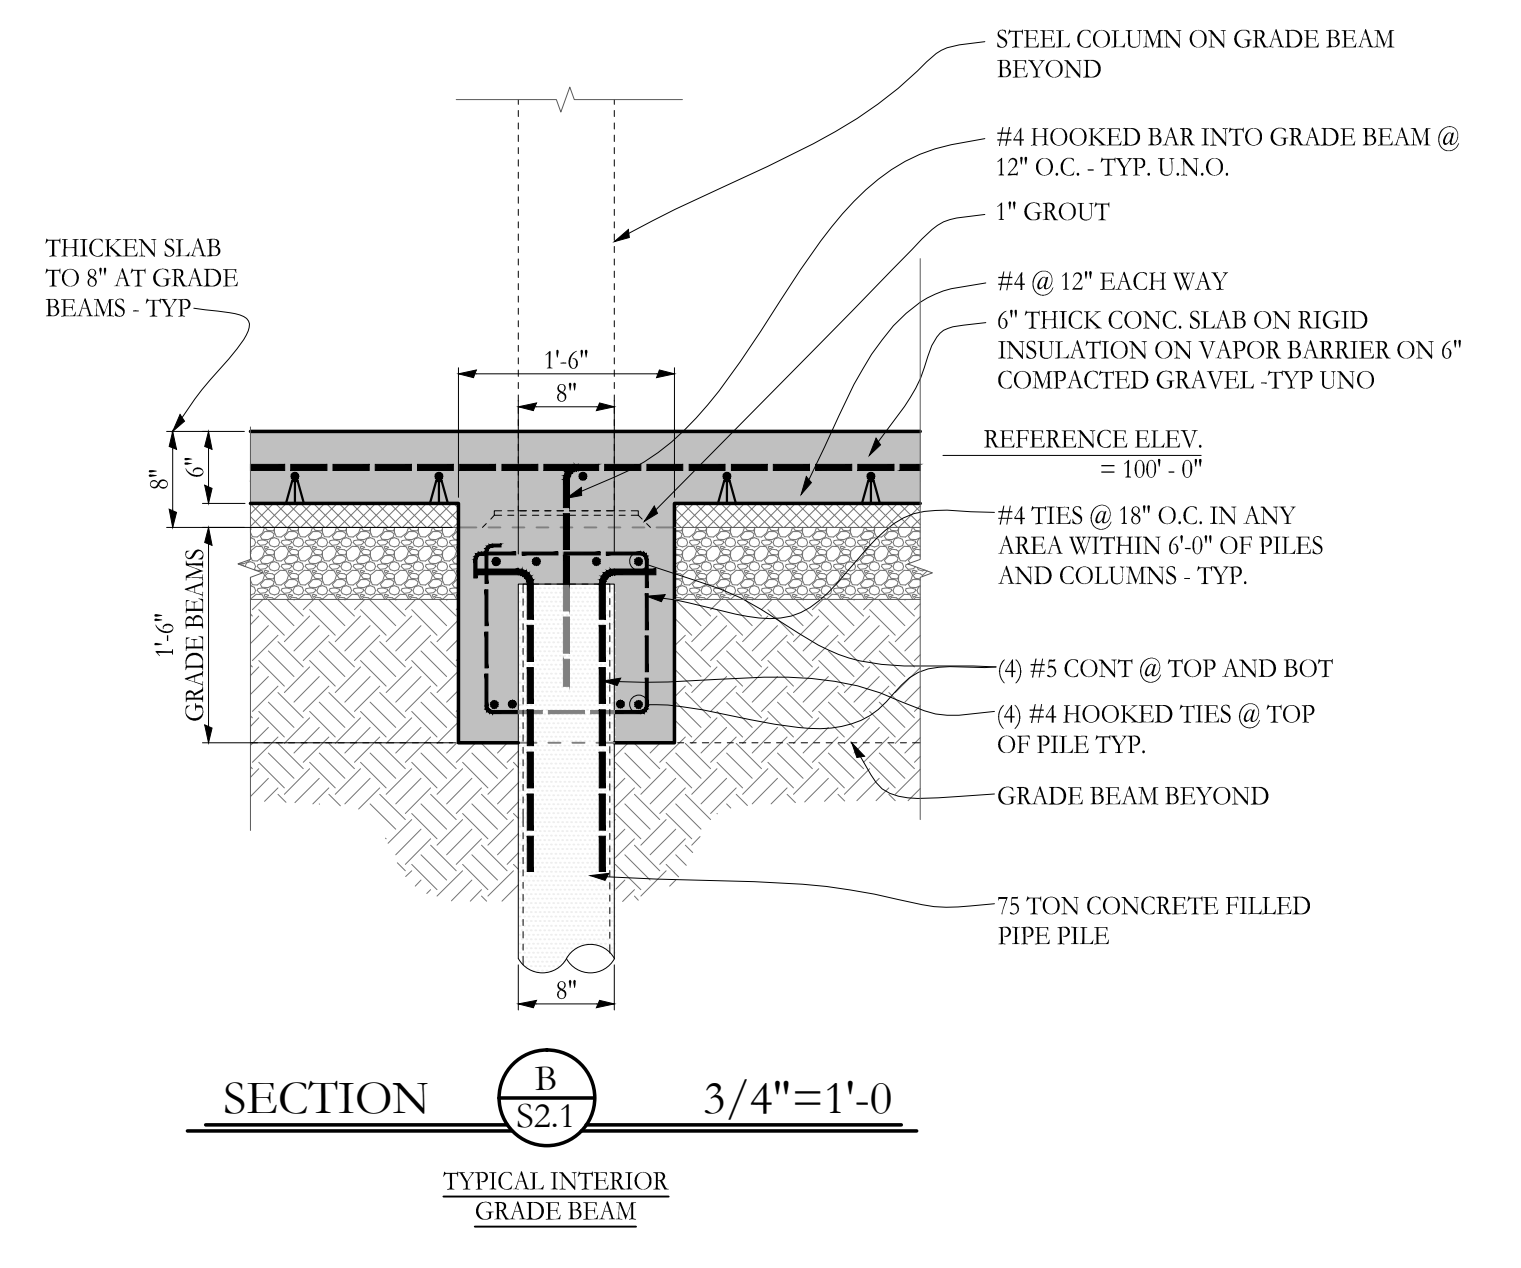
SECTION B S2.1 3/4"=1'-0
 TYPICAL INTERIOR GRADE BEAM

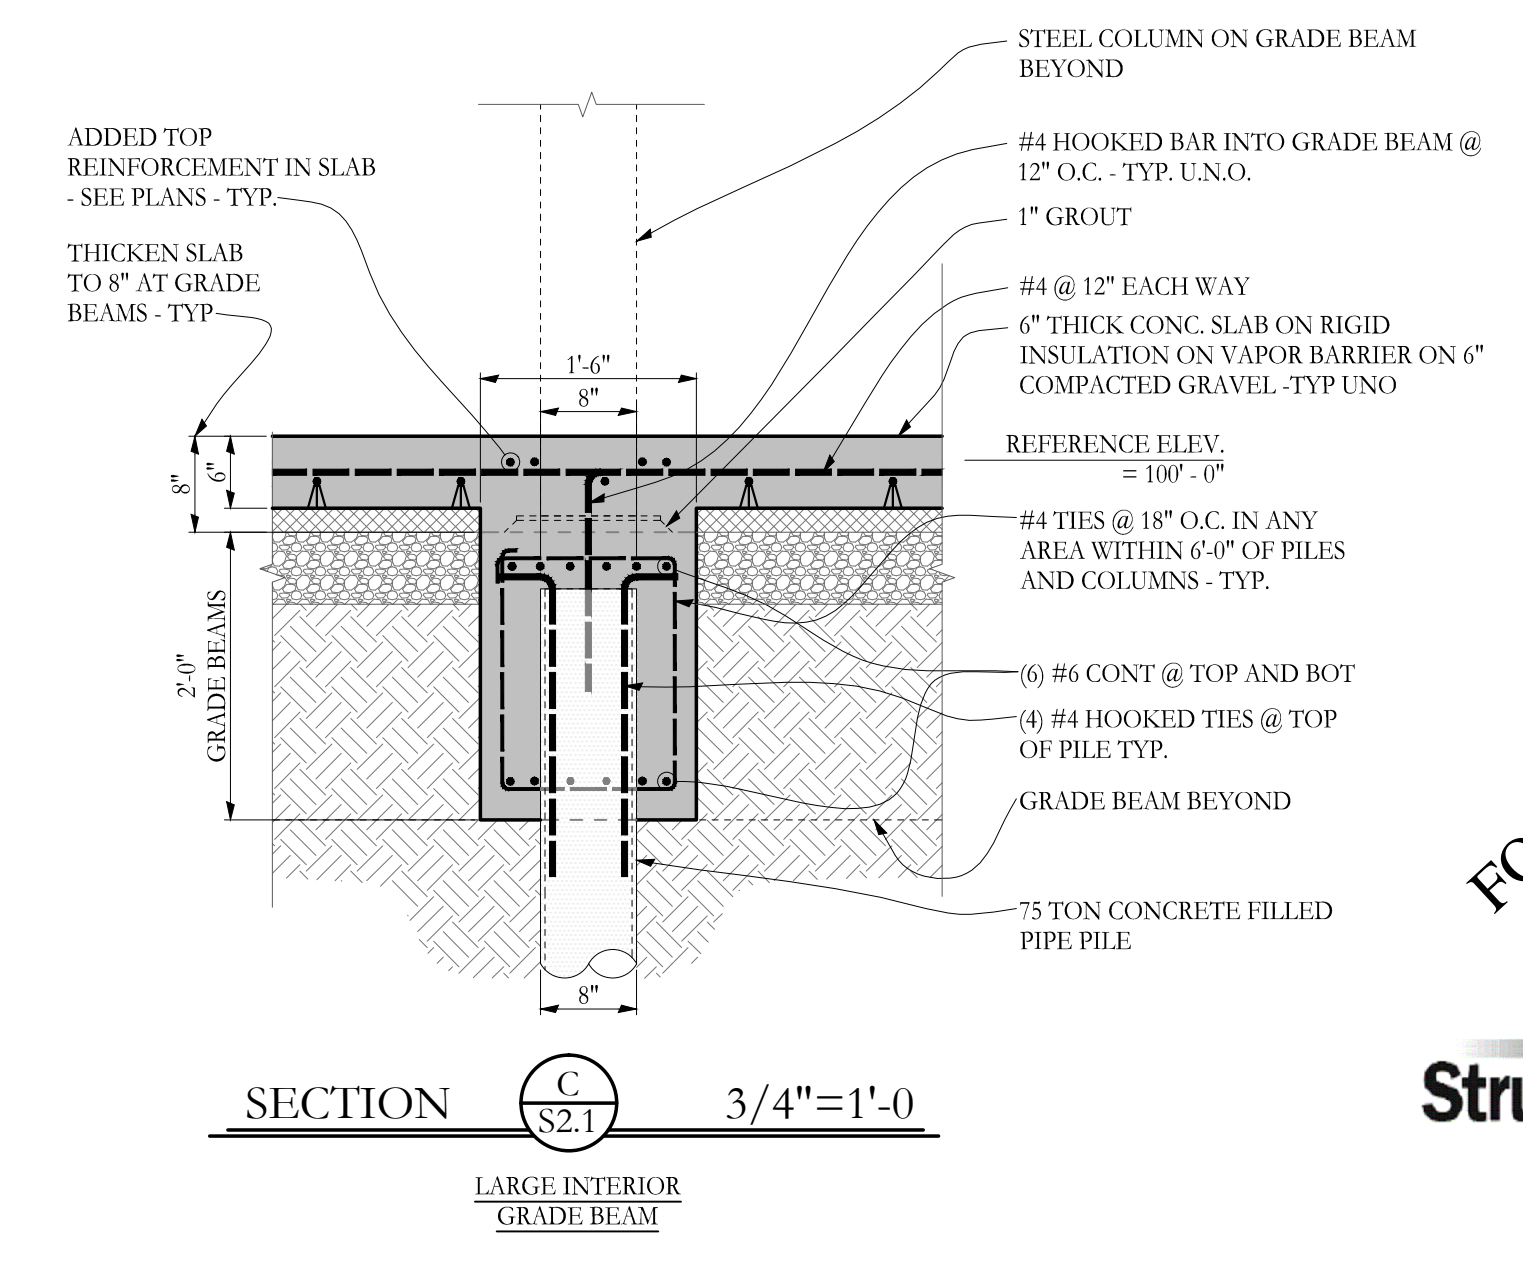
SECTION C S2.1 3/4"=1'-0
 LARGE INTERIOR GRADE BEAM
