ADDITION TO BAYSIDE BOWL
ALDER STREET
PORTLAND, MAINE

SHEET TITLE: DETAILS

A5-2

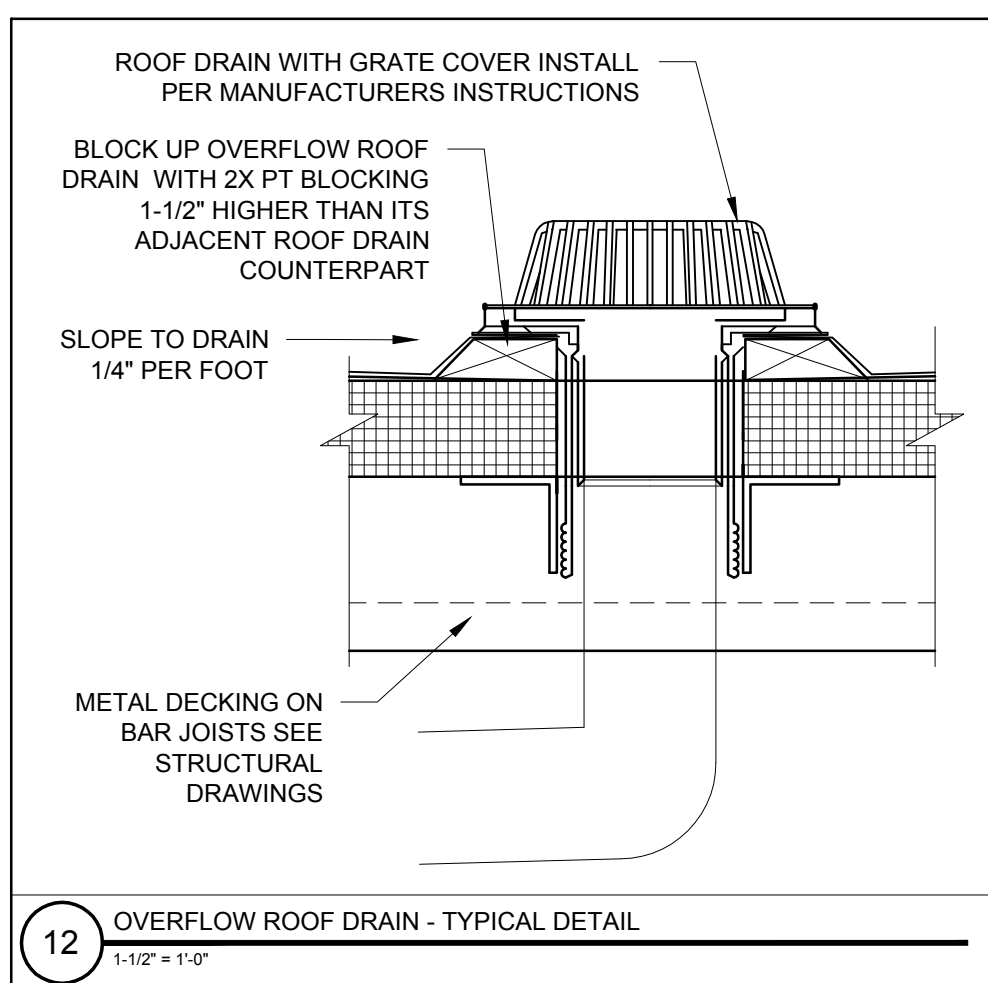
12 OVERFLOW ROOF DRAIN - TYPICAL DETAIL
1:1/2" = 1'-0"

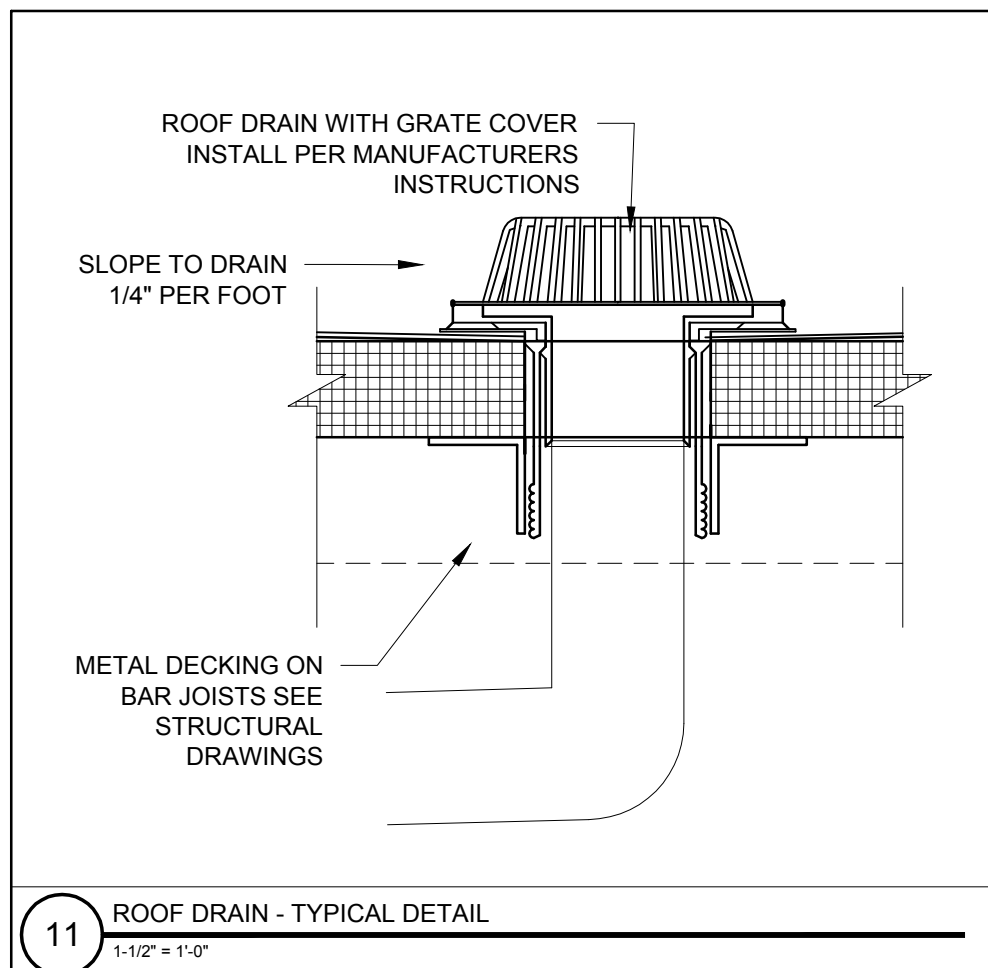
11 ROOF DRAIN - TYPICAL DETAIL
1:1/2" = 1'-0"

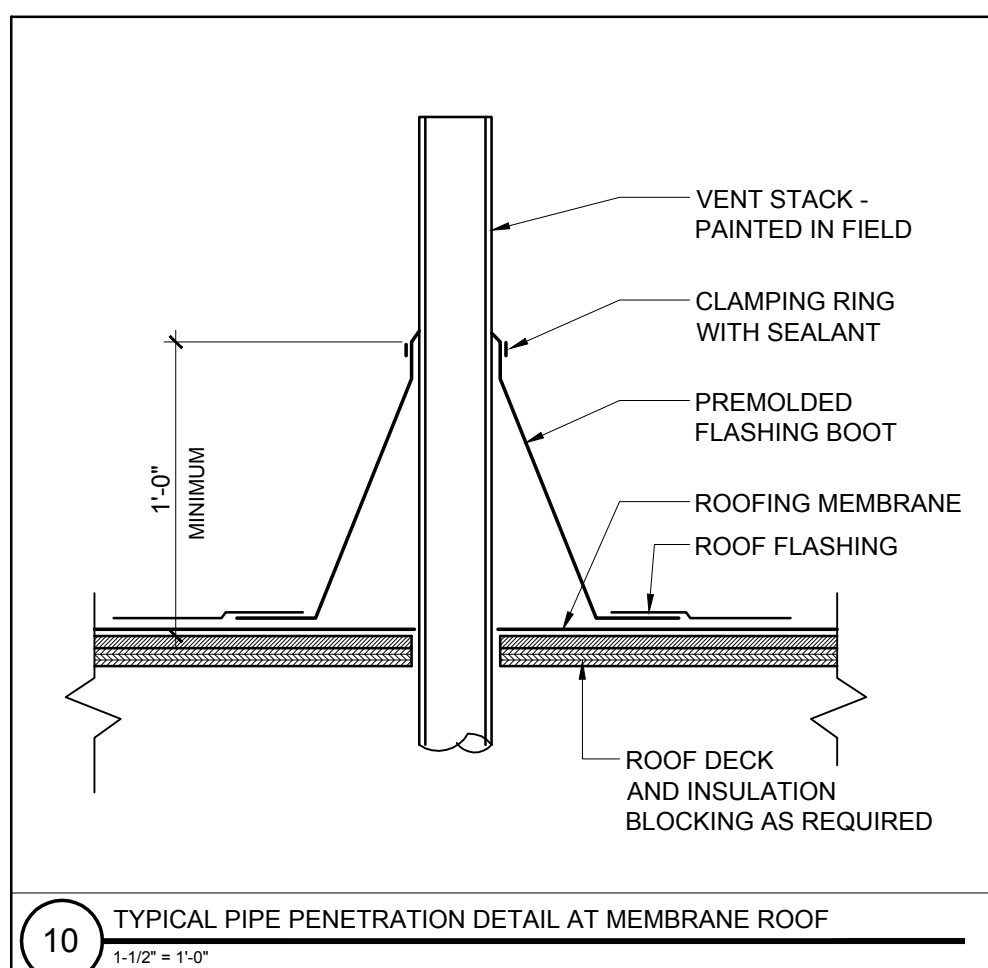
10 TYPICAL PIPE PENETRATION DETAIL AT MEMBRANE ROOF
1:1/2" = 1'-0"

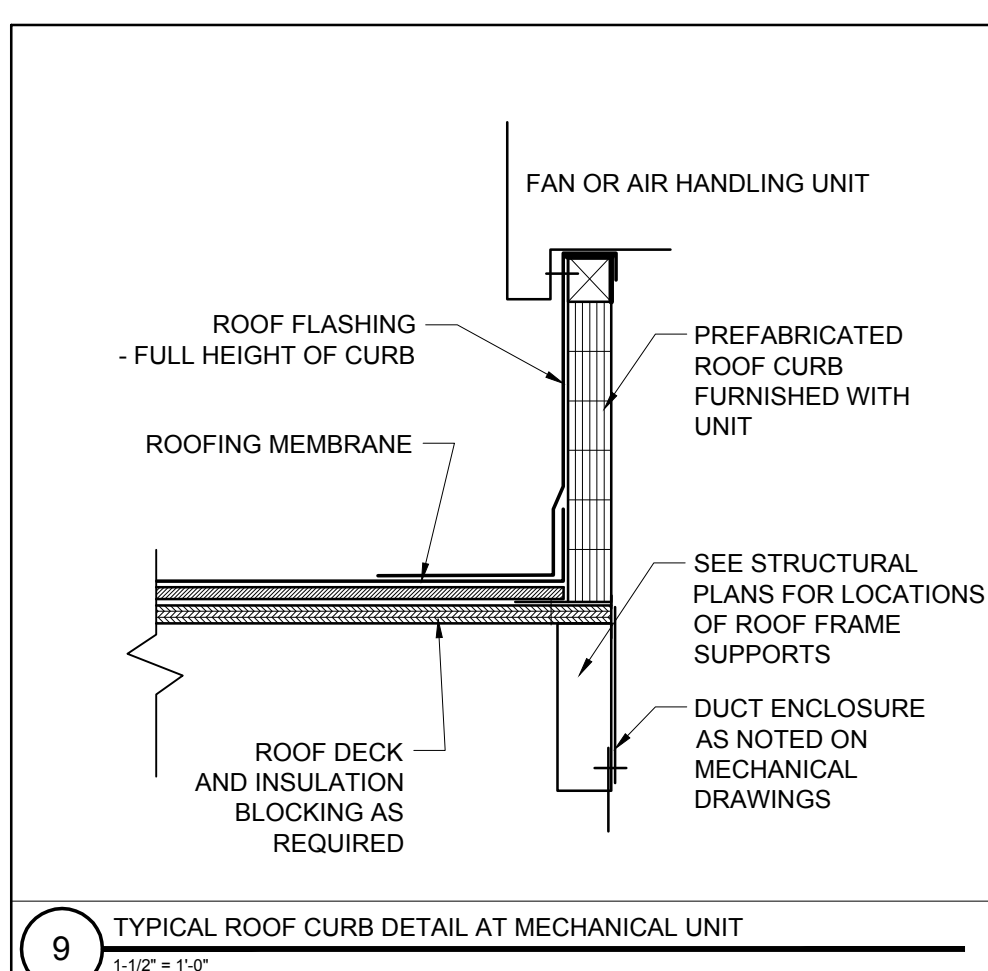
9 TYPICAL ROOF CURB DETAIL AT MECHANICAL UNIT
1:1/2" = 1'-0"

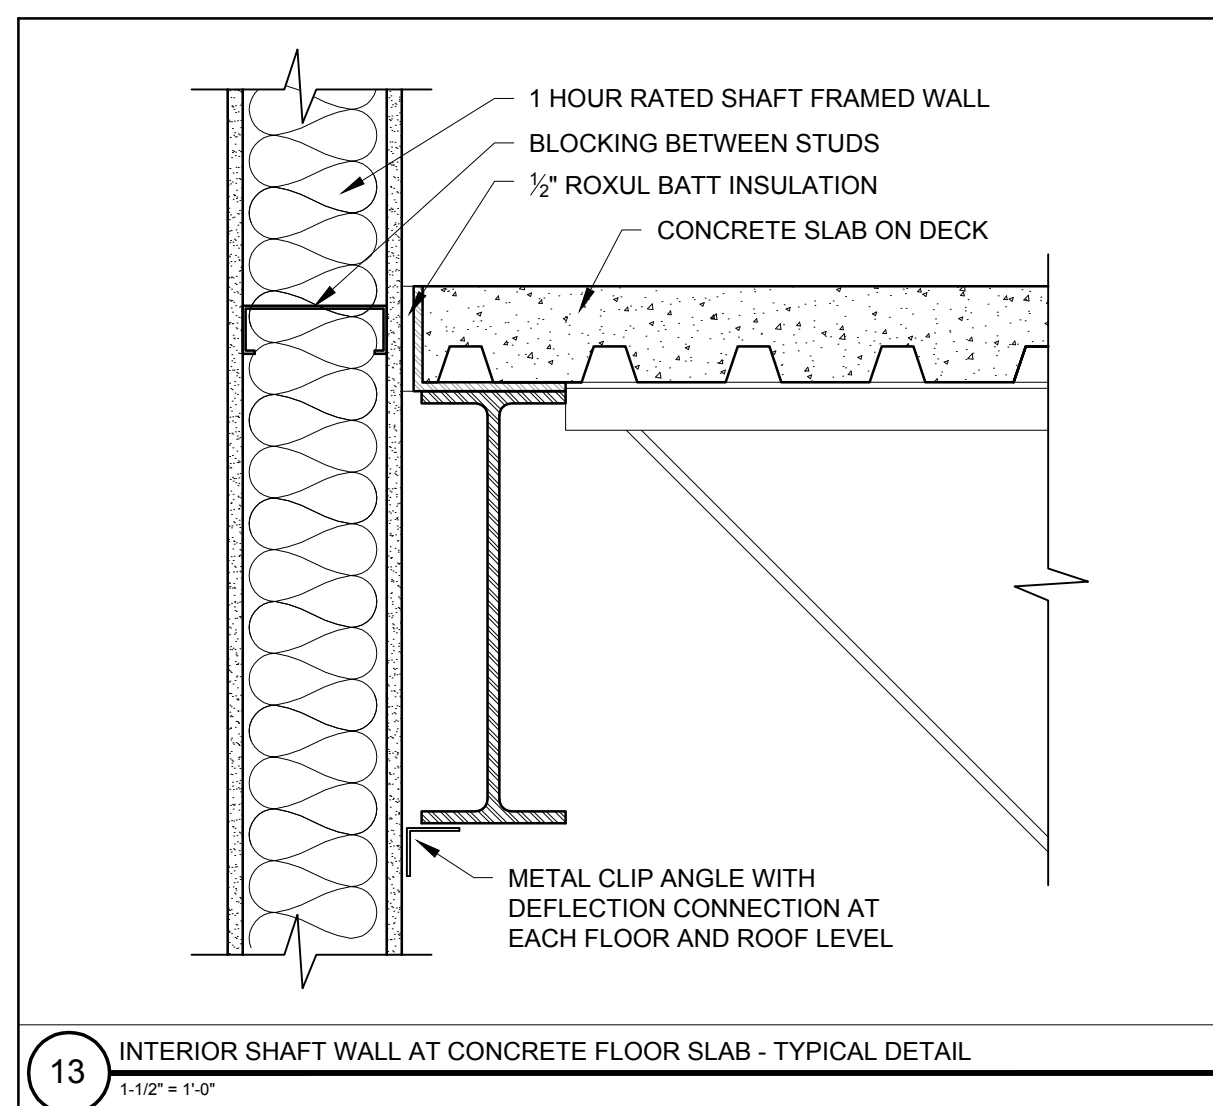
13 INTERIOR SHAFT WALL AT CONCRETE FLOOR SLAB - TYPICAL DETAIL
1:1/2" = 1'-0"

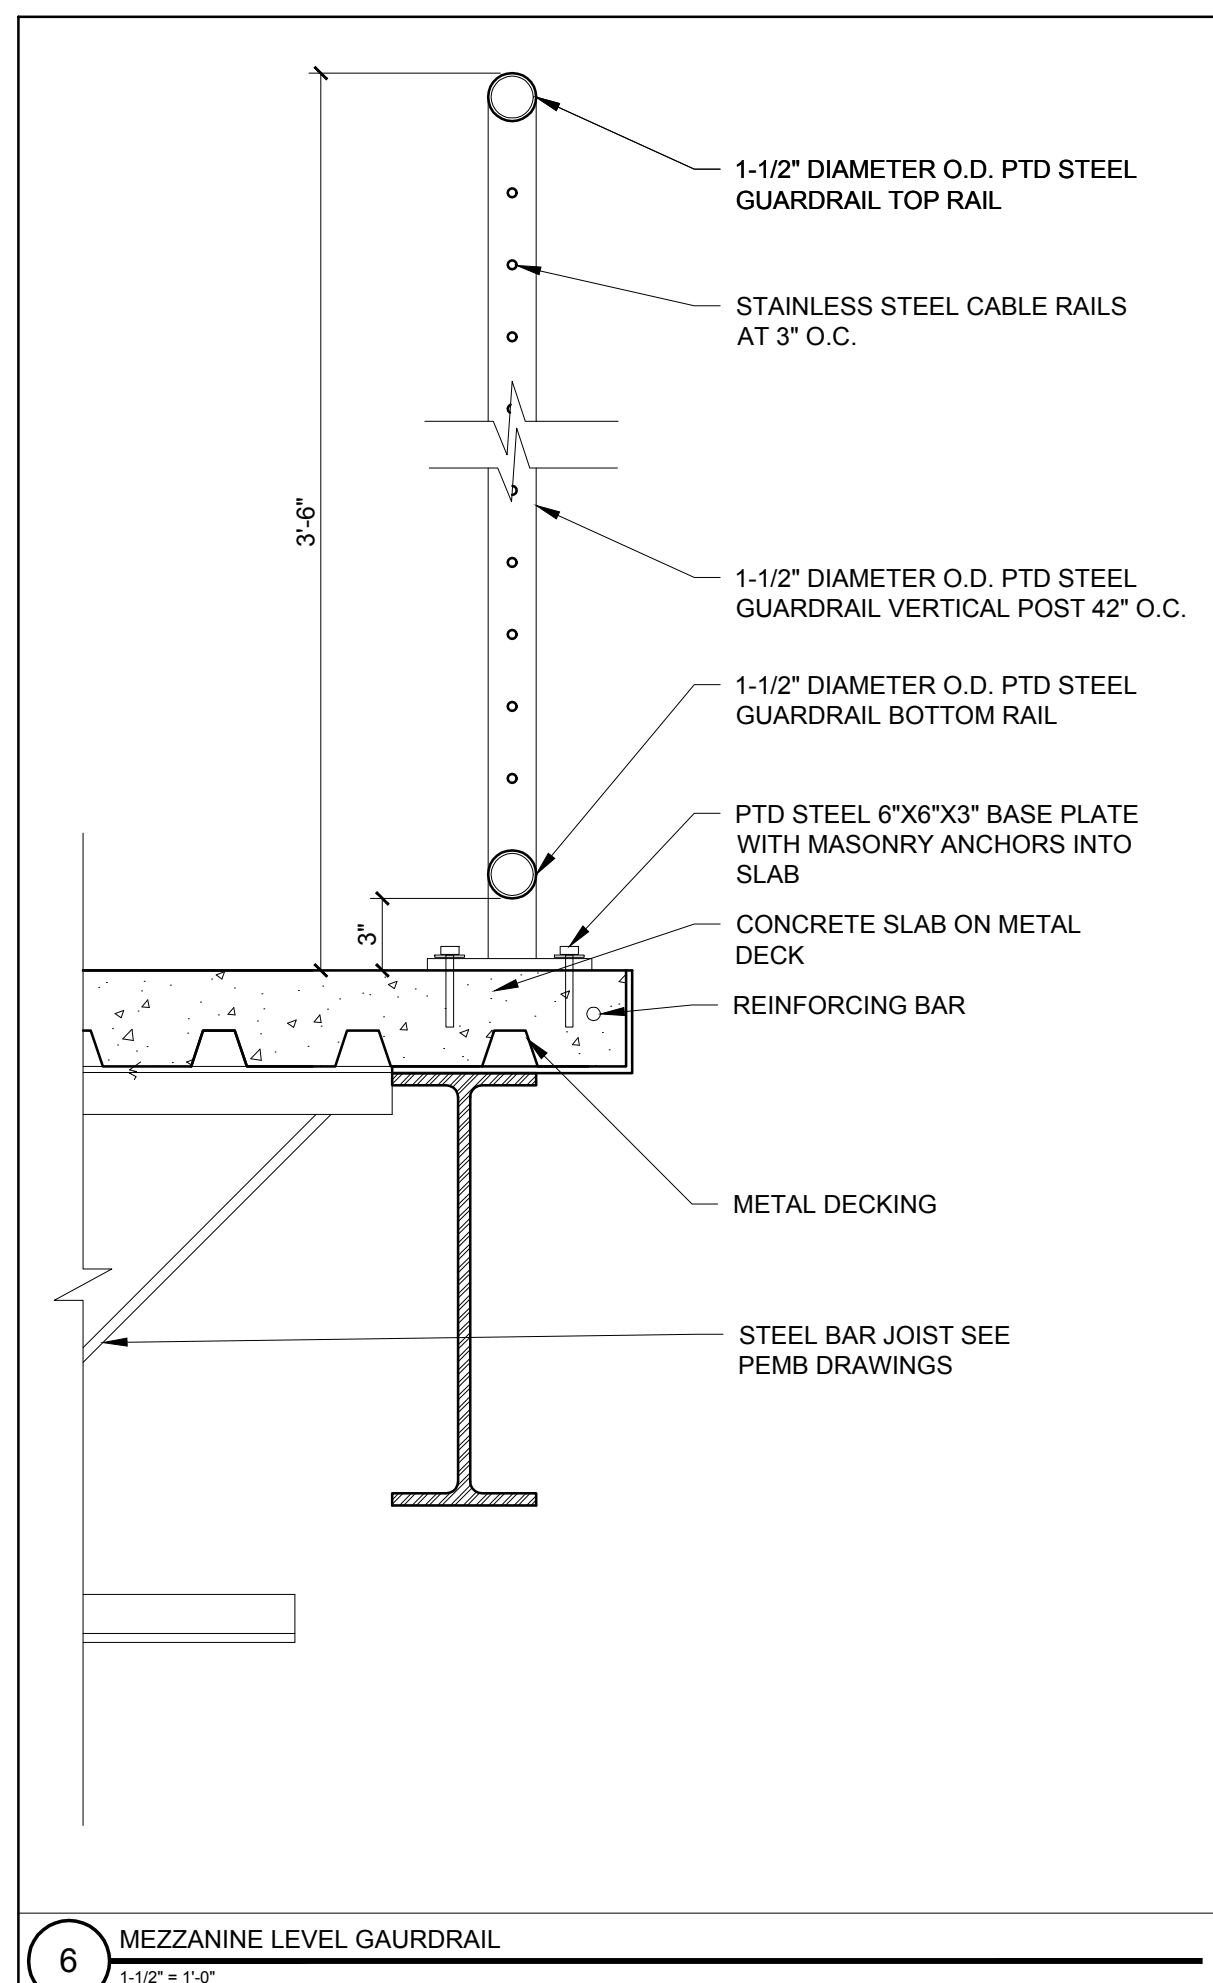
6 MEZZANINE LEVEL GAURDRAIL
1:1/2" = 1'-0"

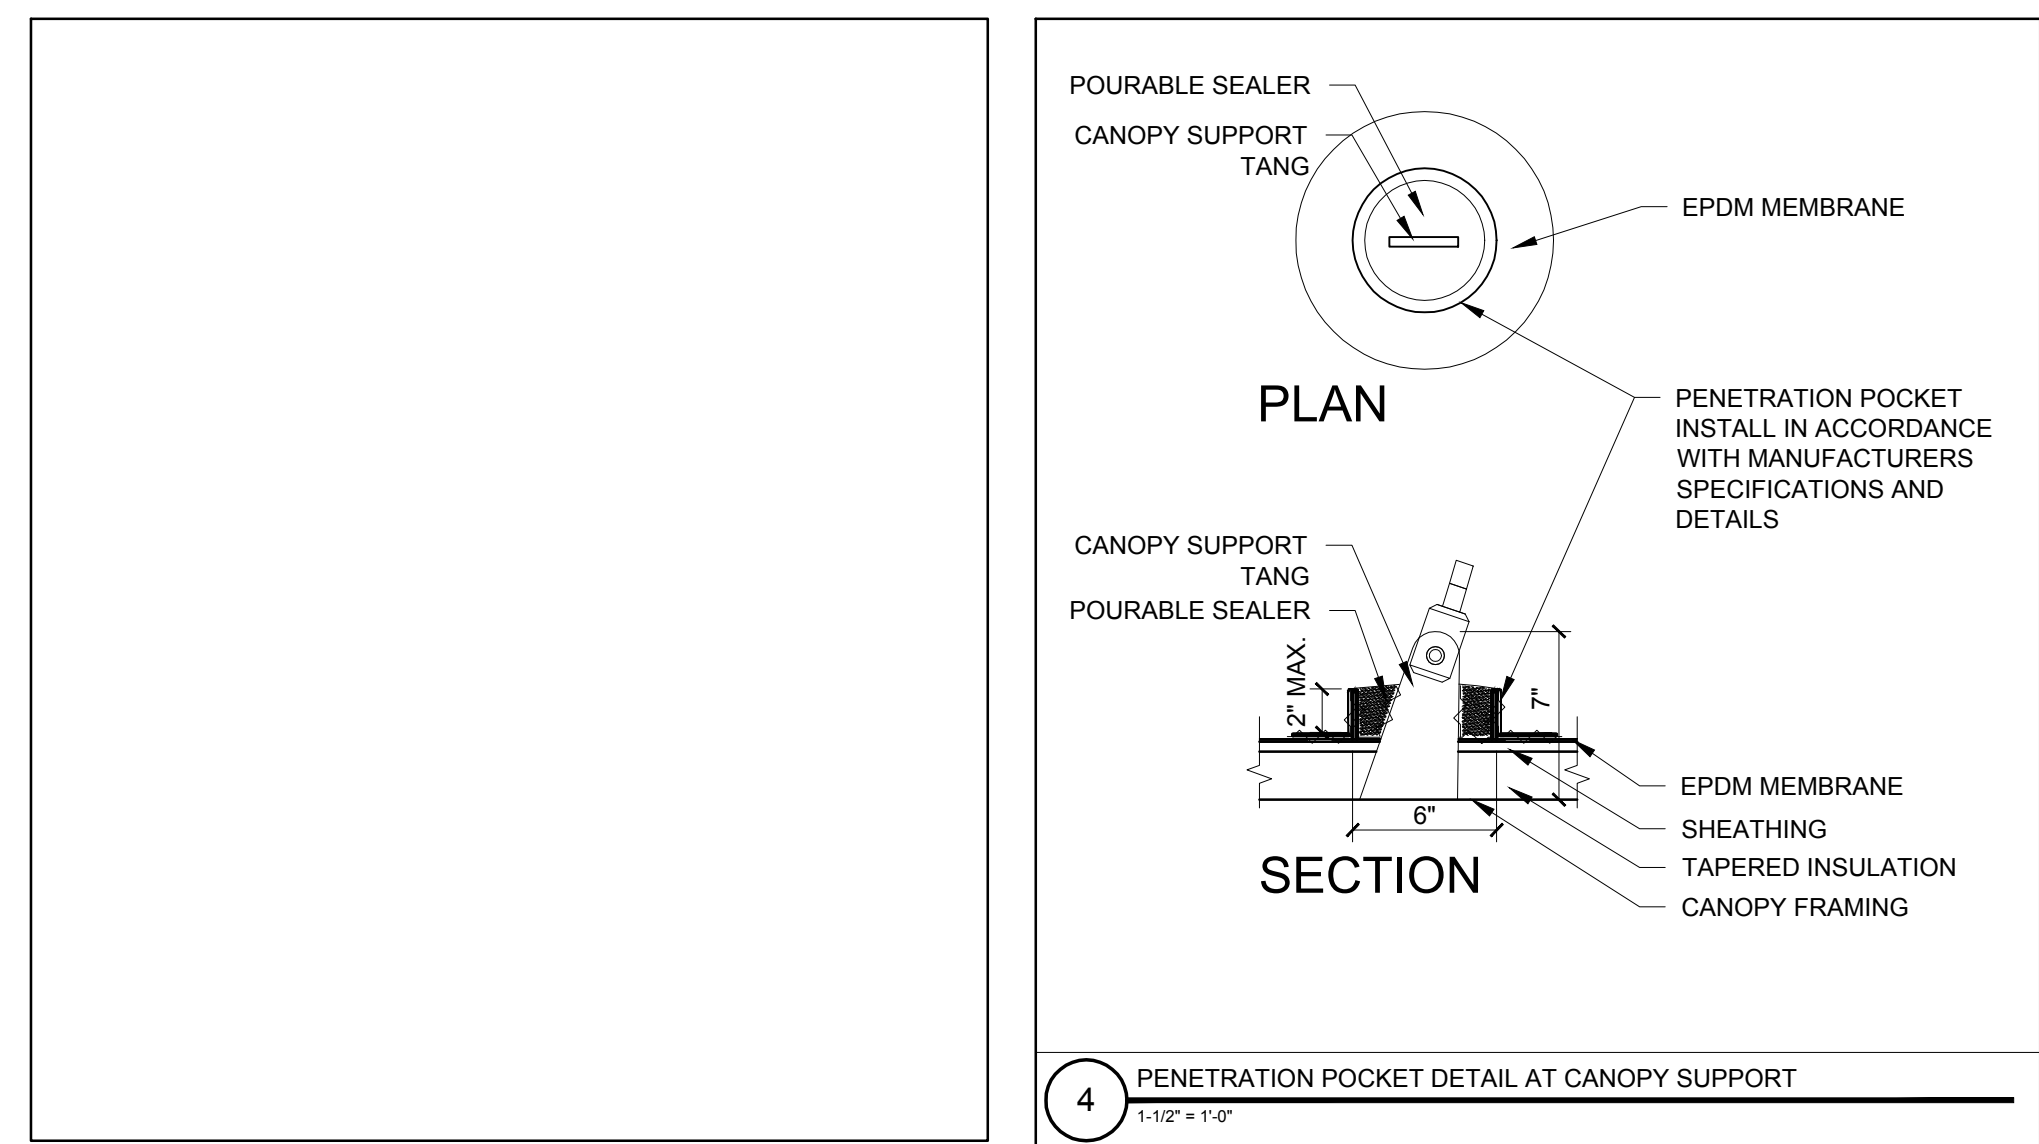
4 PENETRATION POCKET DETAIL AT CANOPY SUPPORT
1:1/2" = 1'-0"

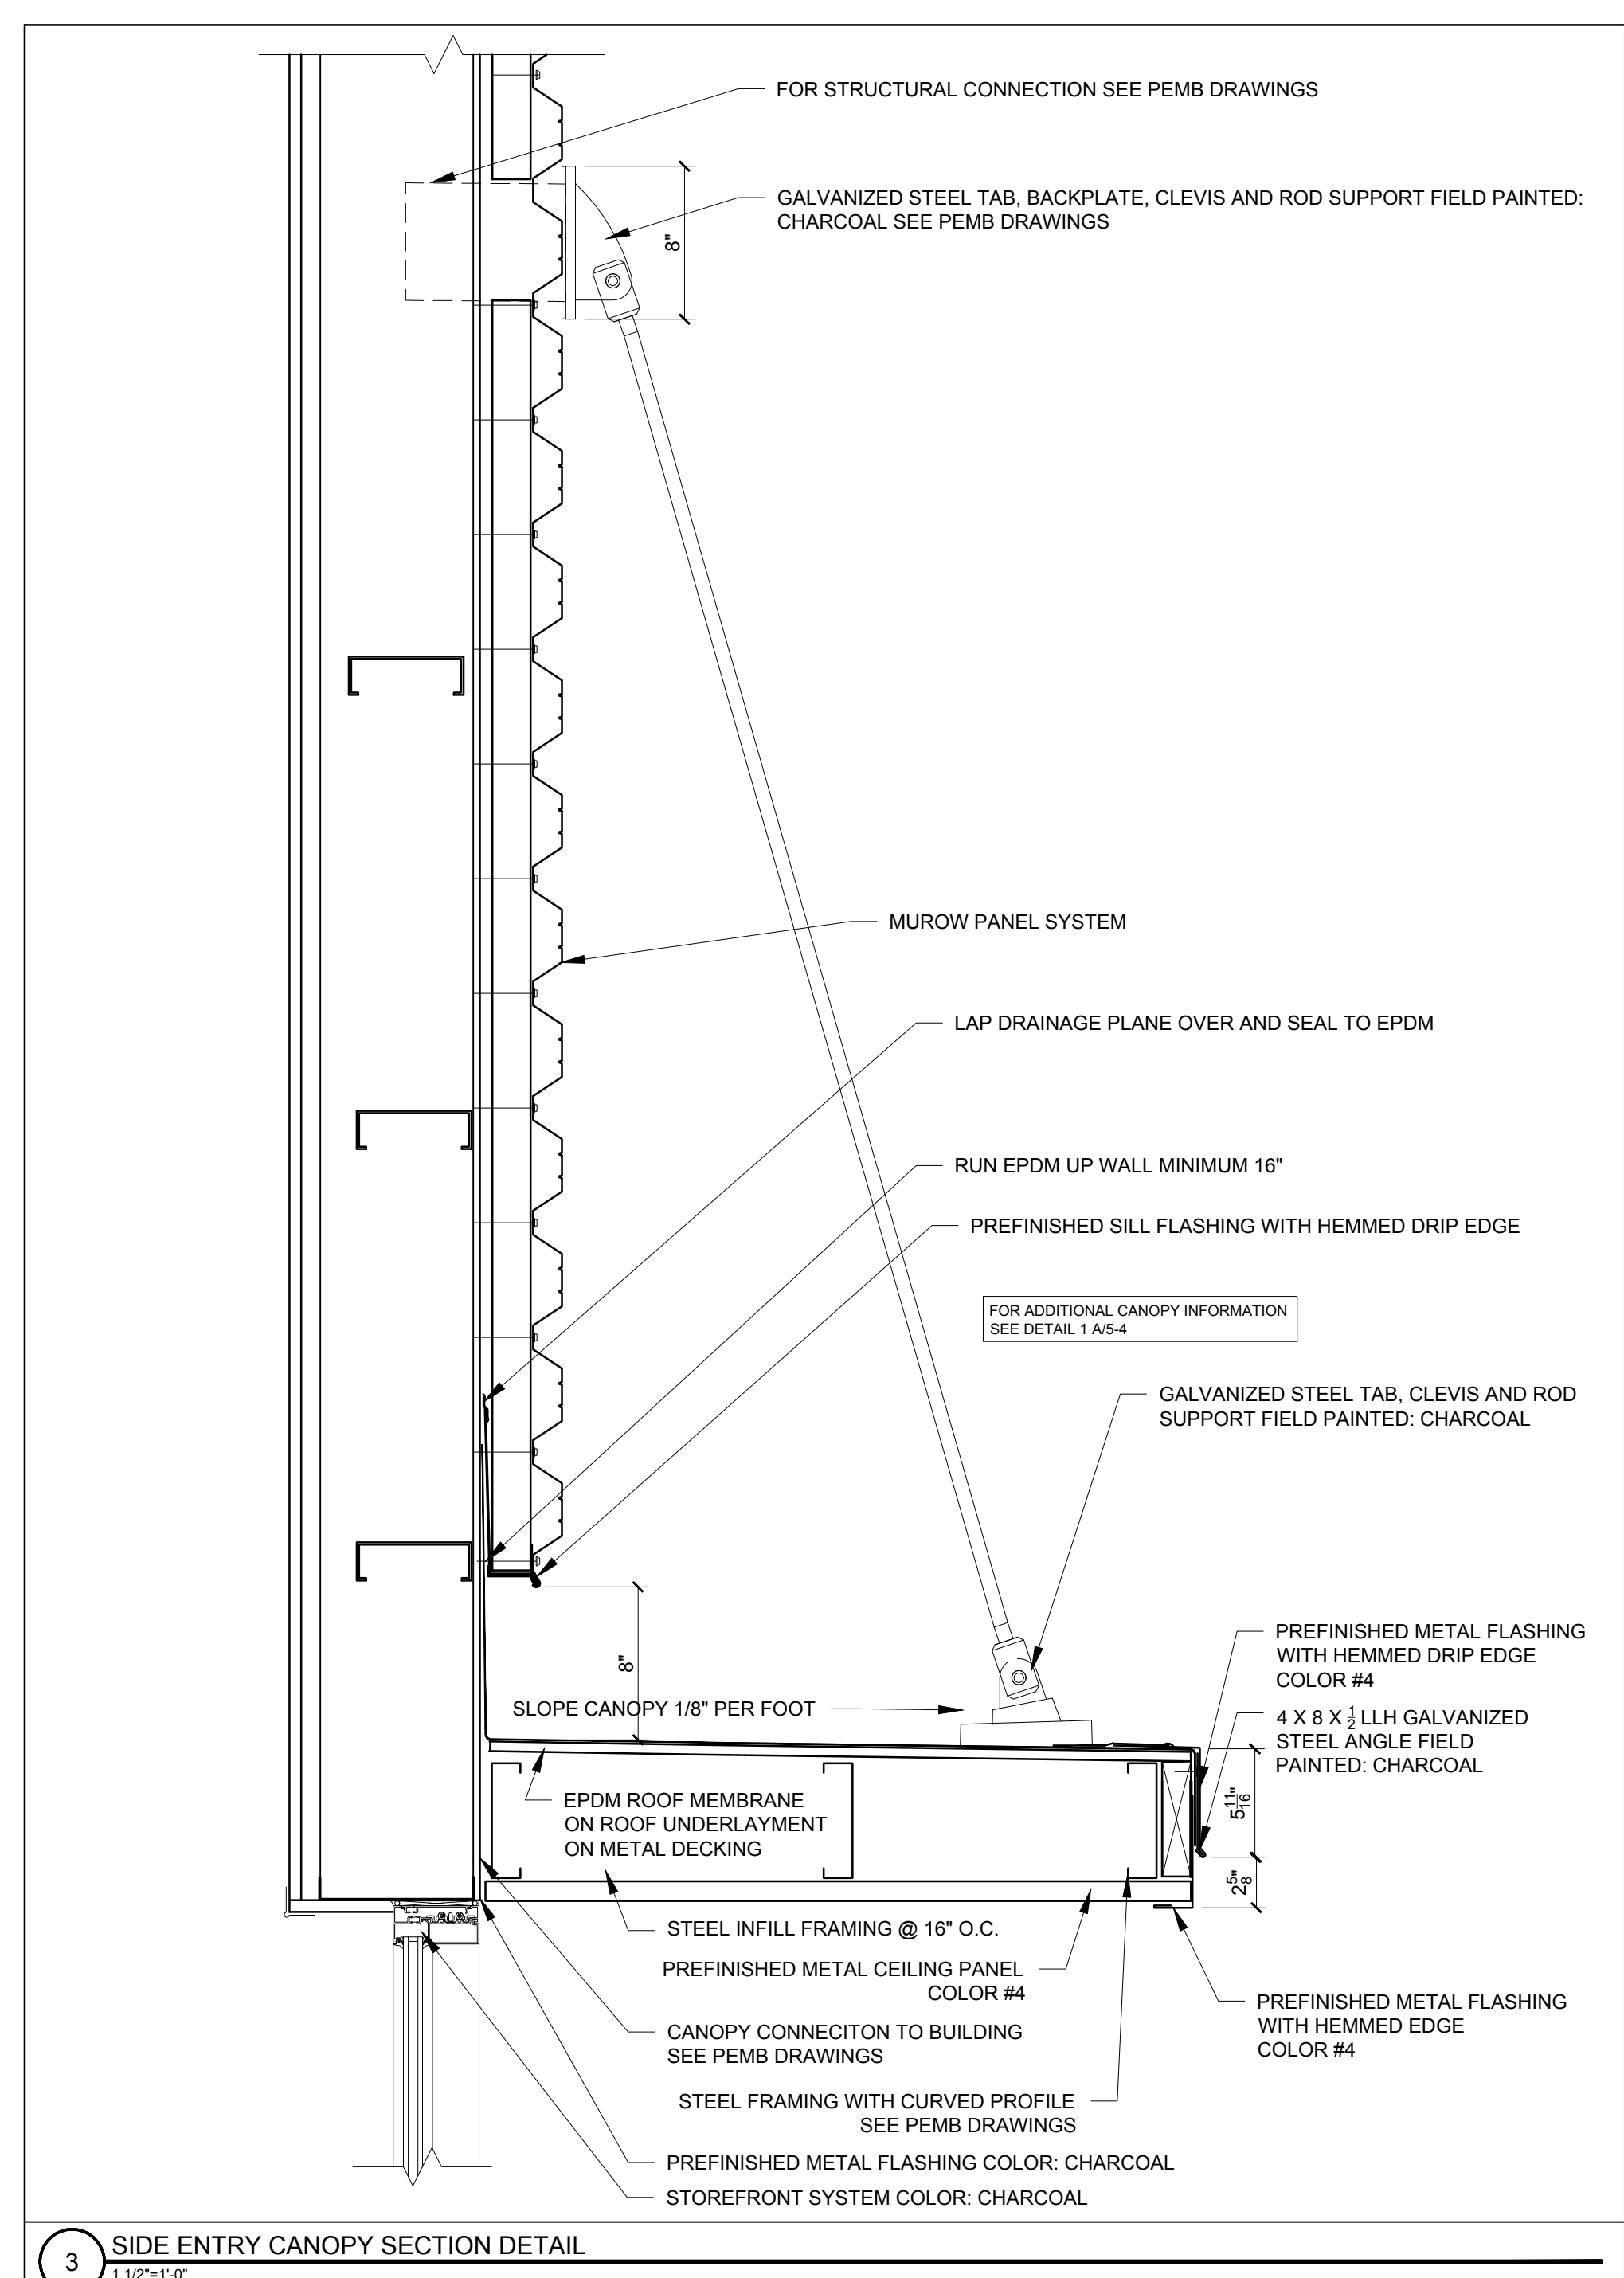
3 SIDE ENTRY CANOPY SECTION DETAIL
1:1/2" = 1'-0"

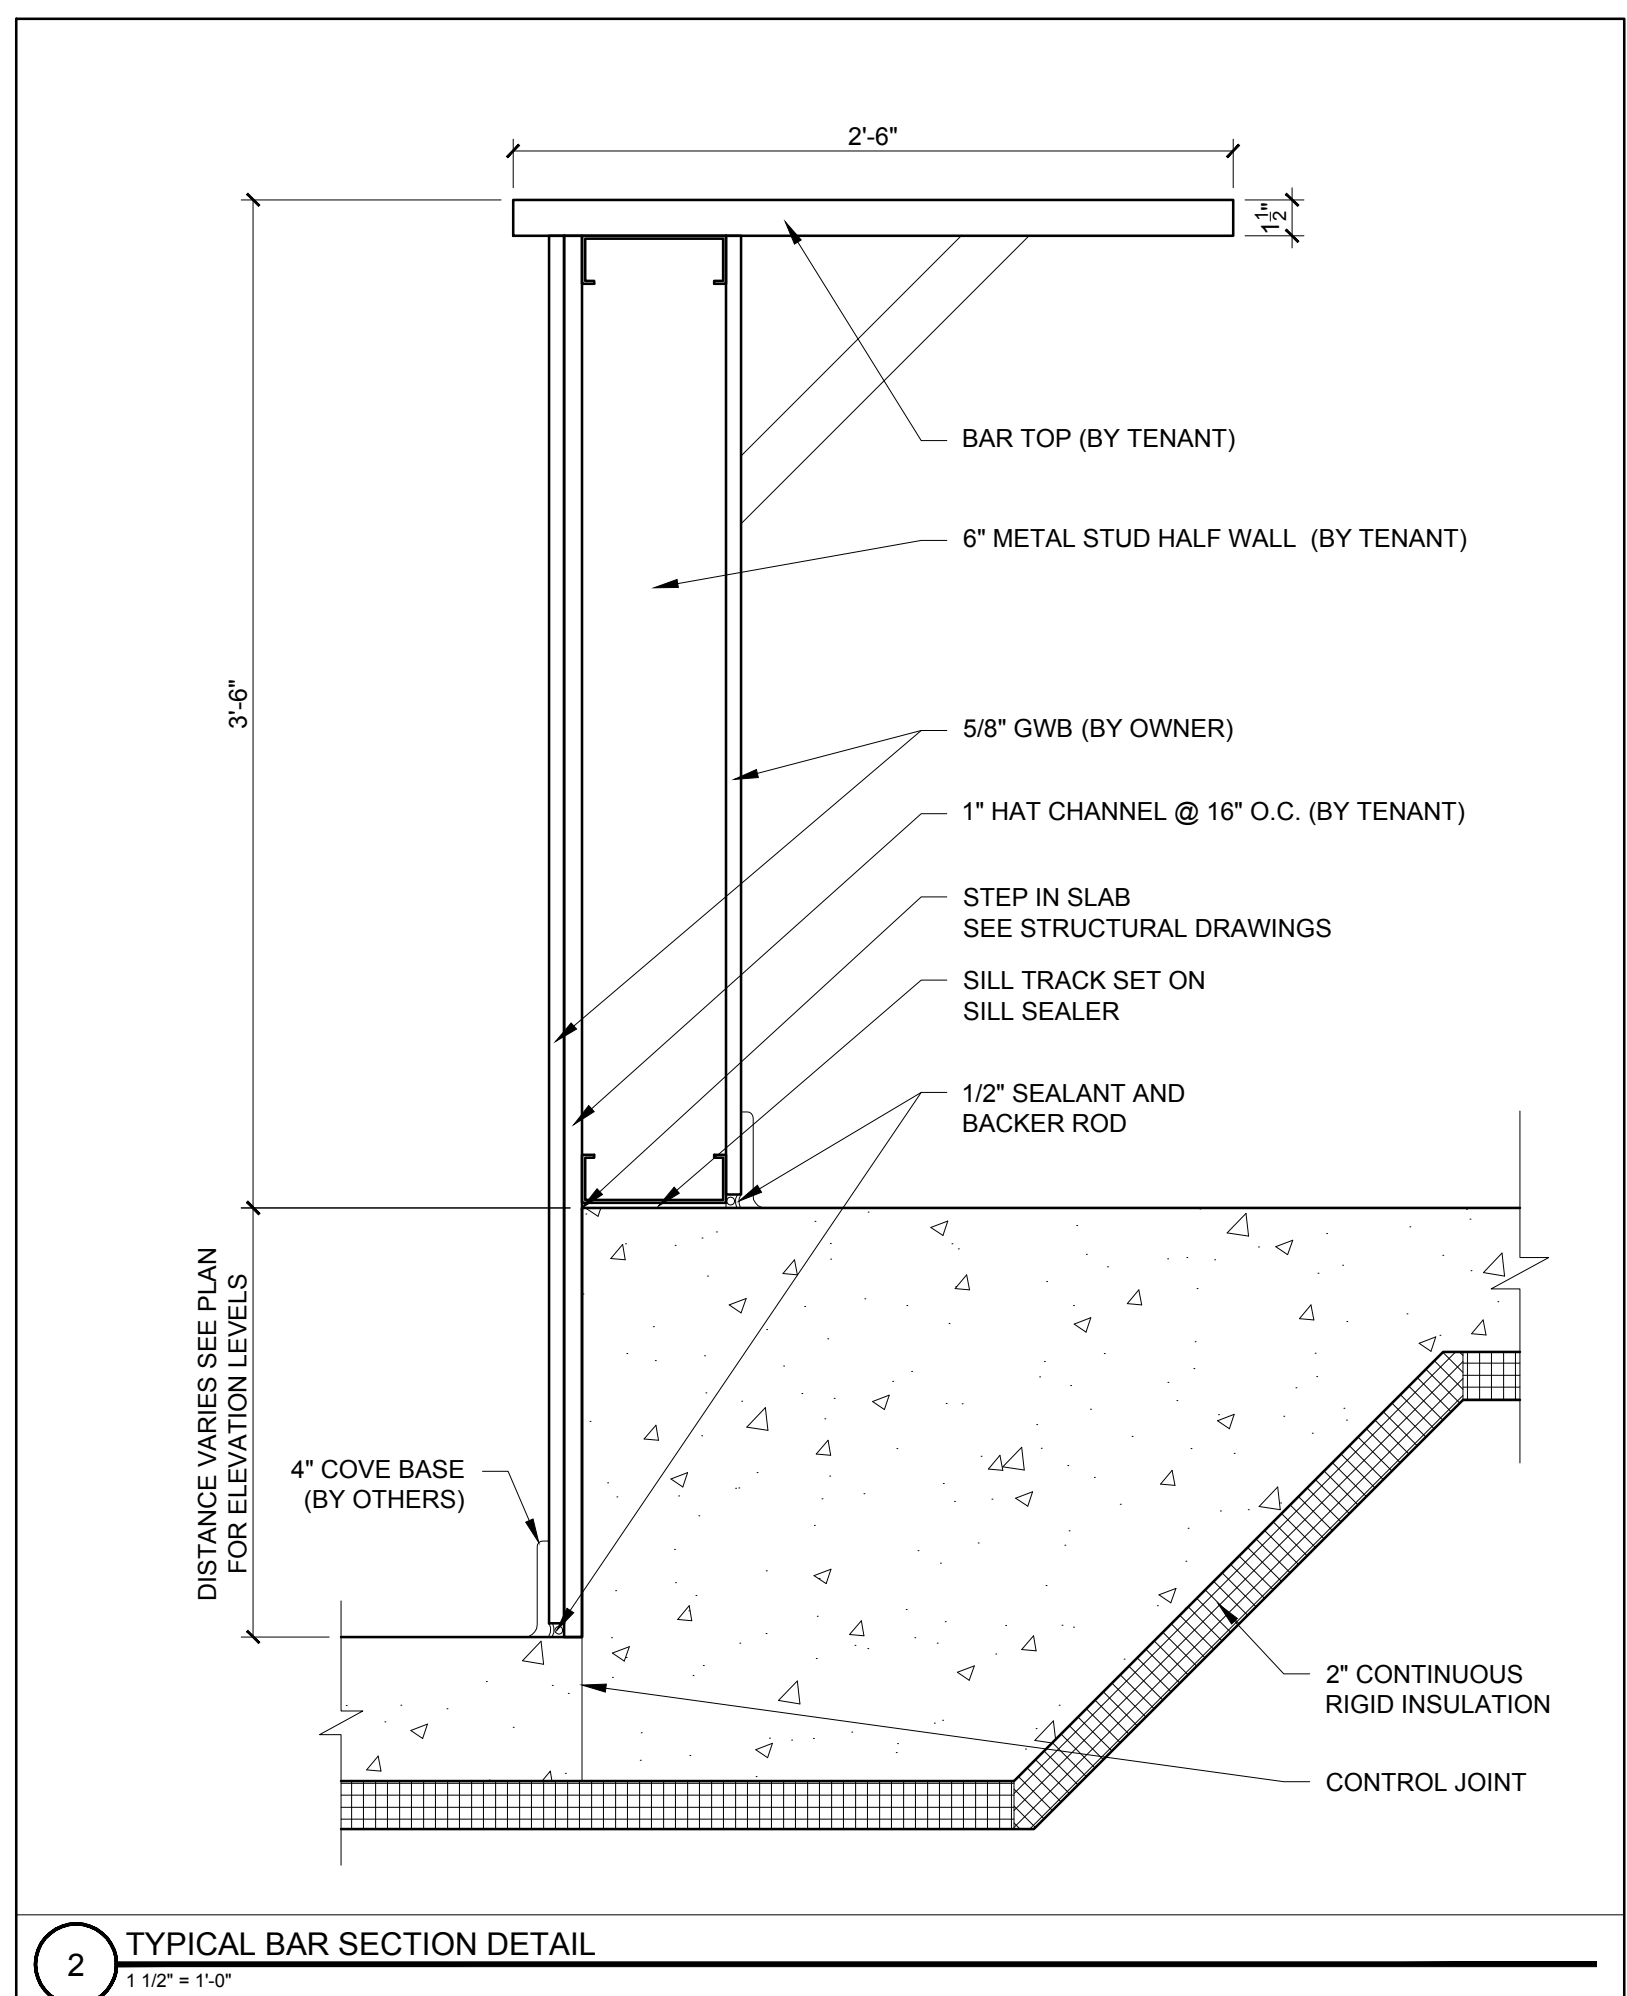
2 TYPICAL BAR SECTION DETAIL
1:1/2" = 1'-0"

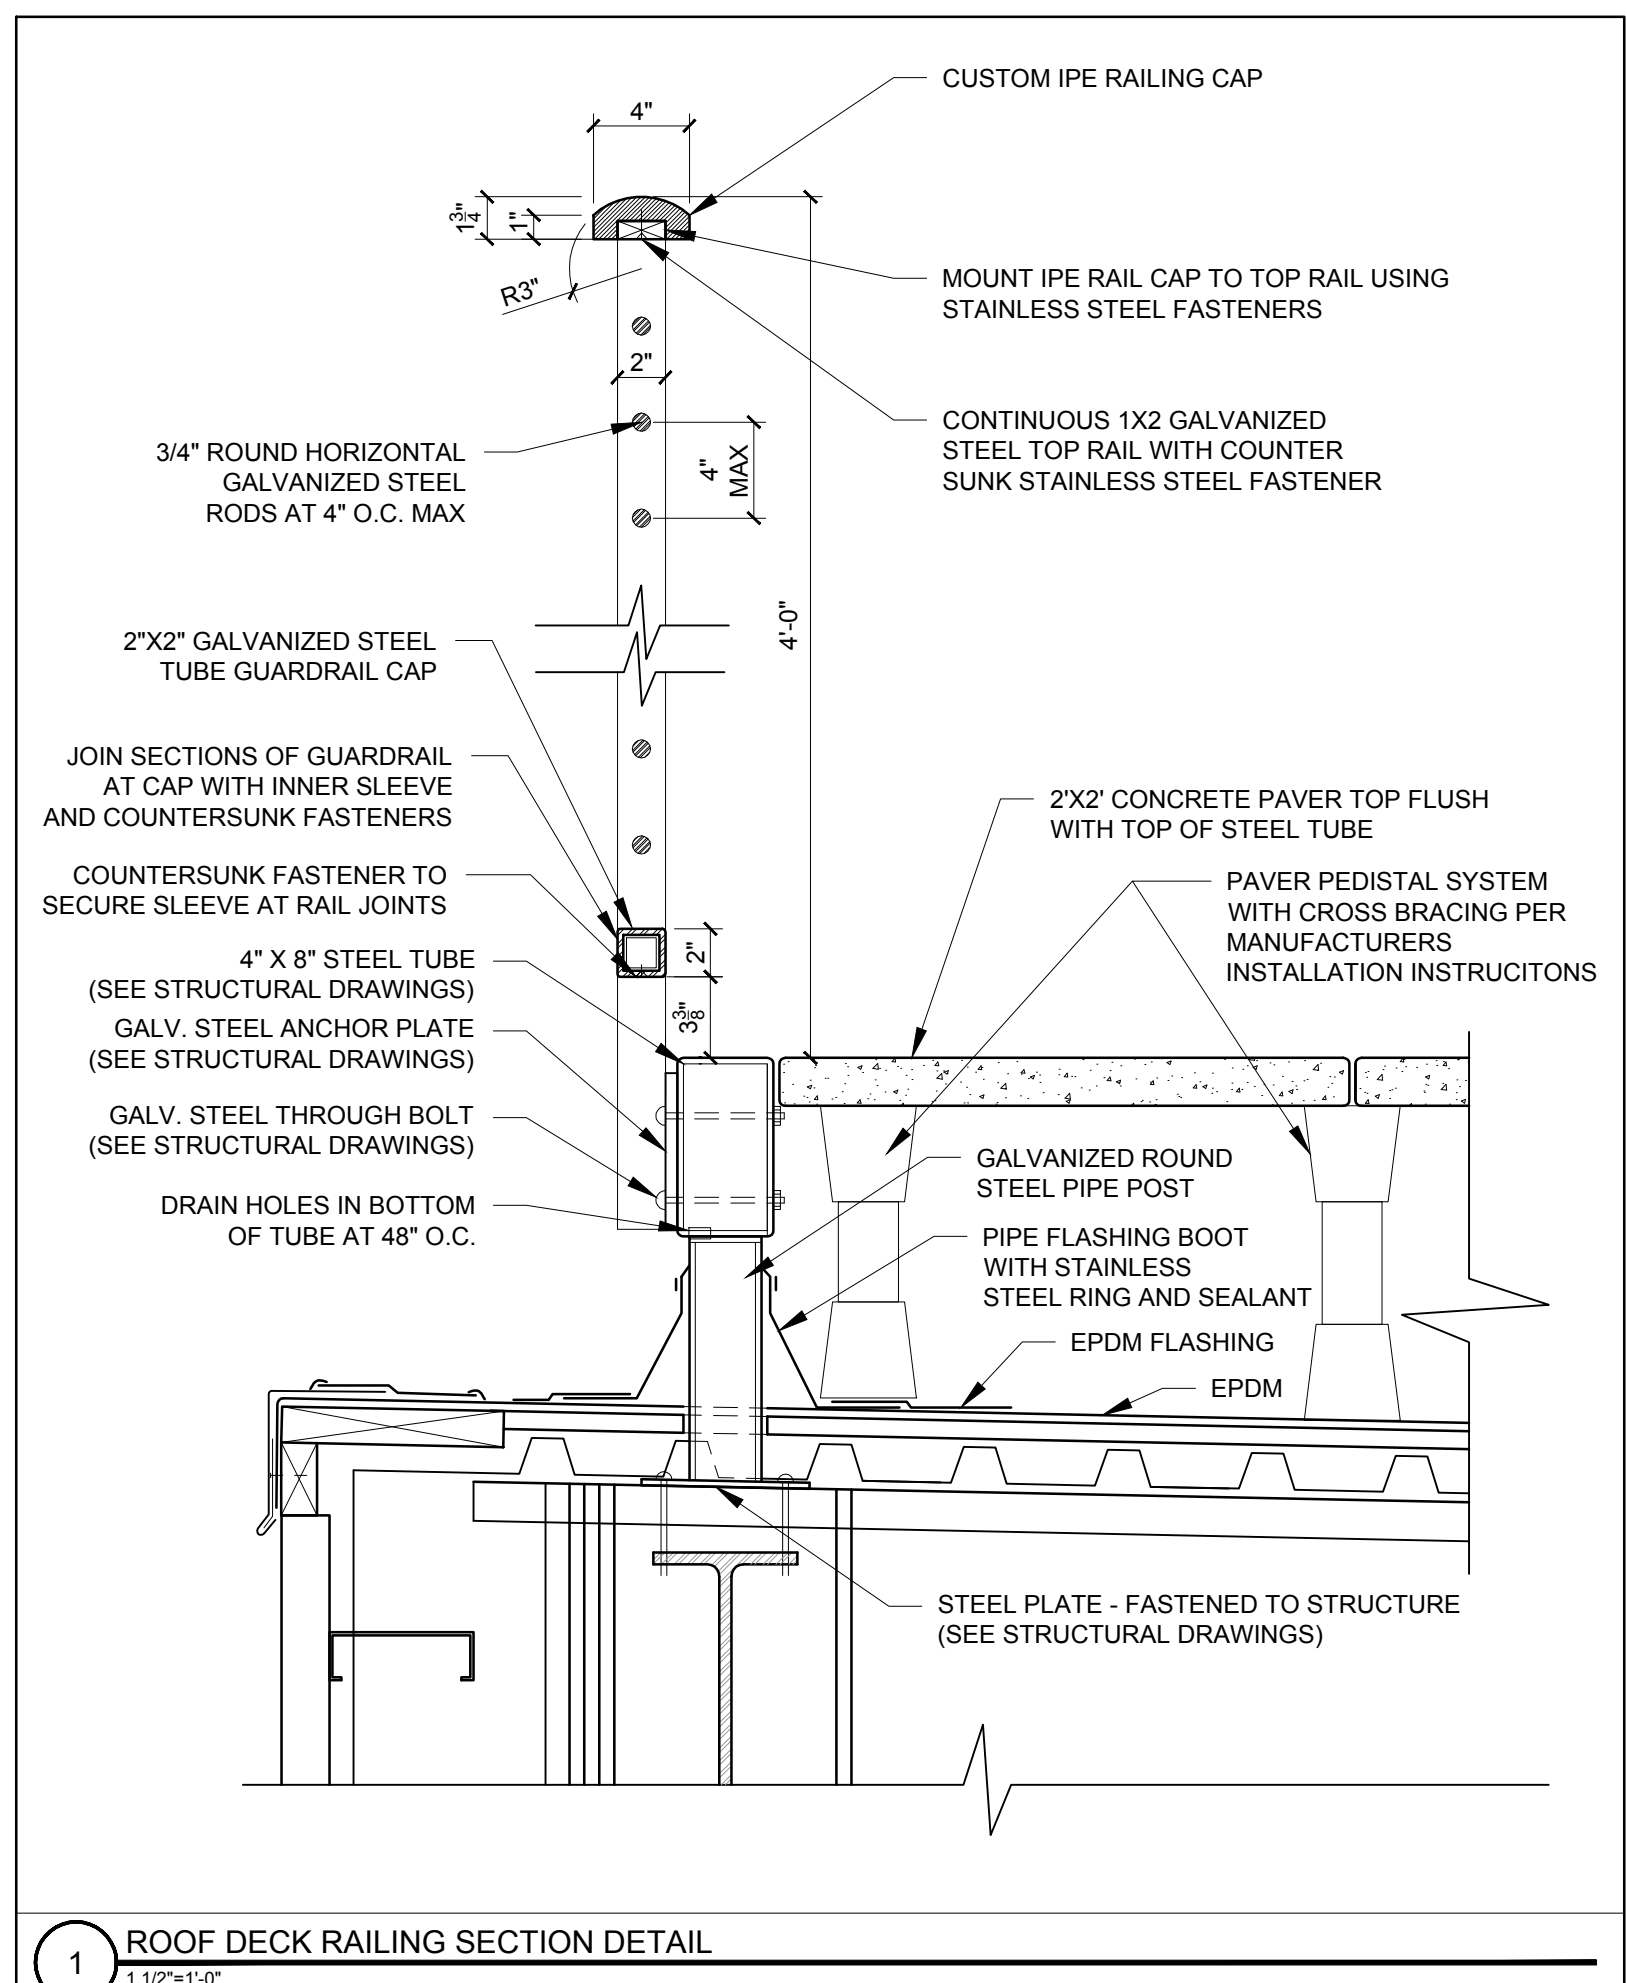
1 ROOF DECK RAILING SECTION DETAIL
1:1/2" = 1'-0"
