## Field Report #3

**Project:** Gateway PG - High St Façade Repairs Phase 1  
**Project #:** WO 3521  
**Date/Time:** October 16, 2015, 10:30 a.m.  
**Observers** Adam Sampson (BSE)

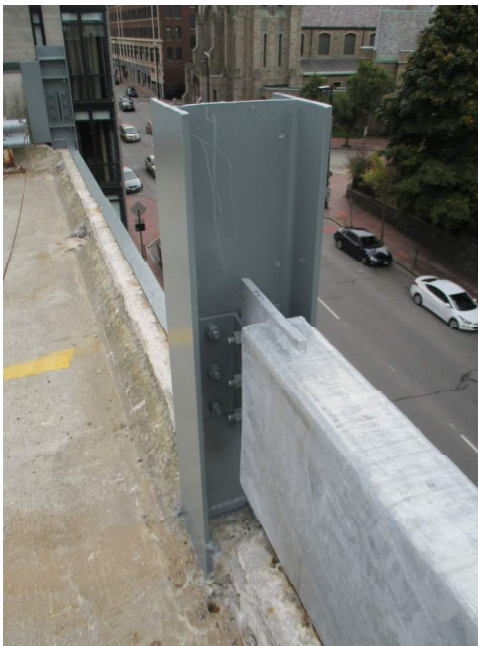
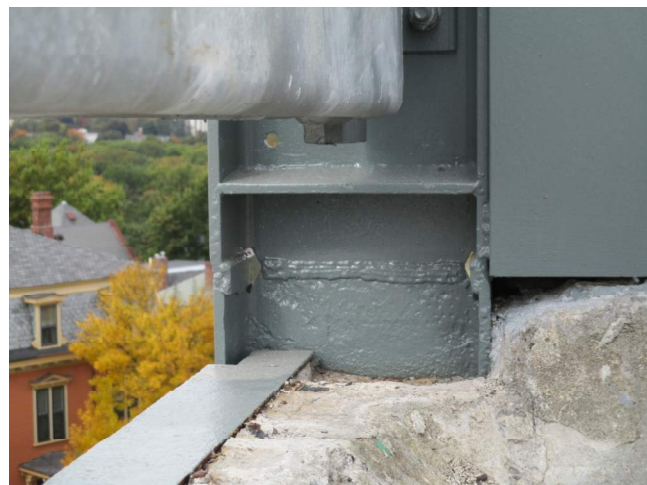
1. SCF and KISC has installed all bumpers at the roof level except between column lines 1 and 2. All column extensions have cleaned, primed and painted.
2. Holes for the bottom pedestrian cable need to be drilled into the existing columns at column line 1 and 13 and primed and painted prior to installation of cables. (Update as of 10/19/15 the column holes have been drilled.)

3. Any scratches or dings in the column extensions or HSS bumpers coatings should be touched up with paint or cold galvanizing, respectively.
4. KISC has removed roughly half the CMU block wall and brick façade from the 3<sup>rd</sup> level. The CMU has been reinforced but un-grouted providing no lateral resistance to the wall.

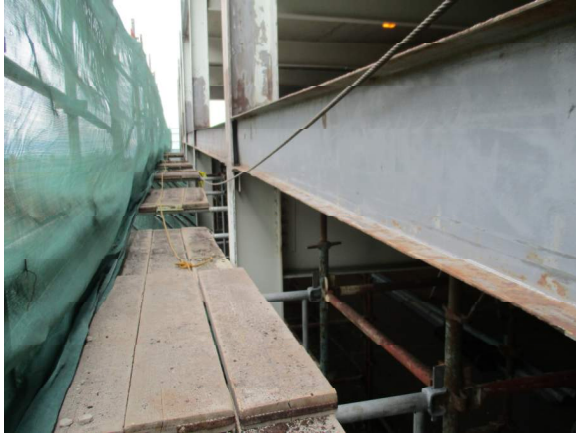
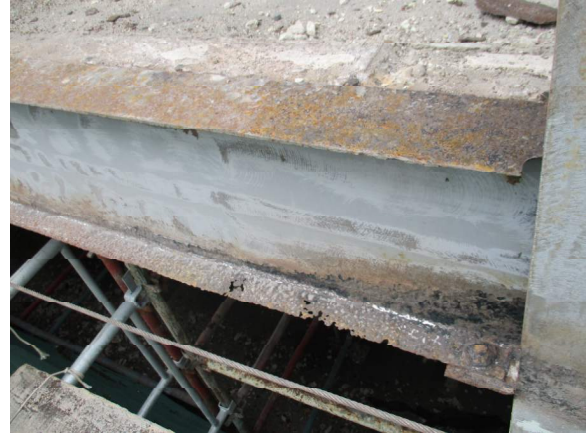
5. Generally, the existing exposed beams and columns are in fair to good condition. Repairs may need to be made at two areas showing section loss on the beam flange (between column lines 13/12 and 9/8). Once the steel has been cleaned to show the full extent of the section loss, BSE will review the condition and provide a sketch if a repair is necessary.

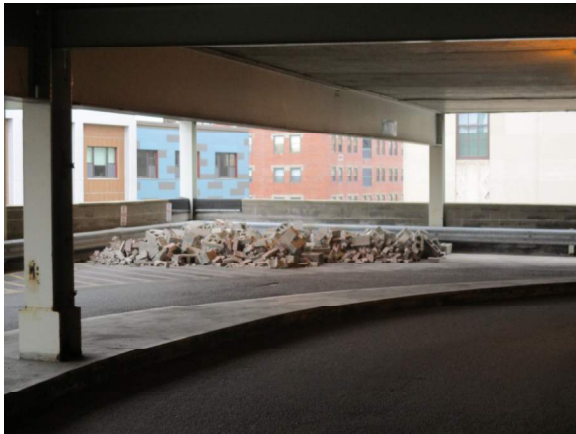
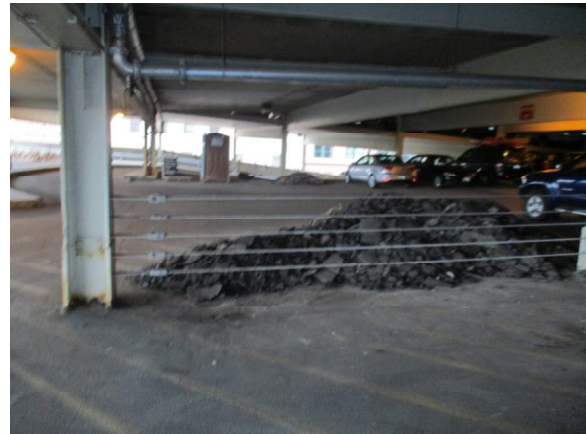
6. KISC is beginning to clean the area of debris on the 3<sup>rd</sup> level to allow SCF to drill bolt and cable holes into the existing columns for the installation of the HSS bumpers and cables.
7. CMU, brick and asphalt demolition debris stored on the 1st level should be removed from the site at a minimum weekly basis.
