**Portland Harbor Hotel  
Interior Renovation,  
Phase I**

**Demolition  
Reflected Ceiling Plan**

**ID102**

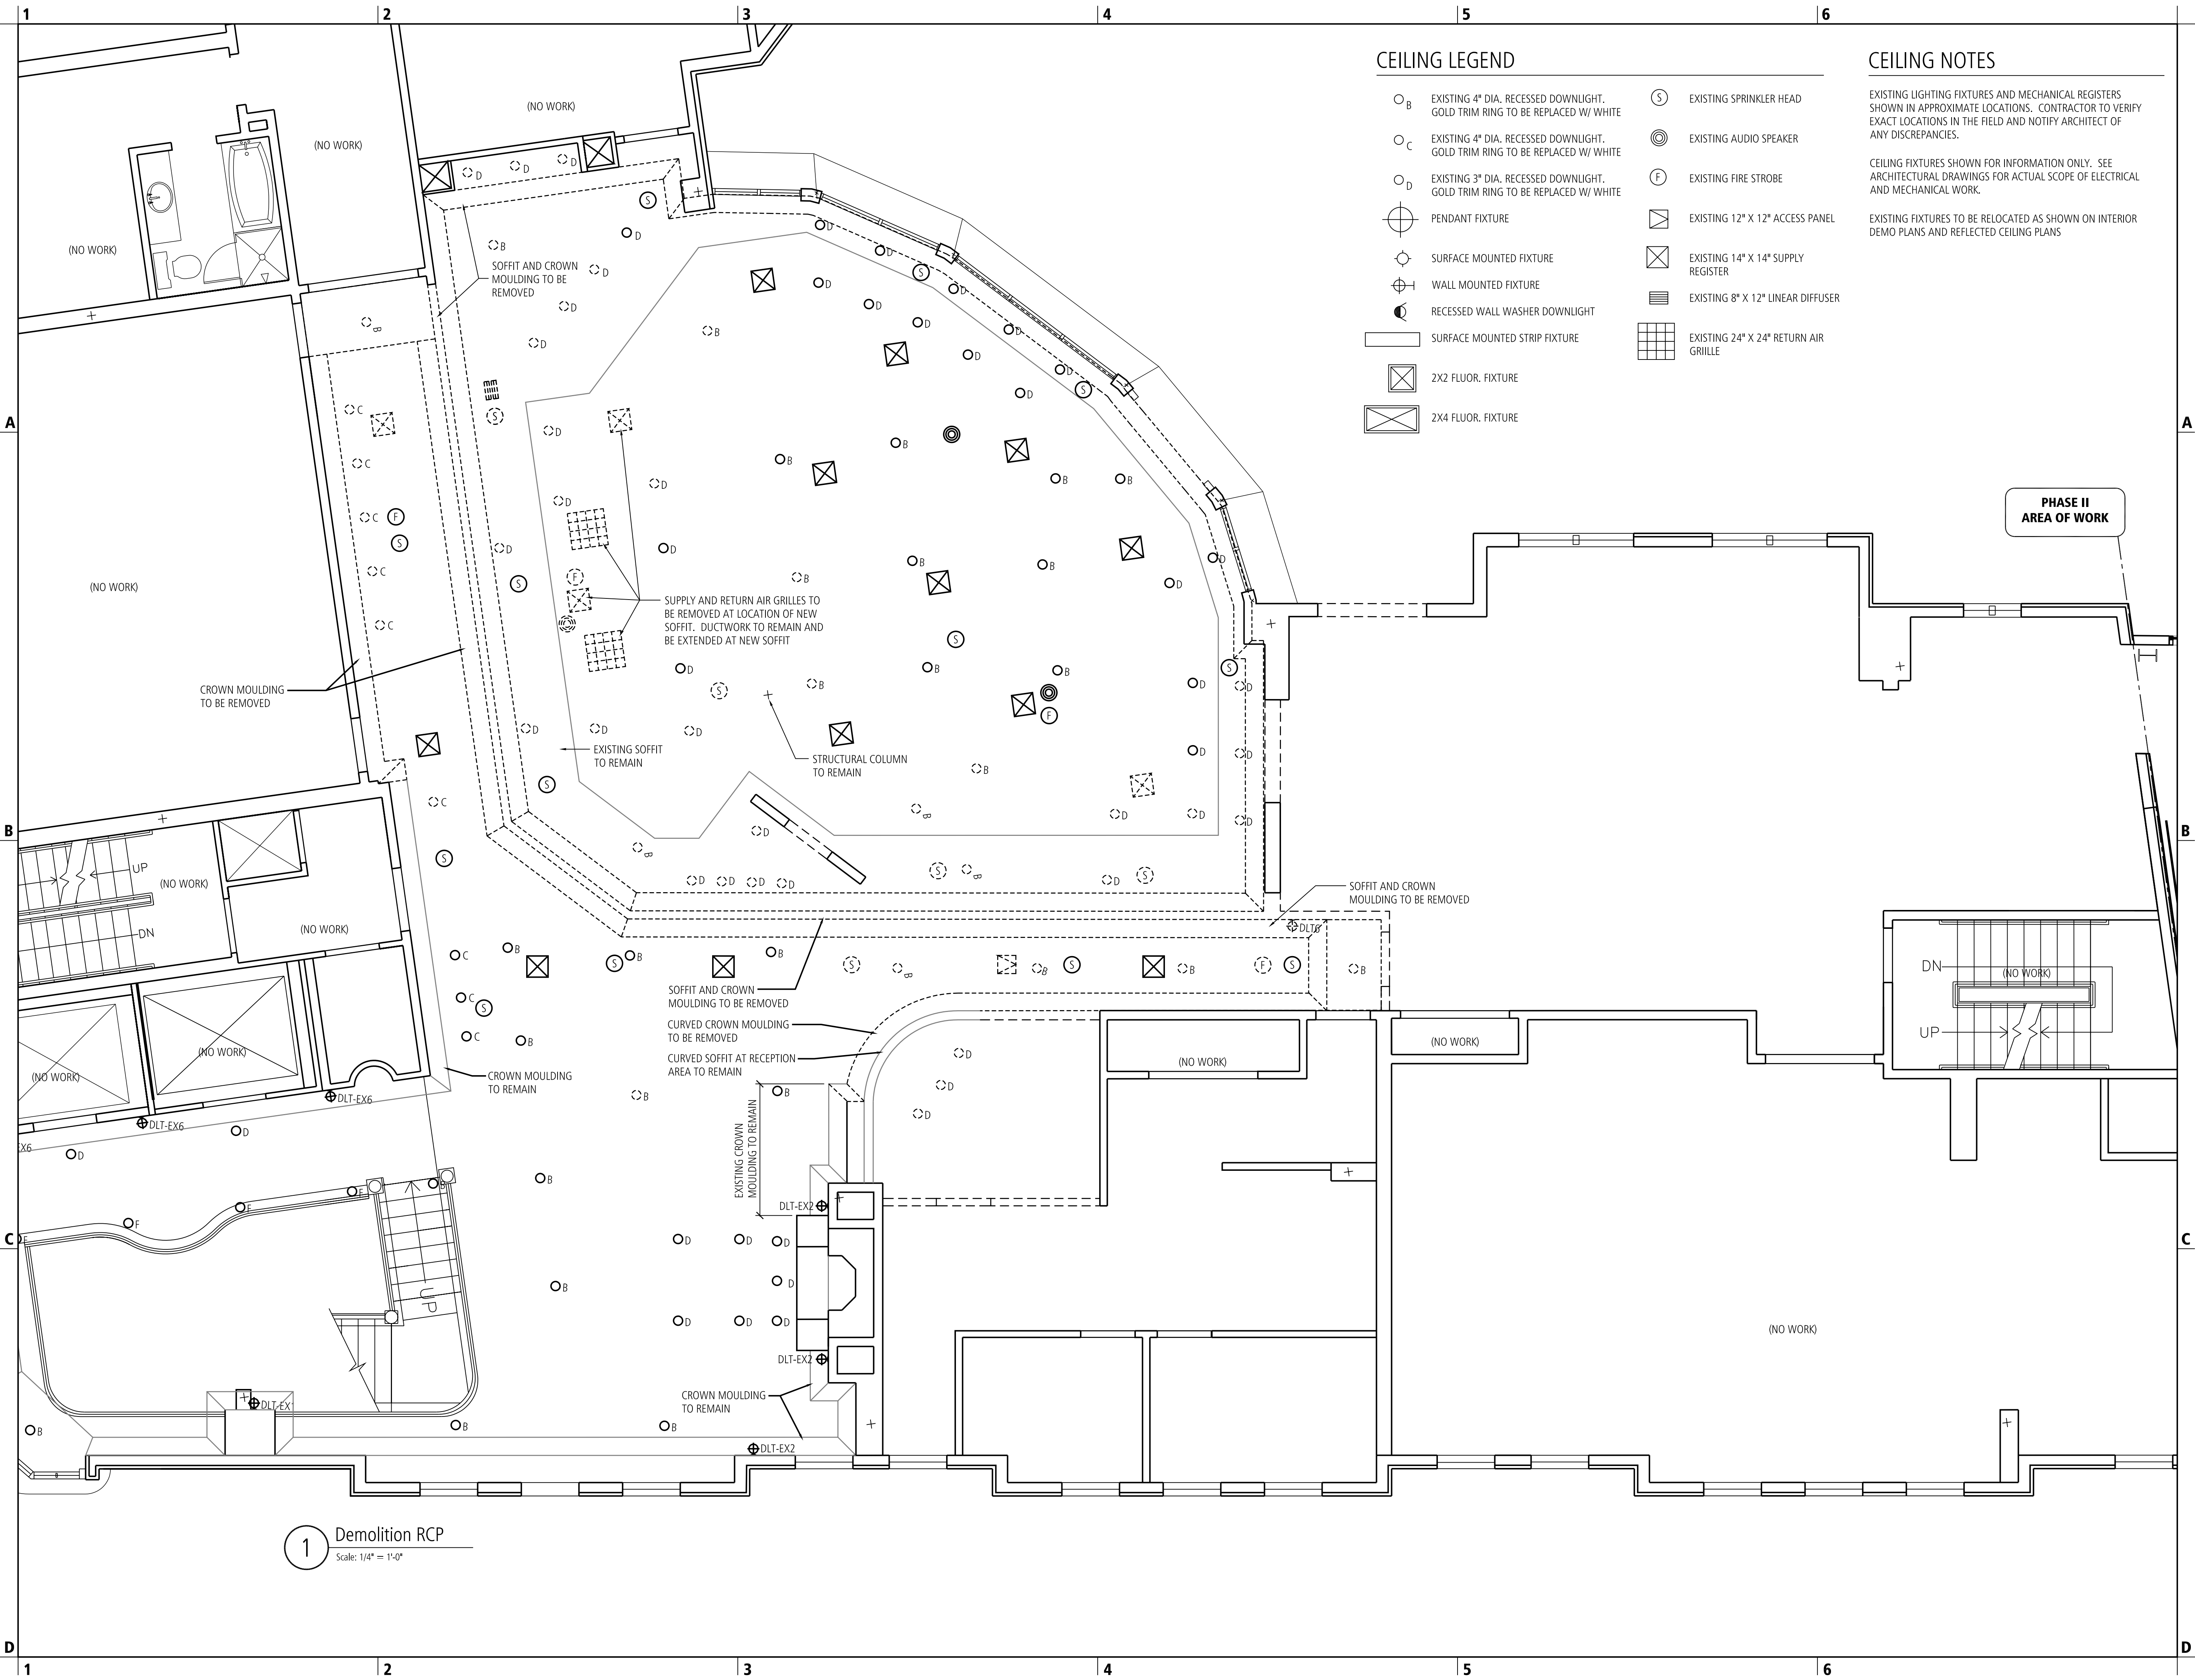
**1** Demolition RCP  
Scale: 1/4" = 1'-0"

EXISTING LIGHTING FIXTURES AND MECHANICAL REGISTERS SHOWN IN APPROXIMATE LOCATIONS. CONTRACTOR TO VERIFY EXACT LOCATIONS IN THE FIELD AND NOTIFY ARCHITECT OF ANY DISCREPANCIES.

EXISTING FIXTURES TO BE RELOCATED AS SHOWN ON INTERIOR DEMO PLANS AND REFLECTED CEILING PLANS
