Greater Portland Landmarks
Safford House
Roof and Eave Restoration
93 High Street
Portland, Maine

Title:
Roof Details
Sheet No: **A-5**

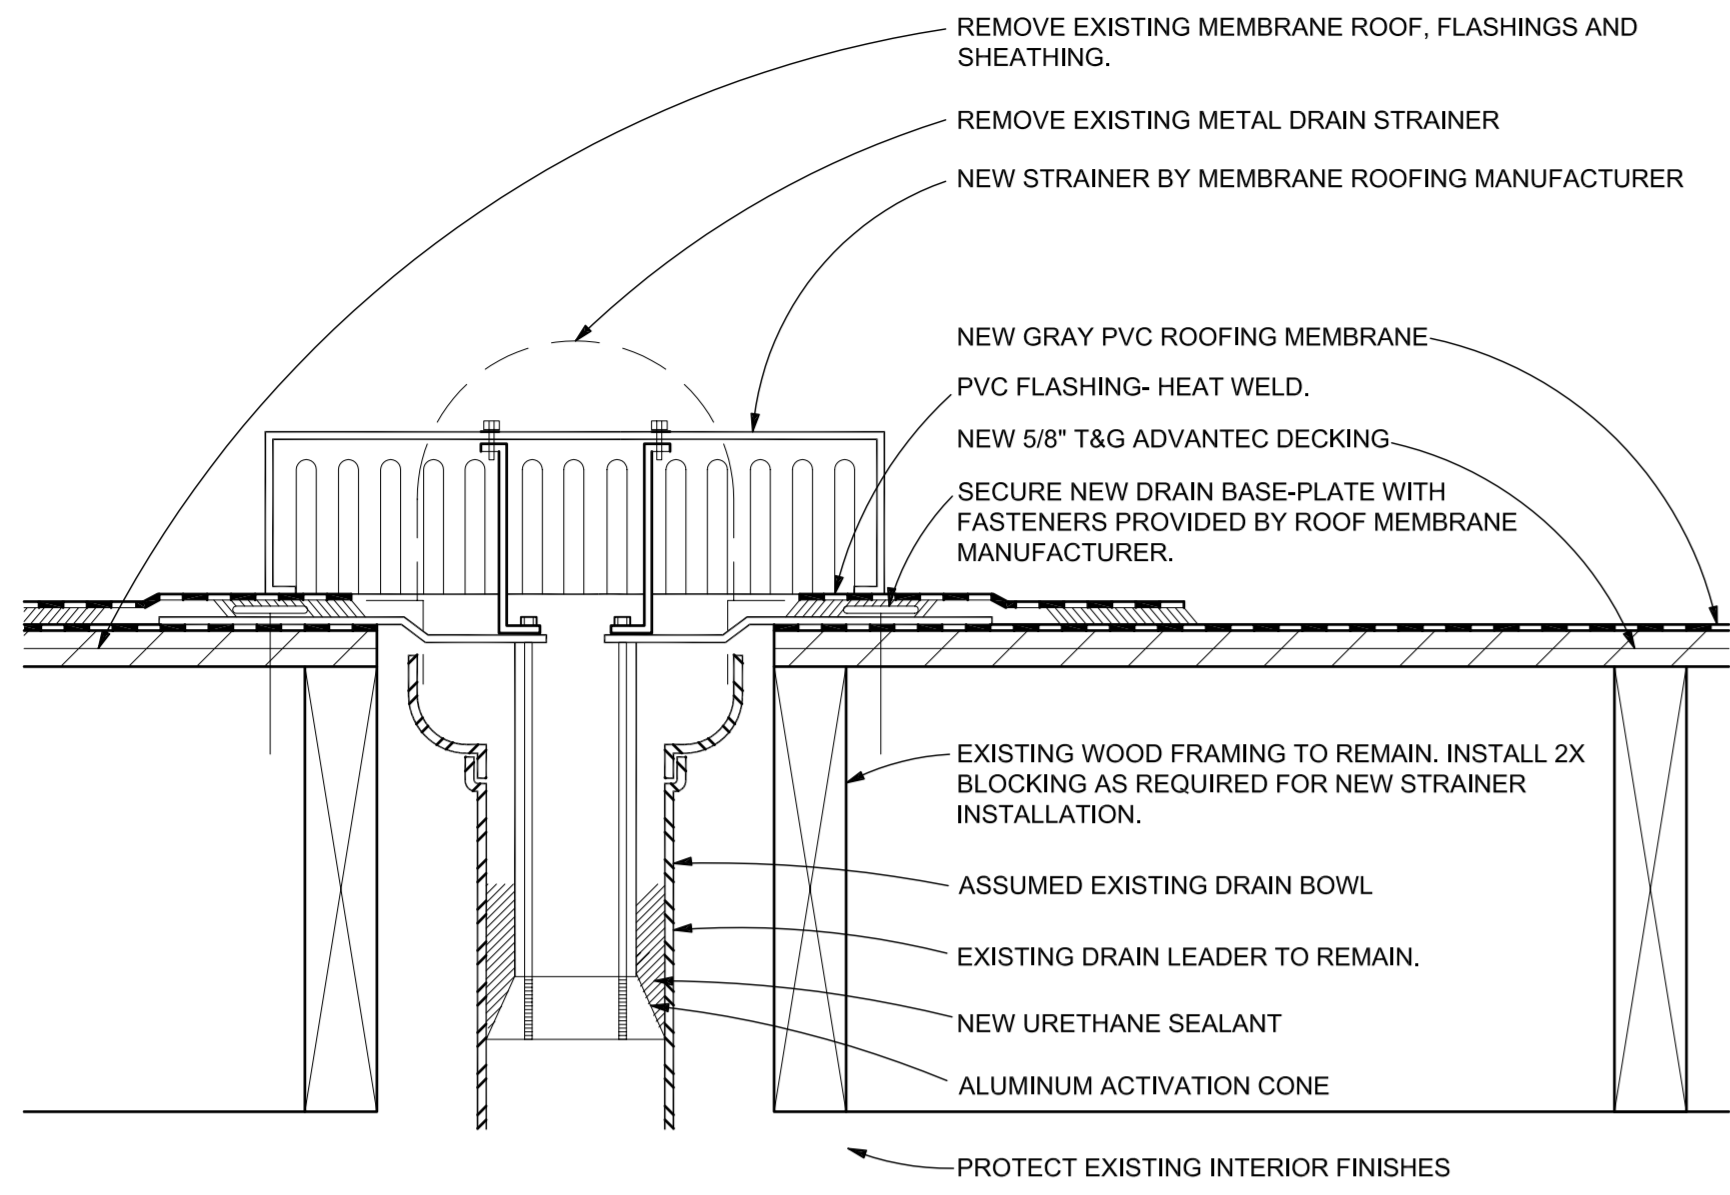
1 SECTION AT ROOF DRAIN
A-5 3" = 1'-0"
