## Concrete Construction Observation Report

| <b>Project Name/Location:</b> | Marriott Courtyard | <b>Project No:</b> | 08-0494.2 |
| <b>Placement Location:</b> | Footing: line A, 8 to 4.6. line 8, A.7 to A.<br>Interior Spread footing: line 1 at G & K. | <b>SWCE Rep.:</b> | V. Terrell |

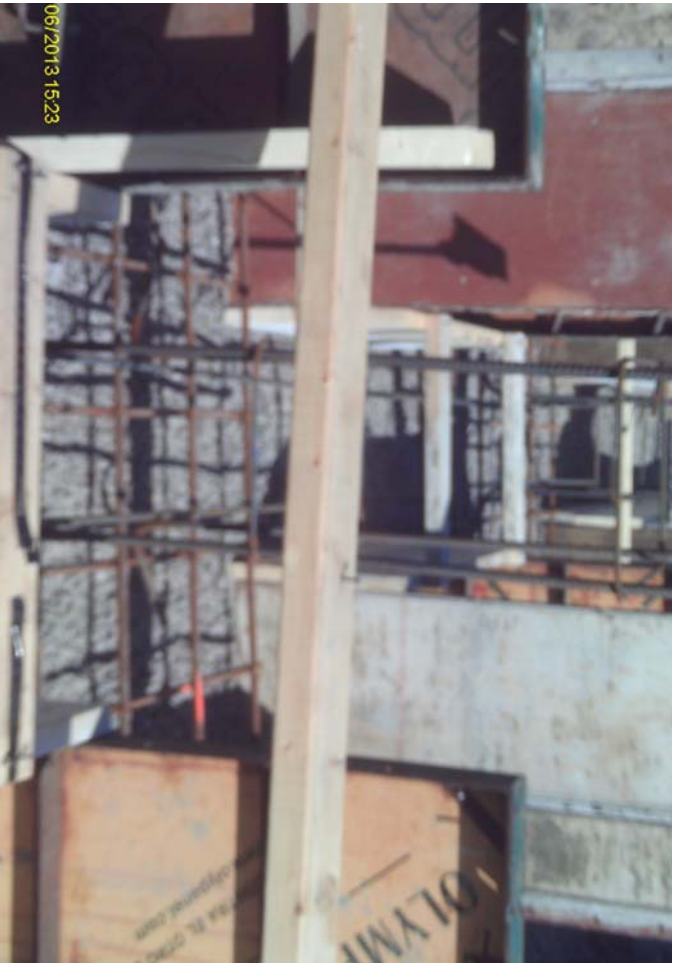
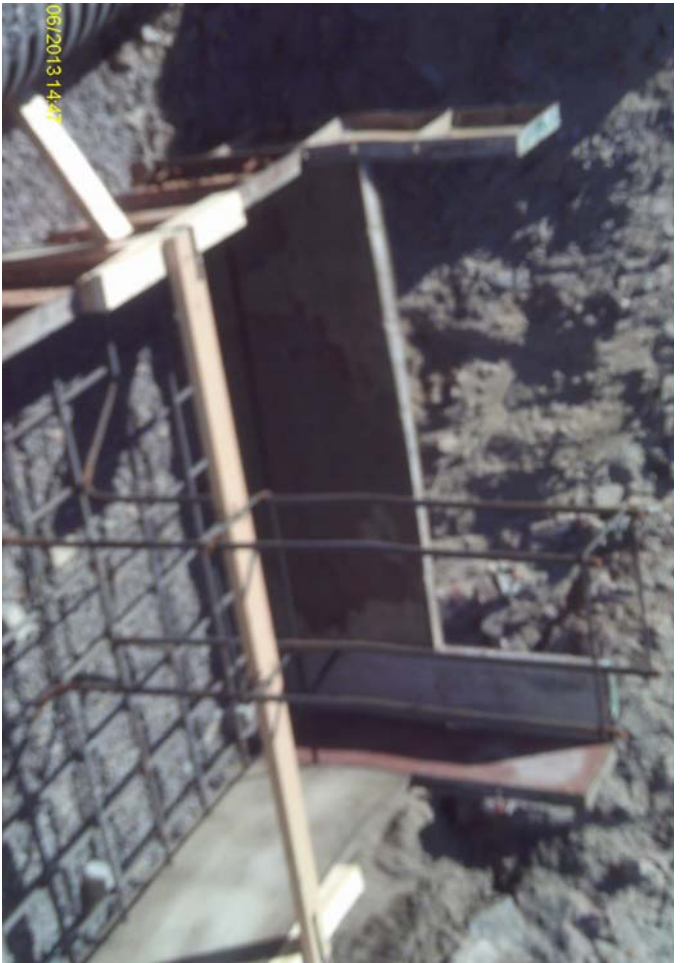
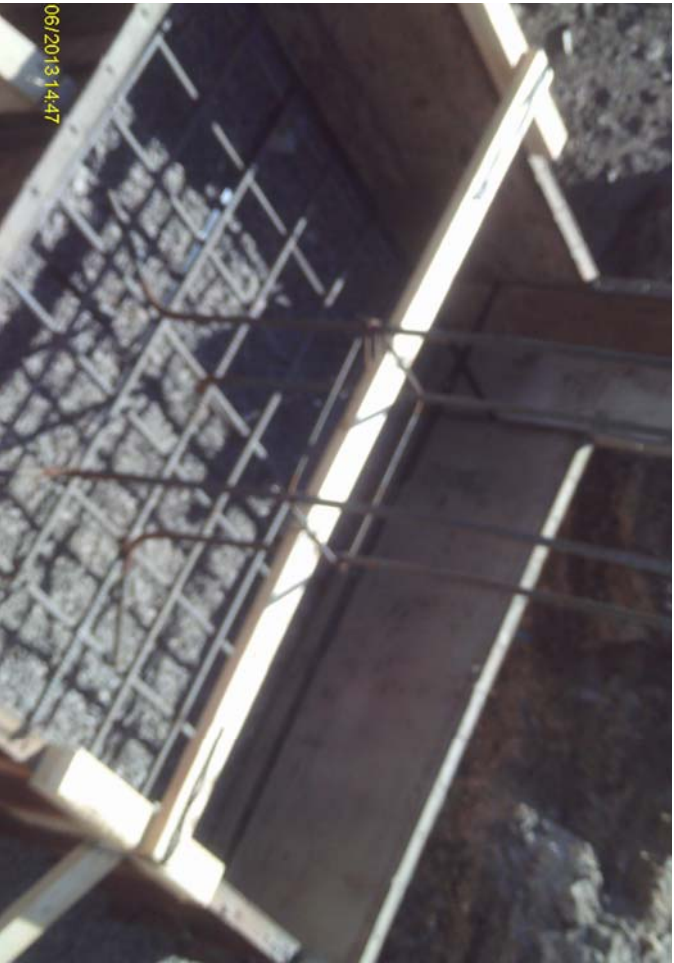
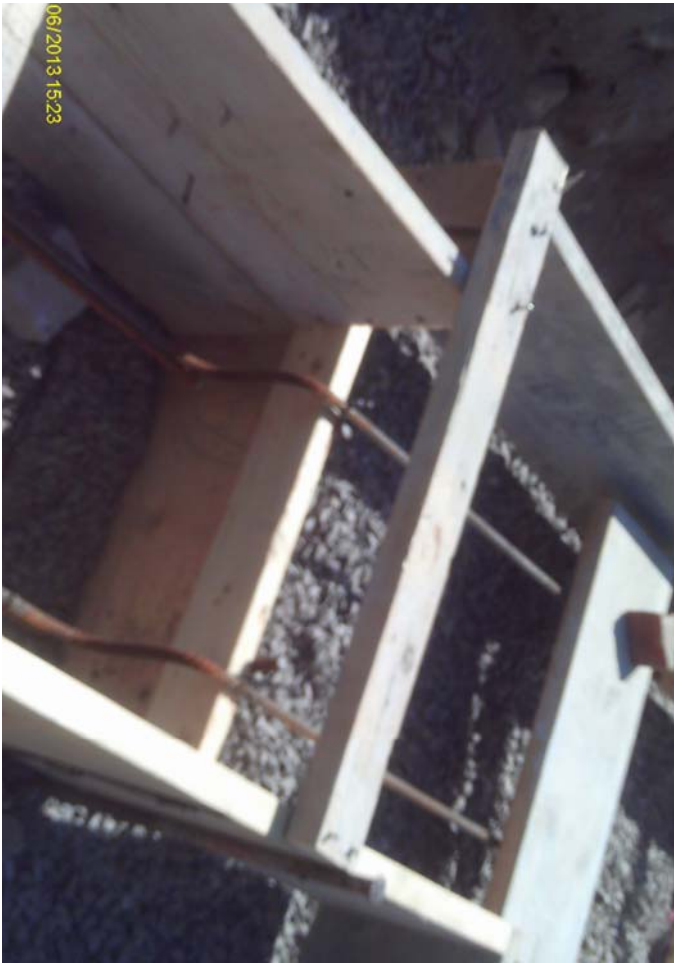
Newman Concrete wet stuck the vertical wall dowels #4's @ 48" O.C. Newman Concrete installed "Z" bars, as well as "L" bars in order to meet requirement of (2) #5's continuously at steps in footing line A and line 8.
