Concrete Construction Observation Report

Project Name/Location:	Marriott Courtyard	Project No.:	08-0494.2
Client/Client's Rep.:	J.B. Brown & Sons	Date:	5-15-13
Concrete Contractor:	Newman Concrete	Sheet:	1 of 1
Placement Location:	Resident's elevator pit and slab	SWCE Rep.:	JBrown
Placement Type:	Footing <input checked="" type="checkbox"/> Wall <input type="checkbox"/> Column <input type="checkbox"/> Slab <input type="checkbox"/> Other <input type="checkbox"/>	Arrived at Site:	8:45
		Left Site:	1:00

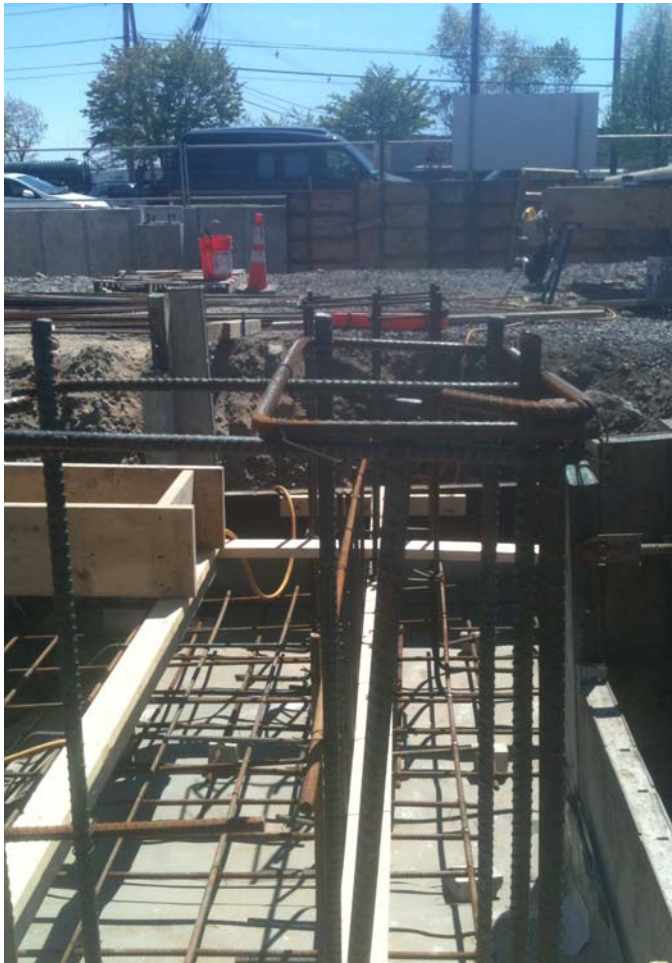
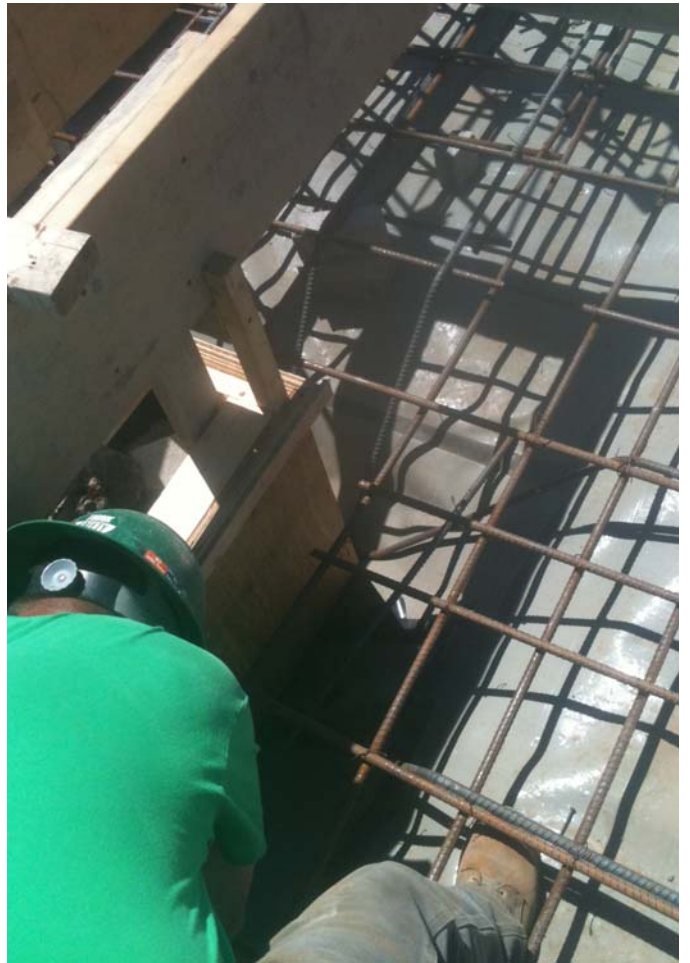
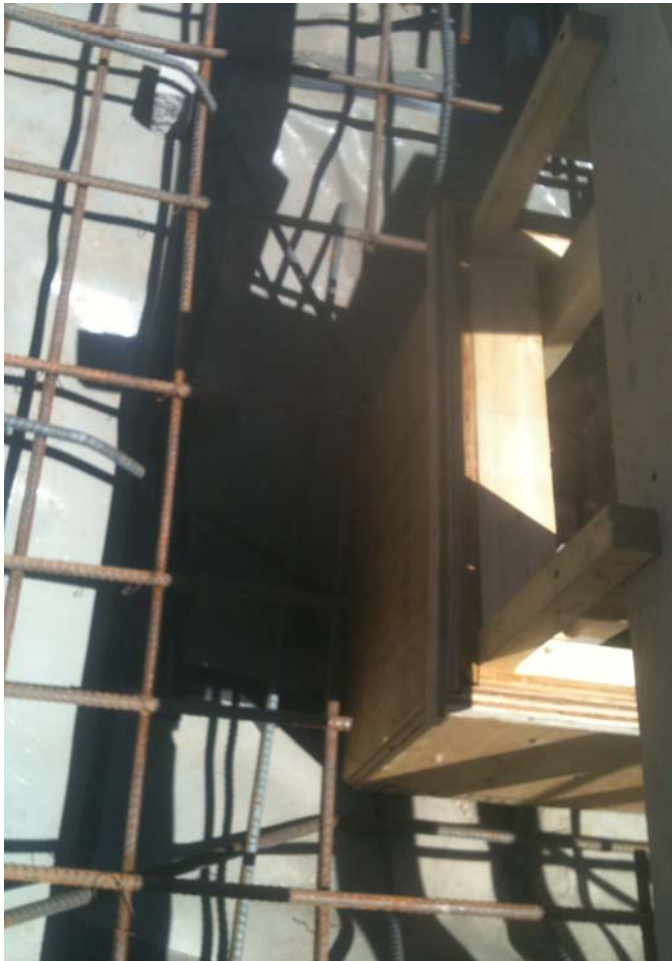
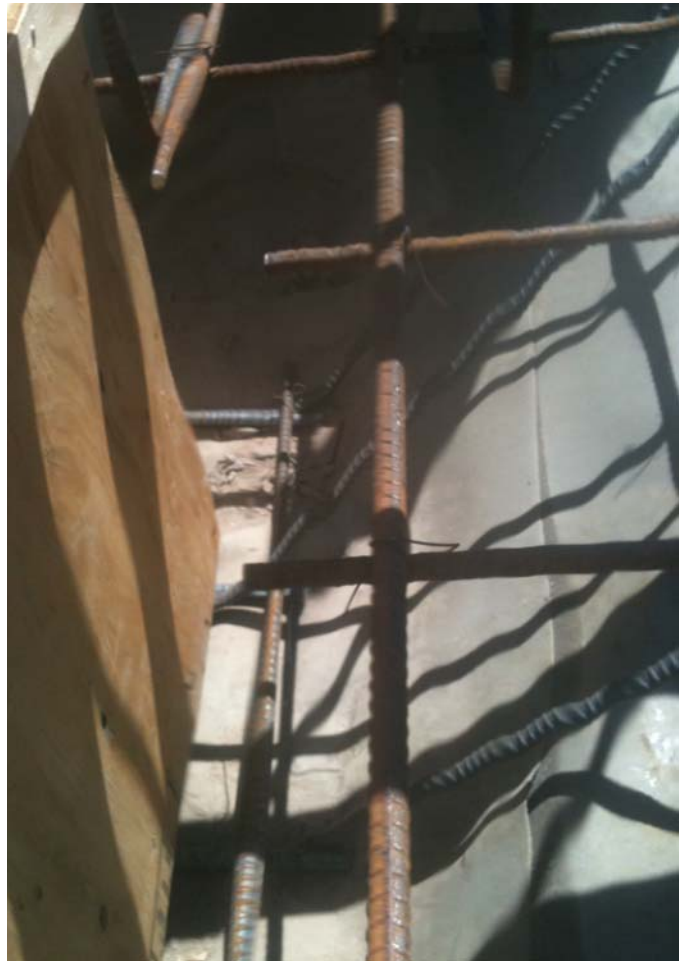
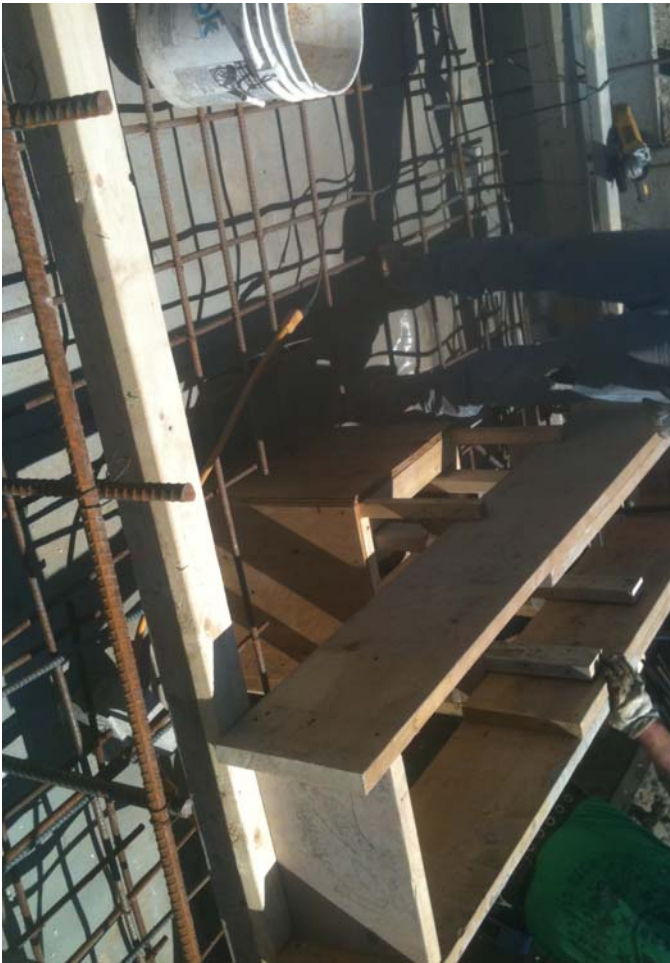
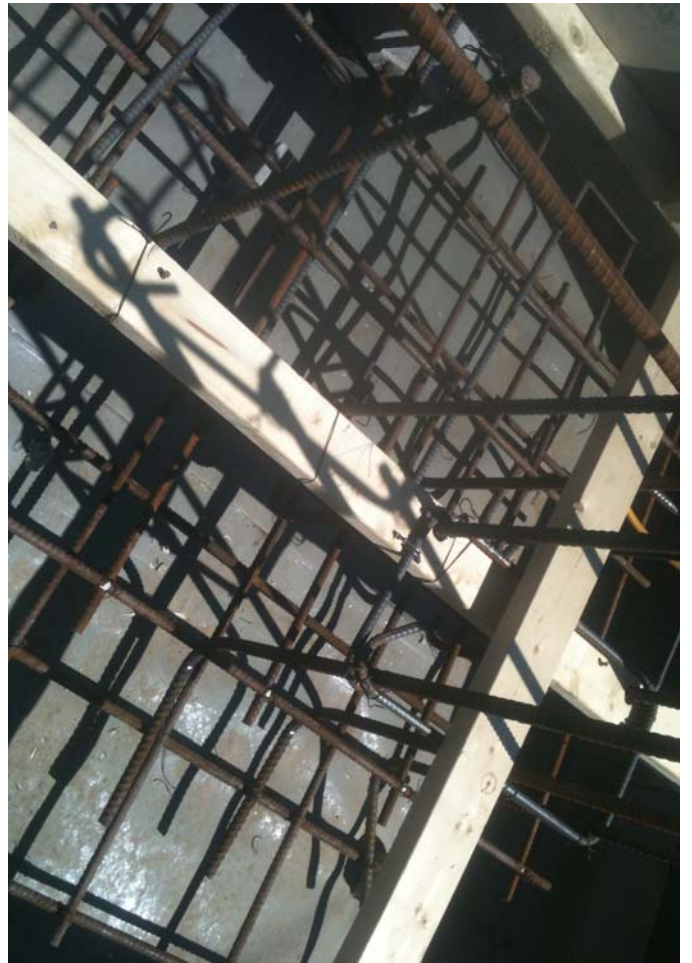
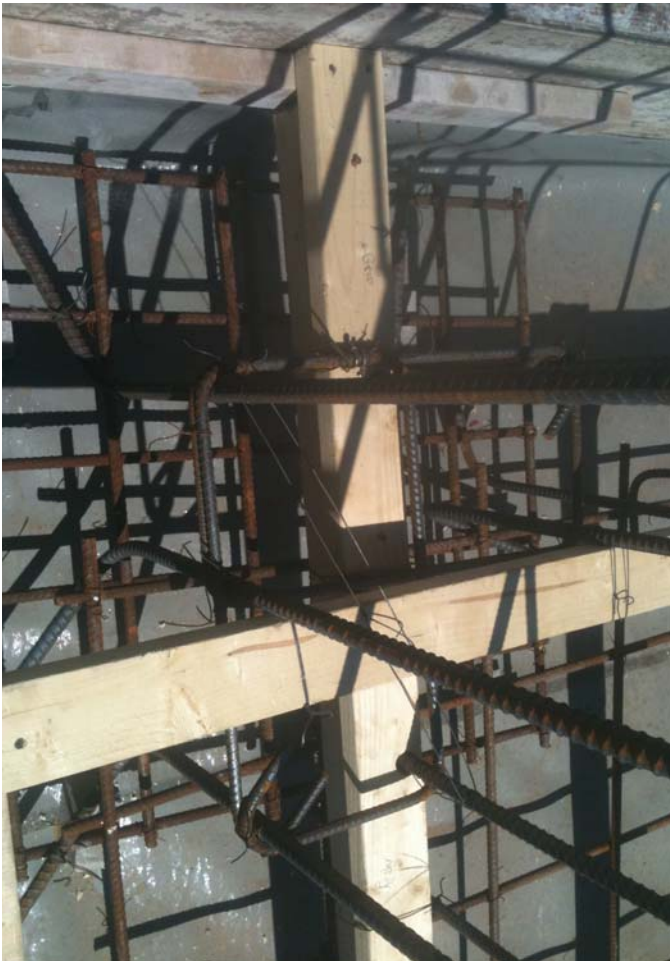
Notes:
 Upon initial rebar inspection, the "Z" bars underneath the elevator sump were on the wrong sides; i.e.: running parallel to Commercial Street instead of perpendicular. Dave (Opechee Construction) left these "Z" bars in place and added three more the correct way, including a horizontal 4' straight bar tied to each new "Z" bar on the sloping face. All other rebar seemed in conformance to the plans and specifications.
