COMPASS HEALTH
Tenant Fit up
 Merrill's Wharf, Portland, Maine

Misc. Details

A3.1

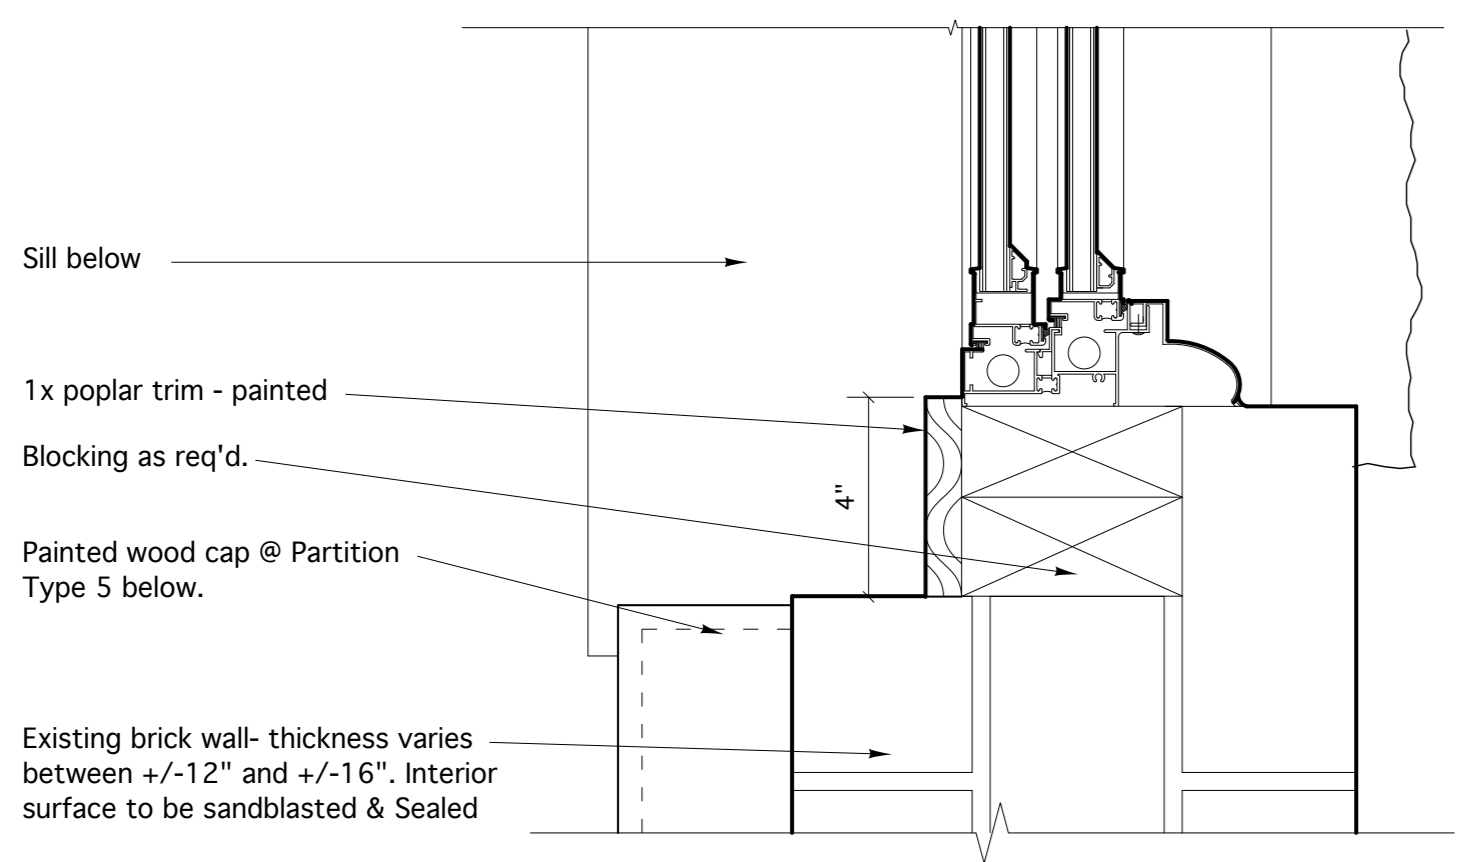
JAMB CONDITION @ Above 48" A.F.F.
