**3 UNIT APARTMENT BUILDING**  
**135 YORK STREET**  
 PEERLESS INVESTMENTS, LLC.  
 1 PORTLAND SQUARE  
 PORTLAND, MAINE 04101

**SECTION & DETAILS**

**A6**  
 COPYRIGHT REPRODUCTION OR REVUE OF THIS DOCUMENT WITHOUT WRITTEN PERMISSION FROM GRANT HAYS ASSOCIATE IS PROHIBITED.

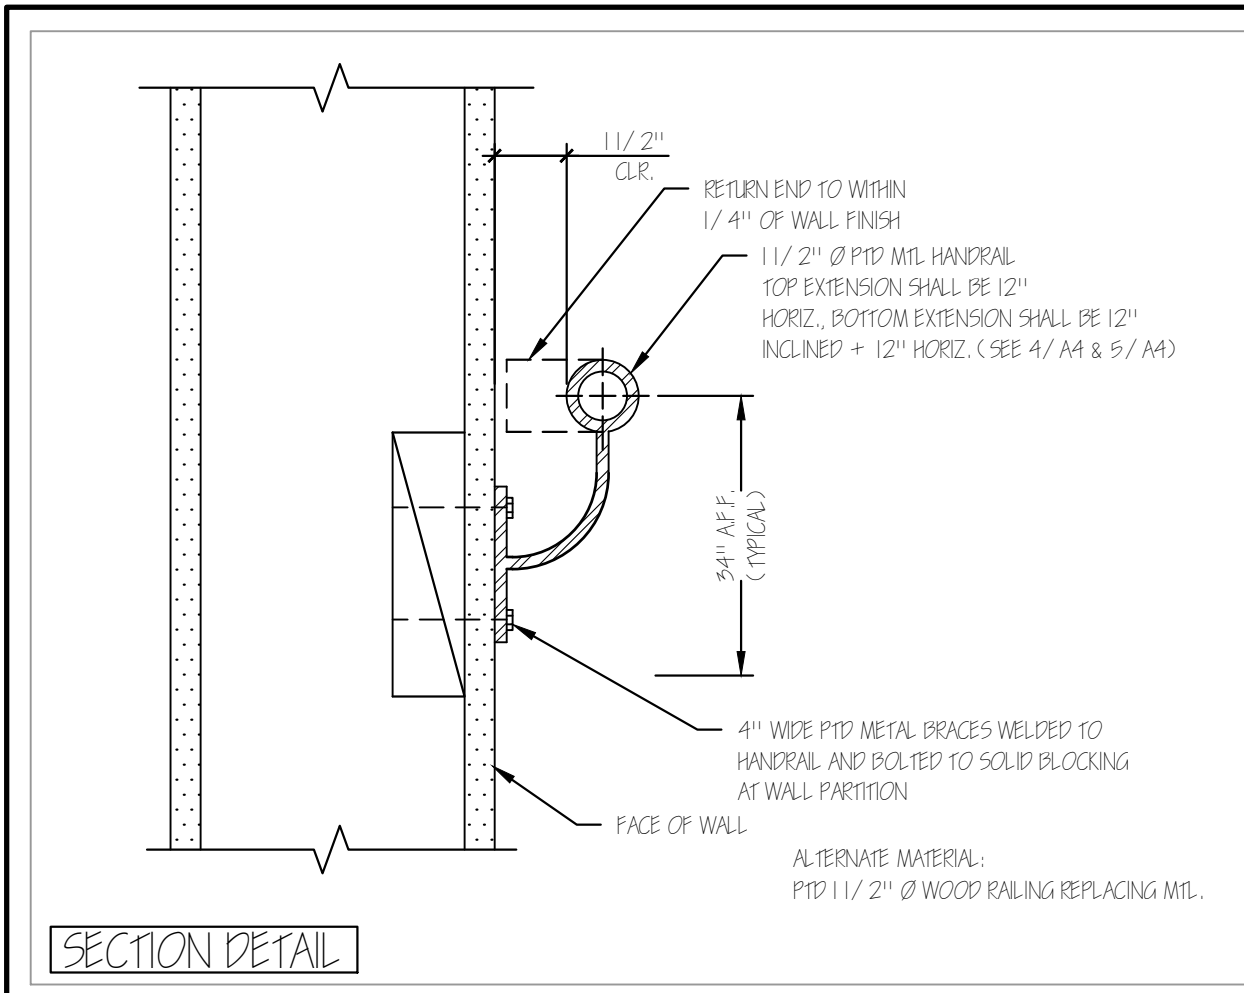
1 TYPICAL WALL HANDRAIL SECTION 3"=1'-0"

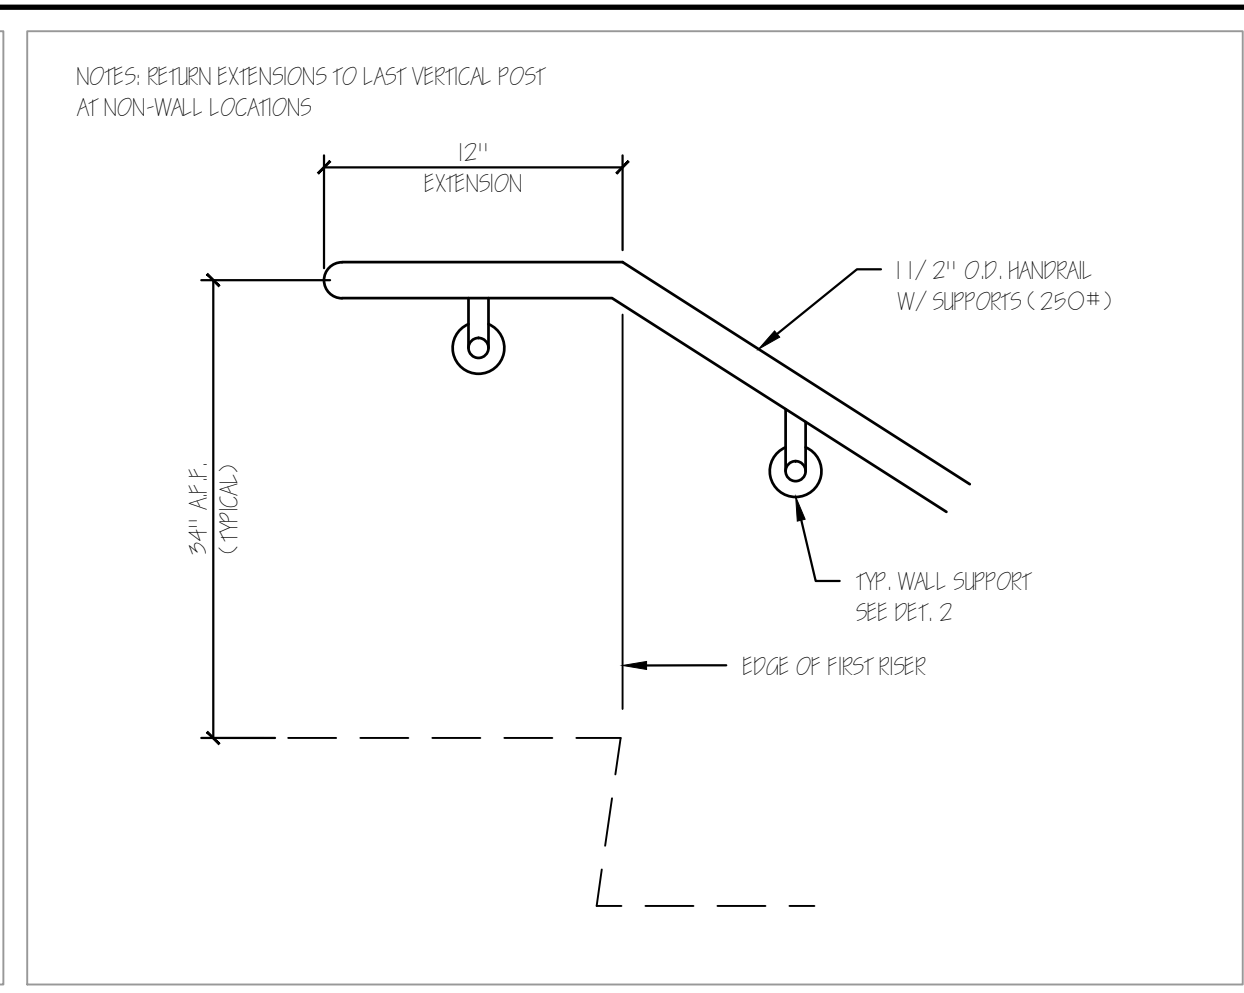
2 TYPICAL WALL HANDRAIL-TOP 3"=1'-0"

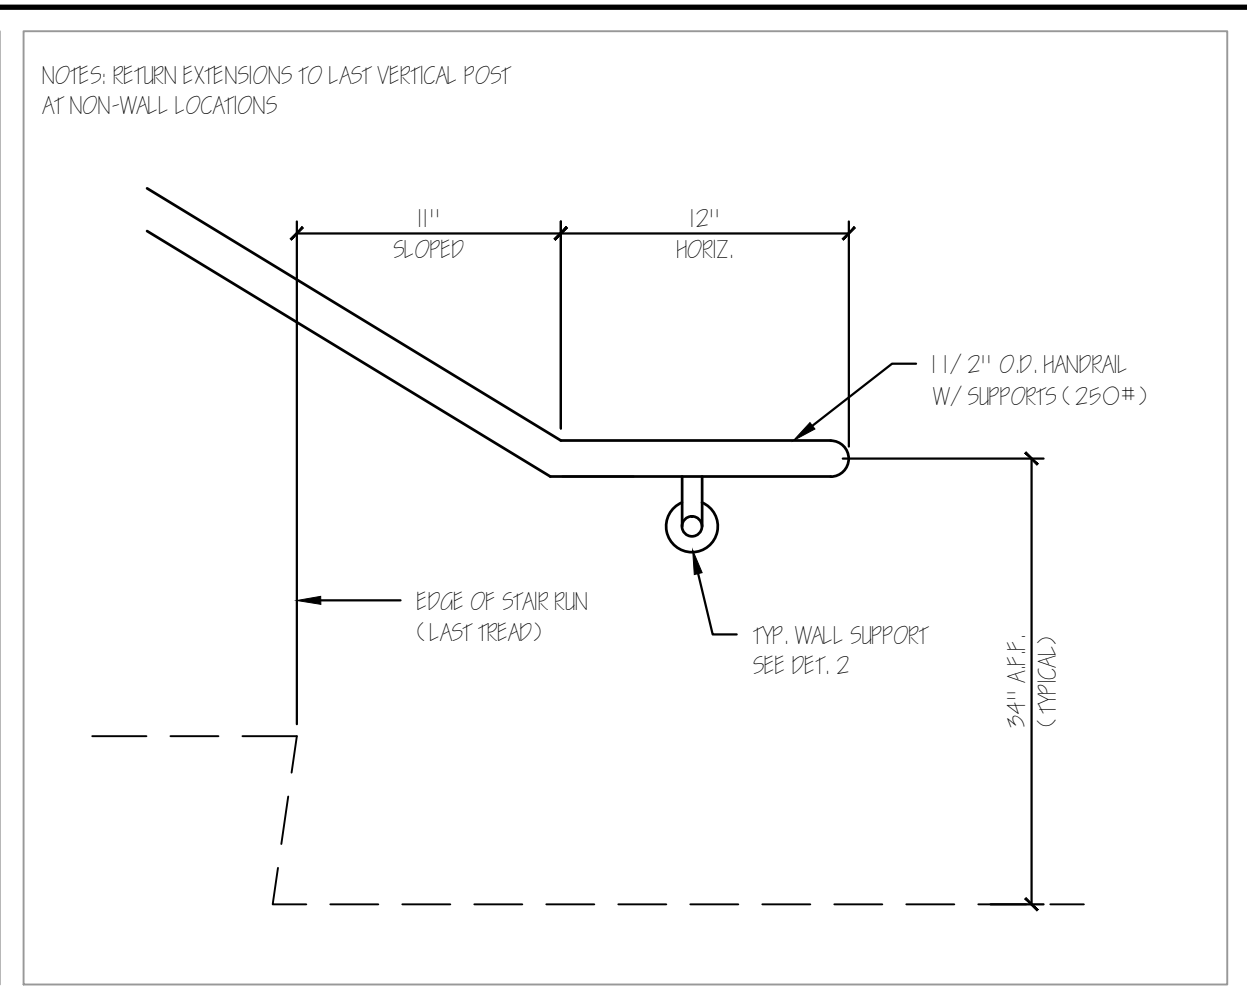
3 TYPICAL WALL HANDRAIL-BOTTOM 3"=1'-0"

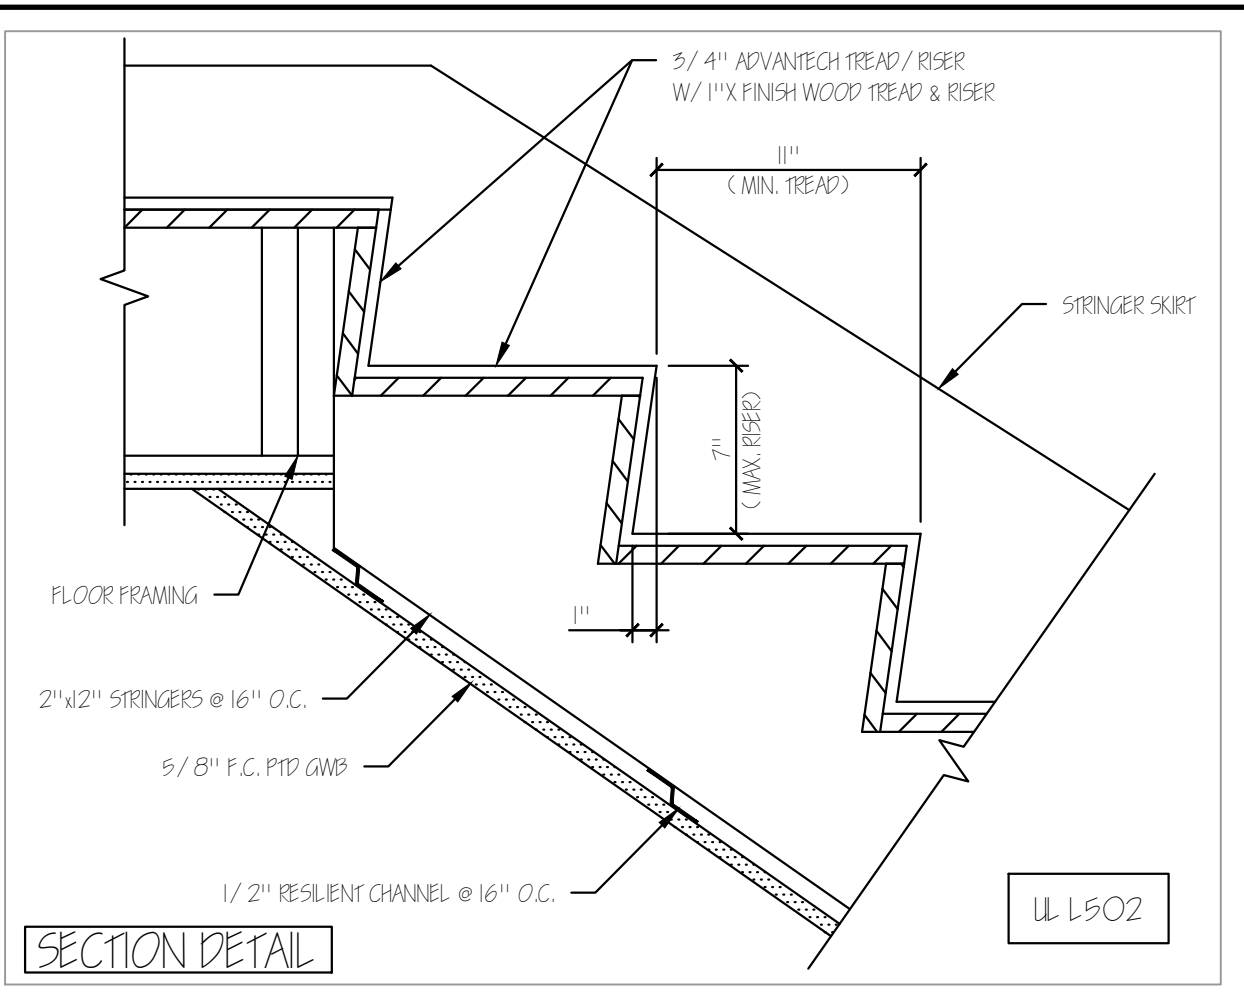
4 INTERIOR STAIR RISER/ TREAD DETAIL 1 1/2"=1'-0"

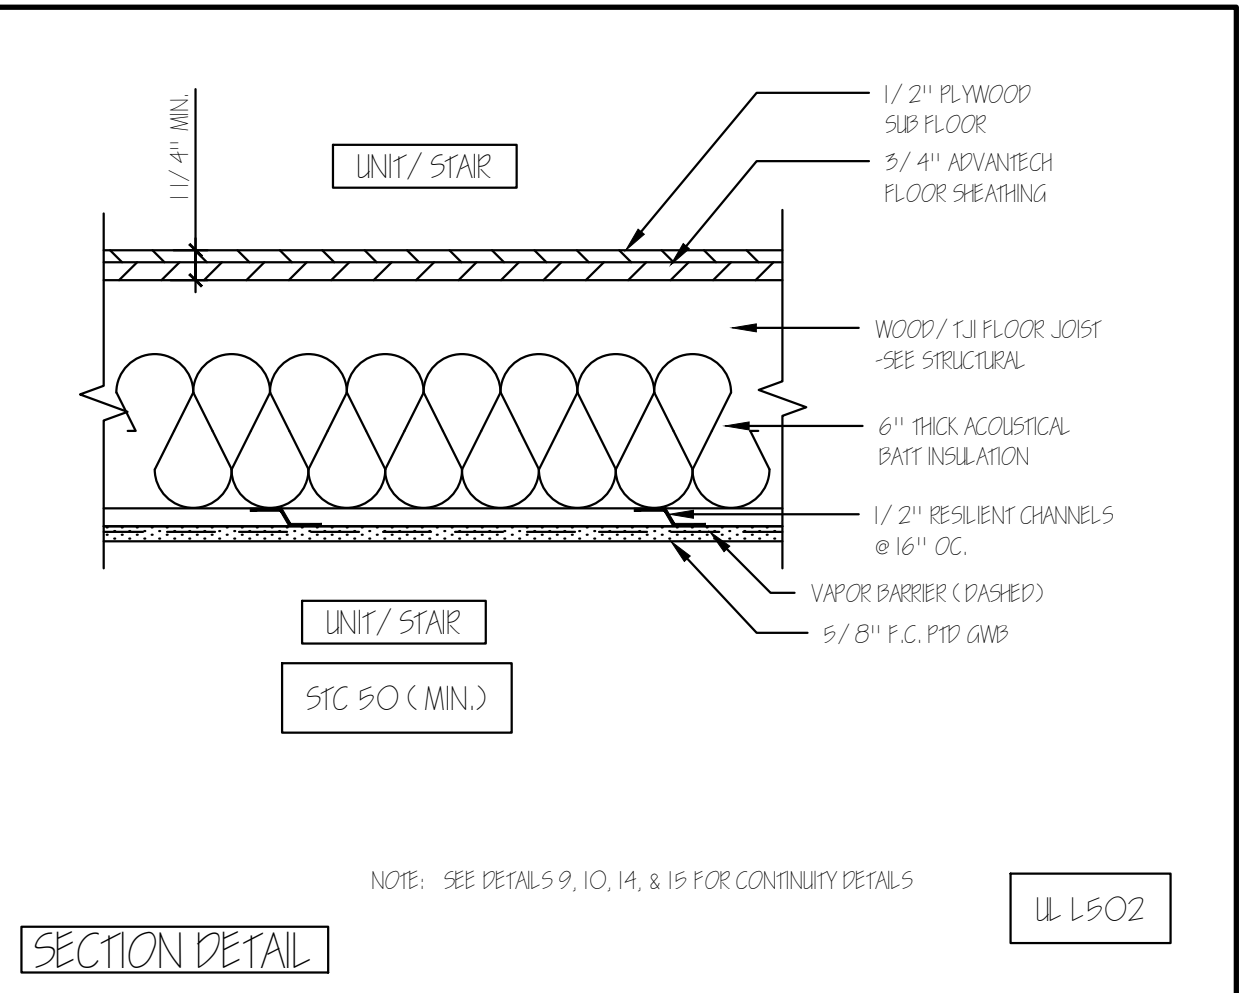
5 1 HR RATED FLOOR/ CEILING ASSEMBLY 1 1/2"=1'-0"

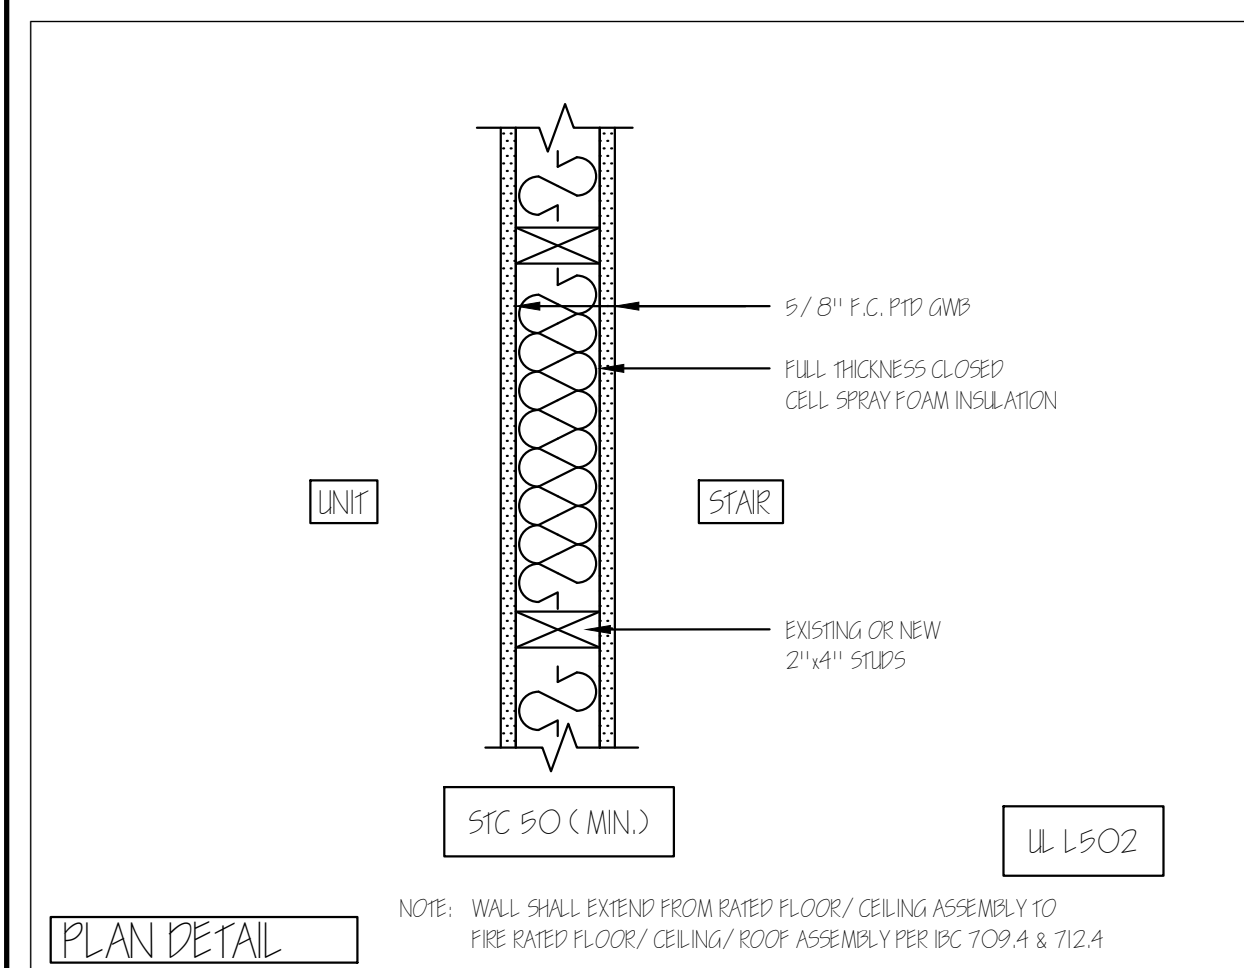
6 1 HR RATED PARTITION AT STAIR 1 1/2"=1'-0"

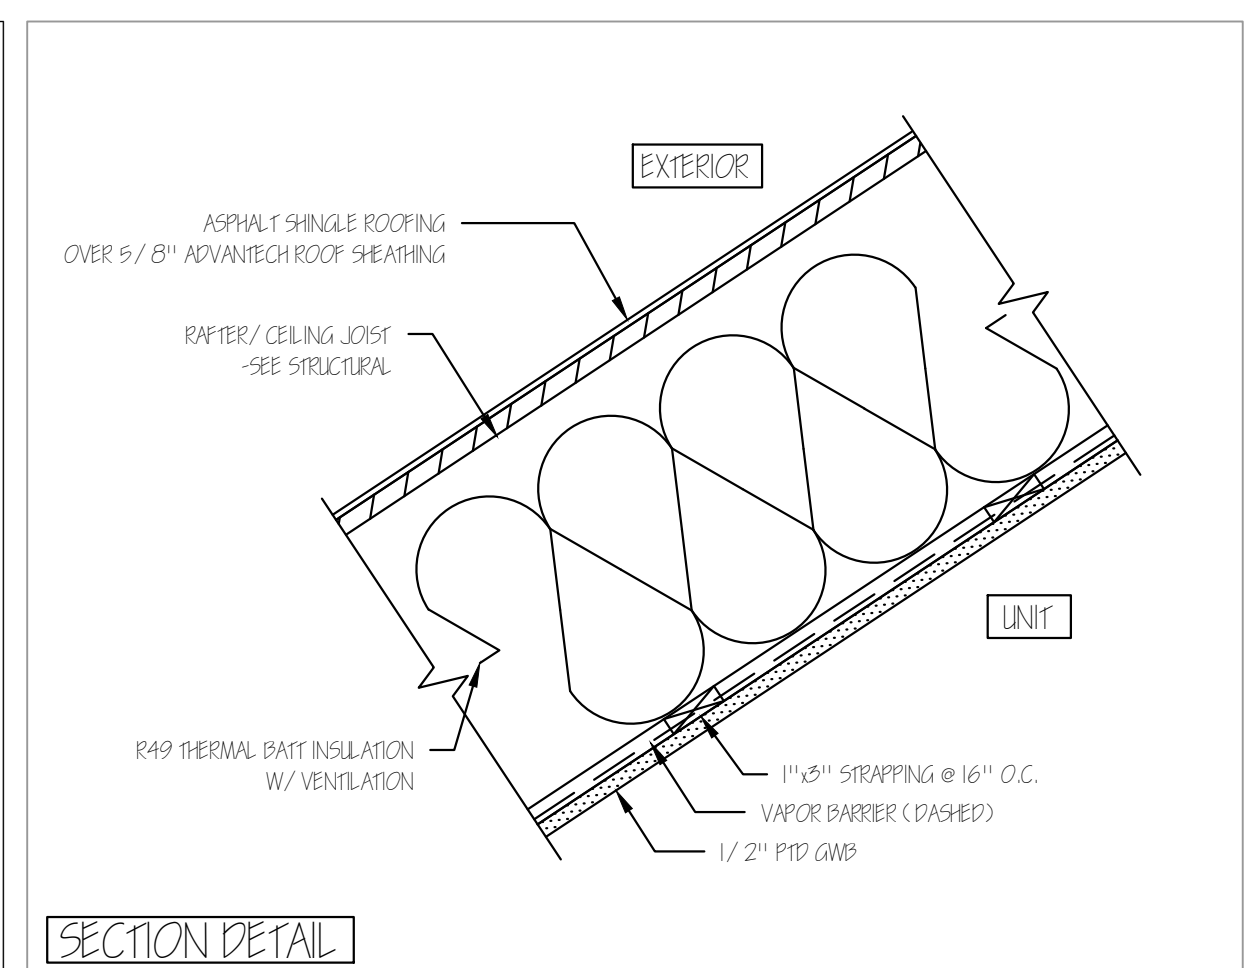
7 NON-RATED NEW ROOF 1 1/2"=1'-0"

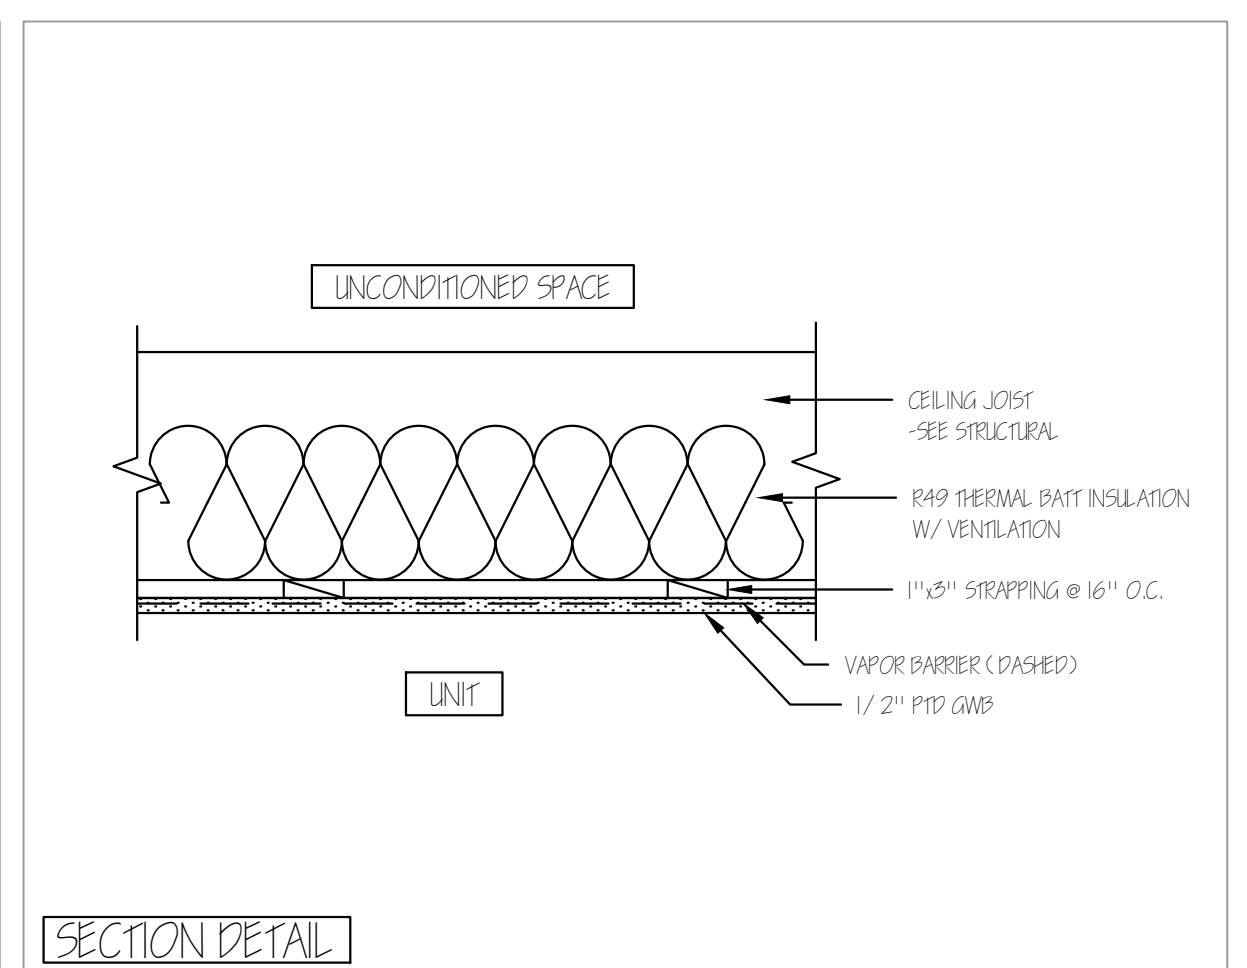
8 NON-RATED NEW CEILING 1 1/2"=1'-0"

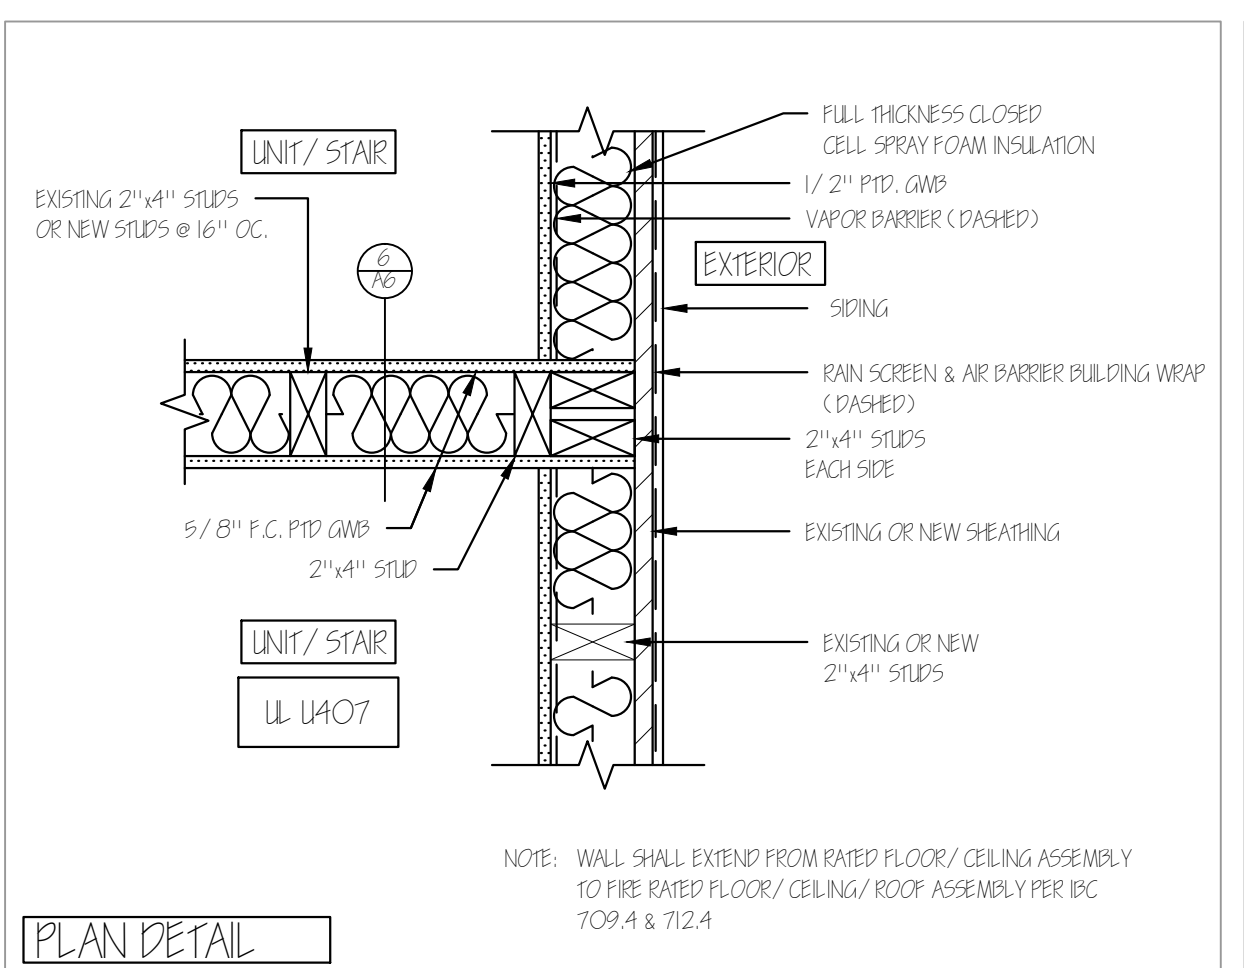
9 1 HR RATED PARTITION @ NON-RATED EXTERIOR WALL ASSEMBLY 1 1/2"=1'-0"

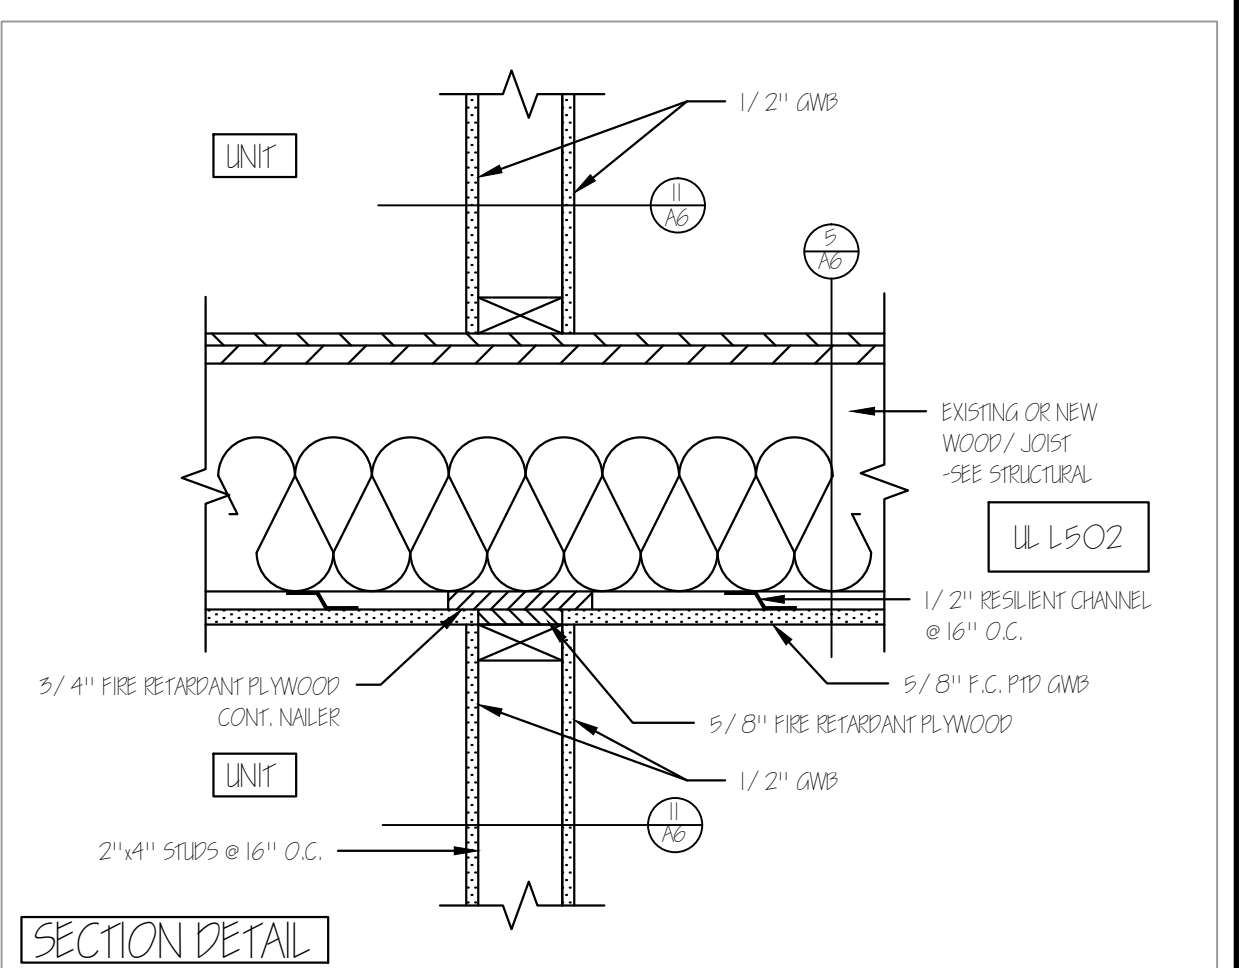
10 NON-RATED PARTITION @ 1 HR FIRE RATED FLOOR/ CEILING ASSEMBLY 1 1/2"=1'-0"

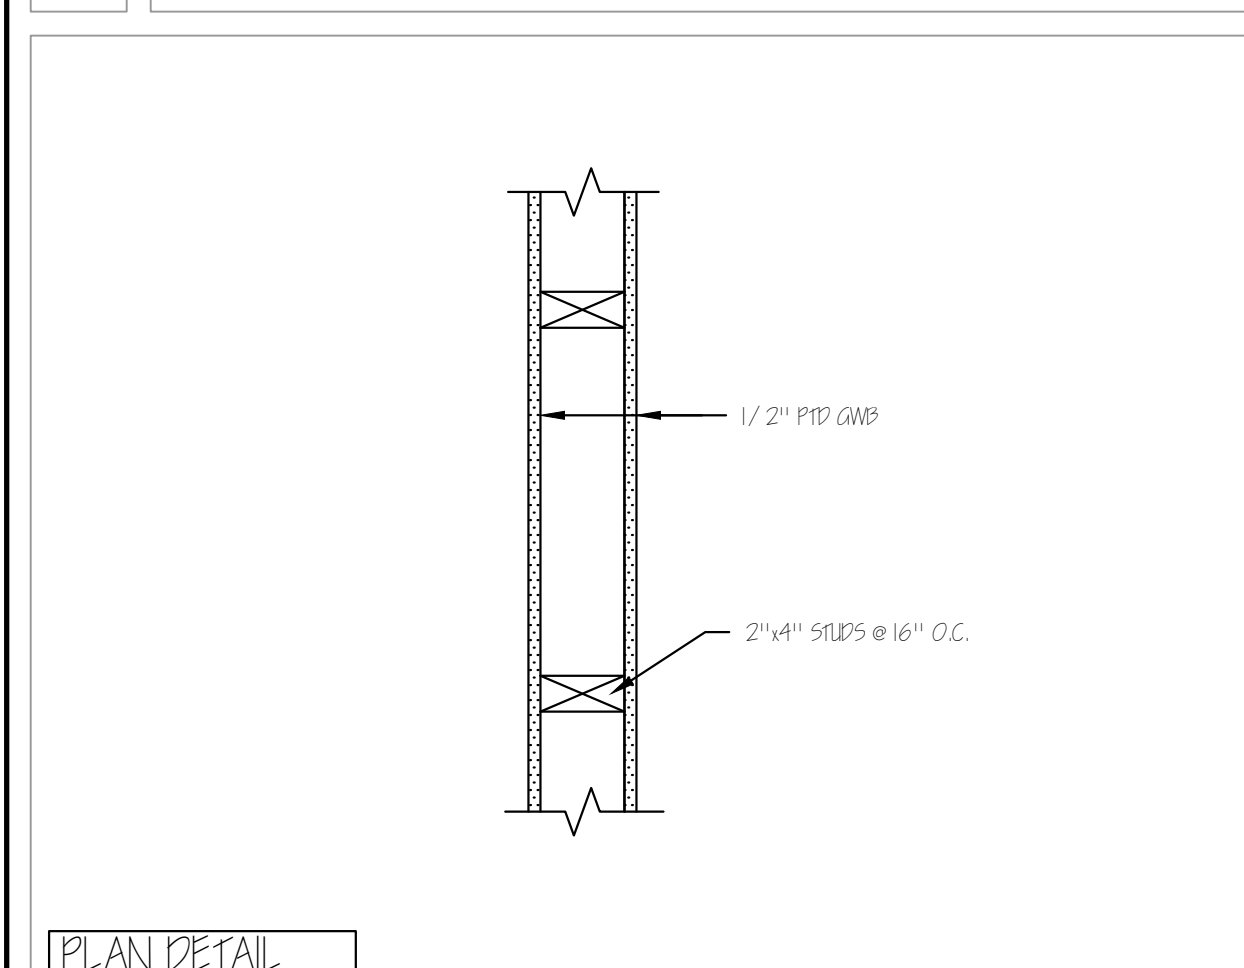
11 NON-RATED INTERIOR PARTITION 1 1/2"=1'-0"

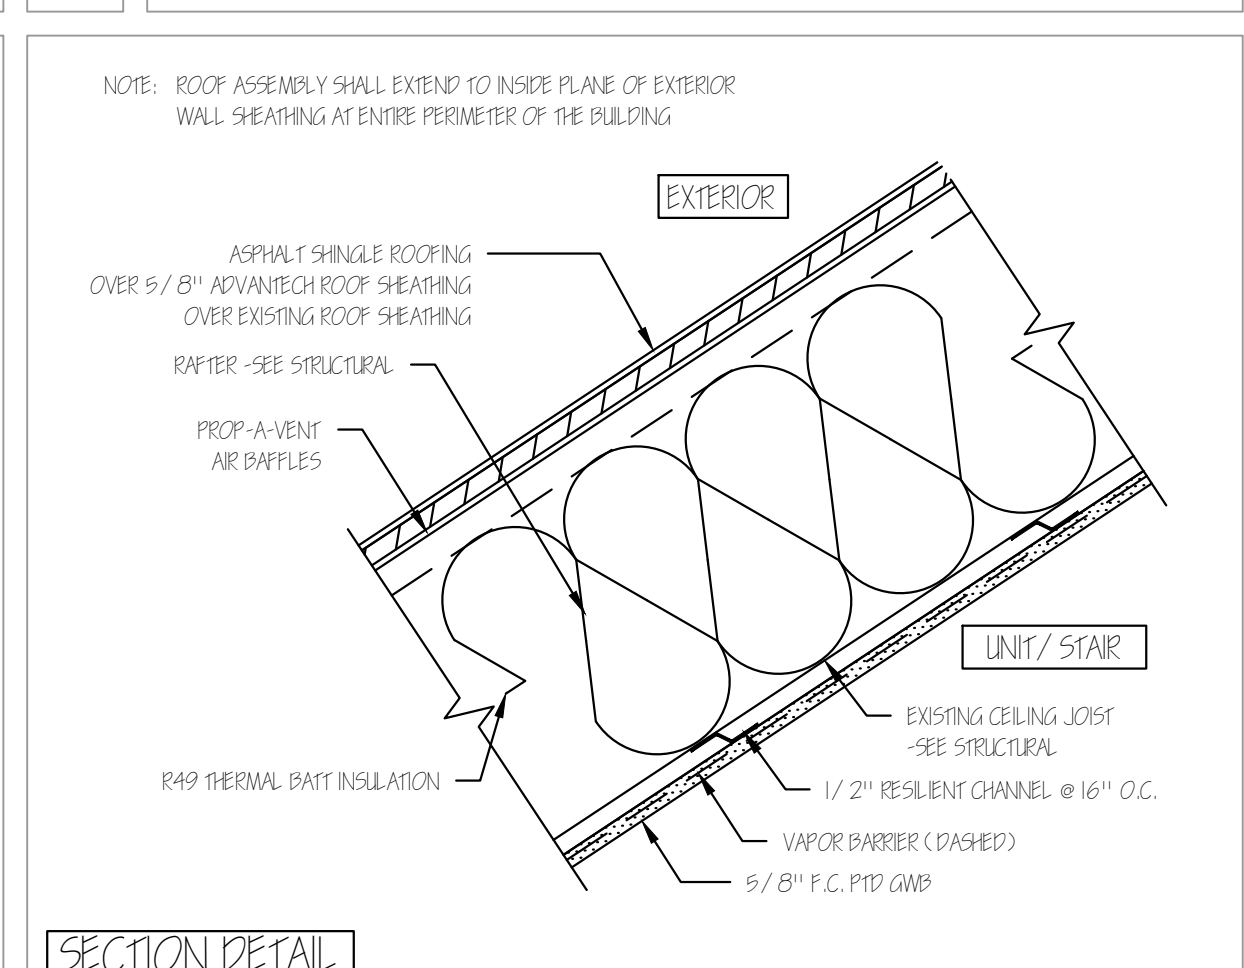
12 1 HR RATED CEILING ROOF ASSEMBLY 1 1/2"=1'-0"

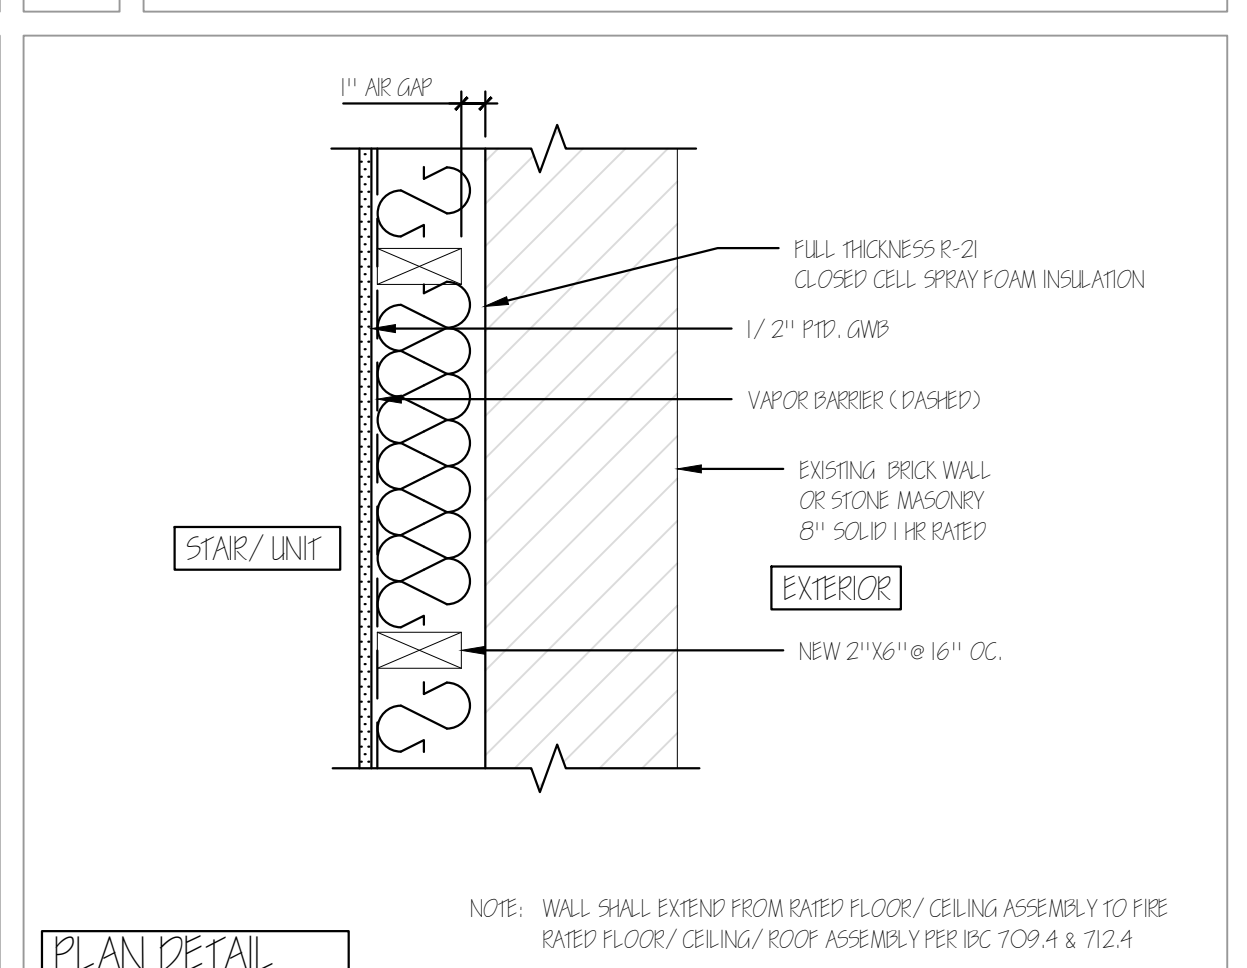
13 EXTERIOR WALL (BRICK/ STONE) 1 1/2"=1'-0"

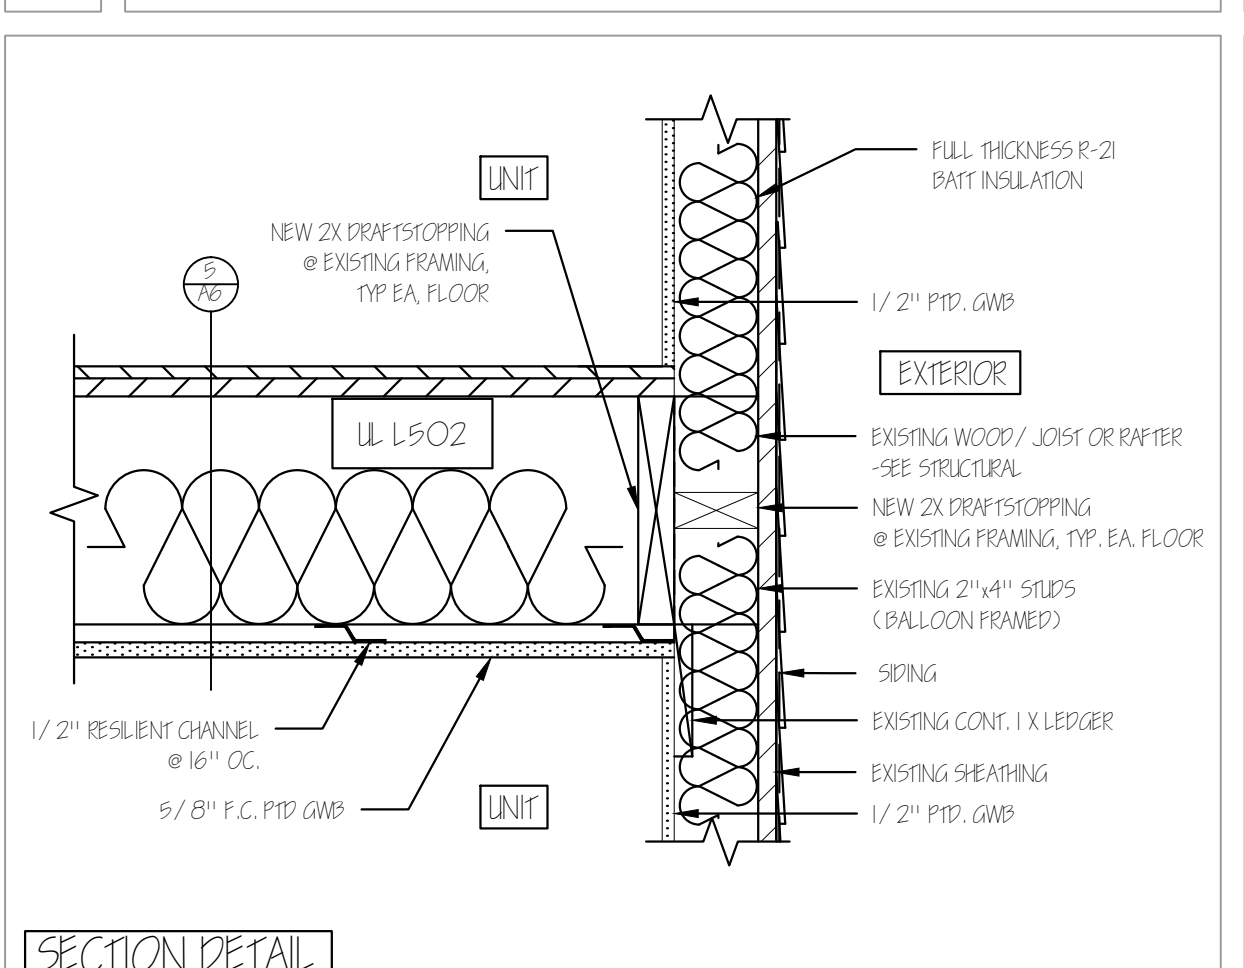
14 NON-RATED EXISTING EXTERIOR WALL 1 1/2"=1'-0"

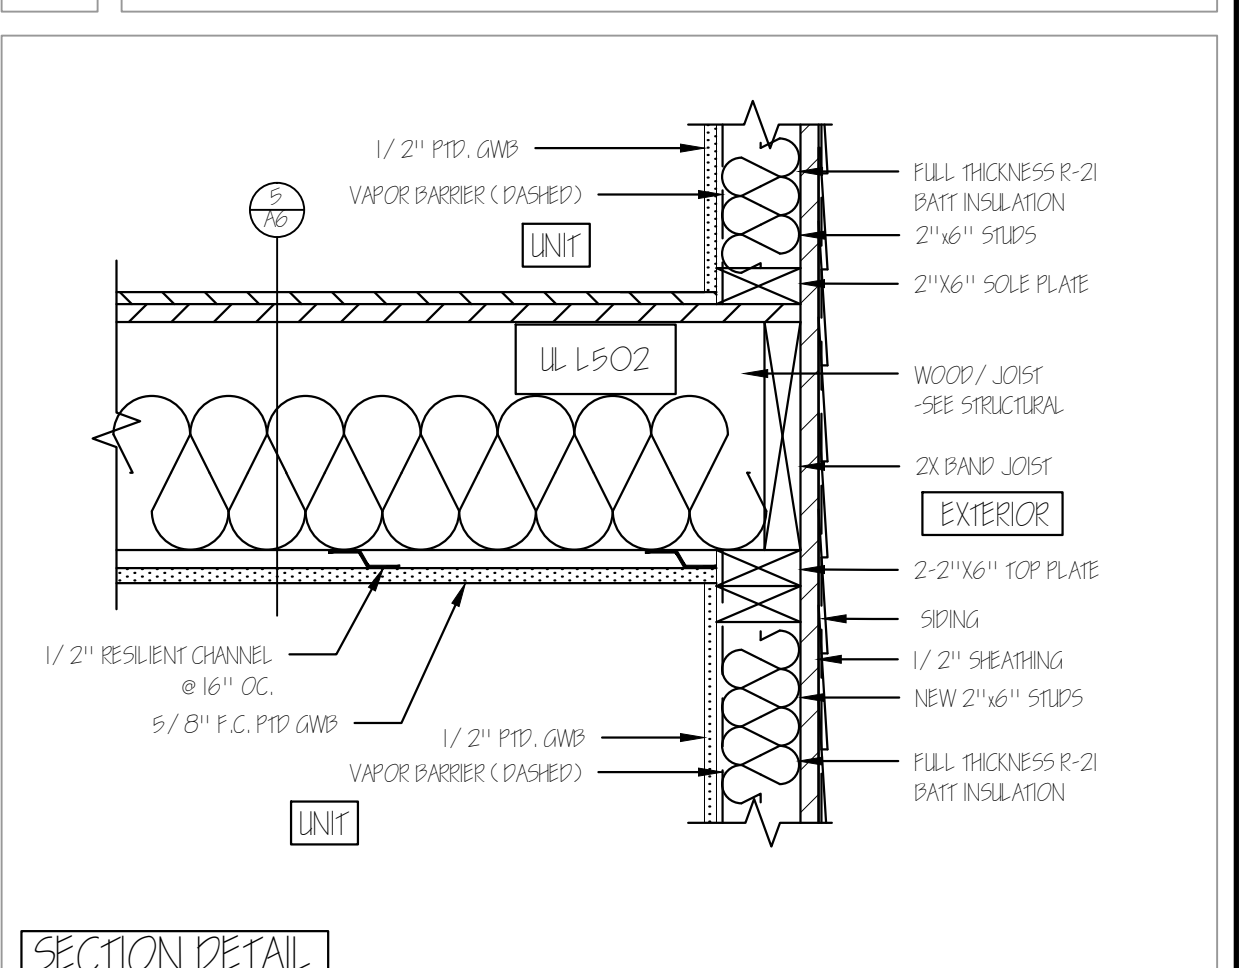
15 NON-RATED NEW EXTERIOR WALL 1 1/2"=1'-0"

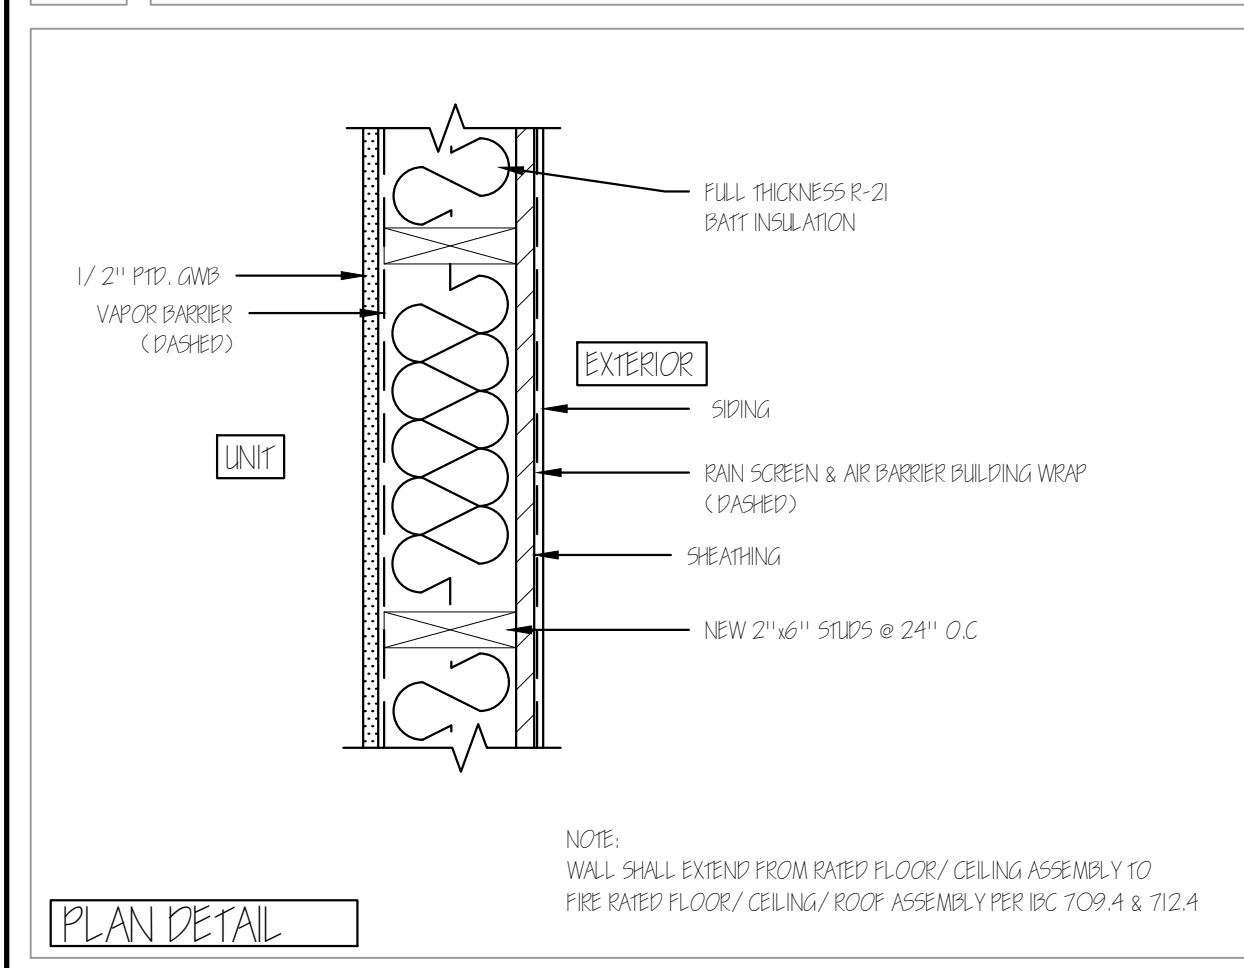
16 NON-RATED NEW EXTERIOR WALL 1 1/2"=1'-0"
