# 3 Stratton Front Stair, Detail (1)

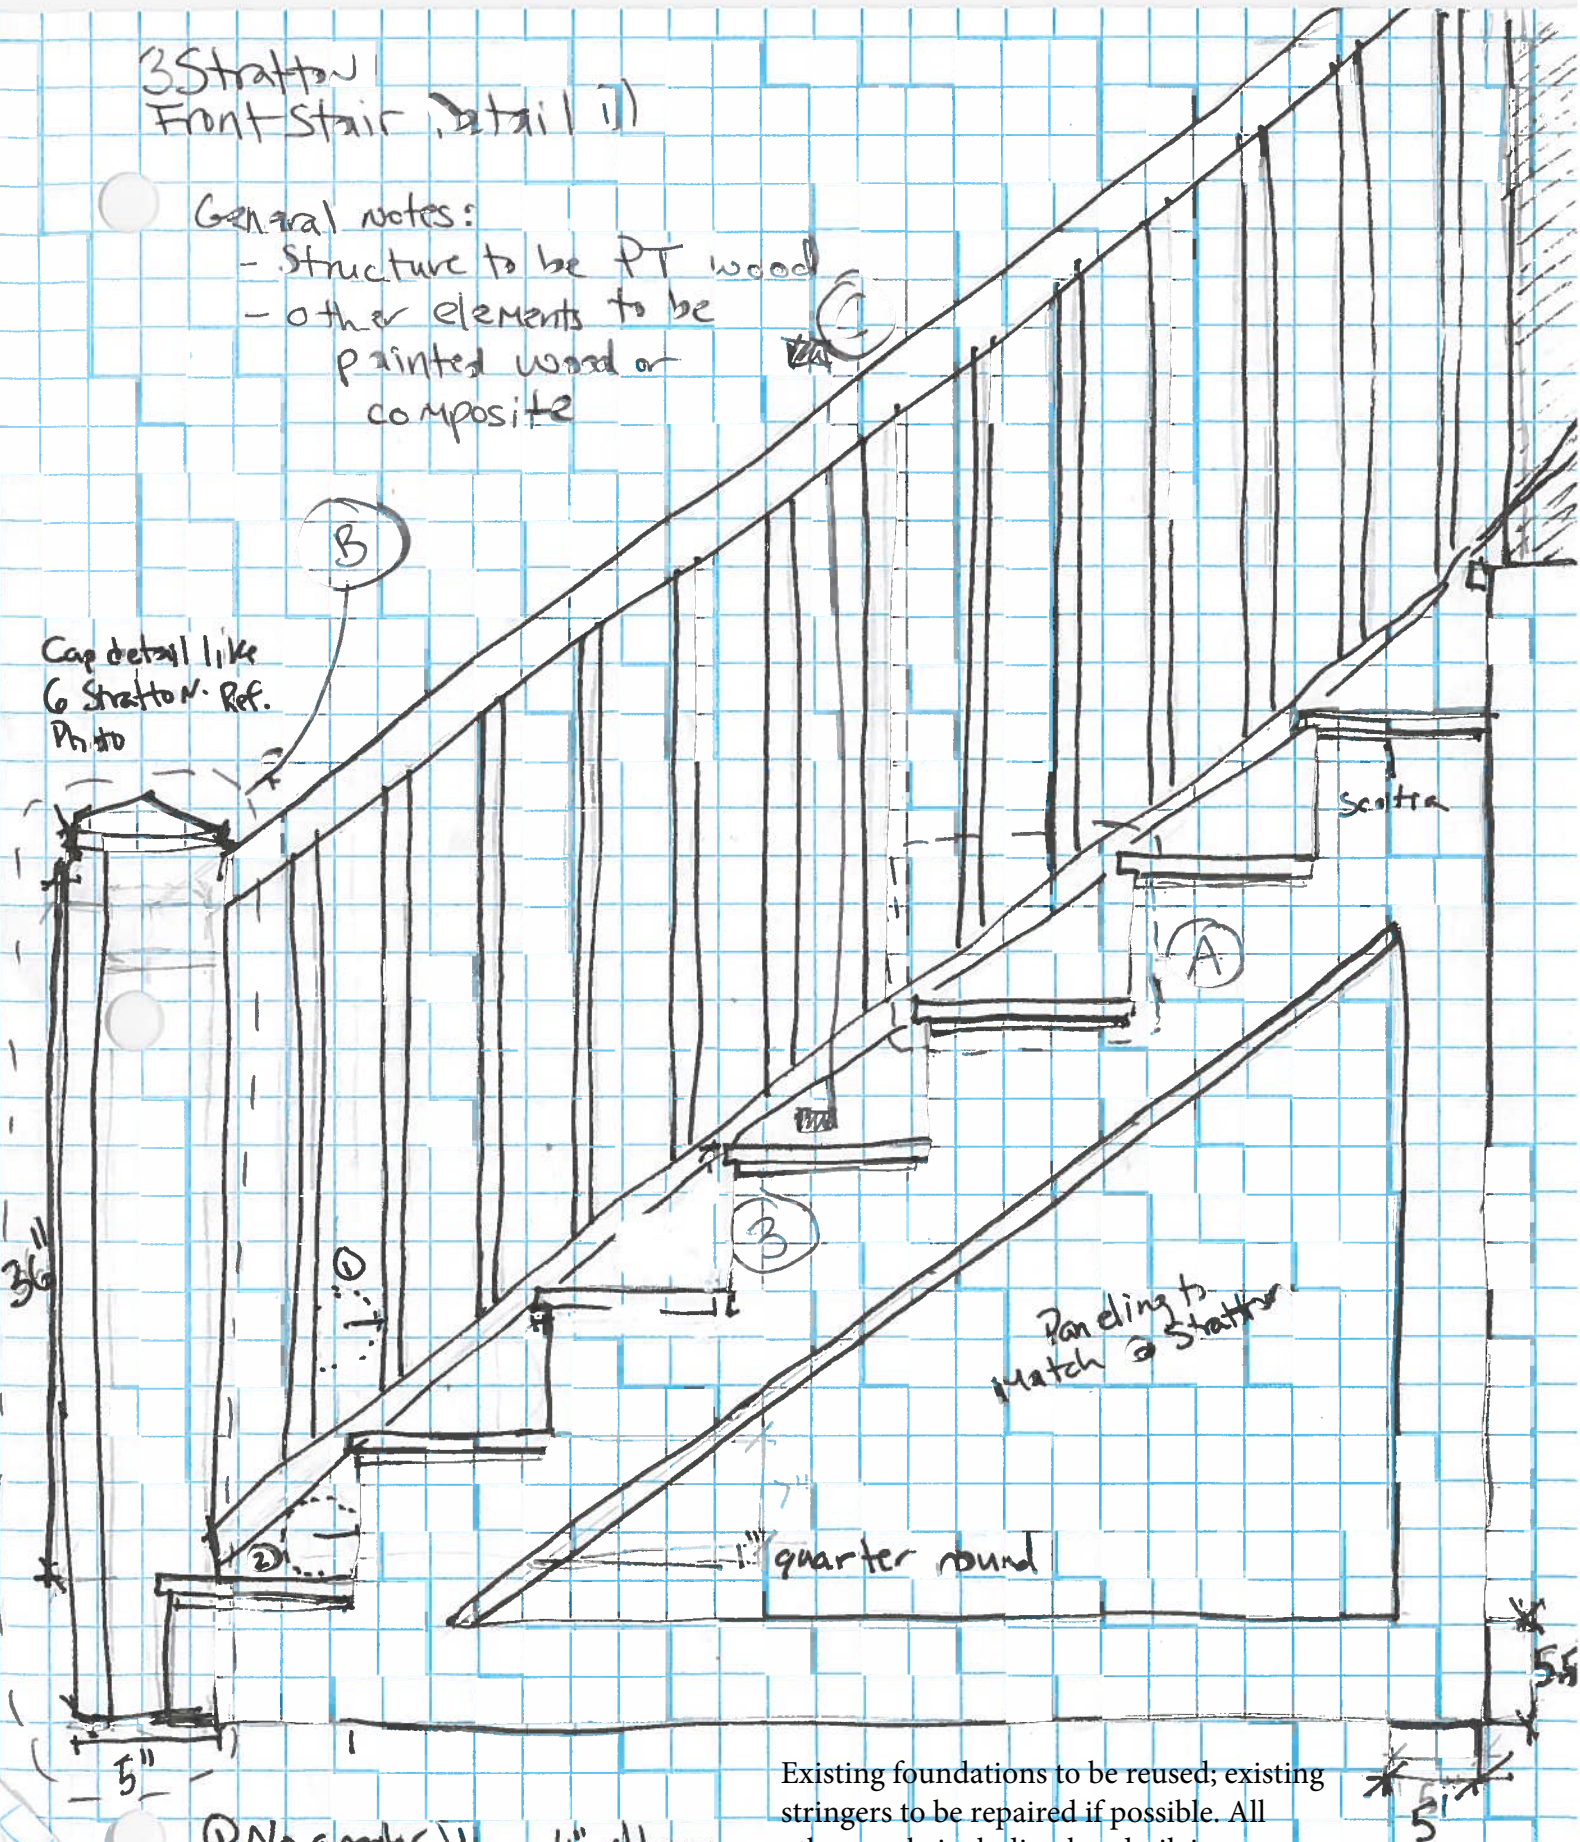
Cap detail like  
6 Stratton. Ref.  
Photo

Existing foundations to be reused; existing stringers to be repaired if possible. All other work, including handrail, is new and will meet 2009 IRC Building Codes.

- ① No greater than 4" sphere
- ② No greater than 3" radius
- ③ Existing stringers to remain or be repaired as needed. Existing rise and run to remain.
