FRONT ENTRY PLAN
SCALE: 1/2" = 1'-0"

DANFORTH STREET ELEVATION
SCALE: 1/2" = 1'-0"

REHABILITATION OF FRONT ENTRY
126 & 128 DANFORTH STREET
PORTLAND, MAINE
PLAN AND DANFORTH STREET PARTIAL ELEVATION

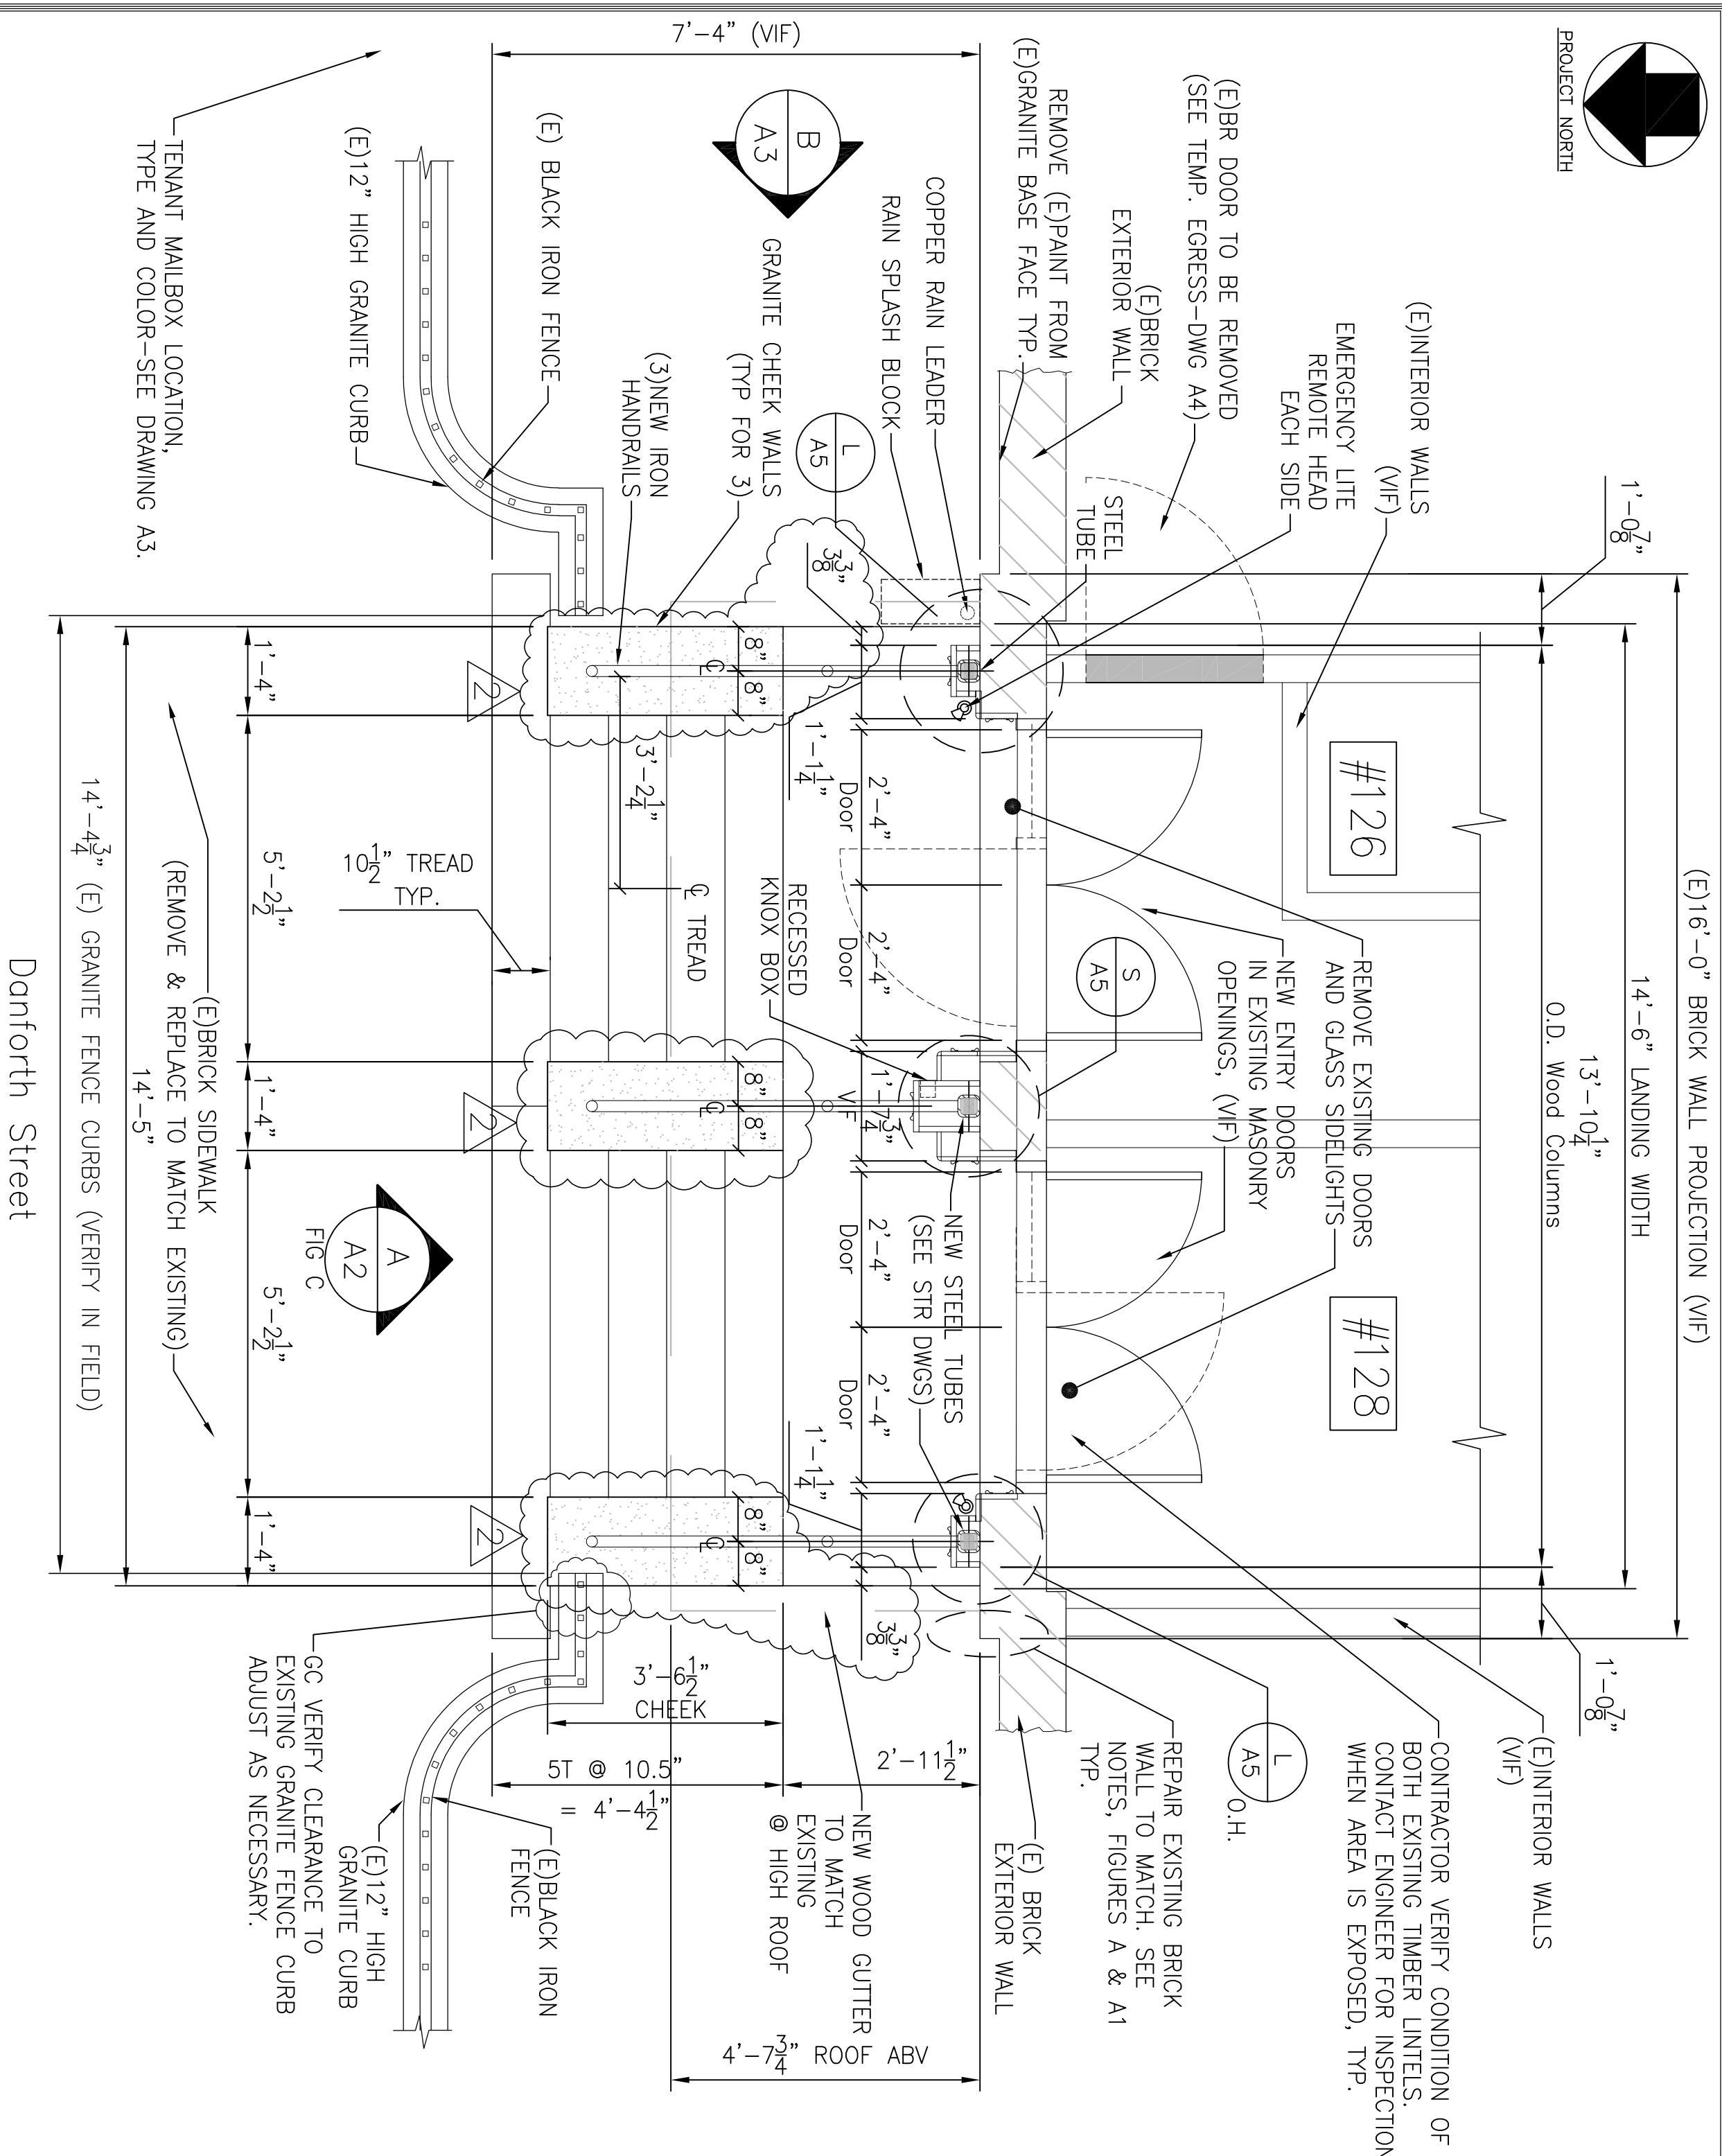
- Comparable building entries in the general area, door is typically single, solid, with sidelites; often with transoms.
- Proposal is to provide solid single entry doors set back from existing entrance plane.

- The set back entry system is enclosed within a square headed transom and is not constrained by existing arch-topped wood trim.
- The flat painted walls just behind the original wood trim offers a transition between the rehabilitated face and new entry panel doors. (Refer Section 1)

- Steps in 1924 image (Fig. 8) show treads with heavy shadow and are difficult to distinguish the material. Appears to be masonry or brownstone? The brick center divider may be a remnant of that stair system. We propose to remove the brick center divider at the landing level only. We proposed to construct granite center wall between the steps and up to the granite slab landing. (See drawings)

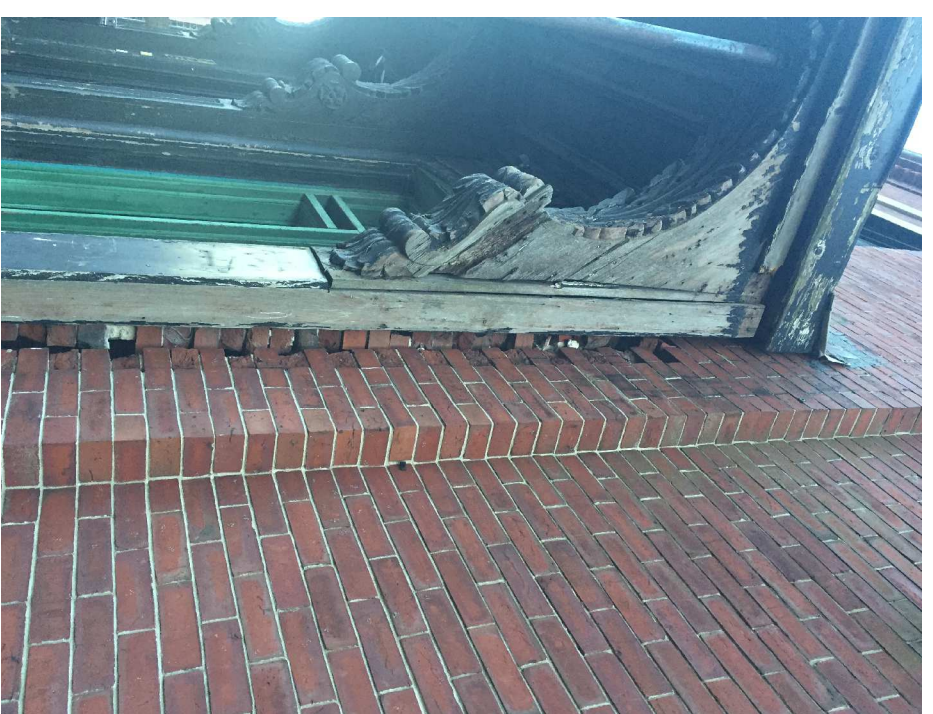
FIGURE A

Existing Structural Brick Wall Deficiency

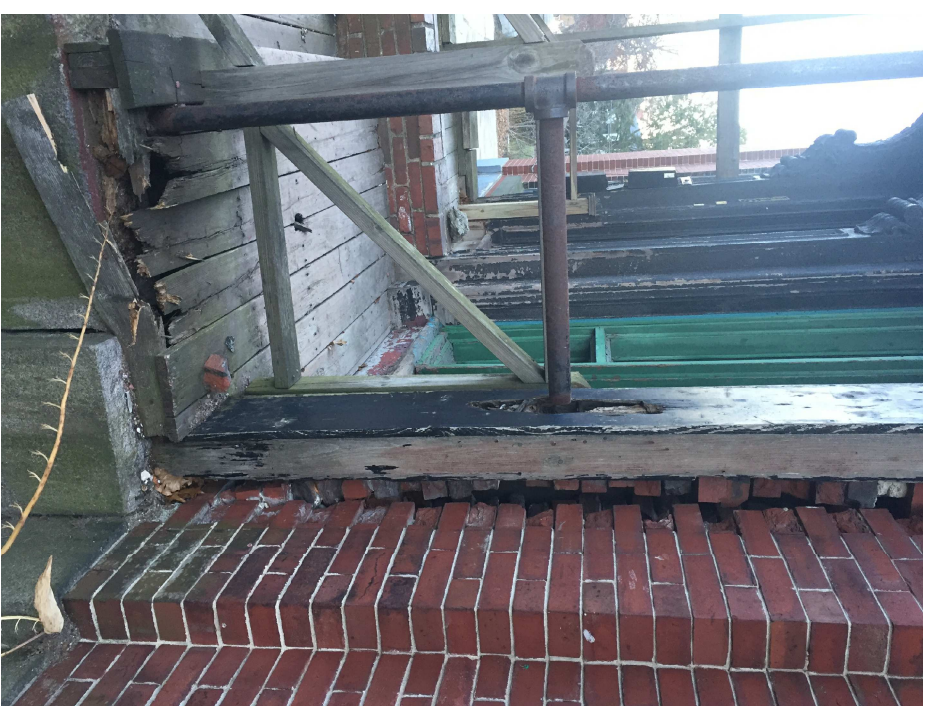
FIGURE A1

Existing Structural Brick Wall Deficiency

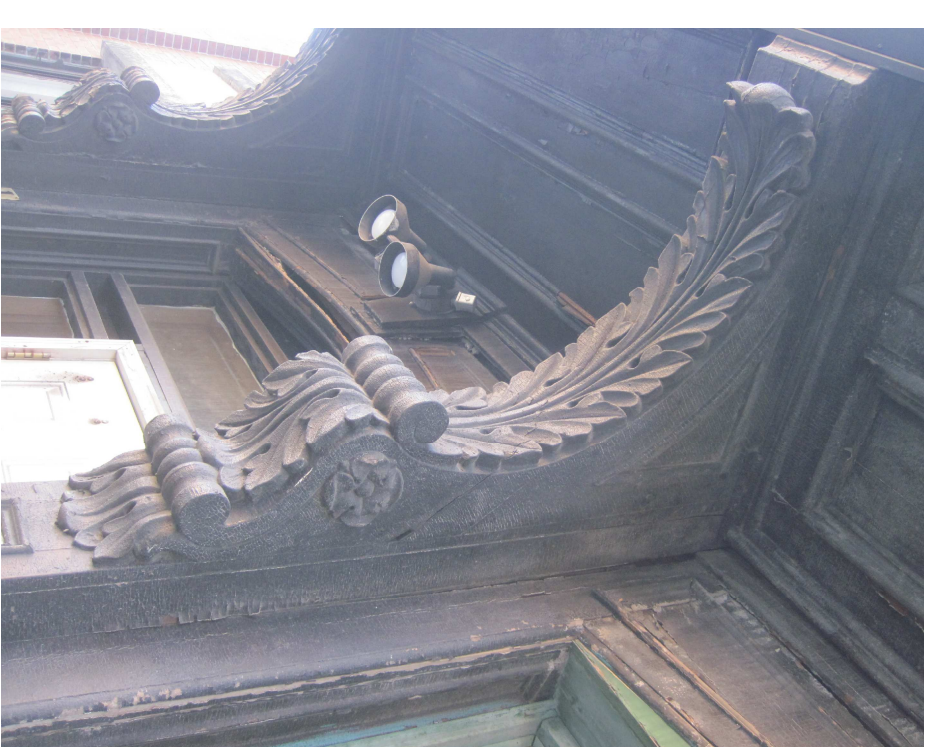
FIGURE B

Existing Carved Wood Brackets

- Existing segmental arched door surrounds relate to original bracketed door hood. No photos or evidence of original entry doors or their frames can be found other than the 1924 picture shown.
